MINERALS PROGRAM INSPECTION REPORT
PHONE: (303) 866-3567

MINE NAME: BLM/West End Pit	MINE/PROSPECTING ID#: M-1992-017	MINERAL: Sand and gravel	COUNTY: Montrose
INSPECTION TYPE: Monitoring	WEATHER: Clear	INSP. DATE: February 5, 2025	INSP. TIME: 11:00
OPERATOR: Montrose County	OPERATOR REPRESENTATIVE: Bo Andrews	TYPE OF OPERATION: 112c - Construction Regular Operation	
REASON FOR INSPECTION: Normal I&E Program	BOND CALCULATION TYPE: None	BOND AMOUNT: \$0.00	
DATE OF COMPLAINT: NA	POST INSP. CONTACTS: None	JOINT INSP. AGENCY: None	
INSPECTOR(S): Dustin Czapla	INSPECTOR'S SIGNATURE:

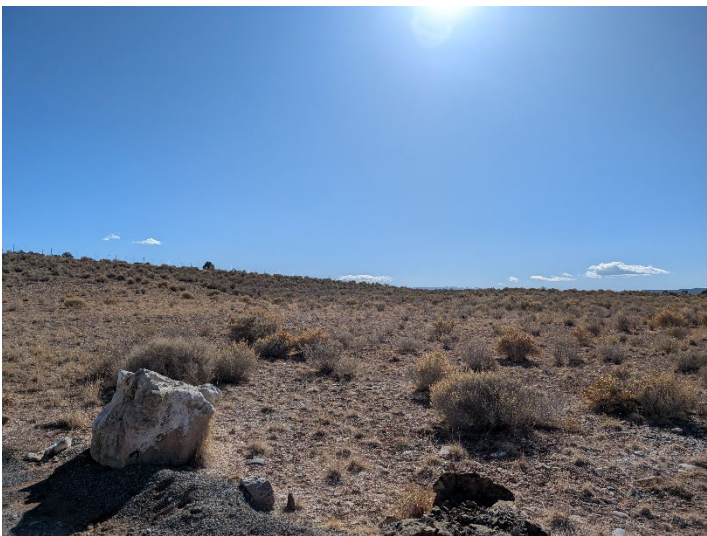
Reclamation area south side of pit

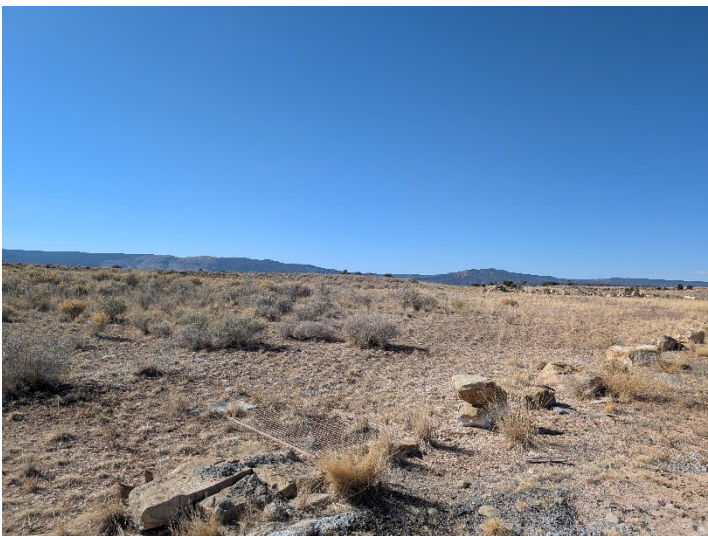
Reclamation area south side of pit
