**MINERALS PROGRAM INSPECTION REPORT**  
**PHONE: (303) 866-3567**

<b>MINE NAME:</b> Angie Pit	<b>MINE/PROSPECTING ID#:</b> M-2000-049	<b>MINERAL:</b> Gravel	<b>COUNTY:</b> Montrose
<b>INSPECTION TYPE:</b> Monitoring	<b>WEATHER:</b> Clear	<b>INSP. DATE:</b> February 5, 2025	<b>INSP. TIME:</b> 14:00
<b>OPERATOR:</b> Louisiana Land and Gravel Company, LLC	<b>OPERATOR REPRESENTATIVE:</b> Ward Priestly	<b>TYPE OF OPERATION:</b> 112c - Construction Regular Operation	
<b>REASON FOR INSPECTION:</b> Normal I&E Program	<b>BOND CALCULATION TYPE:</b> Complete Bond	<b>BOND AMOUNT:</b> \$103,365.00	
<b>DATE OF COMPLAINT:</b> NA	<b>POST INSP. CONTACTS:</b> None	<b>JOINT INSP. AGENCY:</b> None	
<b>INSPECTOR(S):</b> Dustin Czapla	<b>INSPECTOR'S SIGNATURE:</b>

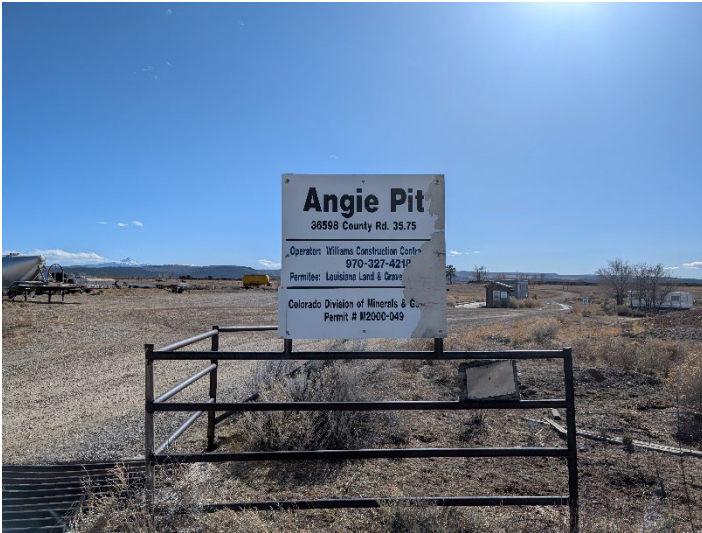
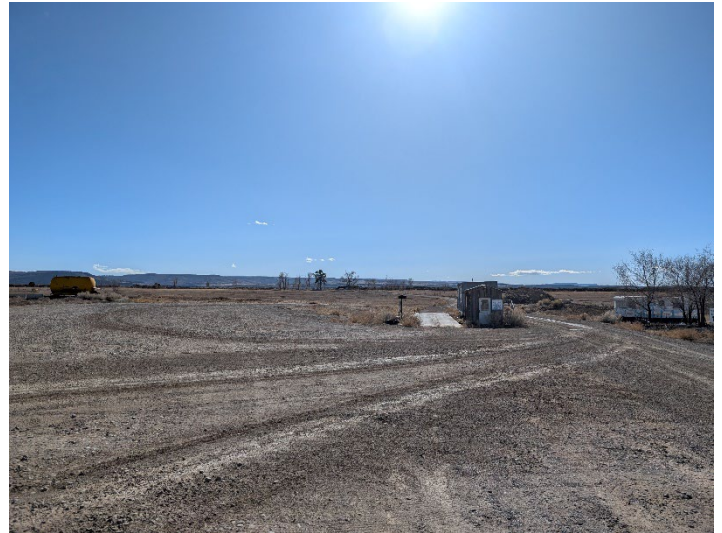
A scalehouse, washout area and stored equipment are located in the north part of the permit area, near the site entrance. The area appeared well maintained and orderly.

Scalehouse and storage area near site entrance

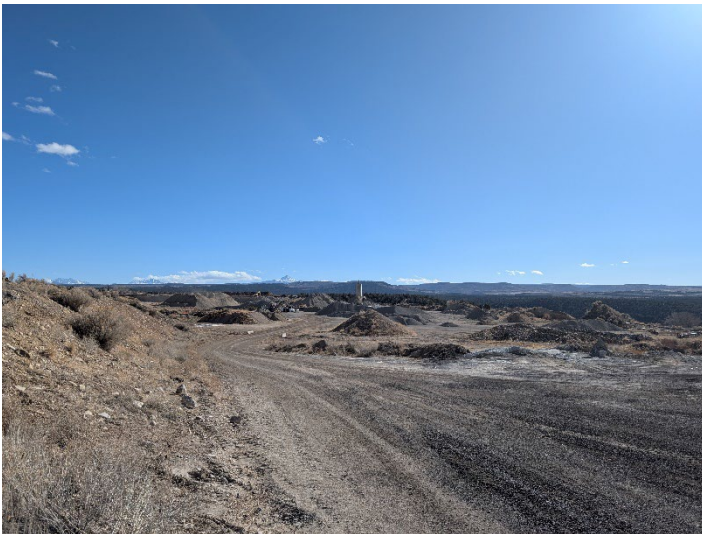
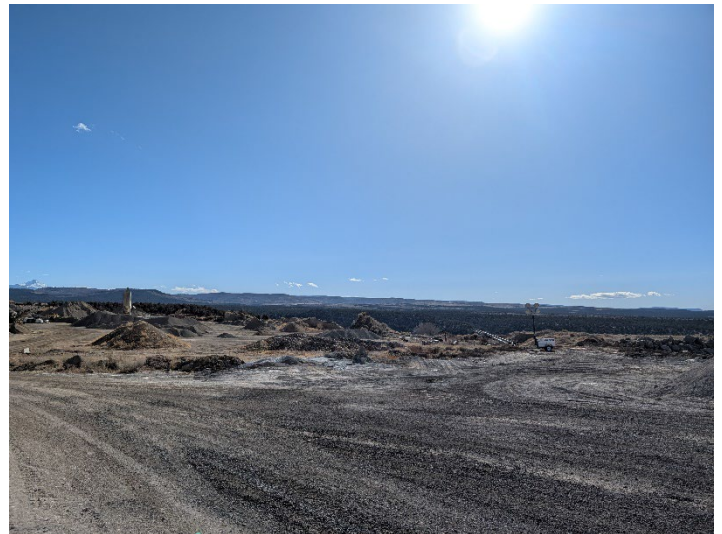
Mining is still occurring in the Phase 1 area, in the south part of the affected area. A wash pond, batch plant, crusher and conveyors are located in this area. Slopes around the wash pond appeared stable. Materials stockpiles are located throughout the pit floor. Mining has progressed through the southern permit boundary, into the adjacent Allen Pit (M-2002-094). This was authorized through TR05.

View of the Phase 1 area from the north side, facing south

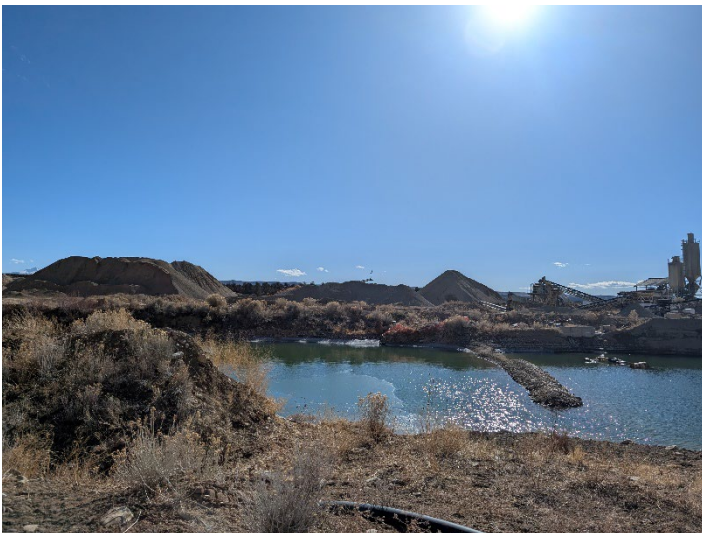
Wash pond in the Phase 1 area

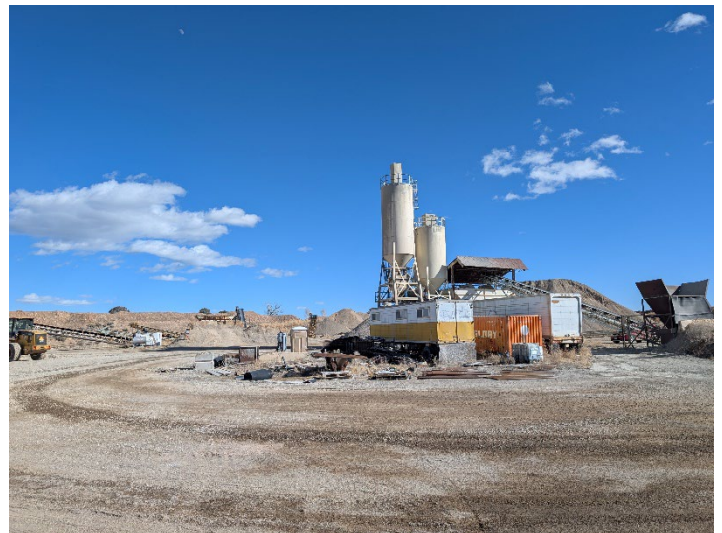
The processing area appeared well maintained and orderly.

Processing area in the Phase 1 area

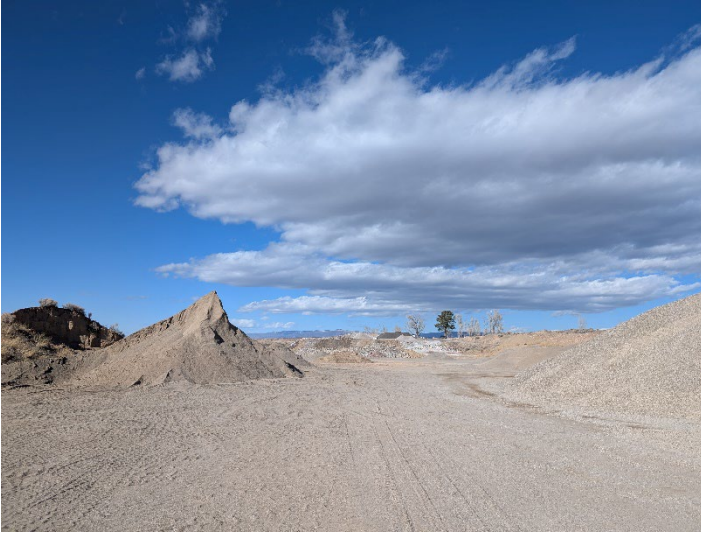
View from the south side of the Phase 1 area, facing north

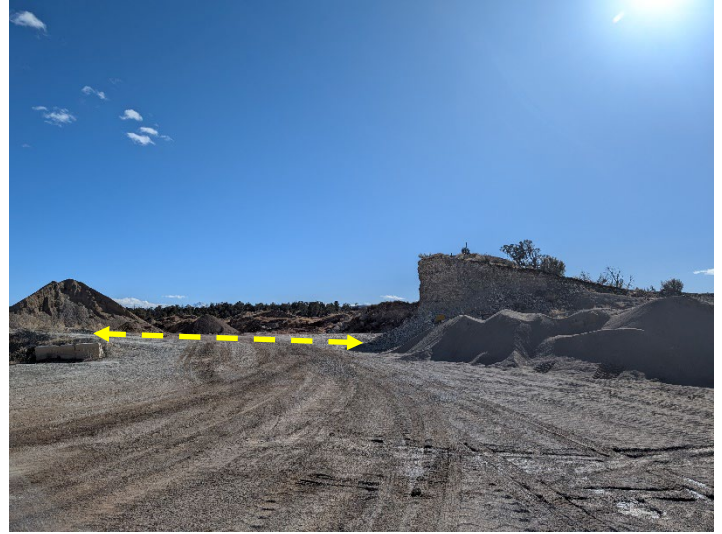
Approximate permit boundary between the Allen Pit and Angie Pit. Angie Pit in the foreground, Allen Pit in the background.
