MINERALS PROGRAM INSPECTION REPORT
PHONE: (303) 866-3567

MINE NAME: Allen Pit	MINE/PROSPECTING ID#: M-2002-094	MINERAL: Gravel	COUNTY: Montrose
INSPECTION TYPE: Monitoring	WEATHER: Clear	INSP. DATE: February 5, 2025	INSP. TIME: 14:15
OPERATOR: Hank Williams, Inc. dba Williams Construction Contractors	OPERATOR REPRESENTATIVE: Ward Priestly	TYPE OF OPERATION: 112c - Construction Regular Operation	
REASON FOR INSPECTION: Normal I&E Program	BOND CALCULATION TYPE: Complete Bond	BOND AMOUNT: \$72,400.00	
DATE OF COMPLAINT: NA	POST INSP. CONTACTS: None	JOINT INSP. AGENCY: None	
INSPECTOR(S): Dustin Czapla	INSPECTOR'S SIGNATURE:

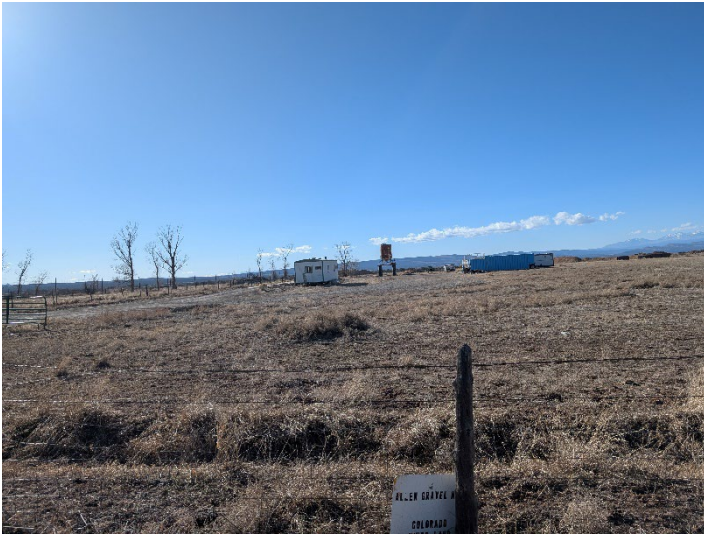
Adequate mine identification signage was noted at the entrance to the site.

Site entrance

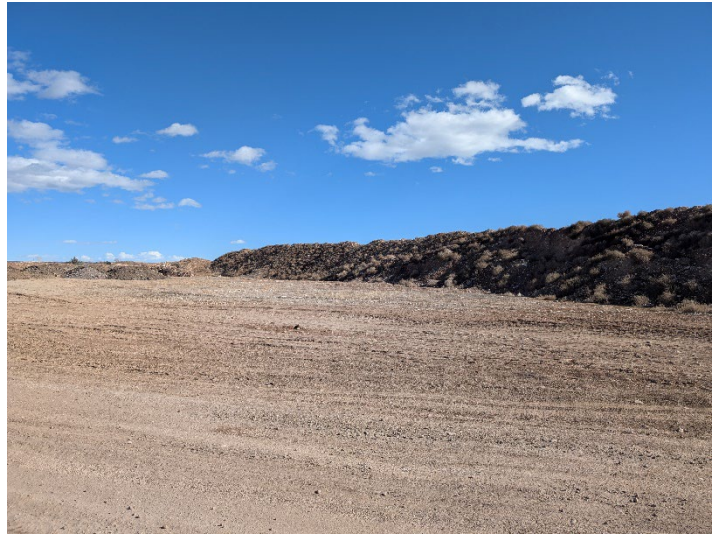
A scale and scalehouse are located near the entrance to the site. Topsoil and backfill material are located on the south side of the pit. These areas appeared well maintained and orderly.

Topsoil stockpile area on southside of pit

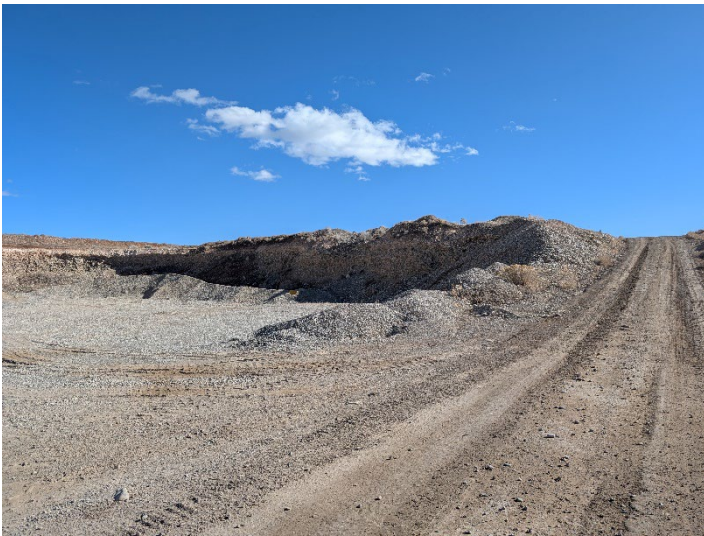
Mining has progressed southward through the Angie Pit (M-2000-049) and continues southward through the Allen Pit. The highwall ridge between the two pits has been removed. This was approved through TR01. The current south facing highwall is approximately 30 feet high and spans approximately 600 linear feet. The slope is near vertical. All processing/crushing for this operation currently takes place in the Angie Pit.

Highwall progressing southward through Allen Pit

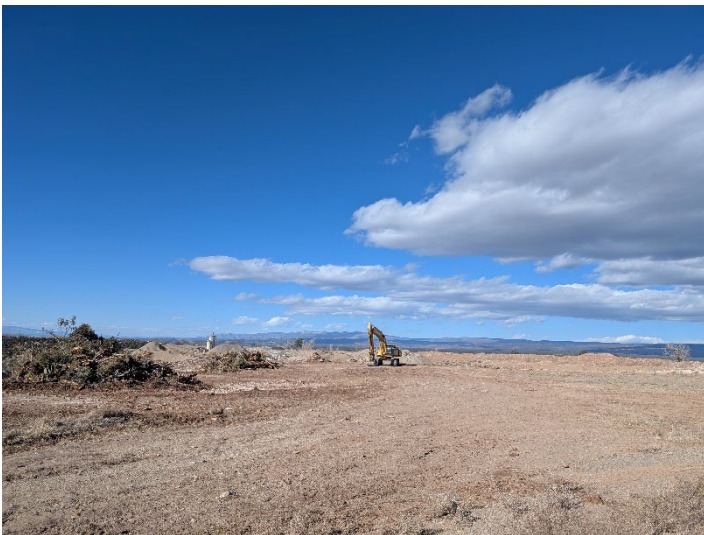
Future mining area on south side of pit
