MINERALS PROGRAM INSPECTION REPORT
PHONE: (303) 866-3567

MINE NAME: Kichelmann one	MINE/PROSPECTING ID#: M-2019-007	MINERAL: Gold	COUNTY: Montrose
INSPECTION TYPE: Monitoring	WEATHER: Clear	INSP. DATE: February 5, 2025	INSP. TIME: 12:40
OPERATOR: Asteroid explorations llc	OPERATOR REPRESENTATIVE: None	TYPE OF OPERATION: 110(1) - Hard Rock Limited Impact	
REASON FOR INSPECTION: Normal I&E Program	BOND CALCULATION TYPE: None	BOND AMOUNT: \$13,080.00	
DATE OF COMPLAINT: NA	POST INSP. CONTACTS: None	JOINT INSP. AGENCY: None	
INSPECTOR(S): Dustin Czapla	INSPECTOR'S SIGNATURE:

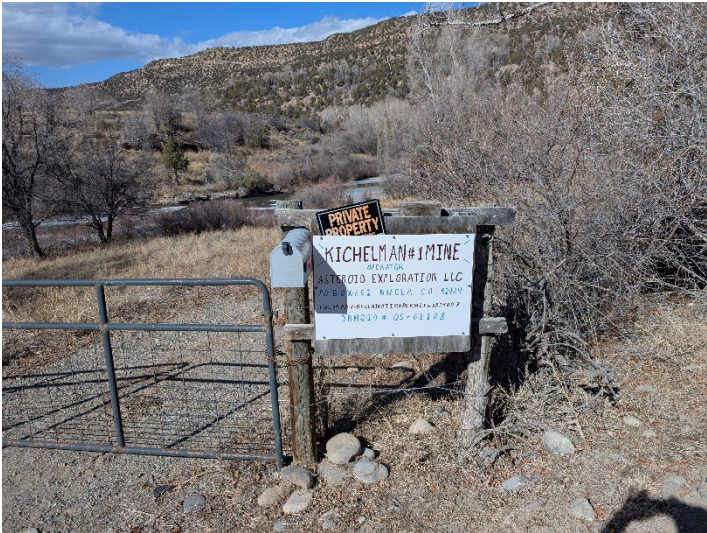
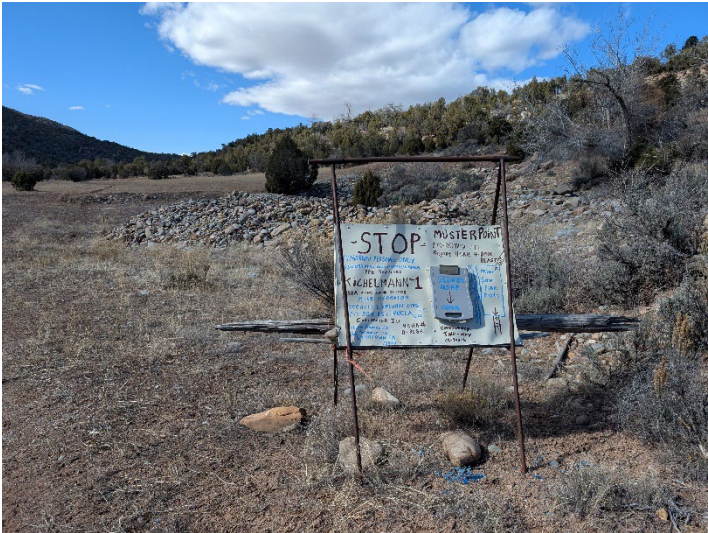
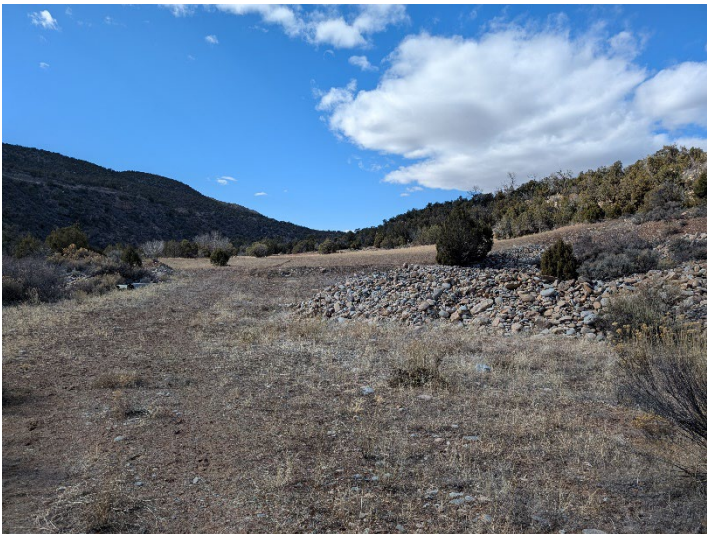
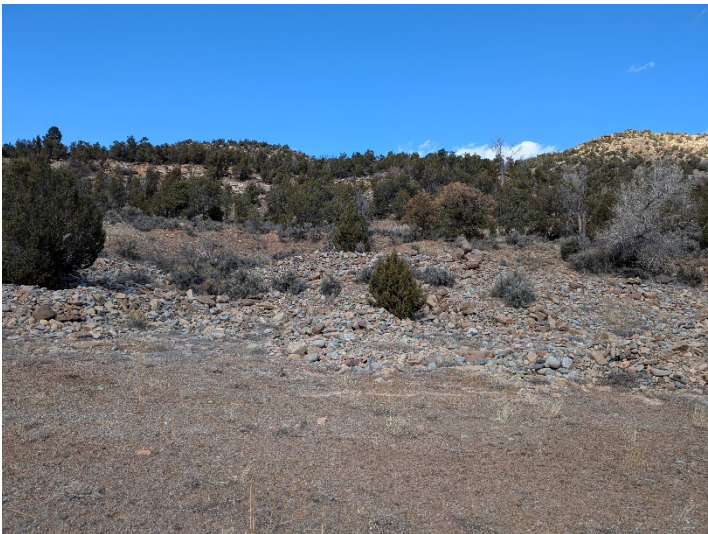
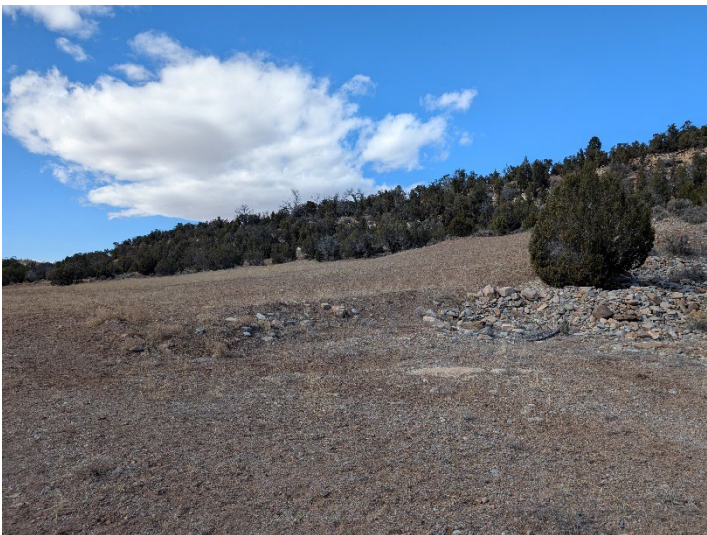
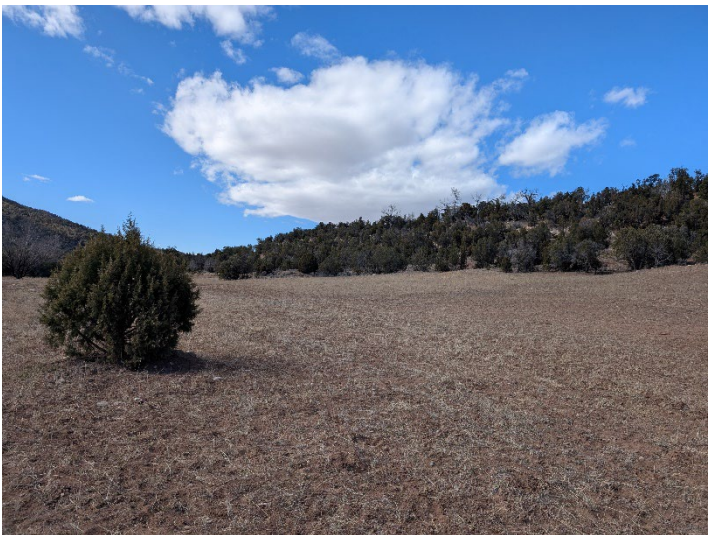
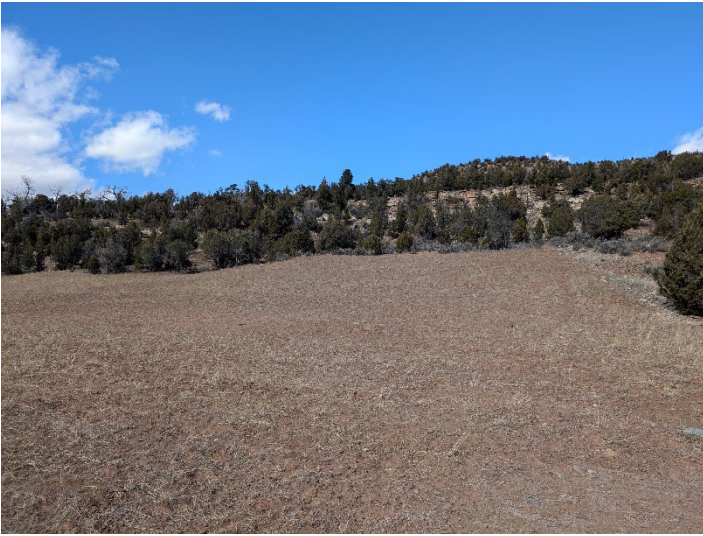
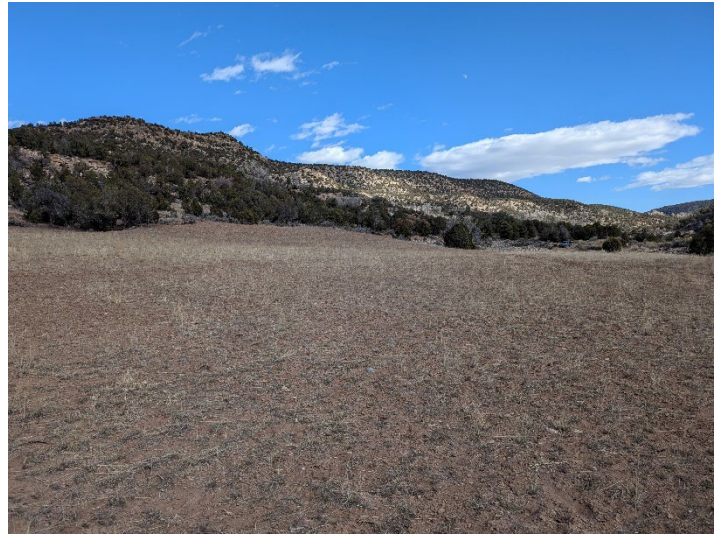
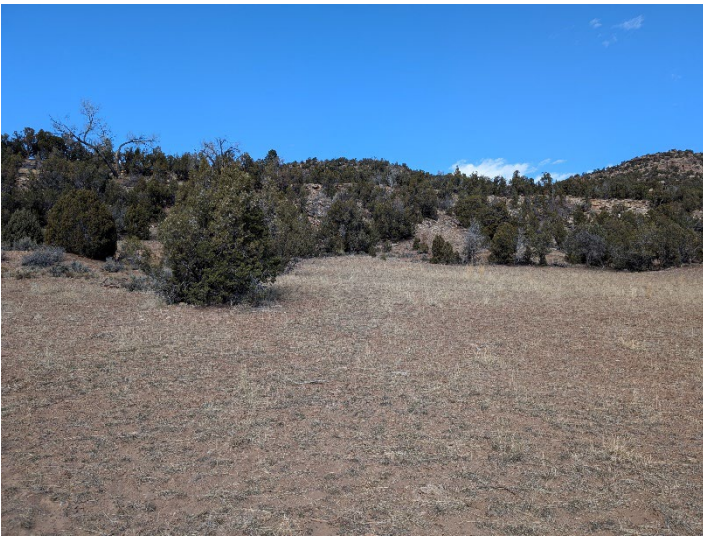
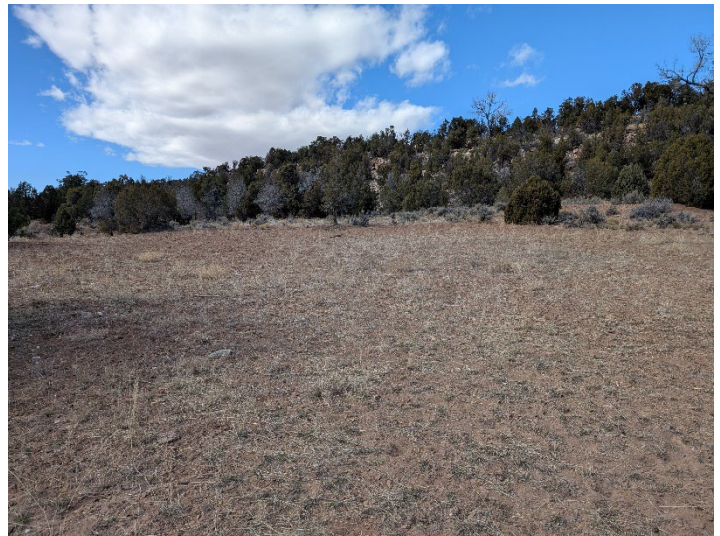
Adequate mine identification signage was noted on the gate at the access road, and also at the entrance to the permit area.

The affected area was marked by stakes that were adequate to delineate the affected area boundary.

Approximately two acres of the disturbed area have been reclaimed. Trash and debris have been removed from the site. The area has been regraded and contoured to blend with the surrounding topography. Topsoil has been spread over the regraded area. The area has been reseeded and vegetation is becoming established. No erosion or rilling was noted in the reclaimed area.

A small excavation area remains at the entrance to the site, where there are piles of cobbles and a small piece of slope to be regraded. This area is approximately ¼ acre.
