### MINERALS PROGRAM INSPECTION REPORT

<b>MINE NAME:</b> Weimer Ranches #4 Mine	<b>MINE/PROSPECTING ID#:</b> M-2021-045	<b>MINERAL:</b> Sand and gravel	<b>COUNTY:</b> Montrose
<b>INSPECTION TYPE:</b> Monitoring	<b>WEATHER:</b> Clear	<b>INSP. DATE:</b> February 6, 2025	<b>INSP. TIME:</b> 12:00
<b>OPERATOR:</b> Weimer Ranches, LLLP	<b>OPERATOR REPRESENTATIVE:</b> None	<b>TYPE OF OPERATION:</b> 110c - Construction Limited Impact

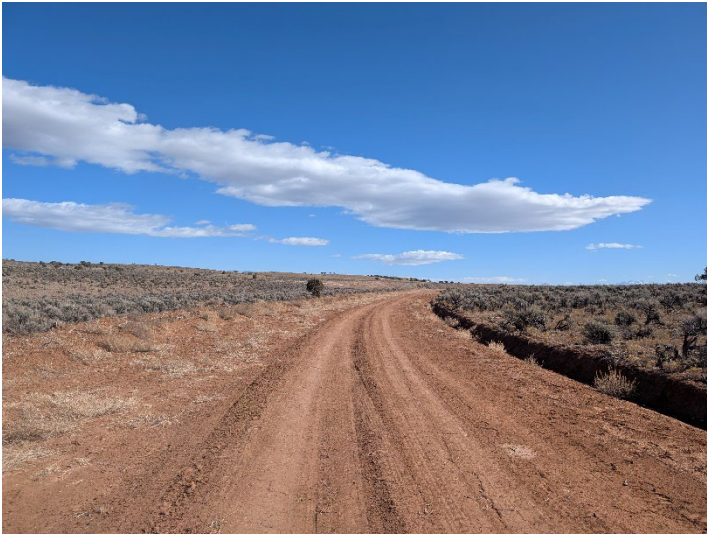
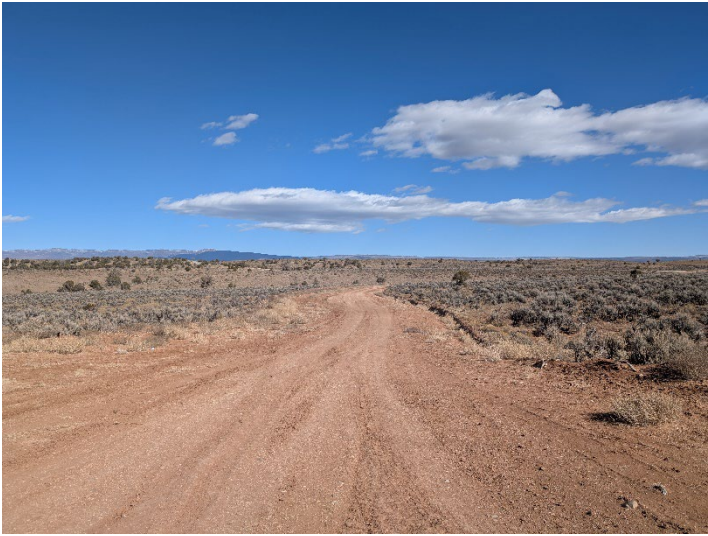
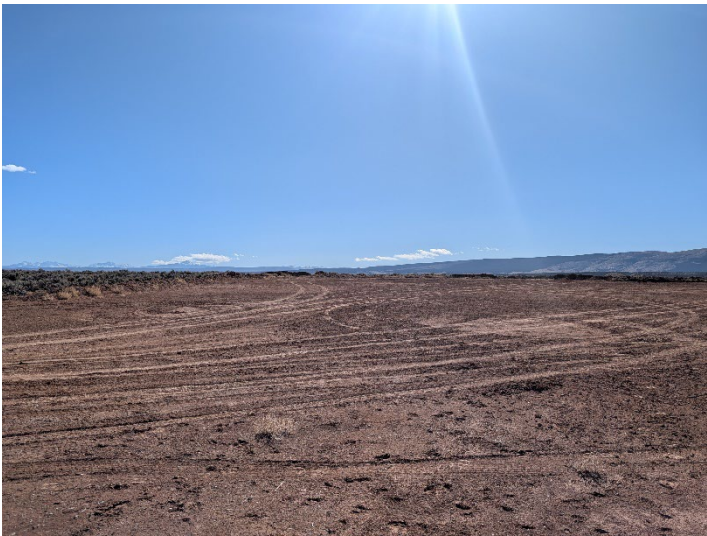
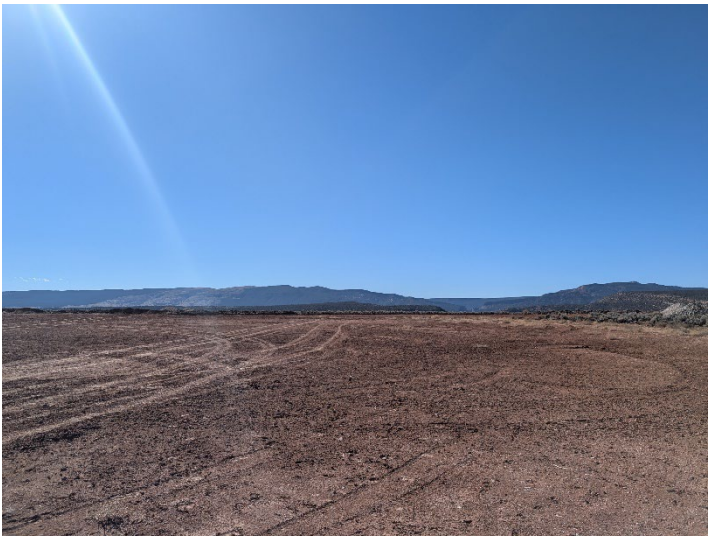
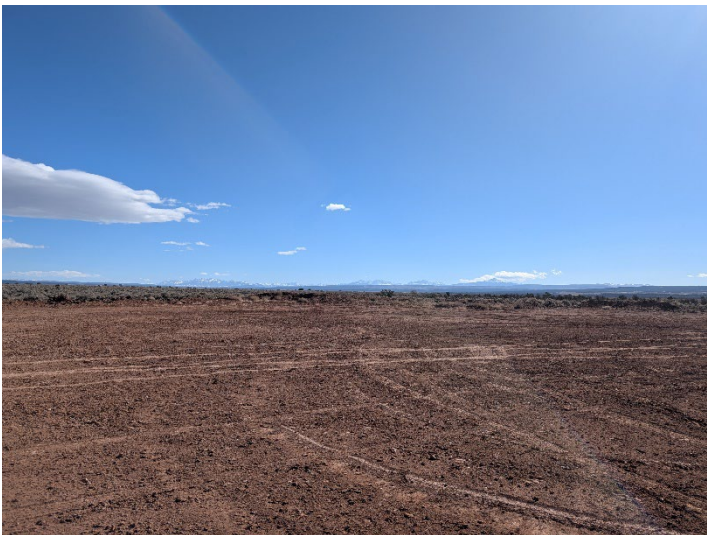
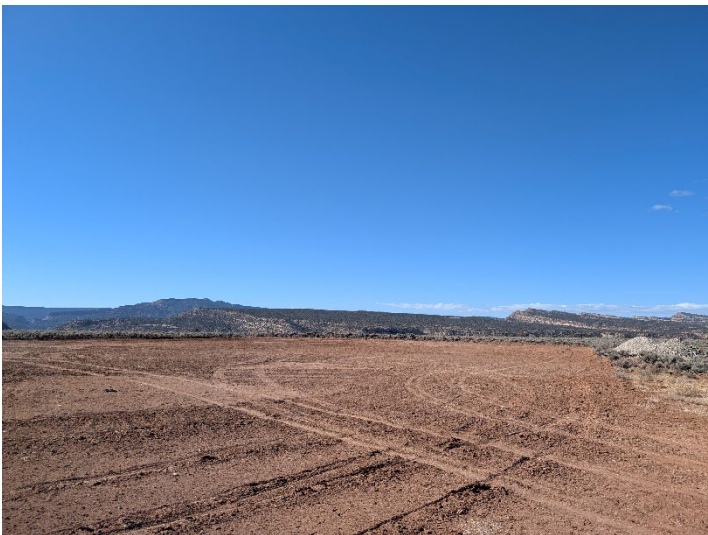
Adequate mine identification signage was not noted at the entrance to the site. This has been noted as a problem on page one of this report.

Operations are just beginning at this site. The access road has been constructed. The road was in good shape, with no ruts or rilling observed. Approximately two acres are currently disturbed in the pit area, where vegetation has been cleared in preparation for topsoil removal. It didn't appear that any gravel had been extracted yet. No stockpiles or equipment were observed on site.

**CORRECTIVE ACTIONS:** The operator shall, at the entrance of the mine site, post a sign which shall be clearly visible from the access road with the following: the name of the operator, a statement that a reclamation permit for the operation has been issued by the Colorado Mined Land Reclamation Board; and the permit number. The operator shall submit photo documentation that a proper sign has been posted by the corrective action date.
