**Roadside Portals Mine, C-1981-041, January Partial Inspection Report**

**PERMIT INFORMATION**

<b>Permit Number:</b> C-1981-041 <b>Mine Name:</b> Roadside Portals <b>Operator:</b> Snowcap Coal Company, Inc <b>Operator Address:</b> Ms Tonya Hammond P. O. Box 443 Grand Junction, CO 81502	<b>County:</b> Mesa <b>Operation Type:</b> Underground <b>Permit Status:</b> Active <b>Ownership:</b> Private
	<b>Operator Representative Present:</b>  Tonya Hammond
<b>Operator Representative Signature:</b> (Field Issuance Only)

<b>Inspection Start Date:</b> January 30, 2025 <b>Inspection Start Time:</b> 10:05 <b>Inspection End Date:</b> January 30, 2025 <b>Inspection End Time:</b> 10:45		<b>Inspection Type:</b> Coal Partial Inspection <b>Inspection Reason:</b> Normal I&E Program <b>Weather:</b> Clear	
<b>Joint Inspection Agency:</b>  None		<b>Joint Inspection Contacts:</b>  None	
<b>Post Inspection Agency:</b>  None		<b>Post Inspection Contacts:</b>  None	
<b>Inspector(s):</b>  Clayton Wein	<b>Inspector's Signature:</b>  <i>Clayton Wein</i>		<b>Signature Date:</b> 2/11/2025

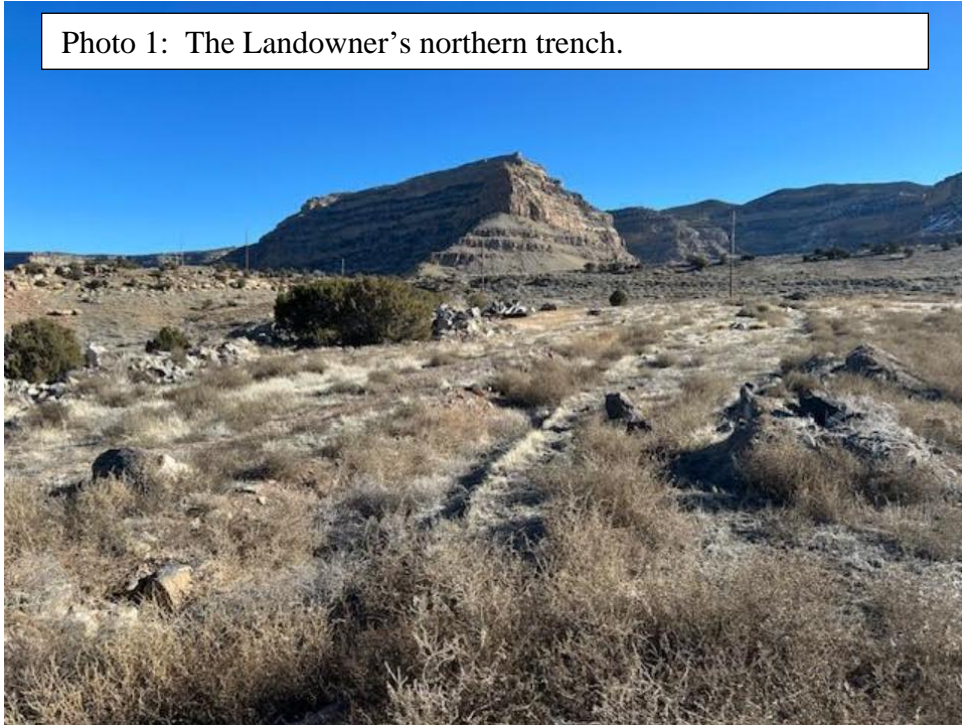
During the inspection, the landowner's eastern and northern trenches located on Tract 71 were dry (Photo 1). There were no indications of recent water application within the trenches. The Carey pit is located within the southwest corner of the permit area. The landowner's pit was observed to have a small puddle of water in the bottom (Photo 2). There was no indication of water application from the landowner's buried pipeline through the open trench into the pit. The water in the pit was likely from recent precipitation events.

Photo 1: The Landowner's northern trench.

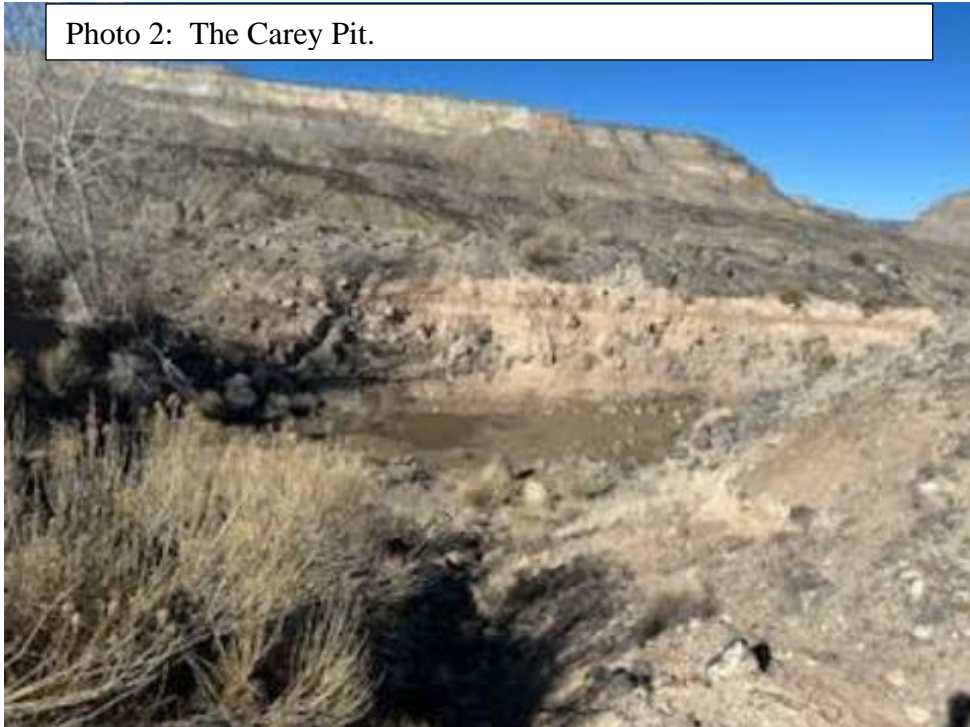
Photo 2: The Carey Pit.

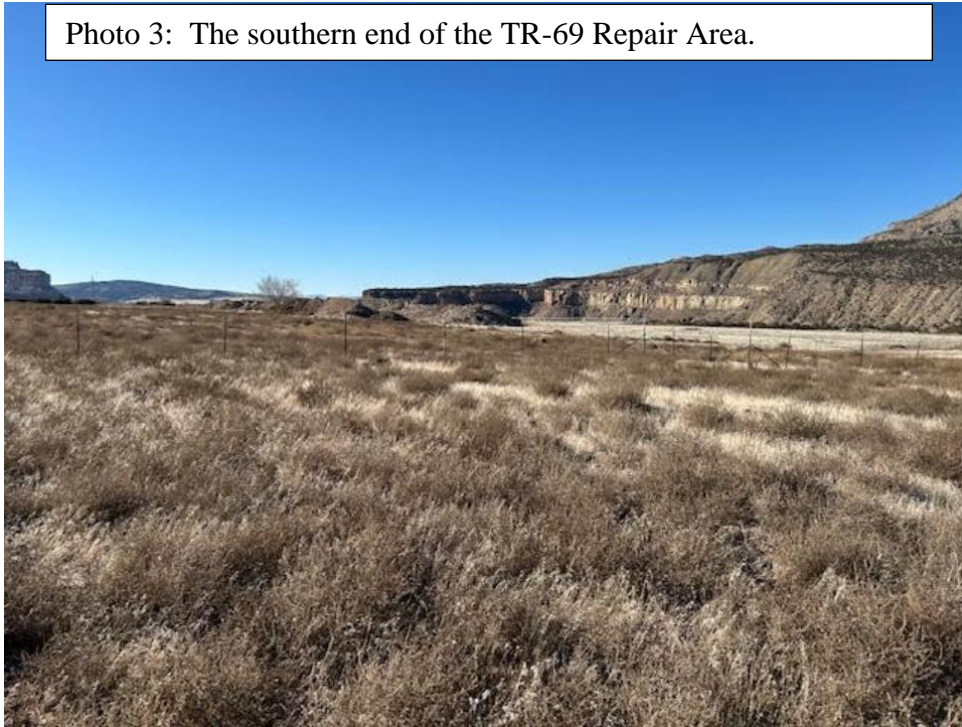
Photo 3: The southern end of the TR-69 Repair Area.

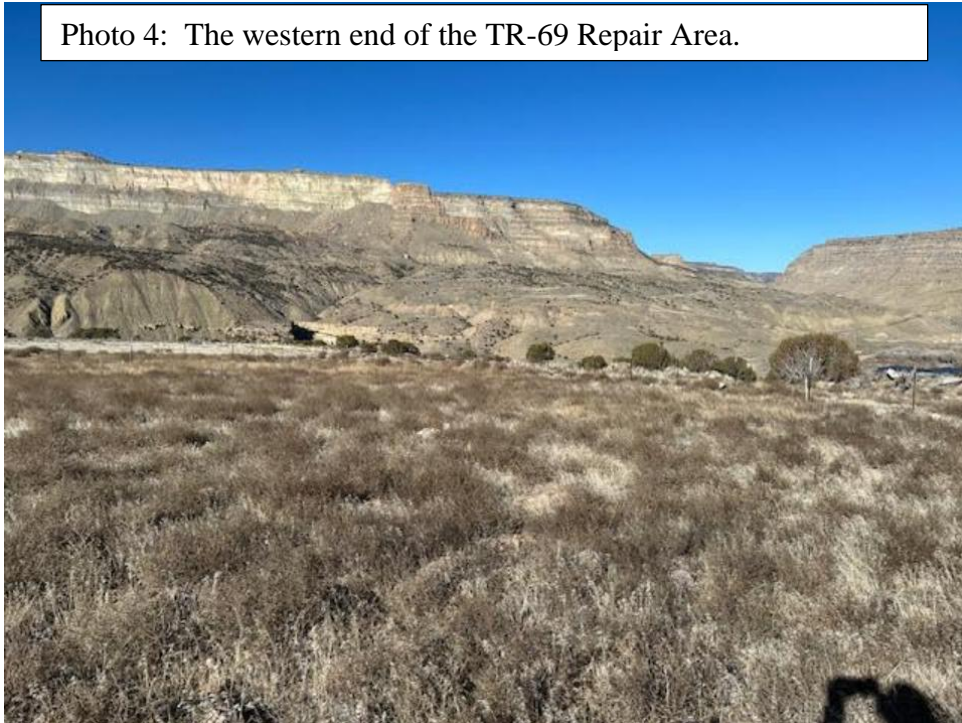
Photo 4: The western end of the TR-69 Repair Area.

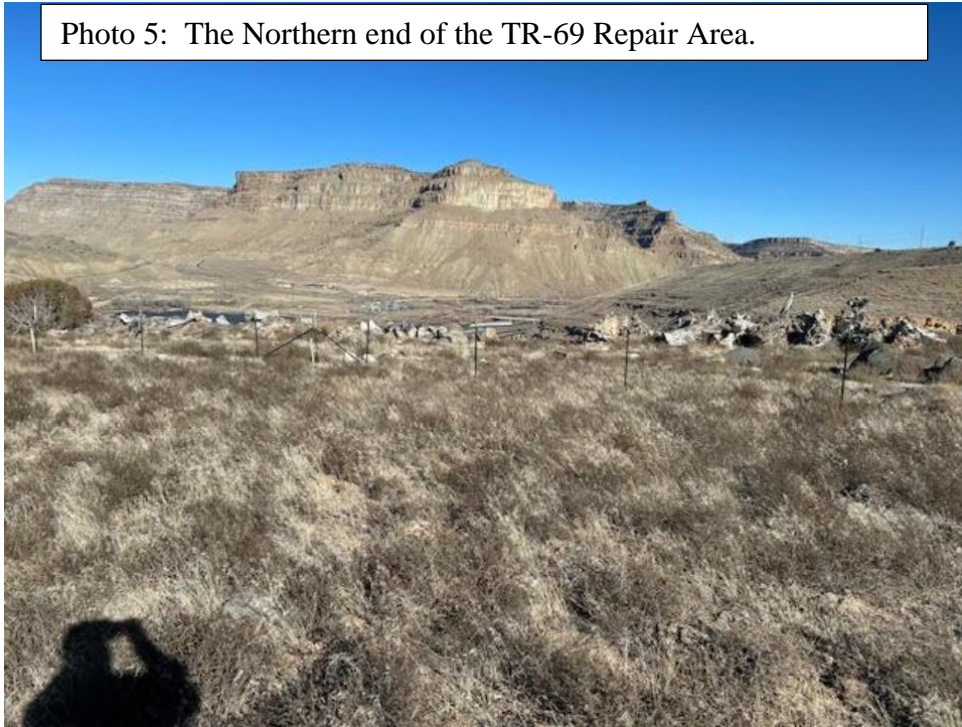
Photo 5: The Northern end of the TR-69 Repair Area.

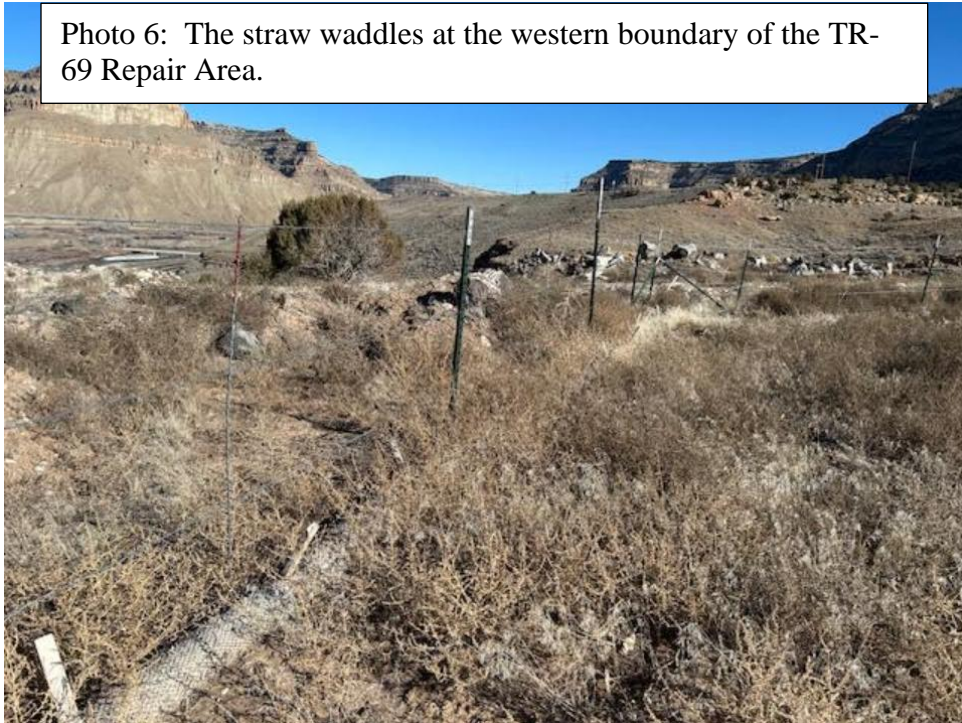
Photo 6: The straw waddles at the western boundary of the TR-69 Repair Area.
