MINERALS PROGRAM INSPECTION REPORT
PHONE: (303) 866-3567

MINE NAME: Gleason Pit	MINE/PROSPECTING ID#: M-1983-159	MINERAL: Sand and gravel	COUNTY: Montrose
INSPECTION TYPE: Monitoring	WEATHER: Clear	INSP. DATE: February 5, 2025	INSP. TIME: 14:30
OPERATOR: Glacier Ridge Aggregates Corp.	OPERATOR REPRESENTATIVE: Mike Kimball	TYPE OF OPERATION: 112c - Construction Regular Operation	
REASON FOR INSPECTION: Normal I&E Program	BOND CALCULATION TYPE: None	BOND AMOUNT: \$49,191.00	
DATE OF COMPLAINT: NA	POST INSP. CONTACTS: None	JOINT INSP. AGENCY: None	
INSPECTOR(S): Dustin Czapla	INSPECTOR'S SIGNATURE:

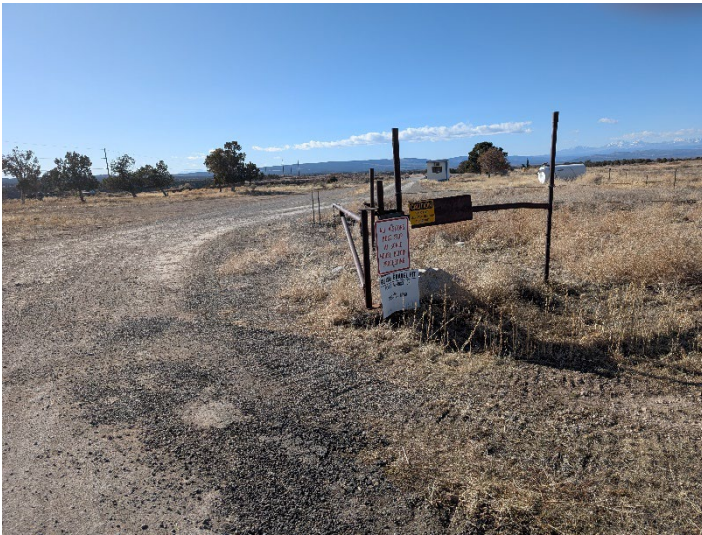
Adequate mine identification signage was noted at the entrance to the site.

Mine sign in place at sight entrance

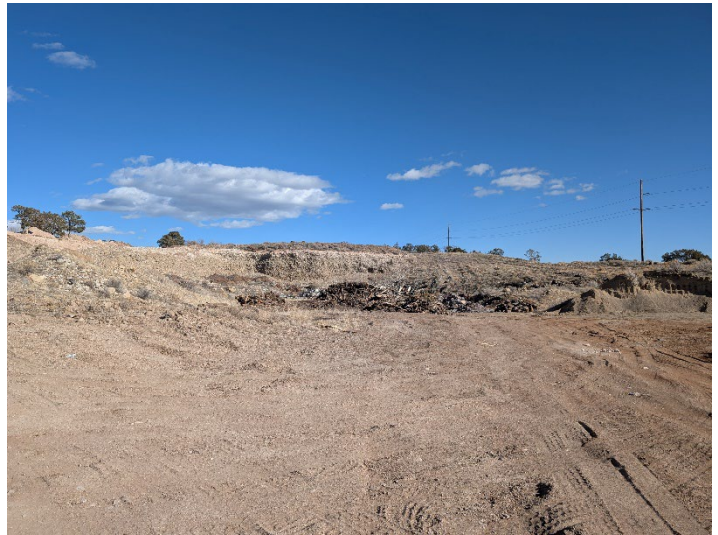
Mining has taken place in the west and north parts of the pit. Mined slopes have mostly been graded to 2H:1V. There is approximately 100 linear feet of near vertical highwall, approximately 20 feet in height, on the south side of the access road.

Section of near vertical highwall on south side of access road

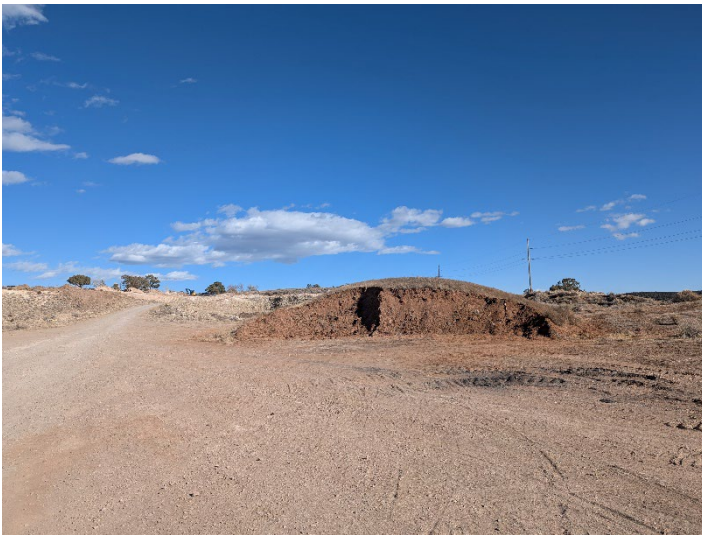
There is a topsoil stockpile in the south-central part of the pit. The pile appears stable, and no erosion concerns were noted.

Topsoil stockpile

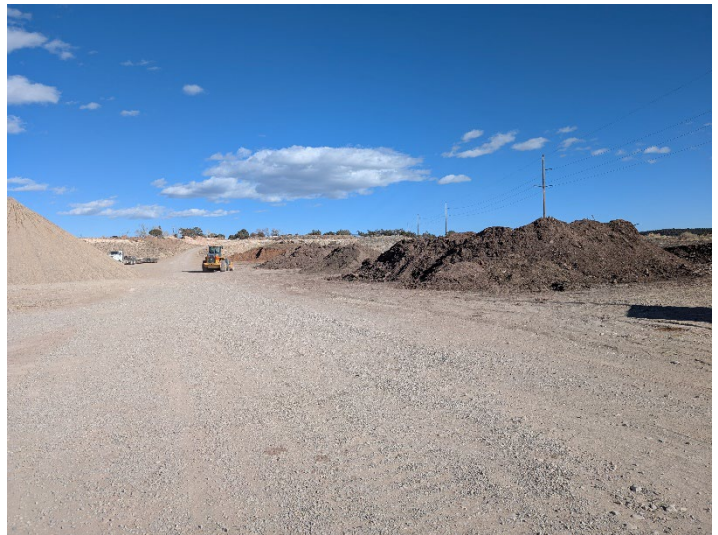
Topsoil and fill materials

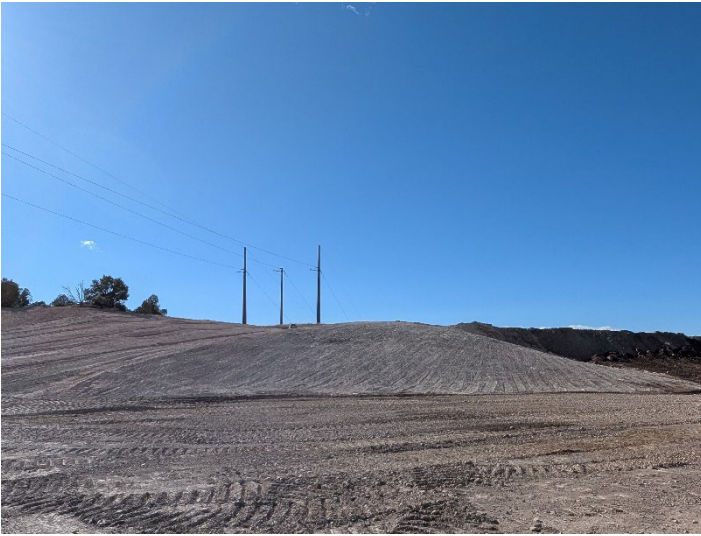
The operator has conducted reclamation in the southwest part of the pit. The slope has been graded to 3-4H:1V and appears stable. No erosion or rilling concerns were noted.

Reclamation area in southwest part of pit

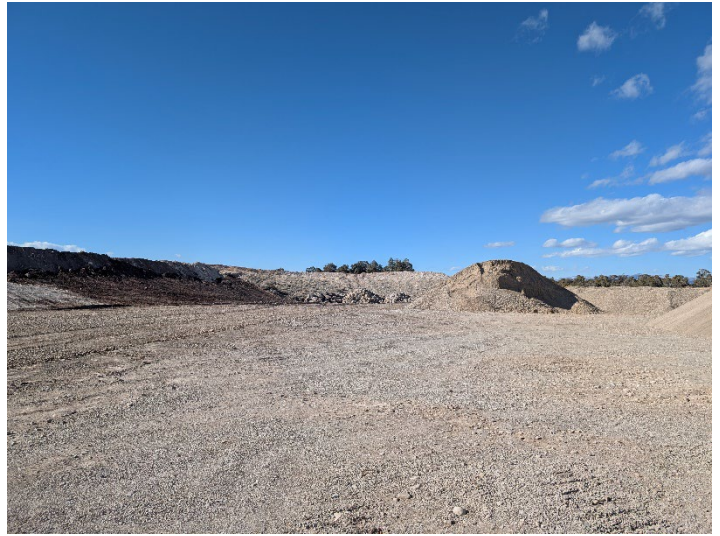
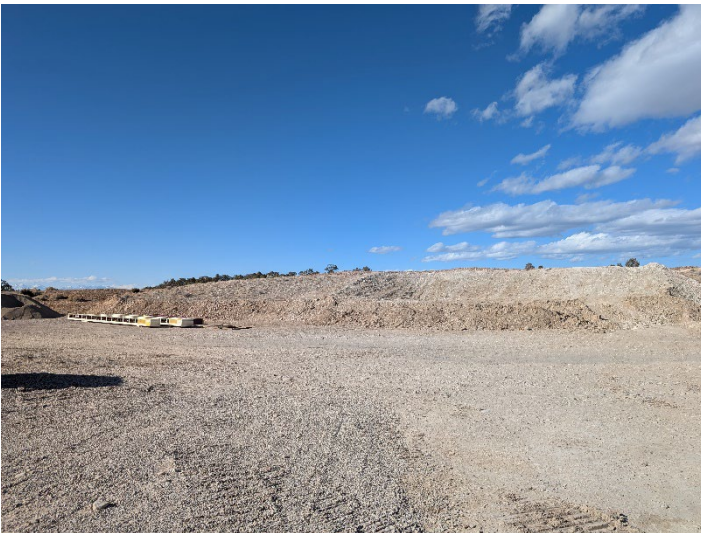
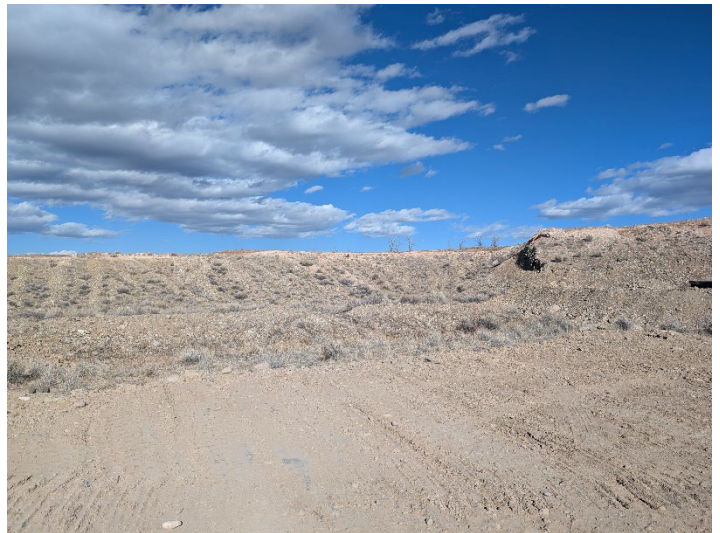
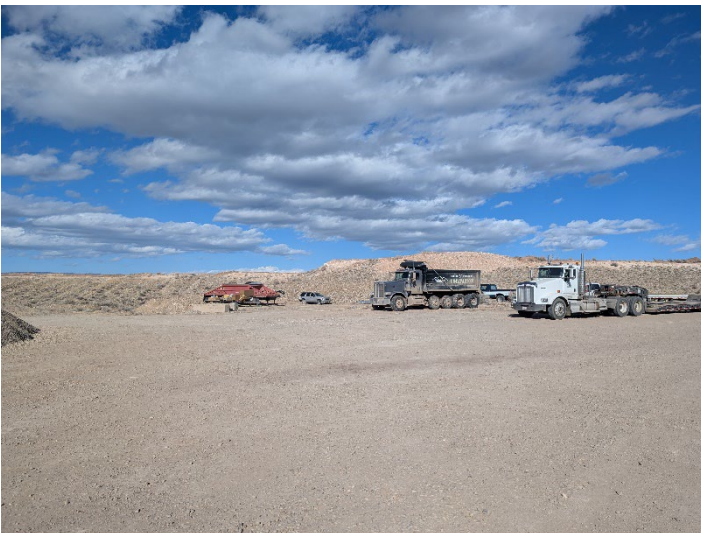
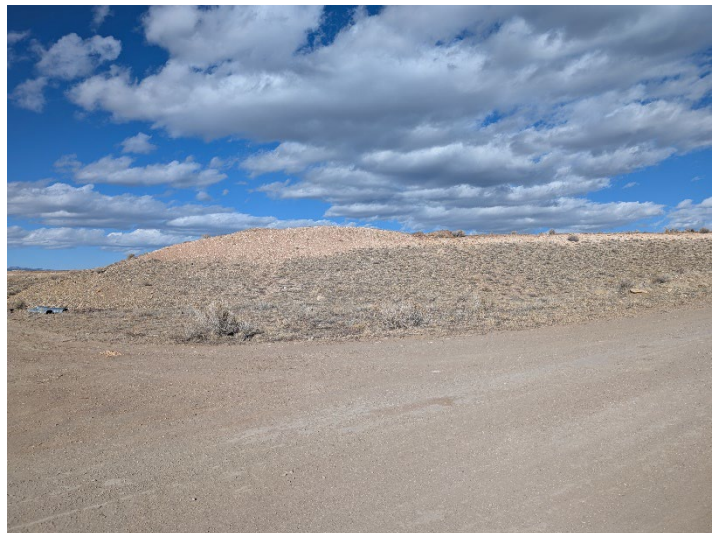
Mined areas graded to 2H:1V
