MINERALS PROGRAM INSPECTION REPORT
PHONE: (303) 866-3567

MINE NAME: Van 4 Shaft	MINE/PROSPECTING ID#: M-1997-032	MINERAL: Uranium and vanadium	COUNTY: Montrose
INSPECTION TYPE: Monitoring	WEATHER: Clear	INSP. DATE: February 5, 2025	INSP. TIME: 15:40
OPERATOR: Pinon Ridge Mining LLC	OPERATOR REPRESENTATIVE: None	TYPE OF OPERATION: 110d - Designated Limited Impact	
REASON FOR INSPECTION: Normal I&E Program	BOND CALCULATION TYPE: None	BOND AMOUNT: \$75,057.00	
DATE OF COMPLAINT: NA	POST INSP. CONTACTS: None	JOINT INSP. AGENCY: None	
INSPECTOR(S): Dustin Czapla	INSPECTOR'S SIGNATURE:

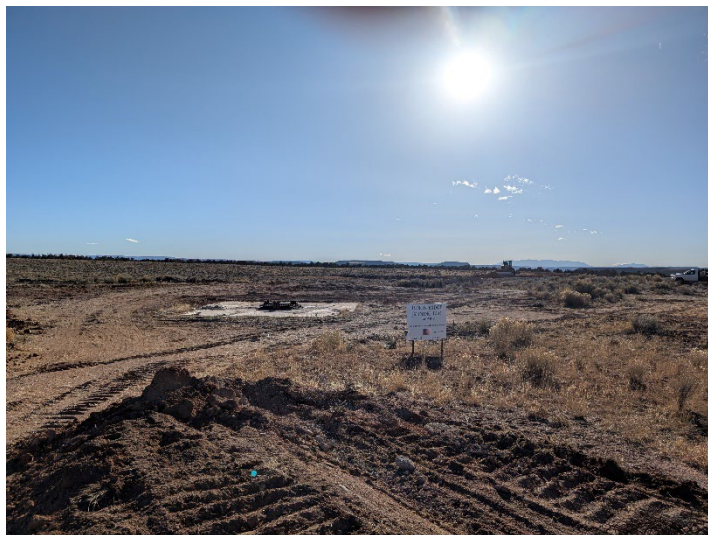
Adequate mine signage was noted at the entrance to the site.

Site entrance

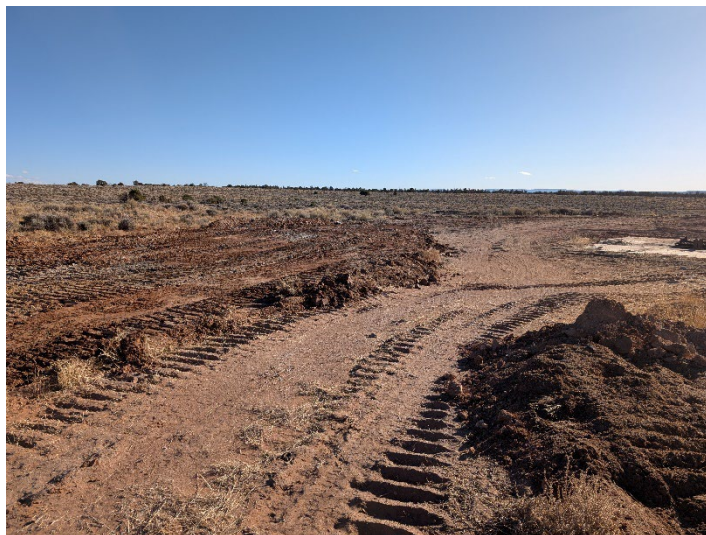
Final reclamation is underway. The metal shop building, headframe, shed and hoist house have been removed. The slab foundations have been removed. The shaft is secured with metal grating, but not yet sealed. On February 6, 2025, the Division approved TR-1, which addressed changes to the shaft closure method. The shaft and vent shaft will now be closed with a reinforced slab placed over the existing slab, and then covered with backfill.

Buildings, structures and slabs have been removed

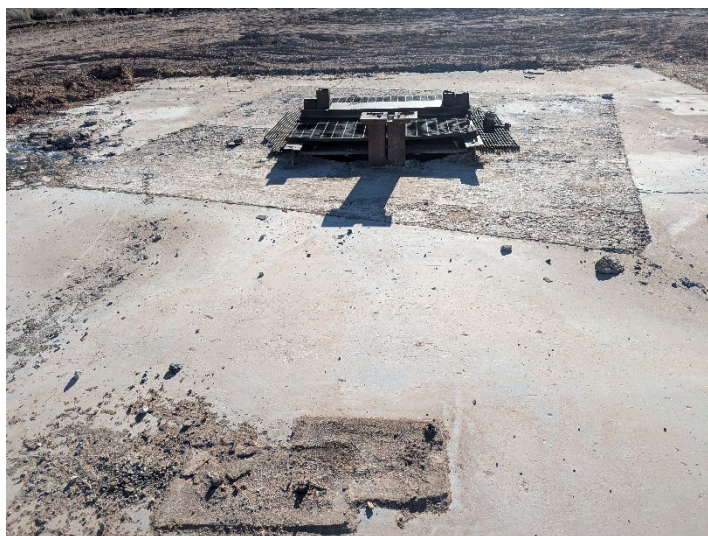
Concrete cap to be installed over this existing slab for shaft closure

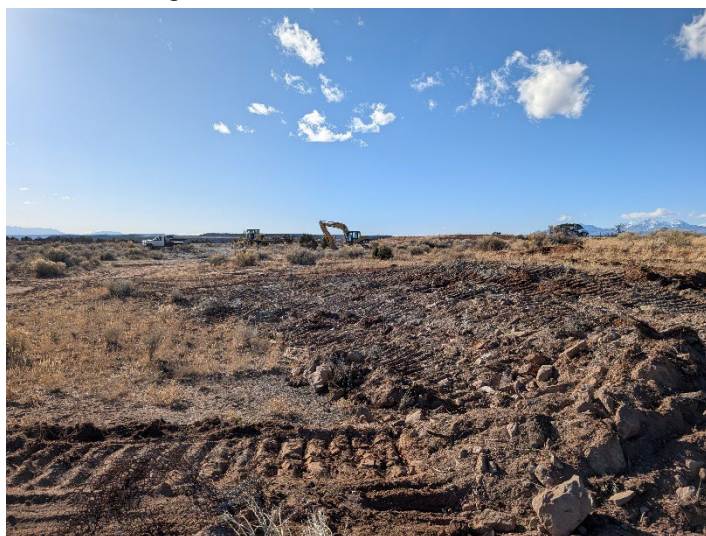
During this inspection, workers were making good progress on grading the waste rock pile. It appeared that the slopes had been reduced to 3H:1V, for the most part, and that topsoil replacement was underway.

Regrading of waste rock pile was underway

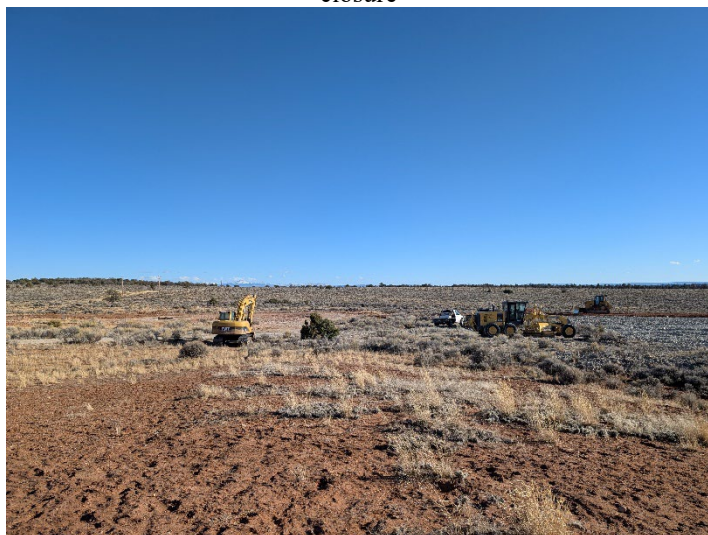
Regrading of waste rock pile was underway

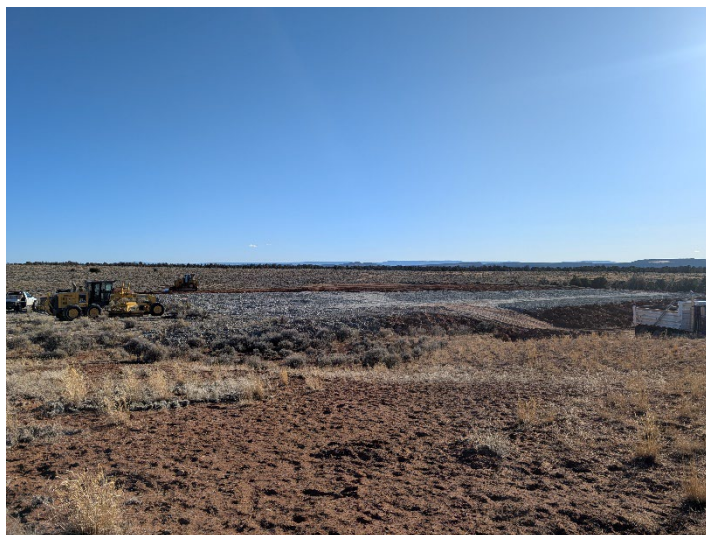
Regrading of waste rock pile was underway

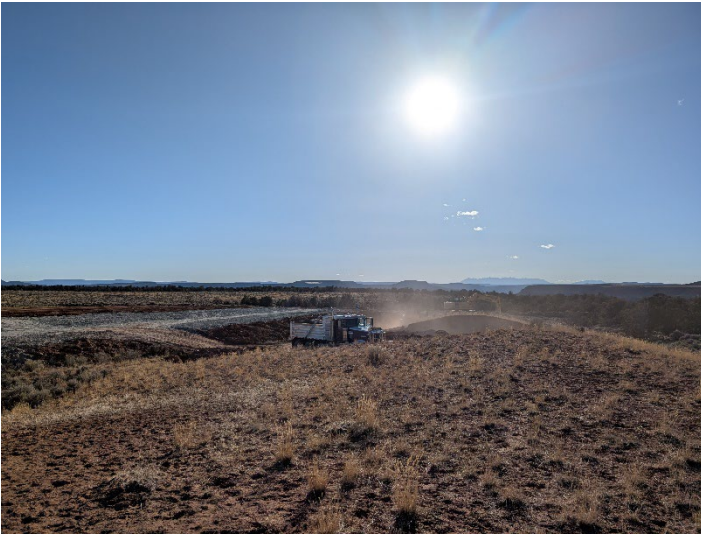
Regrading of waste rock pile was underway

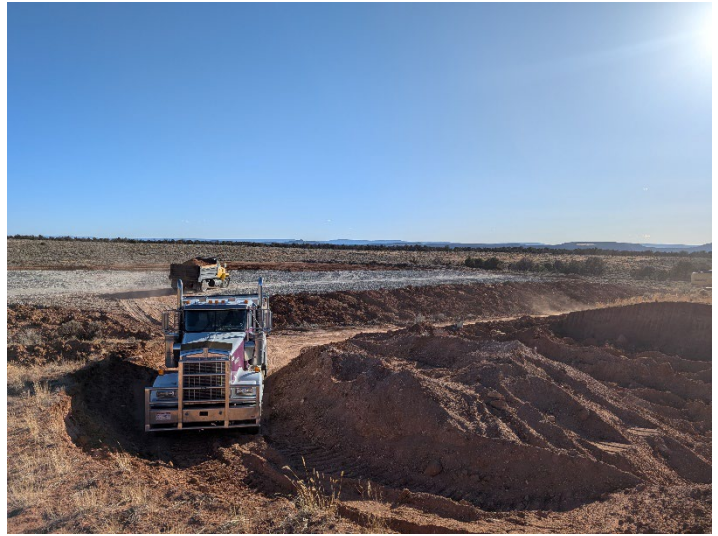
Regrading of waste rock pile was underway
