MINERALS PROGRAM INSPECTION REPORT

MINE NAME: Spotted Burro Pit	MINE/PROSPECTING ID#: M-1979-192	MINERAL: Sand and gravel	COUNTY: Fremont
INSPECTION TYPE: Monitoring	WEATHER: Clear	INSP. DATE: January 9, 2025	INSP. TIME: 09:00
OPERATOR: Rockbottom, LLC	OPERATOR REPRESENTATIVE: Beckie Kagan	TYPE OF OPERATION: 112c - Construction Regular Operation

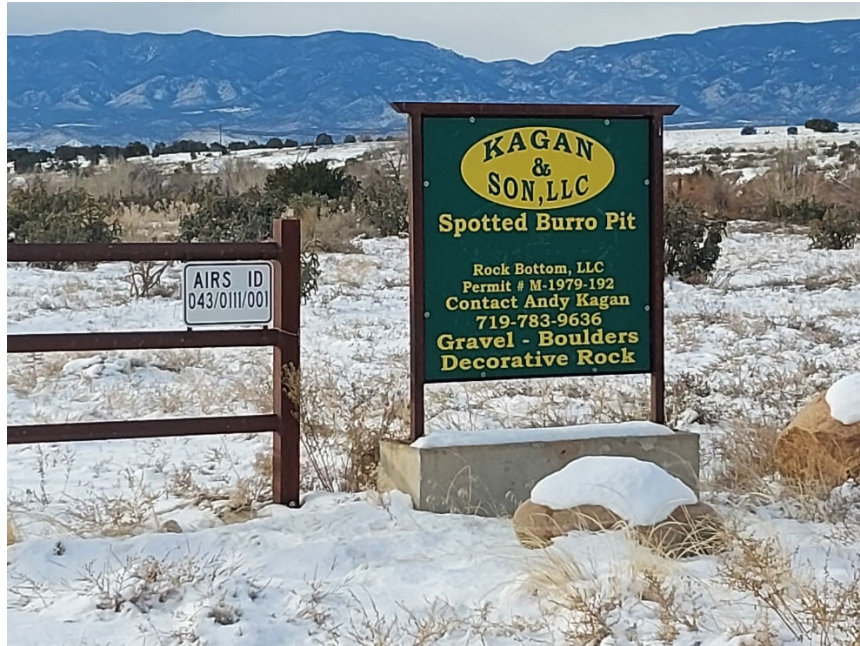
The mine sign was posted at the entrance of the site, in accordance with Rule 3.1.12(1), see Photos #1 and #2. The boundary markers were not verified during the inspection due to ground conditions. It was observed that the western side of the entrance road and northwest portion of the permitted area and the northern permit boundary were marked by fencing.

Photo #1: Mine sign in accordance with Rule 3.1.12(1).

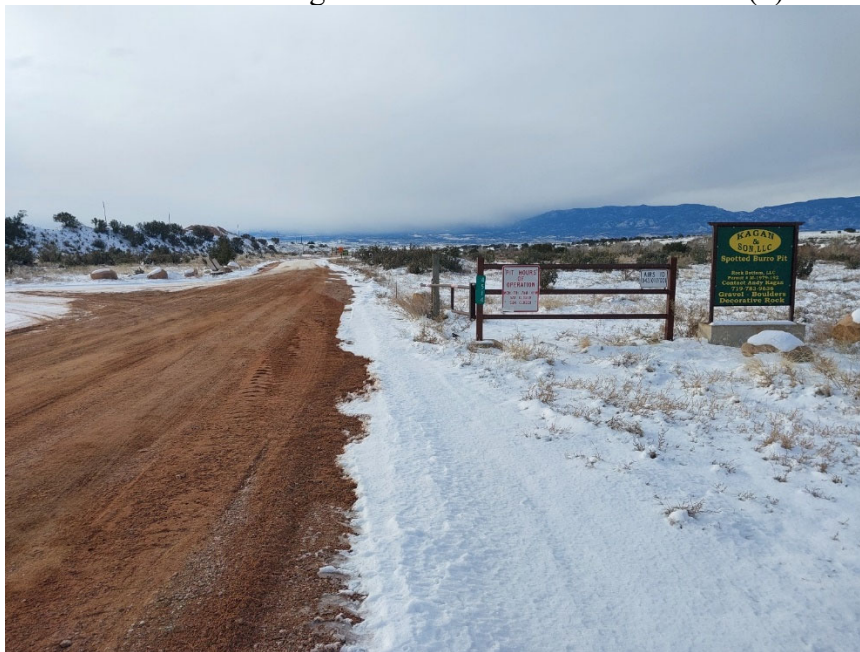
The roads appear to be in good condition and stable with no erosion issues, see Photos #2 and #3.

Photo #2: Mine entrance, mine sign viewed on the right side of the access road; looking to the south from the mine entrance.

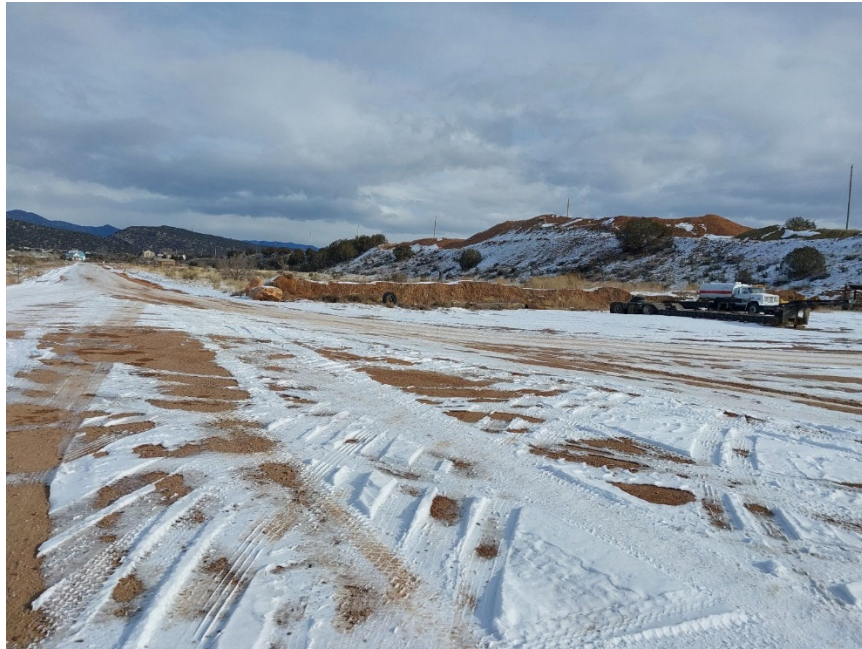
Photo #3: View of the access road, on the left side of the photo, and the parking area for equipment, looking northeast.

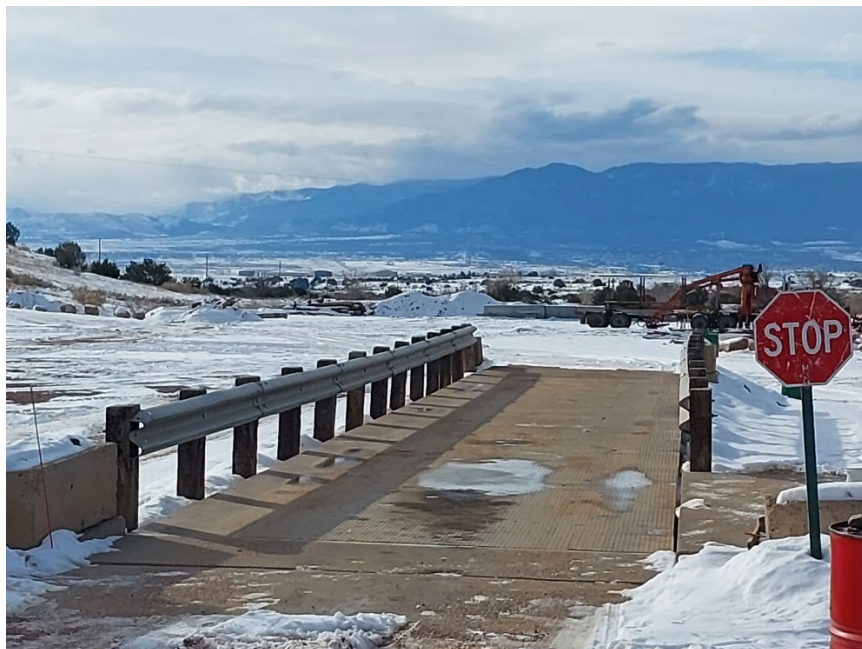
There is a 20-foot Conex on site used as an office and a scale, both located in the southeast portion of the permit area, see Photo #4.

Photo #4: View of the scale, looking southwest. Logs brought on the property can be seen in the background.

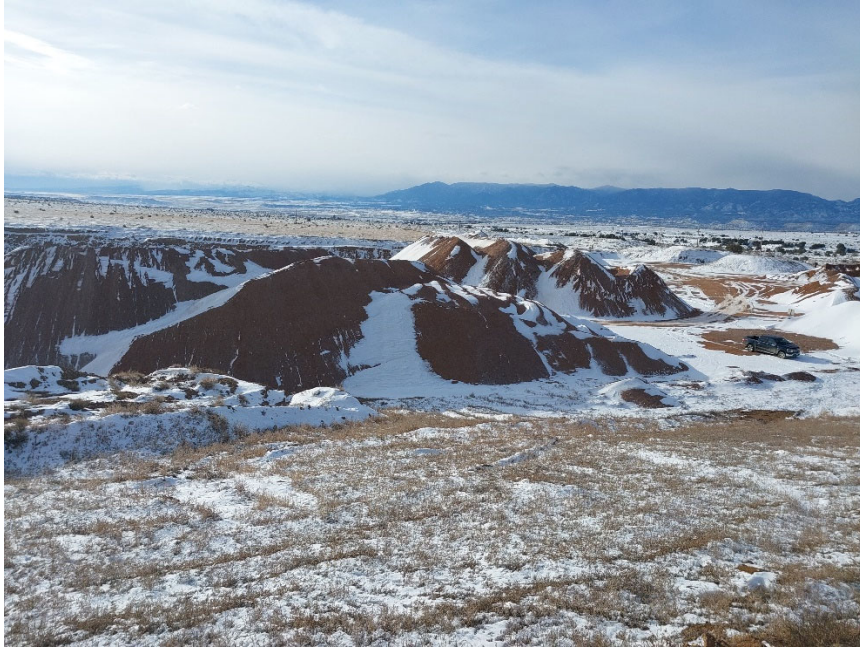
The mining operation appeared to be in compliance with the approved mining plan. At the time of the inspection, the working highwall had reached the furthest north on the Osborn property. According to Ms. Kegan, the operation will be progressing to the east, finishing extraction of materials from the Osborn property. Operations will then progress south while also reclaiming the Osborn property with 4H:1V slopes. There is a 10' high berm of topsoil along the northern permit boundary of the Osborn property. The berm slopes appeared stable with plant litter, implying that they are well vegetated. There are several material stockpiles on the pit floor that all appear to be stable, see Photo #5. Processing equipment were observed on the pit floor near the

Photo #5: Product stockpiles stored on the pit floor, looking southwest from the topsoil berm along the north permit boundary.

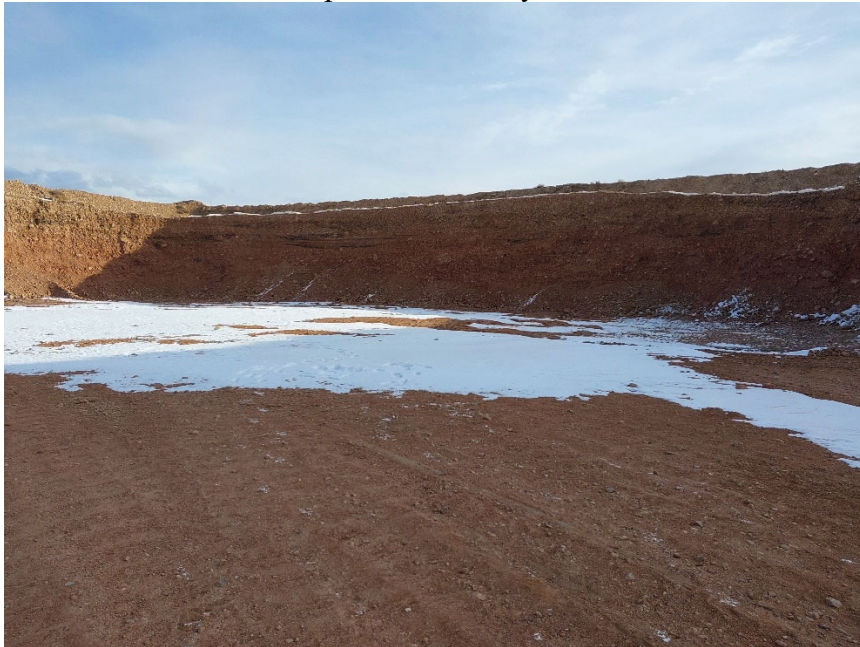
Using Google Earth satellite imagery from June 28, 2024, the length of the highwall was measured to be approximately 965 feet. The height of the highwall appeared to be between 18 and 20 feet during the site visit, in accordance with the mining plan, see Photo #6. Ms. Kegan stated that crushed fines sold well over the past year.

Photo #6: View of the highwall along the east side of the permitted area, looking to the northeast from the pit floor.

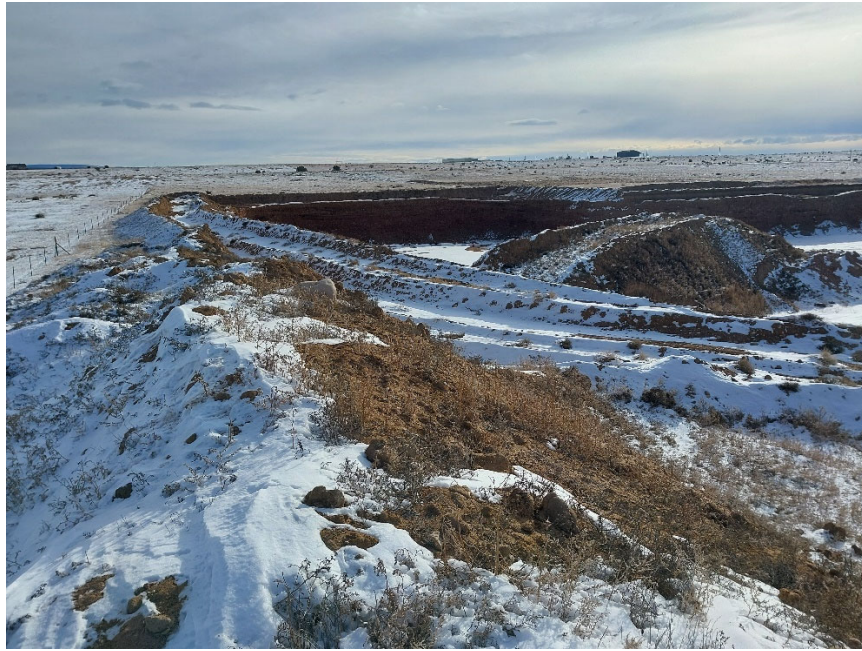
Several stockpiles of overburden were observed on the west side of the pit floor, and they appeared to be stable. There appeared to be plant litter on the slopes indicating that they are well vegetated, see Photo #7.

The topsoil stockpiles appeared to be stable and in good condition, see Photo #7. There was plant litter observed on the slopes of the topsoil stockpiles indicating that they are well vegetated.

Photo #7: View of an overburden stockpile and the topsoil berm along the northern permit boundary, looking to the east from the top of the topsoil berm.

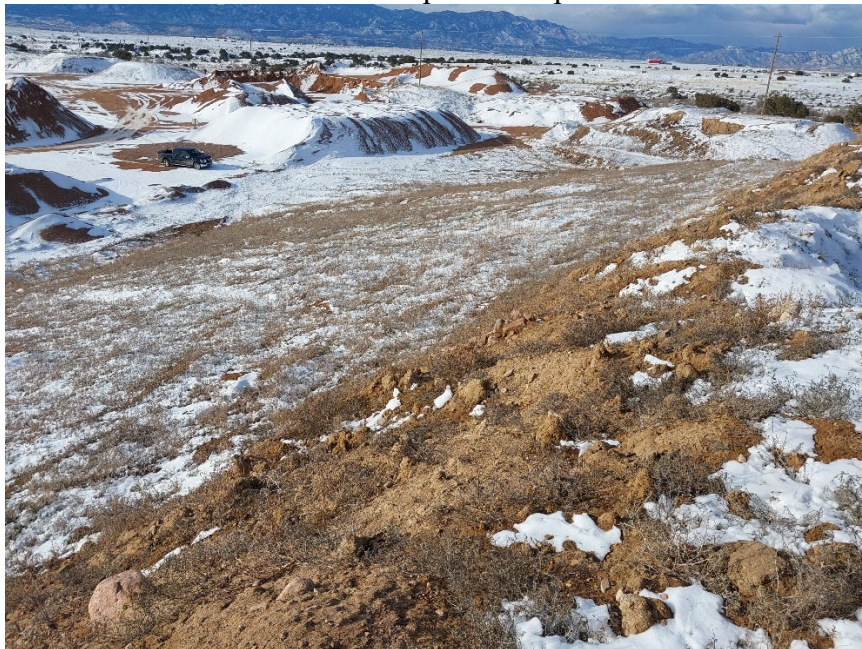
There is about 450 feet of the north portion of the disturbance on the Osborn property that had been backfilled and graded, see Photo #8. The graded slope appeared to be 4H:1V and stable.

Photo #8: View of the backfilled and graded area along the northwest portion of the northern permit boundary, adjacent to the highwall; looking to the south – southwest from the top of the topsoil berm.

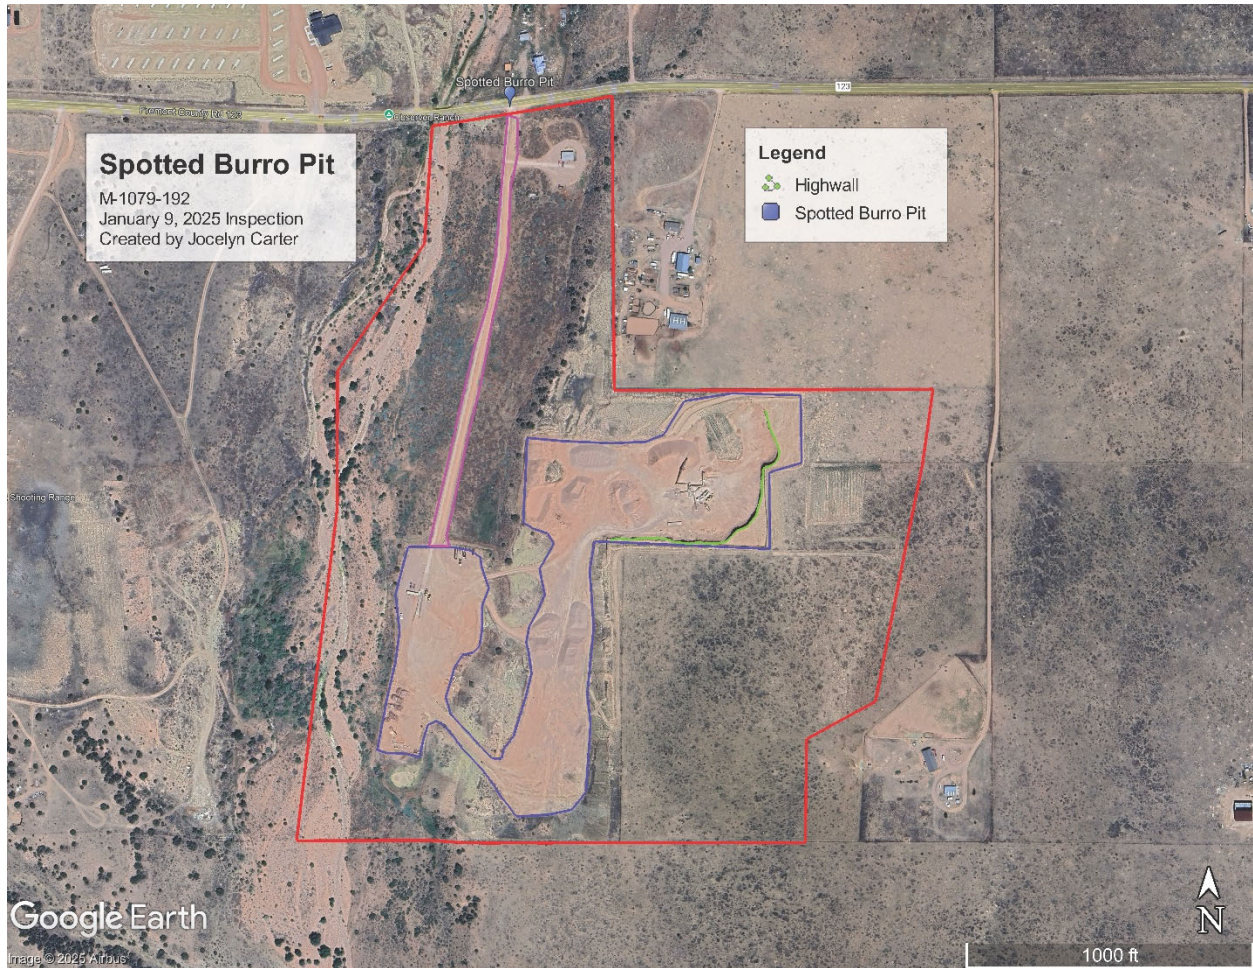
PROBLEM #1: The financial warranty is not adequate to reclaim the site in accordance with the approved reclamation plan. This is a failure to maintain the proper financial warranty amount to complete reclamation of the affected lands pursuant to C.R.S. 34-32.5-117(4)(b) of the Act. The calculated financial warranty based on the observed disturbances and the approved reclamation plan is \$194,593.00; \$82,188.00 more than the current financial warranty or \$112,405.00.

The current financial warranty held by the Division is \$112,405.00. The reclamation cost estimate was recalculated based on the disturbances observed during the site visit, see Figure #1 below for disturbance details. The updated cost estimate is calculated at \$194,593.00; a copy of the Division's reclamation cost estimate (RCE) is attached with this report. The current bond is \$82,188.00 below the calculated reclamation costs and is cited as a problem in this report. See Problem #1 above for information about the corrective action necessary to abate the problem.

Figure 1: Map created from inspection observations and used to create the RCE. The red polygon is the permit boundary, the purple polygon is the area that needs to be topsoiled (18.2 acres), the pink polygon is the road that needs to be ripped (1.5 acres), both areas need to be seeded (19.7 acres), and the green line represents the highwall.

CORRECTIVE ACTIONS: The operator shall review the attached reclamation cost estimate and provide the Division with any comments and/or any additional documents regarding the calculations or any reclamation works that have been completed. If the operator does not have comments, the operator shall submit adequate financial warranty, as determined by the Division. The Division will be sending a separate surety increase notice to the operator regarding the increase of the financial warranty. The operator will have 60 days from the date on the surety increase notice to post the additional financial warranty.
