Minerals Exploration/Sampling/Testing Inspection

U.S. Department of the Interior Bureau of Land Management Royal Gorge Field Office

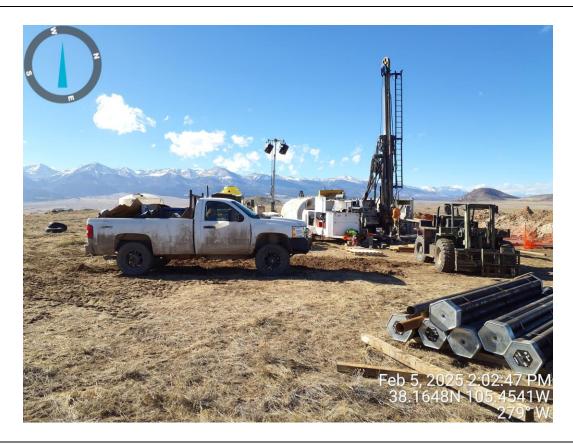
Comment: Overview of the site looking to the west

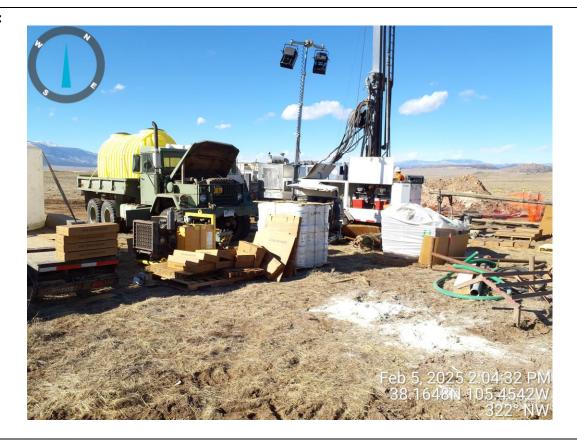
Comment: Overview of site looking to the northwest. Core in middle of photo in cardboard boxes

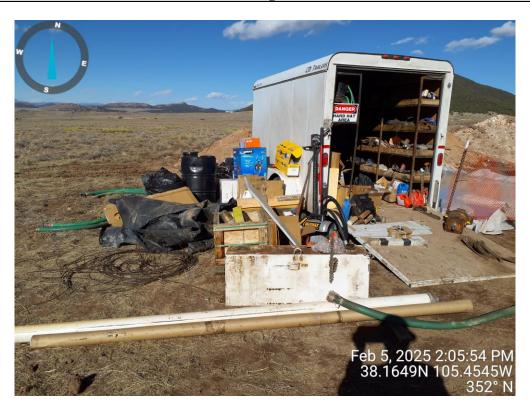
POLs were observed outside secondary containment on the drill pad and secondary containment area. A small hydrocarbon spill was observed on the secondary staging area. The POLs were discussed with drillers on site, and they stated most of them had been delivered the day of the inspection, and they did not have a chance to place them in containment yet.

Comment: Utility trailer with materials/tools. Uncontained POLs along the left side of the trailer

After action report to be submitted to BLM to reflect additional disturbance after drilling is completed POLs to be placed in secondary containment

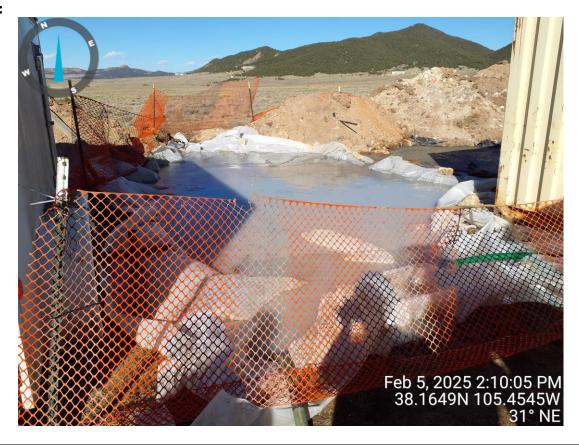
Comment: Overview of one of the lined sumps, looking to the northeast

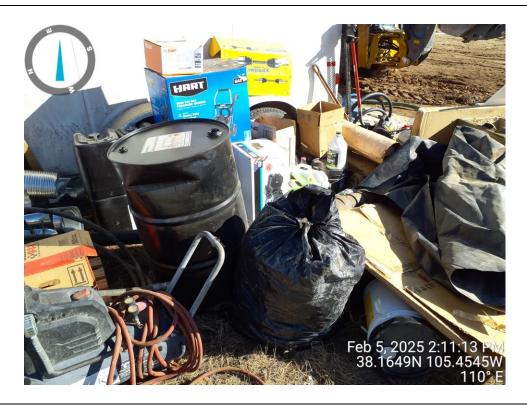
Equipment on site includes a drill rig, pickup truck, forklift, backhoe, water truck, and two utility trailers. Materials and equipment are stacked around one utility trailer which is being used as a workshop. POLs were staged here outside secondary containment. Drill pipe was stacked on blocks around the drill site.

Comment: Uncontained POLs near utility trailer, other materials/tools

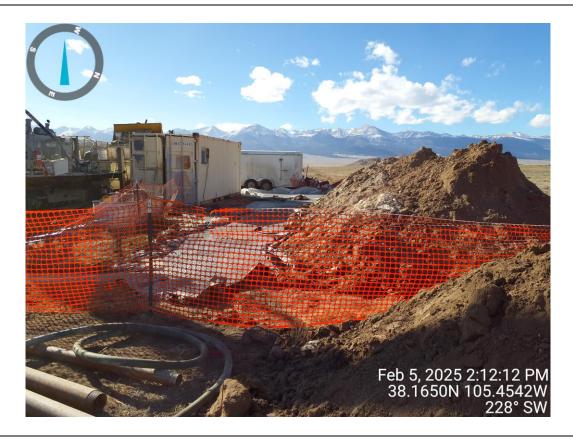
Comment: Overview of sumps looking to the west. Total length of sumps approximately 45 feet

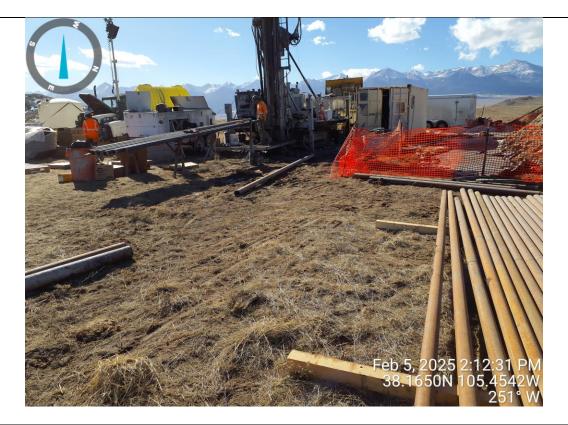
Comment: Overview of site looking the west

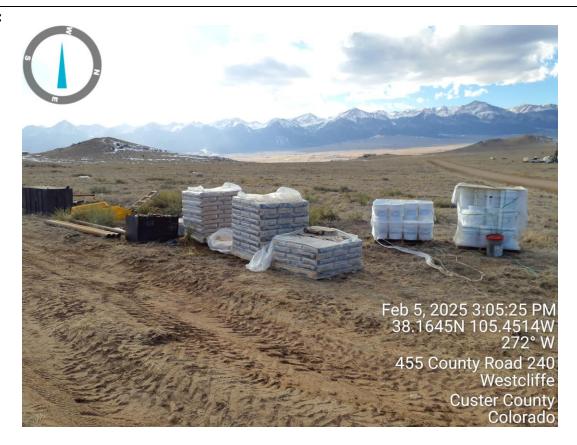
Comment: Secondary staging area separated from drill pad. Secondary area not included in notice

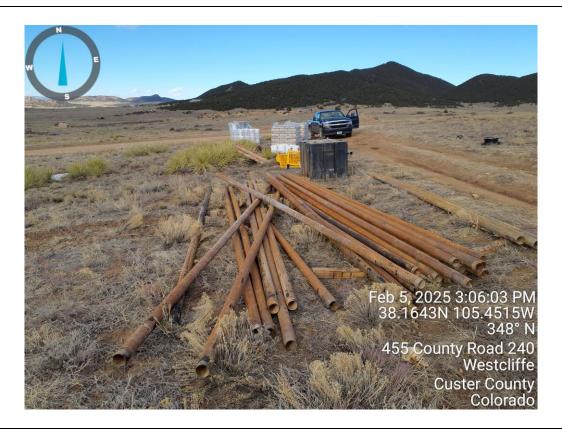
Comment: Secondary staging area looking to the north

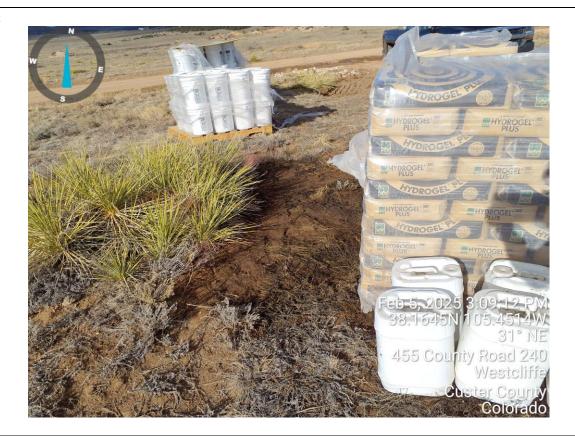
Comment: Hydrocarbon spill at secondary staging area.

Hydrocarbon spill to be cleaned up
