PERMIT INFORMATION

Permit Number: C-1996-084 Mine Name: Lorencito Canyon Mine Operator: New Elk Coal Company, LLC Operator Address: 12250 Highway 12 Weston, CO 81091	County: Las Animas Operation Type: Surface Permit Status: Permanent Cessation Ownership: Private
	Operator Representative Present: None
Operator Representative Signature: (Field Issuance Only)

Inspection Start Date: February 13, 2025 Inspection Start Time: 07:58 Inspection End Date: February 13, 2025 Inspection End Time: 09:32	Inspection Type: Coal Complete Inspection Inspection Reason: Normal I&E Program Weather: Clear
Joint Inspection Agency: None	Joint Inspection Contacts:
Post Inspection Agency: None	Post Inspection Contacts:
Inspector(s): Amber M. Gibson	Inspector's Signature:

This was a complete inspection of the Lorencito Canyon Mine, Colorado Division of Reclamation, Mining and Safety ("DRMS" or "Division") permit number C-1996-084, operated by New Elk Coal Company, LLC. ("NECC"). Amber Gibson, with the Division, conducted the inspection. During the inspection, I was unaccompanied by an Operator representative for the Permittee -- New Elk Coal Company, LLC (NECC). As of July 18, 2024, the presence of staff o

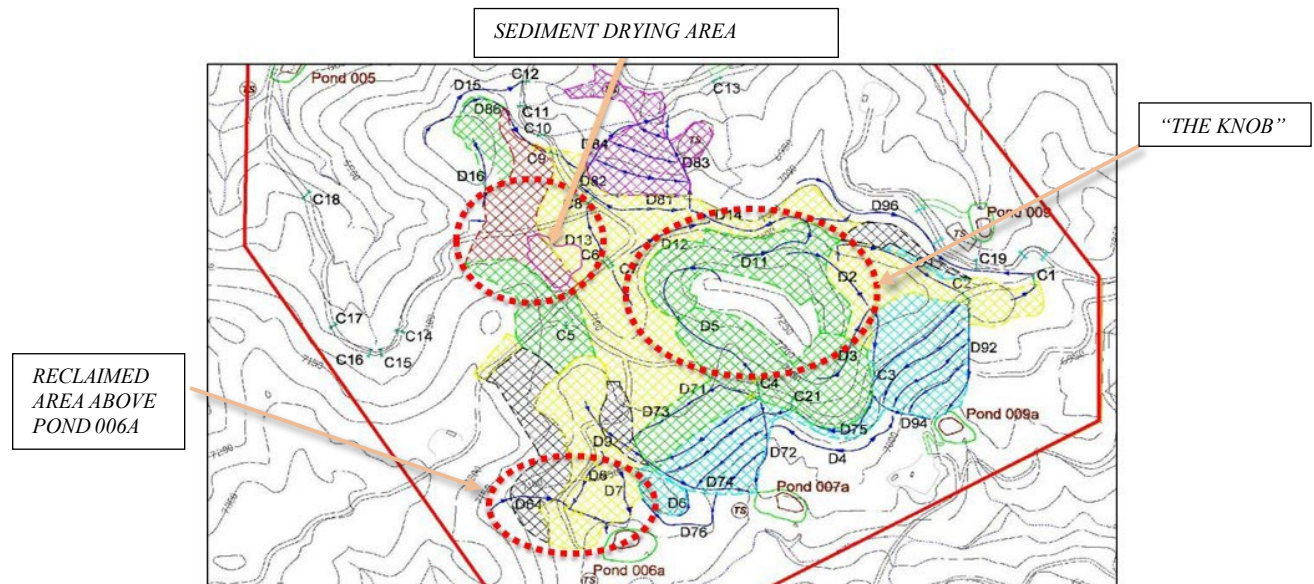
4. The following items pertain to ongoing erosional issues in the areas shown in Figure 1, that pursuant to Rule 4.14.6 need to be addressed. A Technical Revision will be required to expand on the current Rill and Gully plan in the PAP. **The Operator shall submit the technical revision, obtain approval, repair the erosion, and stabilize the slopes pursuant to the approved plan by December 31, 2024.**

FIGURE 1. AREAS WHERE RILLS, GULLIES AND SPARSE VEGETATION HAS BEEN FOUND TO BE A PERSISTENT PROBLEM AT THE SITE ARE WITHIN THE DOTTED CIRCLE AREAS. BACKGROUND IMAGE IS THE 2020 ANNUAL REPORT MAP.

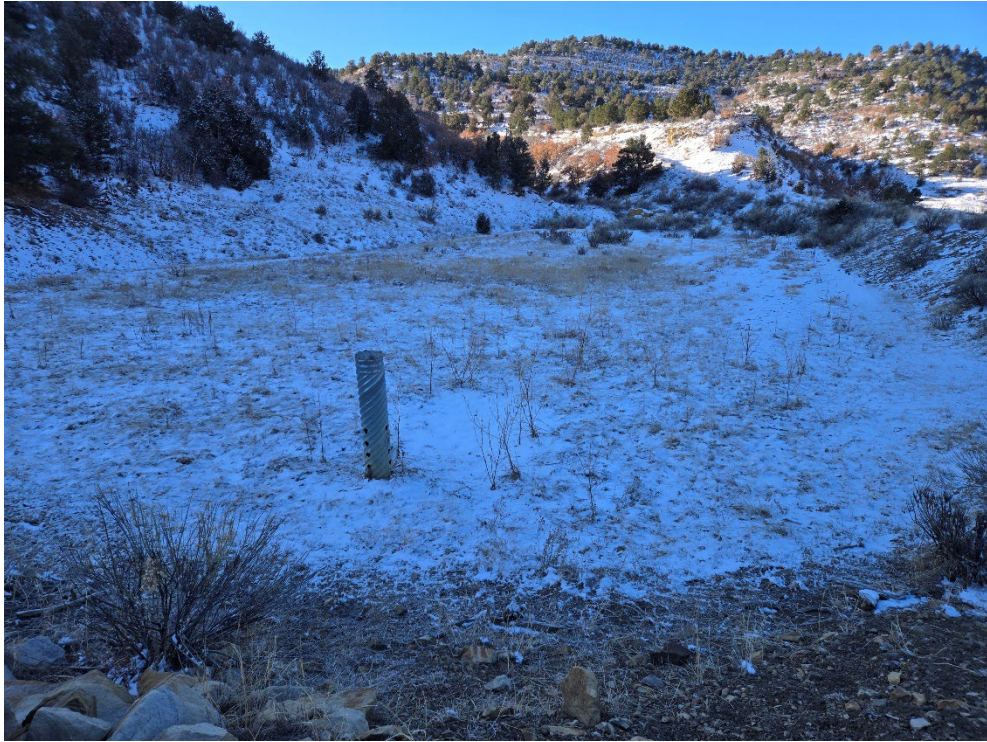
- Pond 005:
 - The pond was dry at the time of the inspection (Photo 1).
 - The flume contained some snow but was not discharging (Photo 2).
 - The pond embankment was stable and vegetated.
 - The primary and emergency spillways appeared clear and functional.
 - The state listed noxious weed, Mullein, was observed by the spillway. **The Operator shall treat and/or remove Mullein in this area.**
- Ditch D9:
 - The check dams within Ditch D9, leading down to Pond 006a, contain an excess amount of sediment. A gully was also observed cutting down from the road and adding sediment to the third check dam. **The Operator shall remove the excess sediment from the check dams within D9.**
- Pond 006a:
 - Pond 006a contained frozen water (Photo 3) and was not discharging at the time of the inspection.

Photo 1: Looking south at Pond 005.

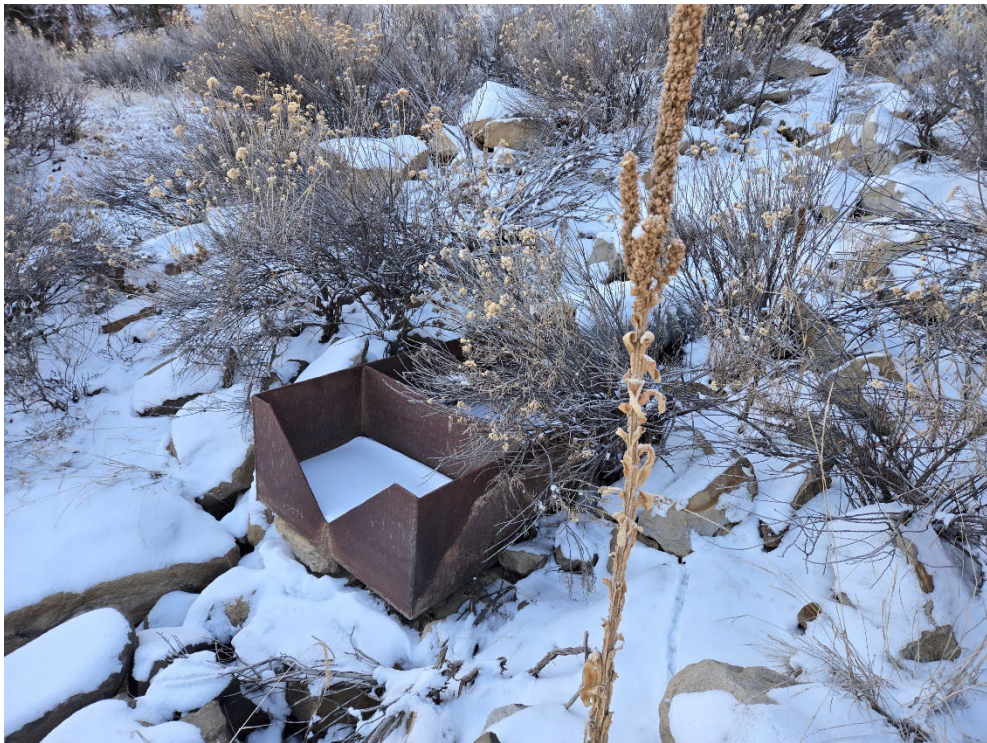
Photo 2: Flume for Pond 005. Mullein stalk in foreground.

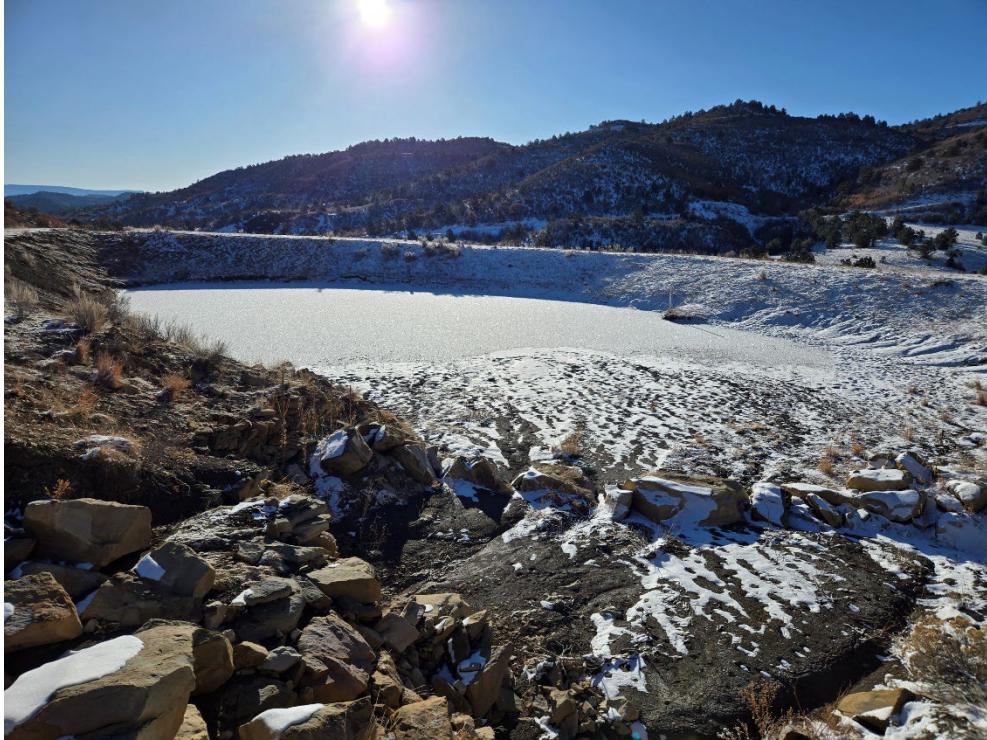
1. Erosion rills are forming on the north and west banks of Pond 006a. The erosion on the north bank appears to have been addressed at some point, because rebar is placed above the rills. However, it appears that the prior BMPs are no longer functioning adequately. **Pursuant to Rule 4.05.5(1)(c), the Operator shall address the erosion and repair the north bank.** The erosion on the west bank appears to have been caused by runoff from the road located east of Pond 006a. **Pursuant to Rule 4.05.5(1)(c), the Operator shall address the erosion and repair the west bank.**

- The north side of the pond embankment still requires maintenance (see Item # 1 in the outstanding maintenance items list on the first page of this report).

Photo 3: Looking east at Pond 006a.

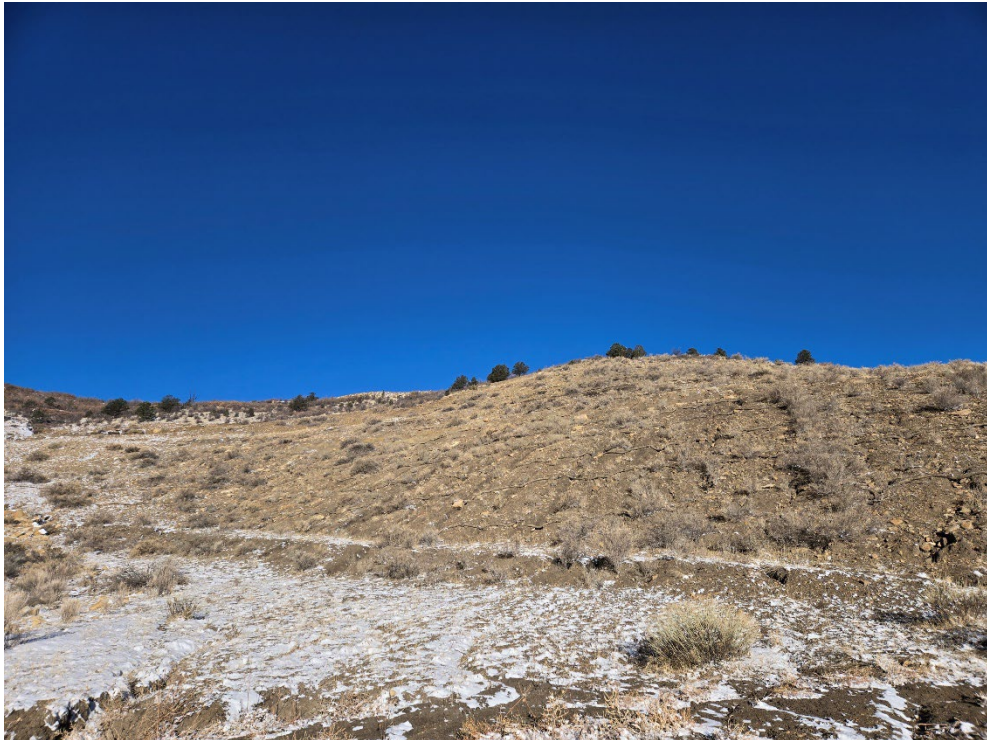
- The ongoing maintenance issues listed in Item #4 at the beginning of this report are still a concern. Photo 4 is in reference to the 'Reclaimed Area Above Pond 006A'.

Photo 4: Looking northwest at the Reclaimed Area above Pond 006a.

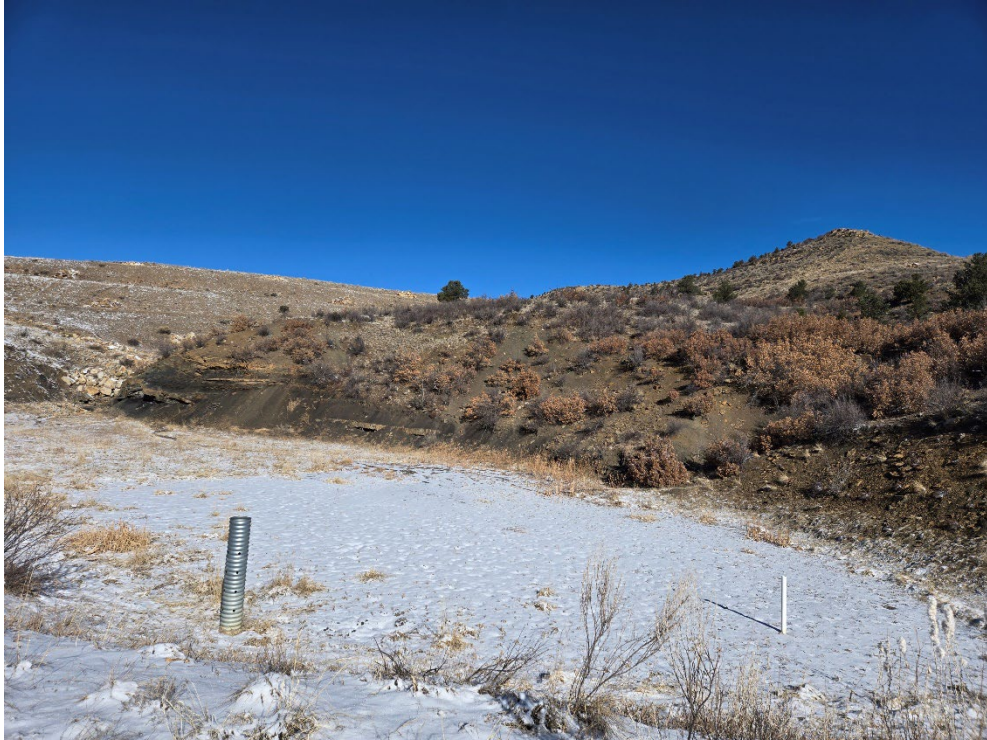
- Pond 007a:
 - The pond contained frozen water at the time of the inspection (Photo 5) and was not discharging at the time of the inspection (Photo 6).

Photo 5: Looking northwest at Pond 007a.

- The pond embankment appeared to be stable and vegetated.
 - The primary and emergency spillways appeared clear and functional.
 - Mullein was observed in the field to the south and west of Pond 007a, within the permit boundary. **The Operator shall treat/remove Mullein within this area.**

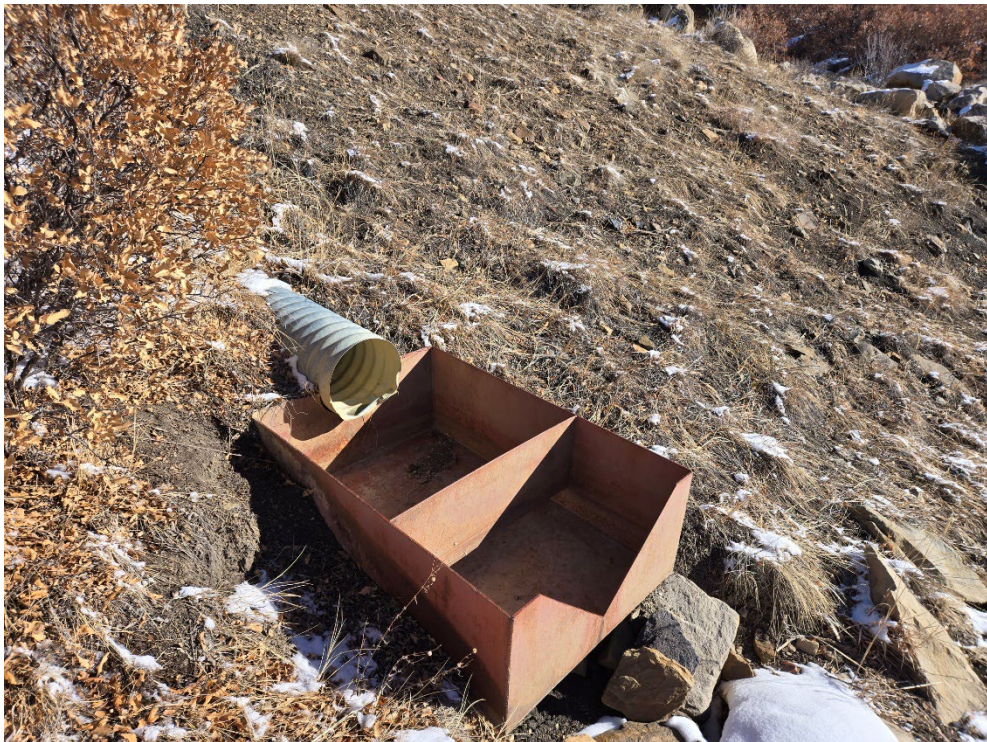
Photo 6: Flume for Pond 007a.

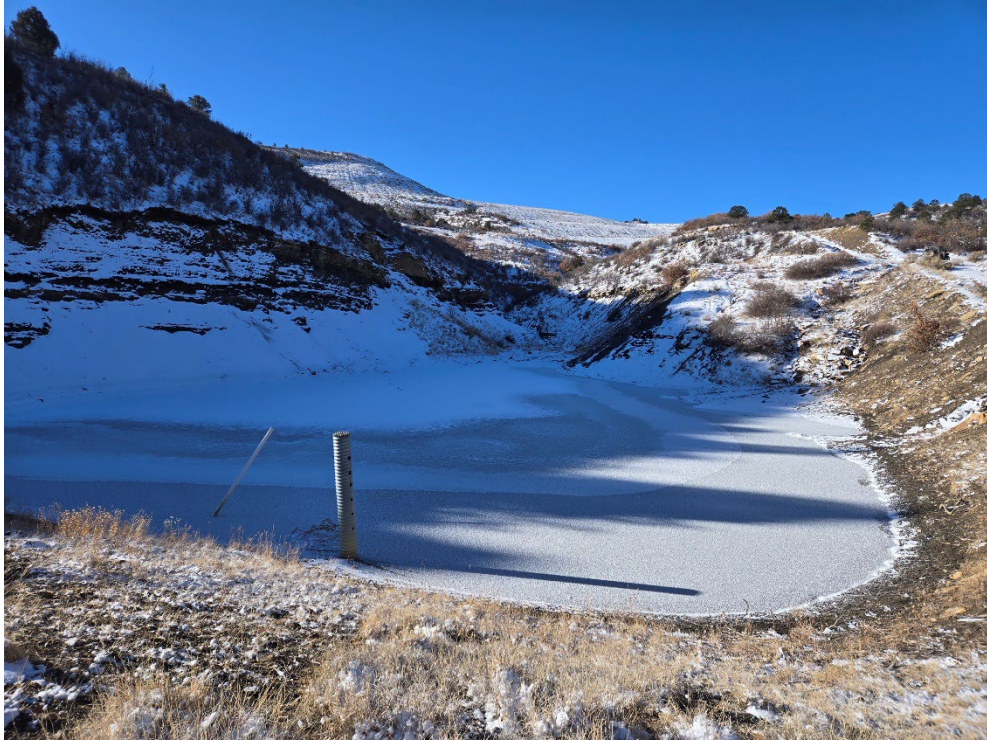
2. The majority of Pond 008's embankment was stable and vegetated, however, the west bank contains some erosion rills and gullies. The erosion appears to have been caused by run-off from the roads above and down to the pond. **Pursuant to Rule 4.05.5(1)(c), the Operator shall repair the erosion and stabilize the west bank of Pond 008.** The Operator stated that they will likely install additional rock berms along the western-most road to help prevent run-off from running

- Pond 08:
 - The pond contained frozen water (Photo 7). The flume contained some snow but was not discharging at the time of the inspection (Photo 8).
 - The pond embankment still requires maintenance (see Item #2 in the outstanding maintenance items list on the first page of this report).

Photo 7: Looking south at Pond 08.

down the slopes and into the pond. The Operator also stated that they plan to remove the sediment (deposited as a result of the bank erosion) along the west bank of Pond 008.

- The primary and emergency spillways appeared clear and functional.
 - Some of the state listed noxious weed, Mullein, observed along the west bank of Pond 08 were treated by the Operator during the June inspection. However, more were observed during the August-February inspections. **The Operator shall treat/remove Mullein within this area.**

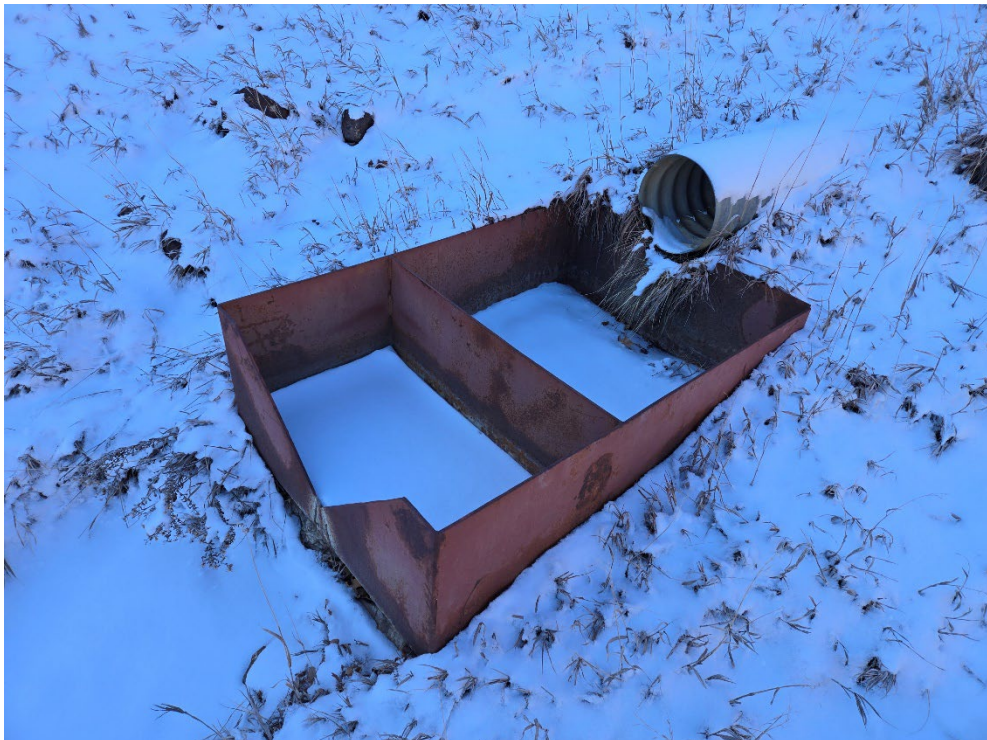
Photo 8: Flume for Pond 08.

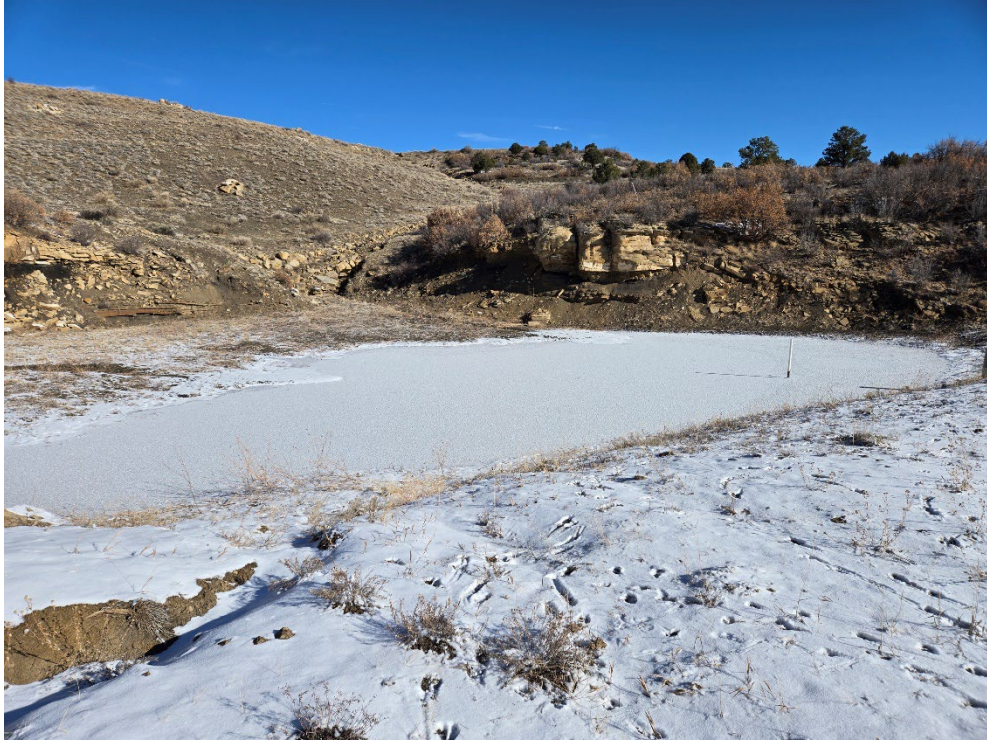
- Pond 009a:
 - The pond contained some frozen water at the time of the inspection (Photo 9).
 - The pond embankment appeared to be stable and vegetated.

Photo 9: Looking northeast at Pond 009a.

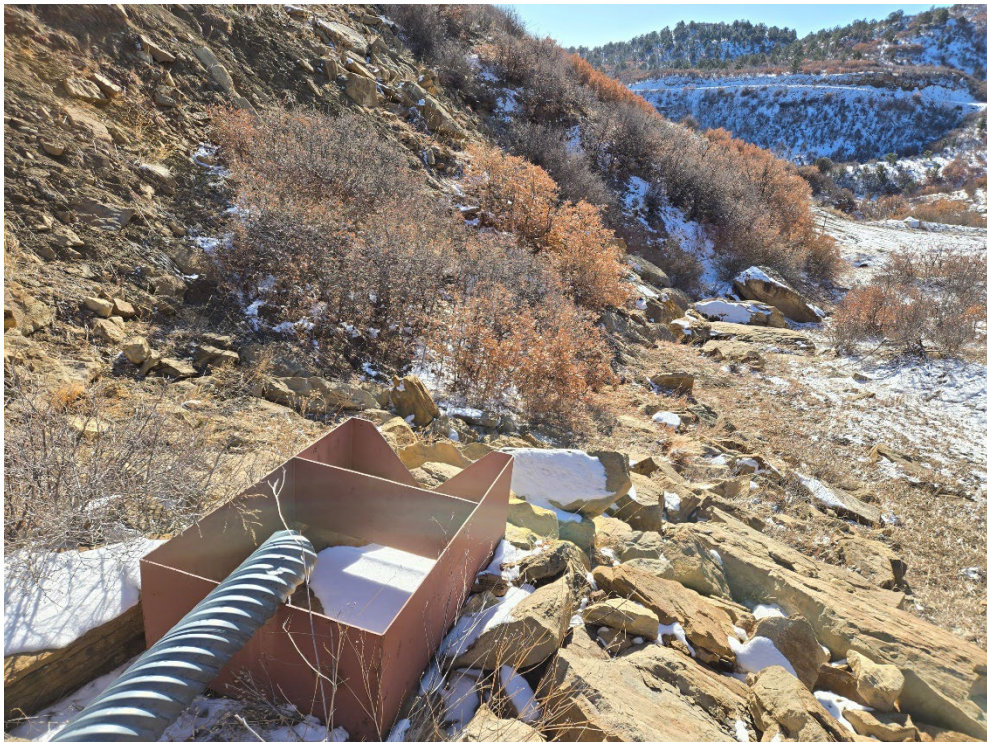
- The primary and emergency spillways appeared clear and functional.
 - The flume contained some snow at the time of the inspection but was not discharging (Photo 10).

Photo 10: Flume for Pond 009a.

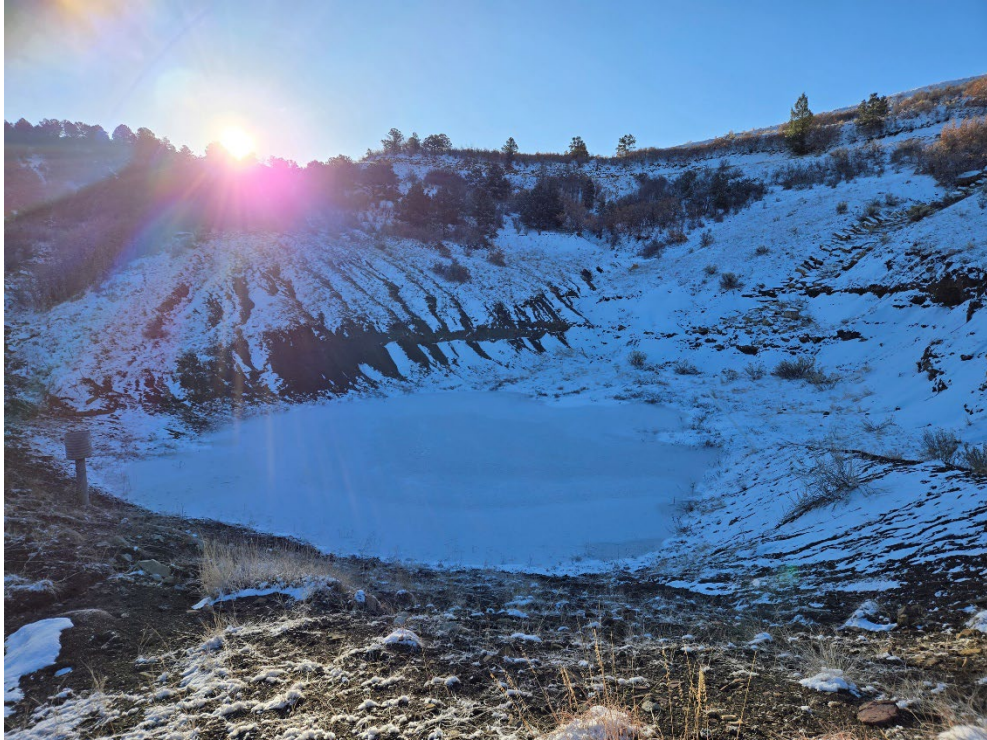
- Pond 009:
 - The pond contained some frozen water at the time of the inspection. (Photo 11).
 - The pond embankment appeared to be stable and vegetated.

Photo 11: Looking south at Pond 009.

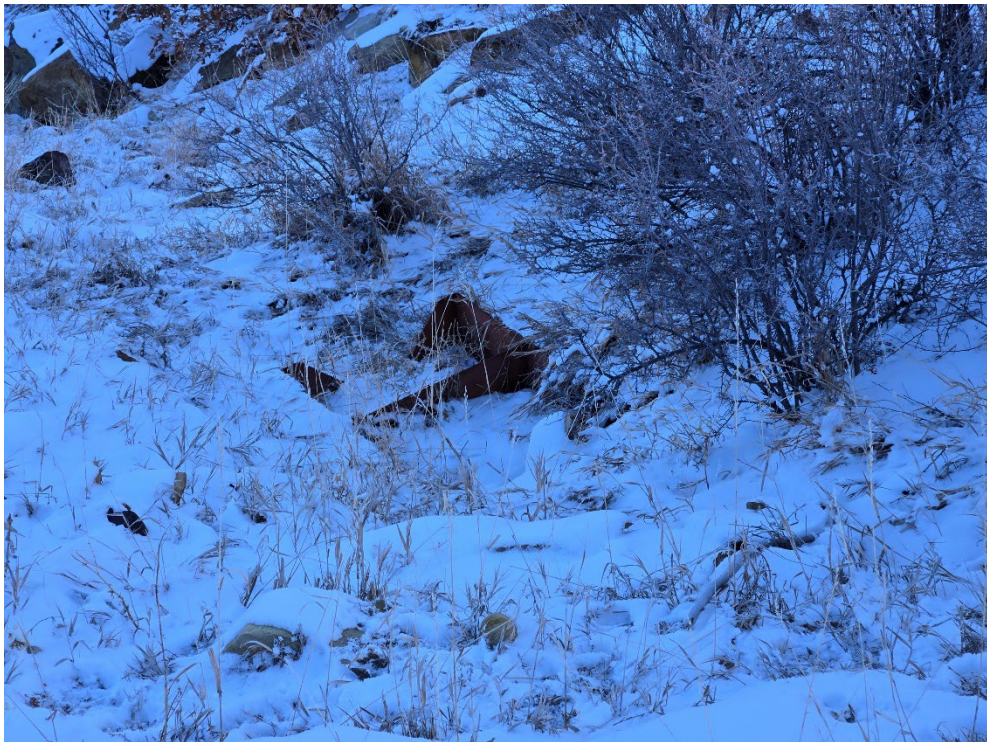
- The primary and emergency spillways appeared clear and functional.
 - The flume was contained snow but was not discharging (Photo 12).

Photo 12: Flume for Pond 009.

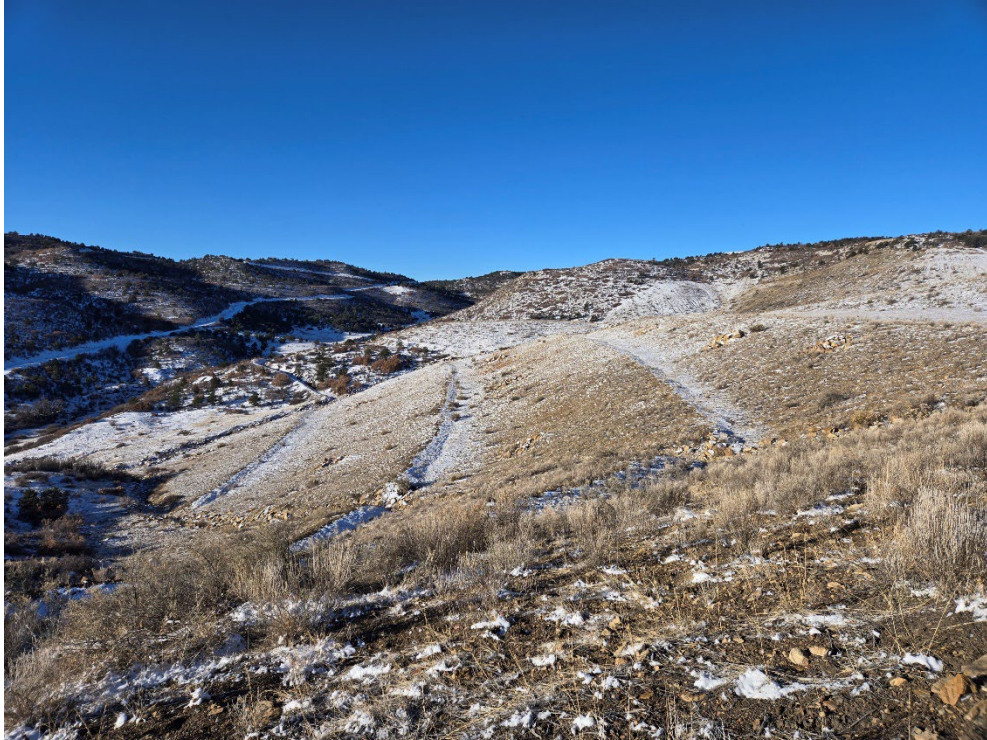
- Fill 7 was observed. Fill 7 was well vegetated and appeared stable (Photo 13).
- Fill 8 was observed. Fill 8 was well vegetated and appeared stable (Photo 14).
- Fill 9 was observed. Fill 9 was well vegetated and appeared stable (Photo 15).

Photo 13: Looking west across the top of Fill 7.

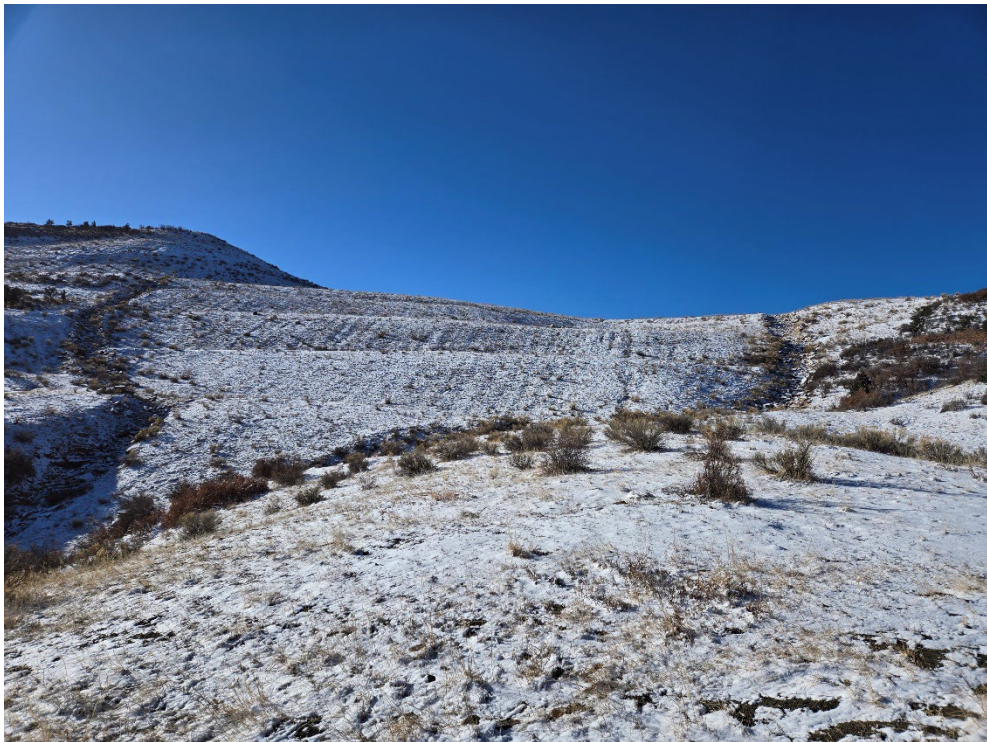
Photo 14: Looking south towards the bottom of Fill 8.

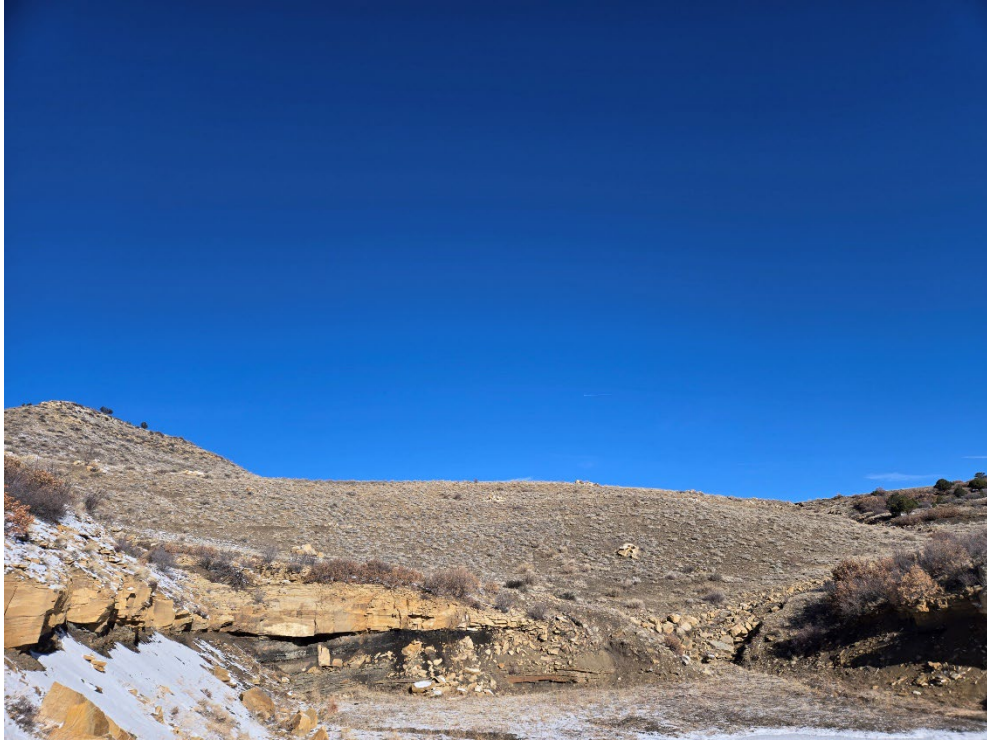
Photo 15: Looking north at Fill 9.

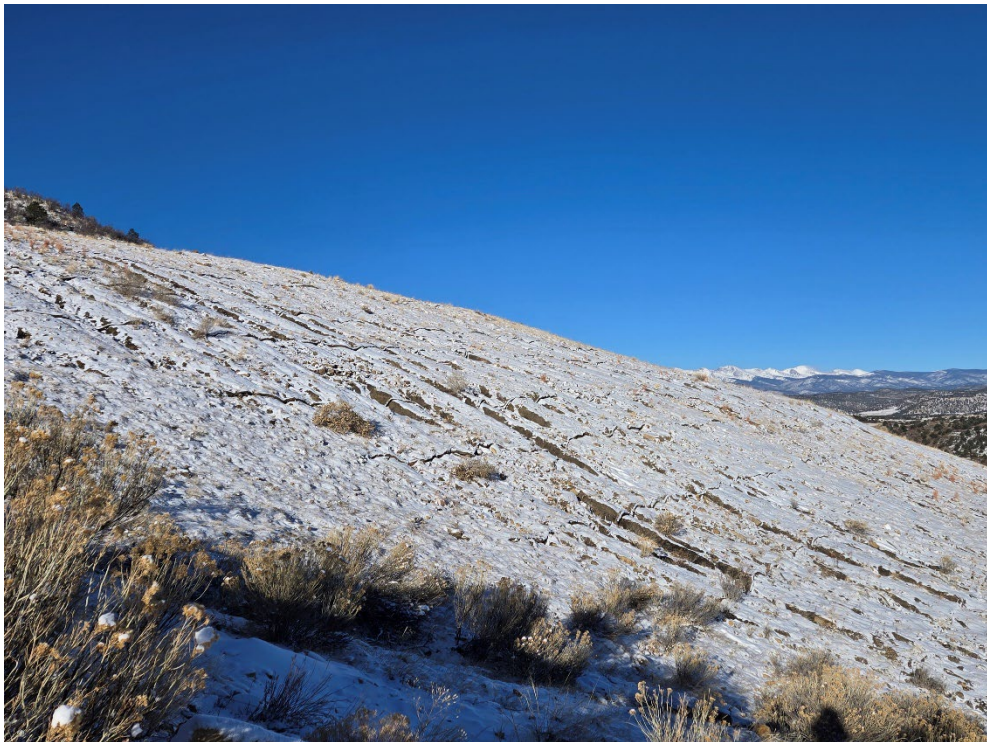
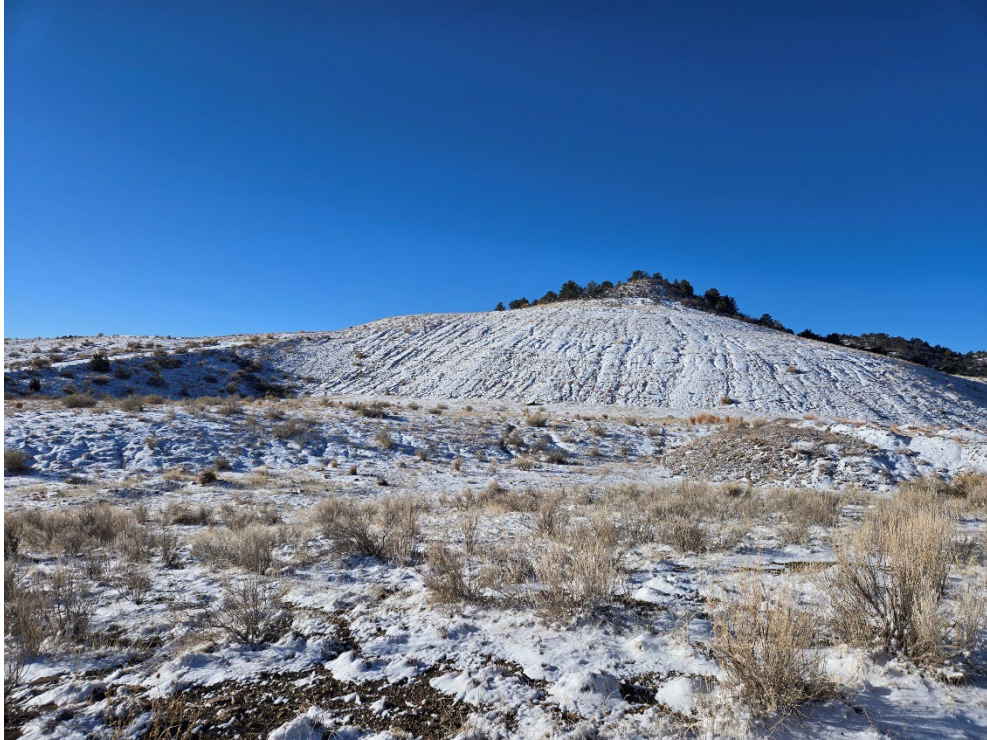
- The area above where NECC stores pond and ditch cleanings consists of a steep slope. This slope was observed during the inspection (Photos 16 and 17). Erosion rills and gullies were observed but the vegetation on this slope appears better established this year than in years previously observed by DRMS. NECC is encouraged to continue to monitor this area and conduct maintenance as needed.
- A previously disturbed area north of Fill 7 and north of the road, referred to as “The Knob”, exhibits erosion on the south and west facing slopes (Photo 18). NECC is required to provide a plan to stabilize this area through a revision following the approval of RN5 (see ongoing maintenance item number 4).

Photo 16: Looking west across the Reclaimed Area above the Sediment Drying Area.

Photo 17: Looking south at the Reclaimed Area above the Sediment Drying Area.

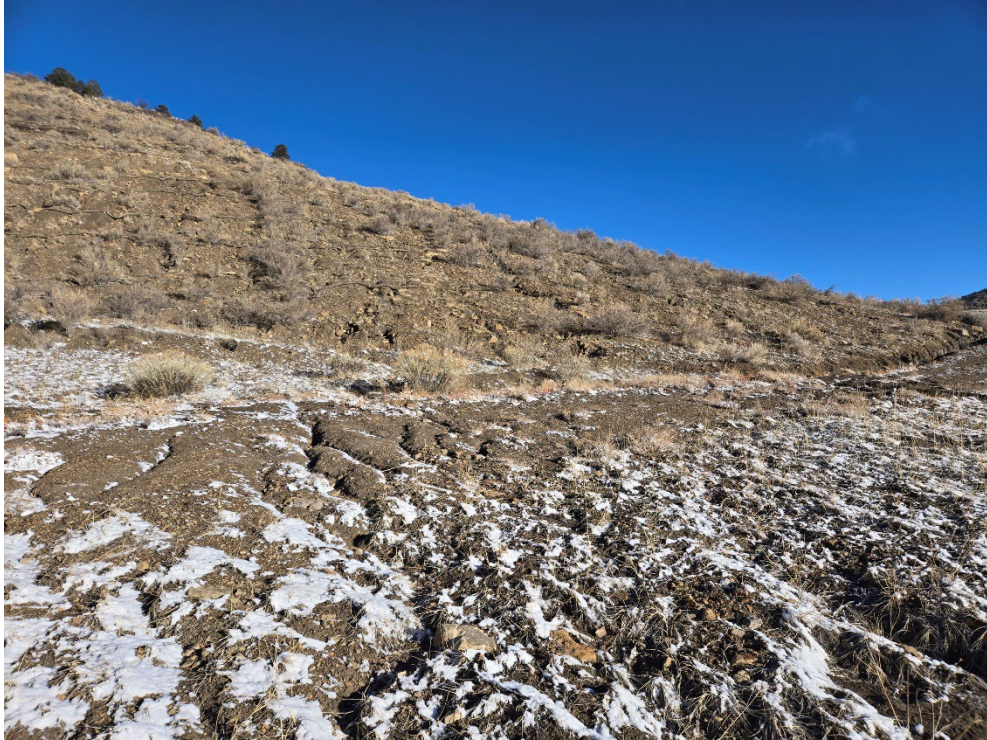
3. The following items pertain to ongoing maintenance issues, cited in previous reports for the area in and around the reclaimed area above Pond 006a:
 - The ditch along the road leading to Pond 006a is eroding and nearly full of sediment. The overloaded ditch is contributing to the build-up of sediment in the check dams of ditches D8 and D64. **Pursuant to Rule 4.03.2(4), the ditch along the west side of the road leading to Pond 006a needs to be cleaned out and repaired.**

- The check dams leading to Pond 006a, within ditches D8 and D64, are nearly full of sediment. **Pursuant to Rules 4.05.3(1)(c)-(e) and 4.05.5, the Operator shall clean out the sediment from the check dams to prevent excess sediment from entering the pond.**

- See ongoing maintenance Item #2. The road along Pond 006A is washed out in the area between the reclaimed area and Pond 006A, and needs to be repaired (Photo 19).
- See ongoing maintenance Item #3. The road leading down into Pond 008 has some ruts that will require repairs. The ruts and divots in the road to Pond 008 make vehicle access to the pond difficult and not advisable in adverse conditions and without a high clearance 4-wheel drive vehicle (Photo 20).

Photo 19: Looking northwest across where the Reclaimed Area above Pond 006a has caused erosion across the road and towards the check dams leading to Pond 006a.

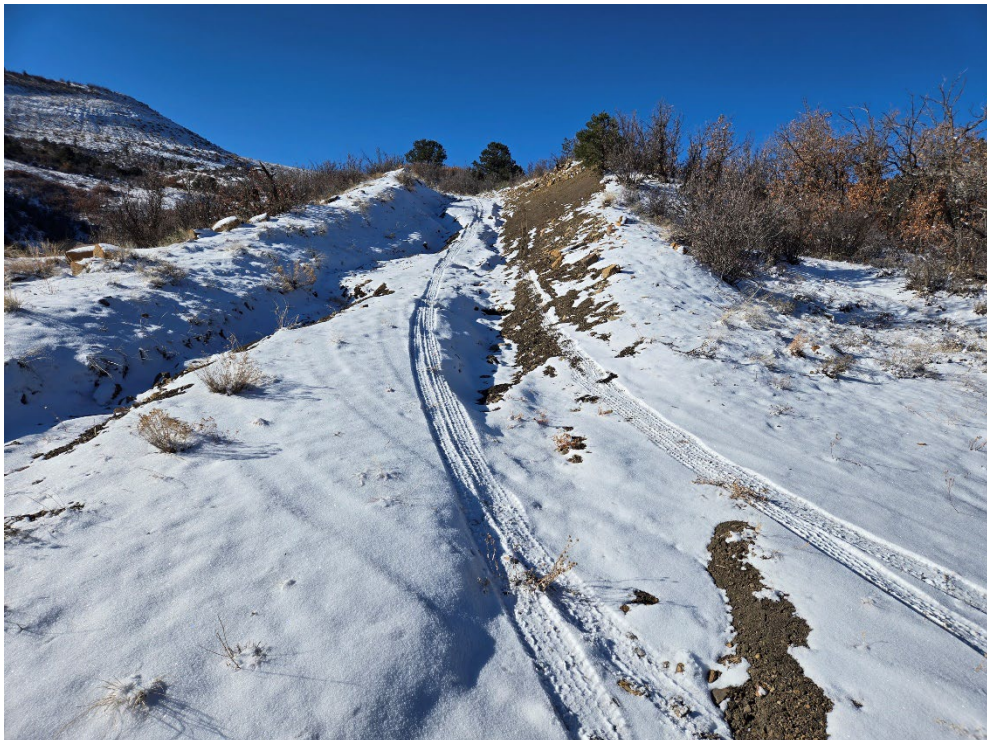
Photo 20: Looking at a difficult portion of the road to traverse with a vehicle leading to Pond 08.

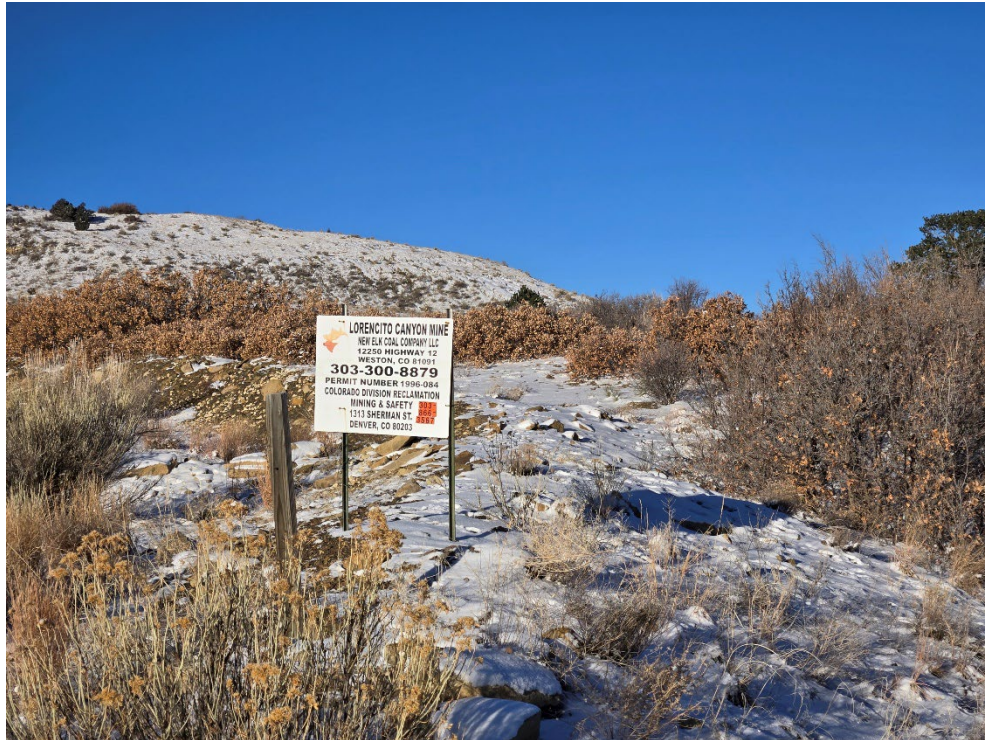
- Mine signs were posted at road entrances and at the entrance to the permit boundary in compliance with Rule 4.02 (Photo 21).

Photo 21: Mine sign posted at the permit boundary.
