MINERALS PROGRAM INSPECTION REPORT
PHONE: (303) 866-3567

MINE NAME: SPN Pit	MINE/PROSPECTING ID#: M-2020-006	MINERAL: Gravel	COUNTY: Huerfano
INSPECTION TYPE: Monitoring	WEATHER: Cloudy	INSP. DATE: February 11, 2025	INSP. TIME: 11:30
OPERATOR: Fremont Paving & Redi-Mix, Inc.	OPERATOR REPRESENTATIVE: None	TYPE OF OPERATION: 112c - Construction Regular Operation	
REASON FOR INSPECTION: Normal I&E Program	BOND CALCULATION TYPE: Partial Bond	BOND AMOUNT: \$79,395.00	
DATE OF COMPLAINT: NA	POST INSP. CONTACTS: None	JOINT INSP. AGENCY: None	
INSPECTOR(S): Amber M. Gibson	INSPECTOR'S SIGNATURE:

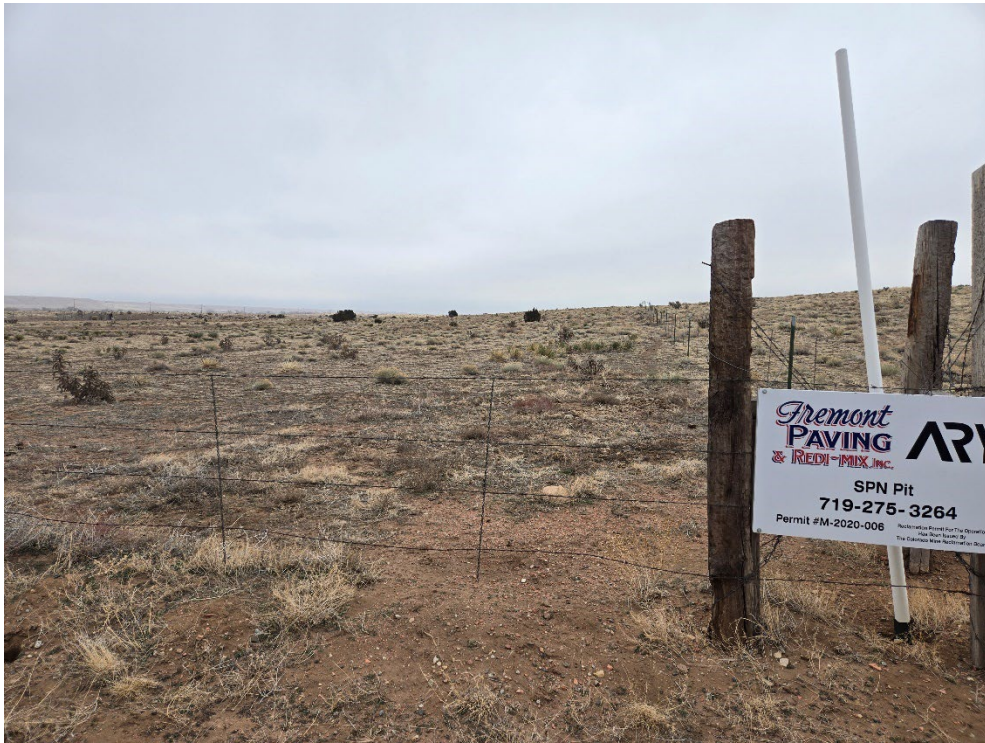
Operations have not yet begun at the SPN pit (Photo 1-3). No compliance concerns were observed at the time of the inspection.

Photo 1: Looking east towards the north/central side of the permit area.

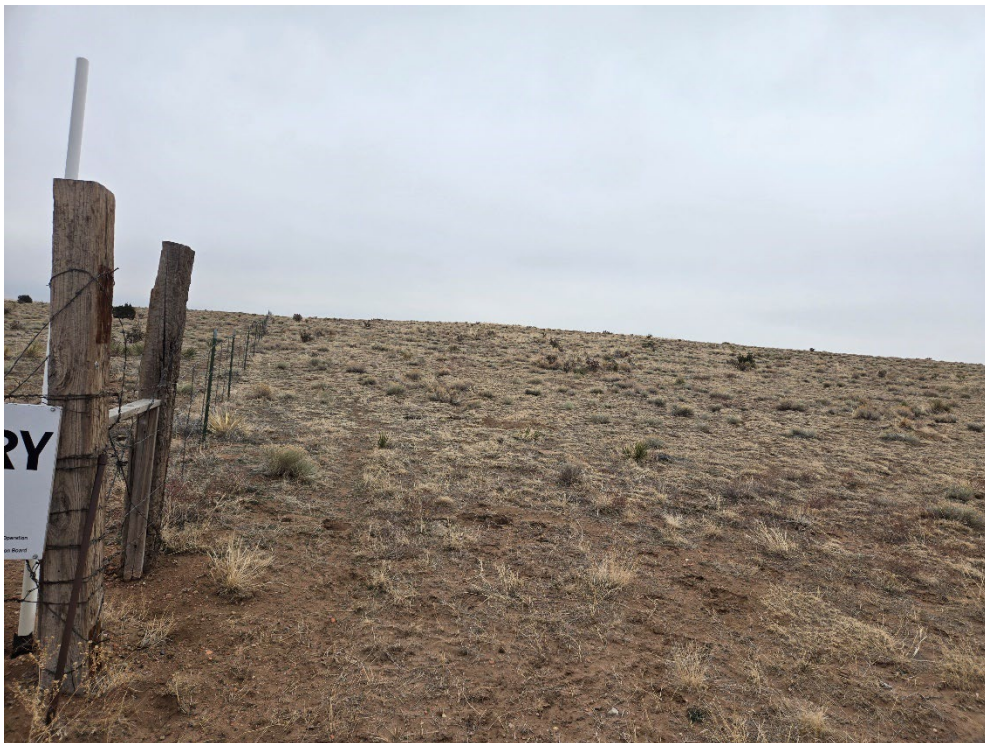
Photo 2: Looking east towards the south side of the permit area.

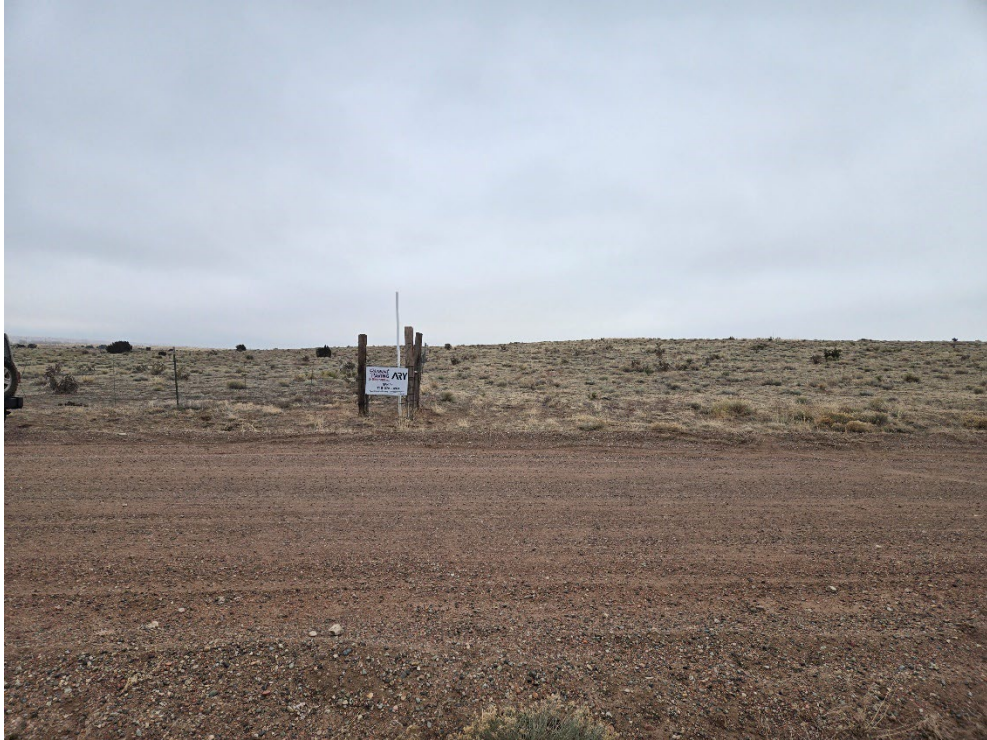
A mine sign is posted at the mine entrance pursuant to Rule 3.1.12(1) (Photos 1-3). The permit boundary was marked pursuant to Rule 3.1.12(2) with 2-inch PVC casing. The permit boundary markers are visible from the road and appear to be in the same locations they were in during the Division's 2020 pre-operation inspection (Map 1).

Photo 3: Looking east into the permit area from the road.

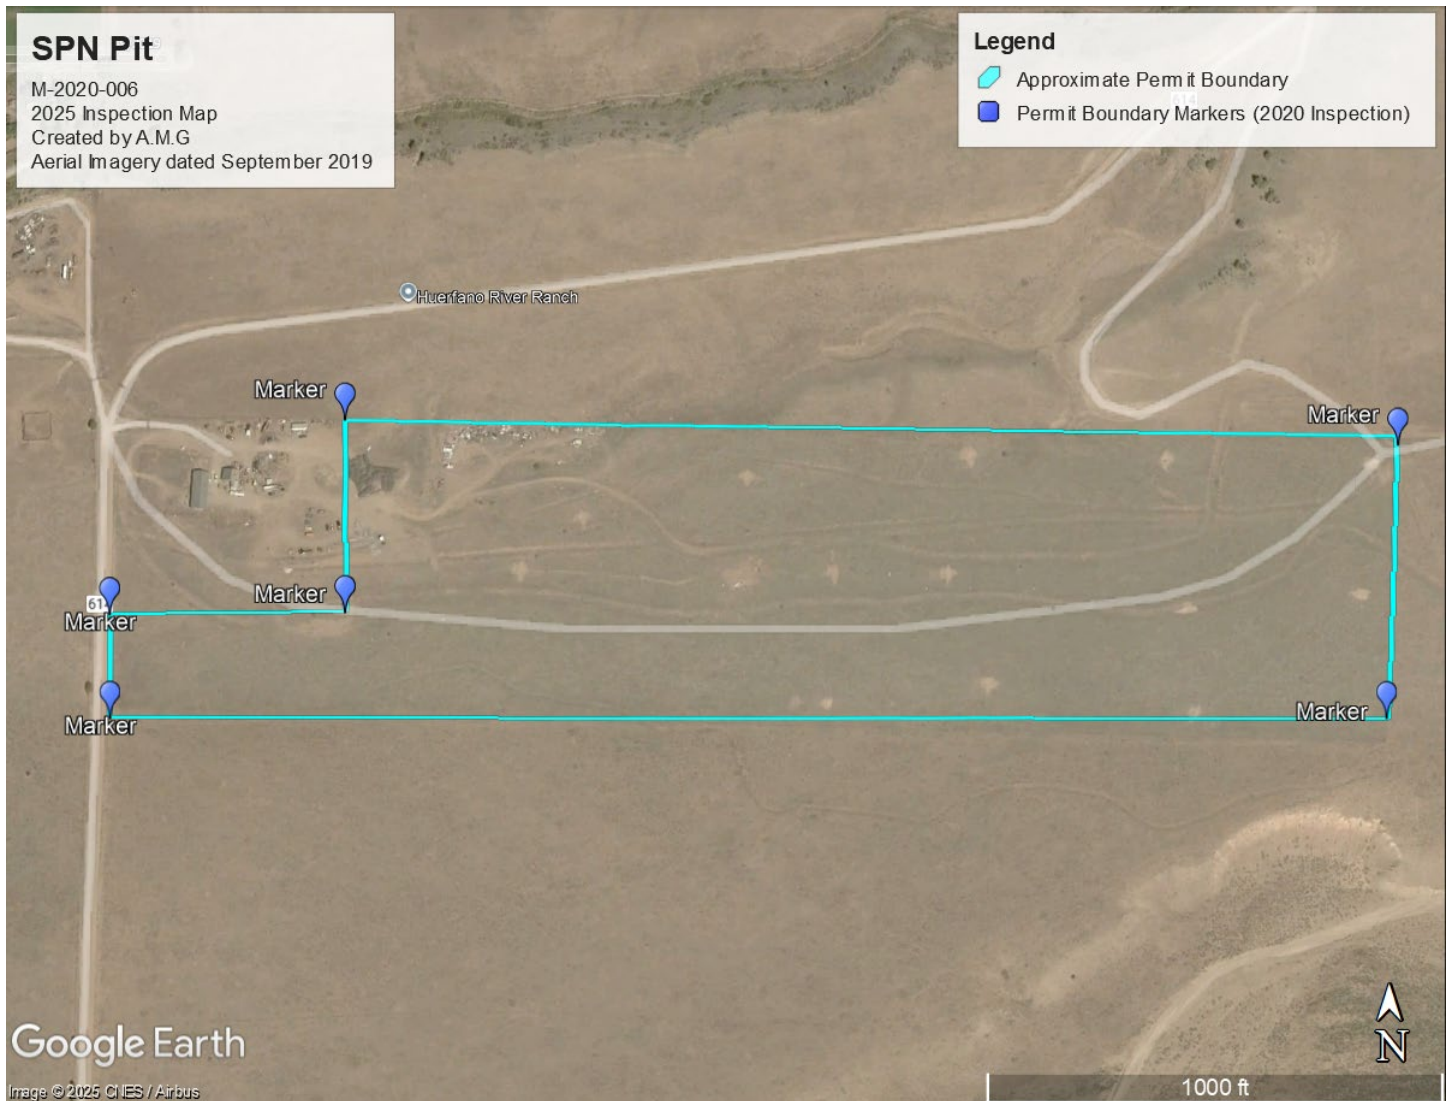
Map 1: Inspection map created in Google Earth Pro. Although the aerial imagery is dated September 2019, little appears to have changed since the photo was taken, as mining activity has not yet begun at the site.
