MINERALS PROGRAM INSPECTION REPORT
PHONE: (303) 866-3567

MINE NAME: Lofdahl	MINE/PROSPECTING ID#: M-2004-001	MINERAL: Sand and gravel	COUNTY: Lincoln
INSPECTION TYPE: Monitoring	WEATHER: Snowing	INSP. DATE: February 18, 2025	INSP. TIME: 01:30
OPERATOR: Lincoln County	OPERATOR REPRESENTATIVE:	TYPE OF OPERATION: 112c - Construction Regular Operation	
REASON FOR INSPECTION: Normal I&E Program	BOND CALCULATION TYPE: None	BOND AMOUNT: \$0.00	
DATE OF COMPLAINT: NA	POST INSP. CONTACTS: None	JOINT INSP. AGENCY: None	
INSPECTOR(S): Ben Hammar	INSPECTOR'S SIGNATURE:

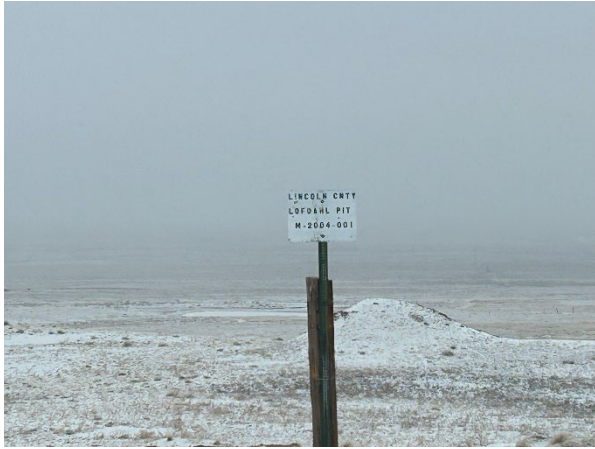
Photo 1: Mine identification sign.

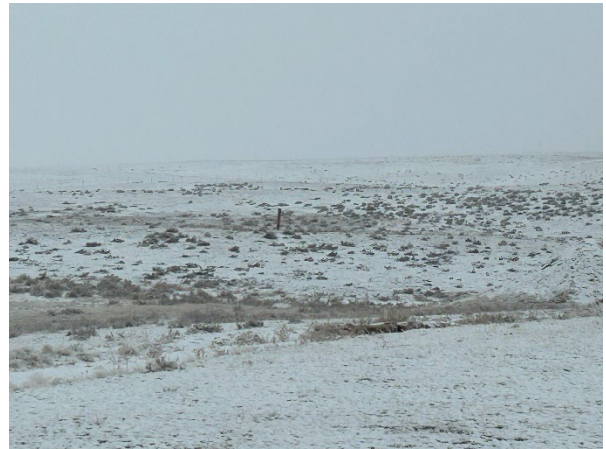
Photo 2: Example site boundary. All bounds were present during inspection.

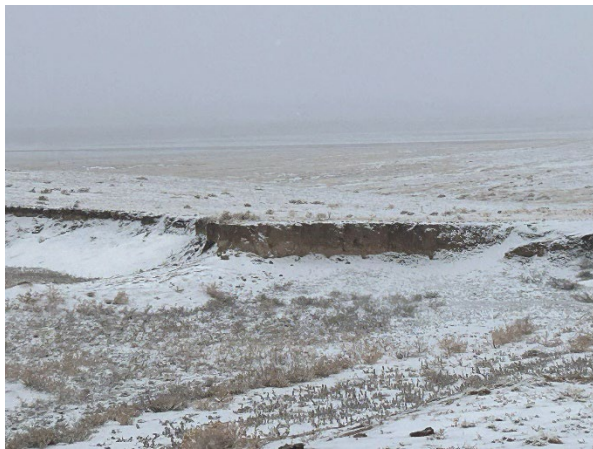
Photo 3: Active highwall.

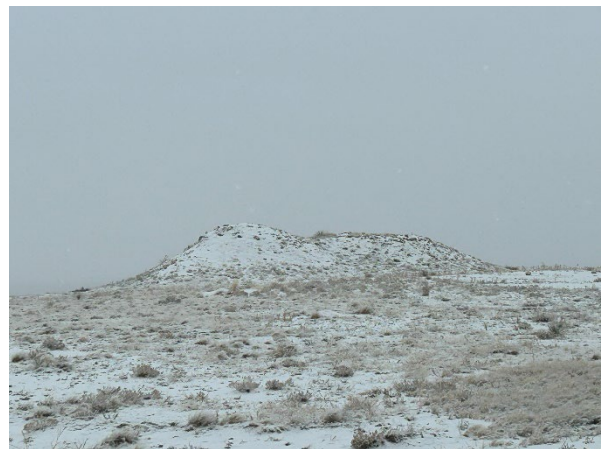
A single topsoil stockpile is located on the eastern portion of the site and appeared to be stable. No vegetation was able to be observed at the time of inspection due to snow cover. Mining appears to be proceeding along a single highwall located in the southern portion of the pit. Material is then stockpiled within the middle of the permit.

Photo 4: Topsoil stockpile. Appears stable at the time of inspection.
