**MINERALS PROGRAM INSPECTION REPORT**  
**PHONE: (303) 866-3567**

<b>MINE NAME:</b> Clark Pit	<b>MINE/PROSPECTING ID#:</b> M-2007-084	<b>MINERAL:</b> Sand and gravel	<b>COUNTY:</b> Lincoln
<b>INSPECTION TYPE:</b> Monitoring	<b>WEATHER:</b> Snowing	<b>INSP. DATE:</b> February 11, 2025	<b>INSP. TIME:</b> 12:00
<b>OPERATOR:</b> Lincoln County	<b>OPERATOR REPRESENTATIVE:</b>	<b>TYPE OF OPERATION:</b> 110c - Construction Limited Impact	
<b>REASON FOR INSPECTION:</b> Normal I&E Program	<b>BOND CALCULATION TYPE:</b> None	<b>BOND AMOUNT:</b> \$0.00	
<b>DATE OF COMPLAINT:</b> NA	<b>POST INSP. CONTACTS:</b> None	<b>JOINT INSP. AGENCY:</b> None	
<b>INSPECTOR(S):</b> Ben Hammar	<b>INSPECTOR'S SIGNATURE:</b>

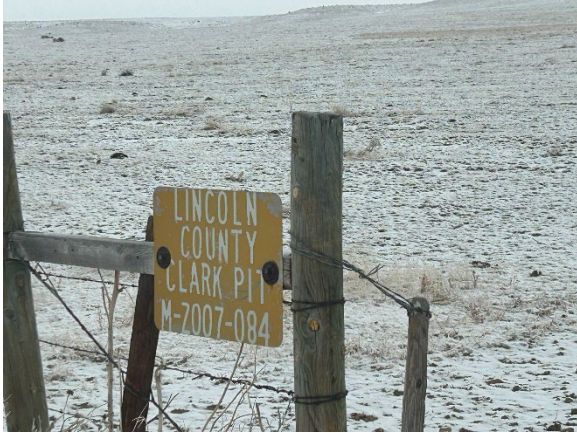
Photo 1: Posted mine sign.

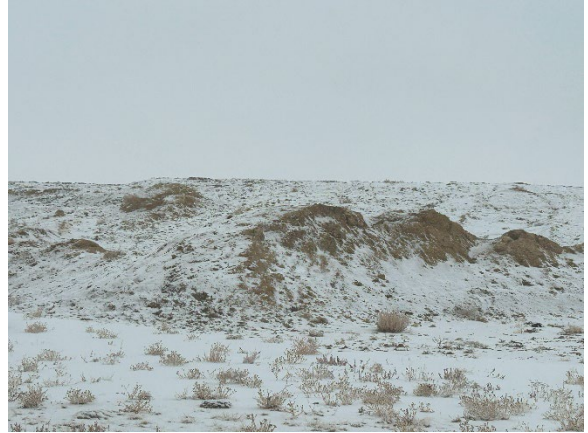
Photo 2: Representative stockpile and sloped material.

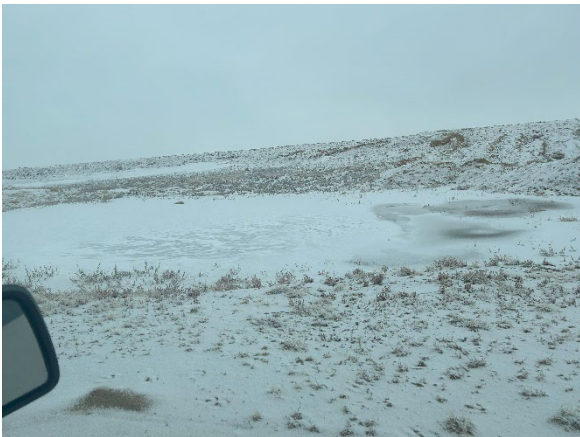
Photo 3: Frozen runoff, located in the pit floor.

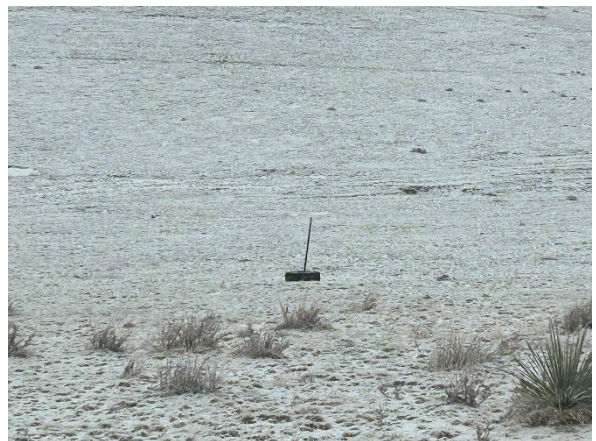
Photo 4: Representative site boundary. All boundaries were present during the inspection.

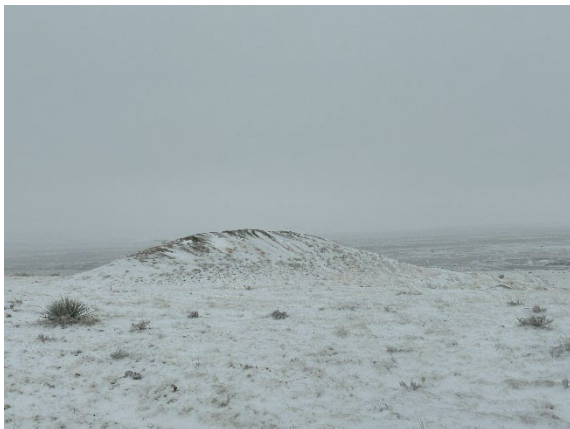
Typical mining practice at this pit is to strip topsoil and push material into piles within the pit floor to be removed as needed. Topsoil is stored within two separate piles, and appears to be well stabilized. No vegetation was able to be observed at the time of inspection due to snow cover.

Photo 5: Southeast topsoil stockpile. Appeared stable at the time of inspection.
