**MINERALS PROGRAM INSPECTION REPORT**  
**PHONE: (303) 866-3567**

<b>MINE NAME:</b> George Ansley Pit	<b>MINE/PROSPECTING ID#:</b> M-1978-078-SG	<b>MINERAL:</b> Sand and gravel	<b>COUNTY:</b> Lincoln
<b>INSPECTION TYPE:</b> Monitoring	<b>WEATHER:</b> Snowing	<b>INSP. DATE:</b> February 11, 2025	<b>INSP. TIME:</b> 10:30
<b>OPERATOR:</b> Lincoln County	<b>OPERATOR REPRESENTATIVE:</b>	<b>TYPE OF OPERATION:</b> 112c - Construction Regular Operation	
<b>REASON FOR INSPECTION:</b> Normal I&E Program	<b>BOND CALCULATION TYPE:</b> None	<b>BOND AMOUNT:</b> \$0.00	
<b>DATE OF COMPLAINT:</b> NA	<b>POST INSP. CONTACTS:</b> None	<b>JOINT INSP. AGENCY:</b> None	
<b>INSPECTOR(S):</b> Ben Hammar	<b>INSPECTOR'S SIGNATURE:</b>

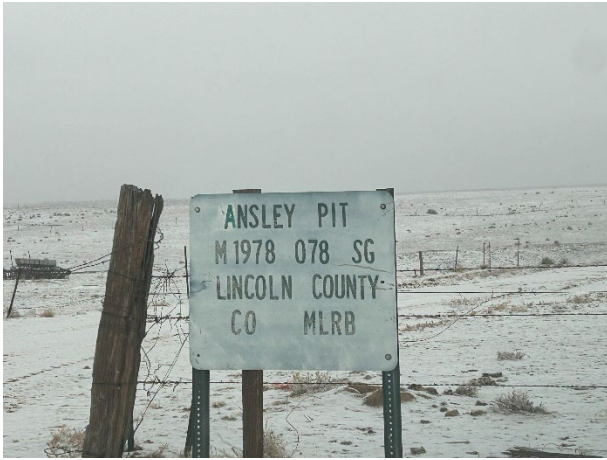
Photo 1: Posted mine sign.

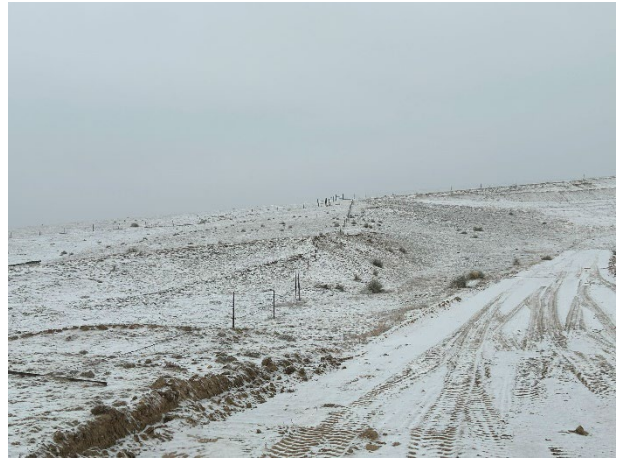
Photo 2: Northern boundary fence.

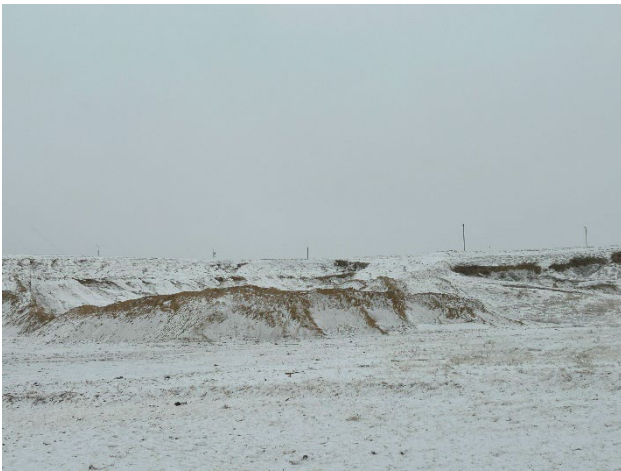
Photo 3: Example material stockpile.

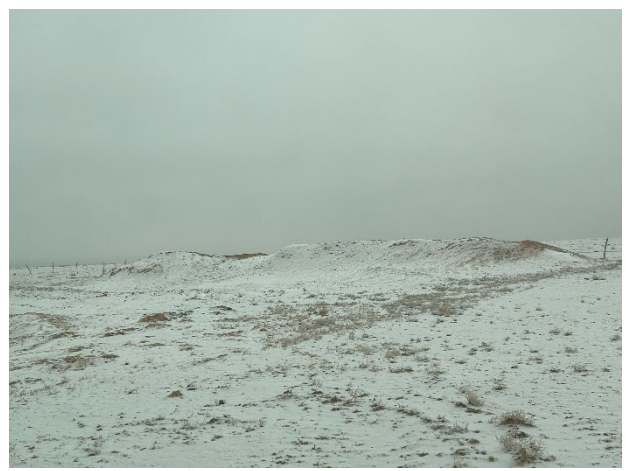
Due to recent snowfall no evidence of impacts to the local hydrologic balance was able to be observed. No vegetation was present, however all topsoil piles appeared to be stable and no evidence of erosion was found within the topsoil stockpiles.

Photo 4: Stable topsoil stockpile.
