MINERALS PROGRAM INSPECTION REPORT
PHONE: (303) 866-3567

MINE NAME: Ravenkamp Pit No 1	MINE/PROSPECTING ID#: M-1991-060	MINERAL: Gravel	COUNTY: Lincoln
INSPECTION TYPE: Monitoring	WEATHER: Clear	INSP. DATE: February 12, 2025	INSP. TIME: 12:30
OPERATOR: Lincoln County	OPERATOR REPRESENTATIVE:	TYPE OF OPERATION: 112c - Construction Regular Operation	
REASON FOR INSPECTION: Normal I&E Program	BOND CALCULATION TYPE: None	BOND AMOUNT: \$0.00	
DATE OF COMPLAINT: NA	POST INSP. CONTACTS: None	JOINT INSP. AGENCY: None	
INSPECTOR(S): Ben Hammar	INSPECTOR'S SIGNATURE:

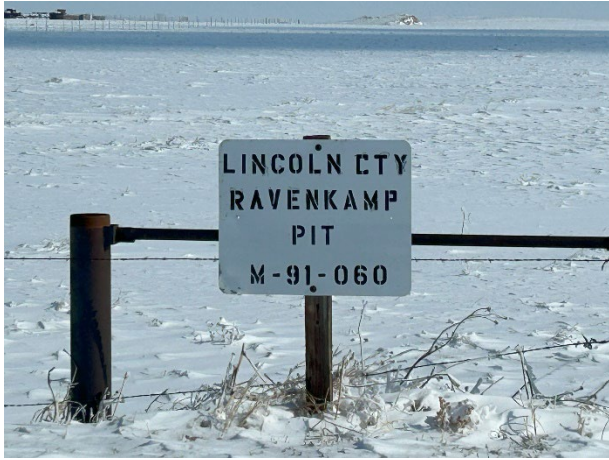
The site was not active at the time of inspection. This is an intermittent operation, so no recent activity is not an issue at this time. The mine sign was clearly posted at the site entrance, and appeared to be in good condition. Site boundaries were marked with T posts and appeared to be in good condition at the time of inspection.

Photo 1: Posted mine ID sign.

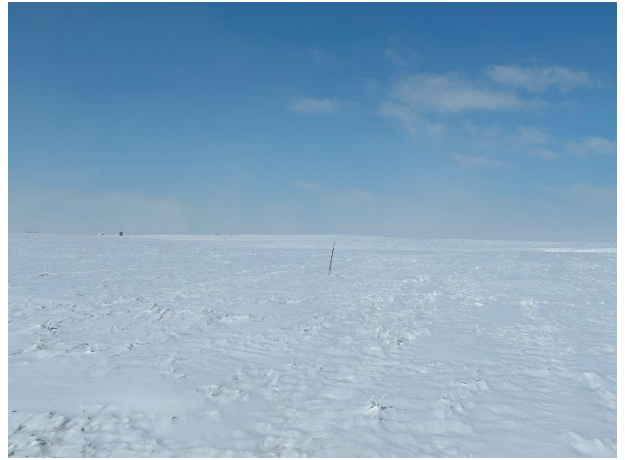
Photo 2: Example site boundary marker.

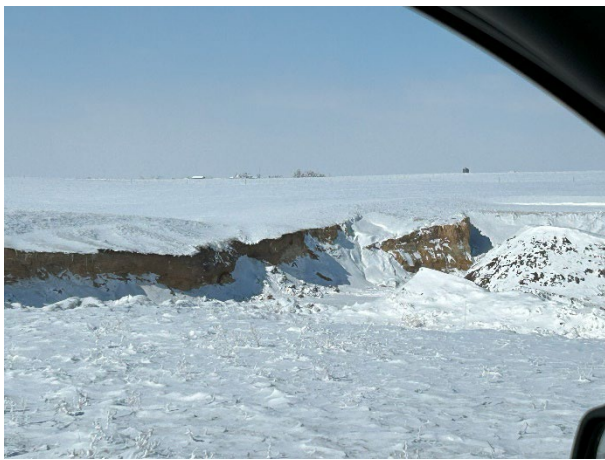
Photo 3: Currently active highwall.

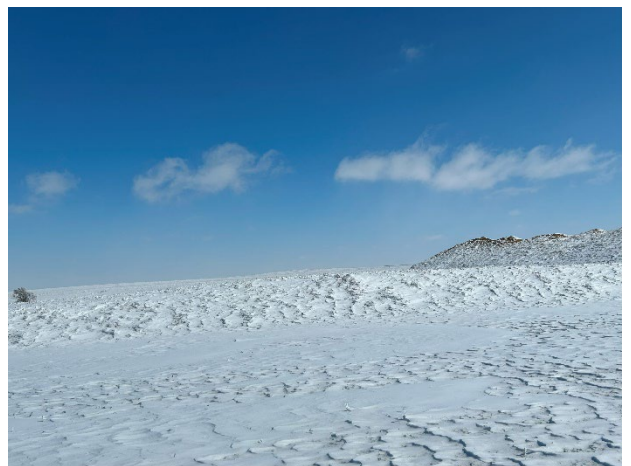
A single topsoil stockpile is located on the western portion of the site and appeared to be stable. No vegetation was able to be observed at the time of inspection due to snow cover. The easternmost section of the site has been reclaimed, and is currently sloped at 3:1 or shallower.

Photo 4: Reclaimed area to the east. Vegetation was not observed due to snow cover.
