MINERALS PROGRAM INSPECTION REPORT
PHONE: (303) 866-3567

MINE NAME: El Rancho Bondo	MINE/PROSPECTING ID#: M-2018-028	MINERAL: Gold	COUNTY: Fremont
INSPECTION TYPE: Monitoring	WEATHER: Clear	INSP. DATE: January 8, 2025	INSP. TIME: 10:15
OPERATOR: Cary Joe Lovett	OPERATOR REPRESENTATIVE: Mr. Cary 'Joe' Lovett	TYPE OF OPERATION: 110(1) - Hard Rock Limited Impact	
REASON FOR INSPECTION: Normal I&E Program	BOND CALCULATION TYPE: Complete Bond	BOND AMOUNT: \$2,319.00	
DATE OF COMPLAINT: NA	POST INSP. CONTACTS: None	JOINT INSP. AGENCY: None	
INSPECTOR(S): Jocelyn Carter	INSPECTOR'S SIGNATURE:

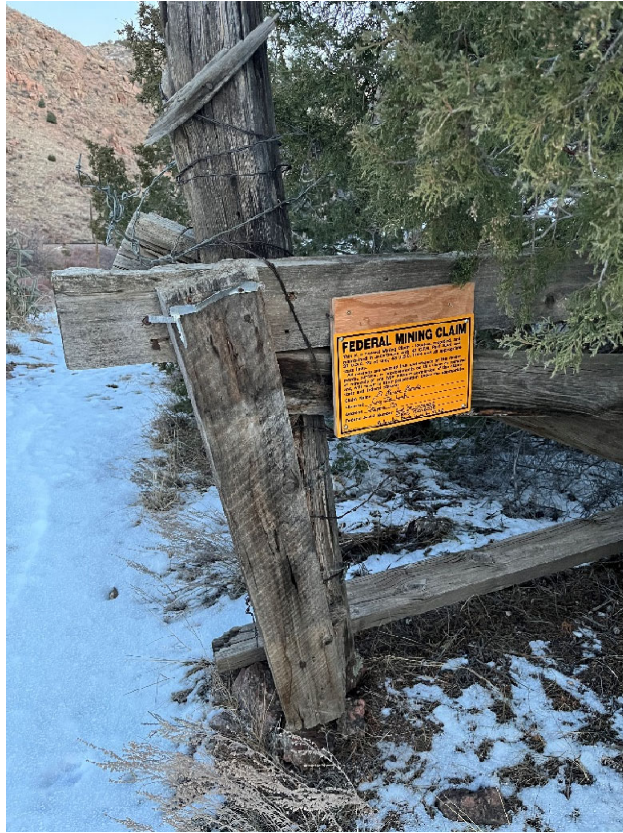
The mine sign at the entrance of the permit site was not present at the time of the inspection. The operator did repost a mine sign on January 14, 2025, and sent a photo of the posted sign located near the entrance of the permitted area at the trailhead of the trail used to access the site, see Photos #1 and #2. T-posts were used to mark the permit boundary, attached to the tops of the post were metal tags with the permit number stamped into them, see Photos #6 and #7.

Photo #1: Mine sign posted on a fence along the access trail; photo was provided by the operator.

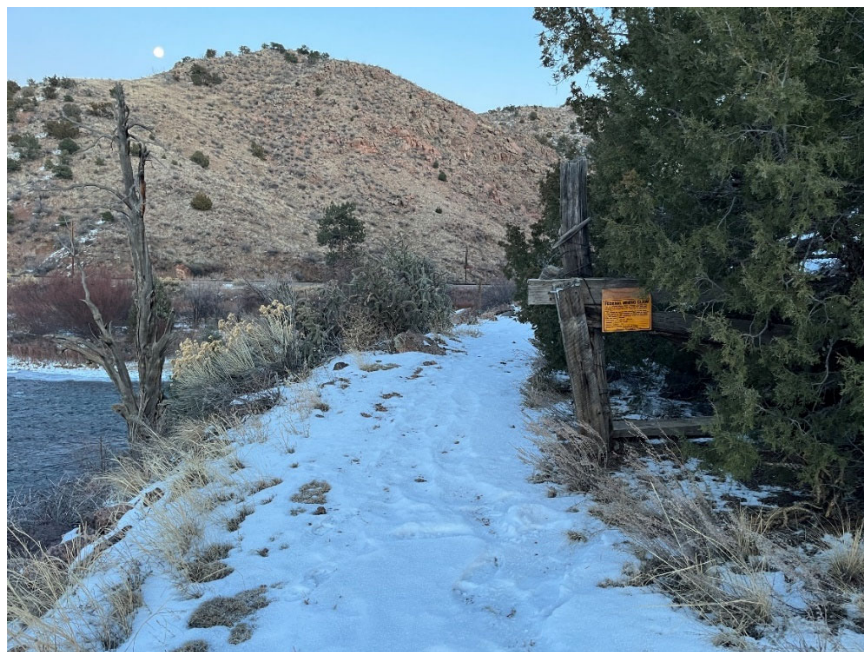
Photo #2: View of the access trail, looking southeast, with the min sign seen on the right.

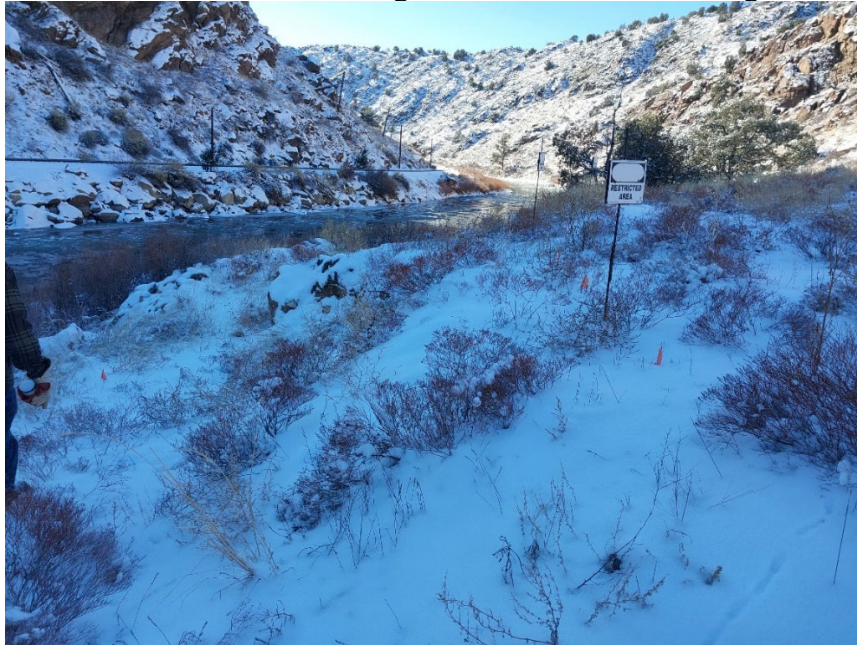
Photo #3: View of the permitted area looking downstream to the southwest.

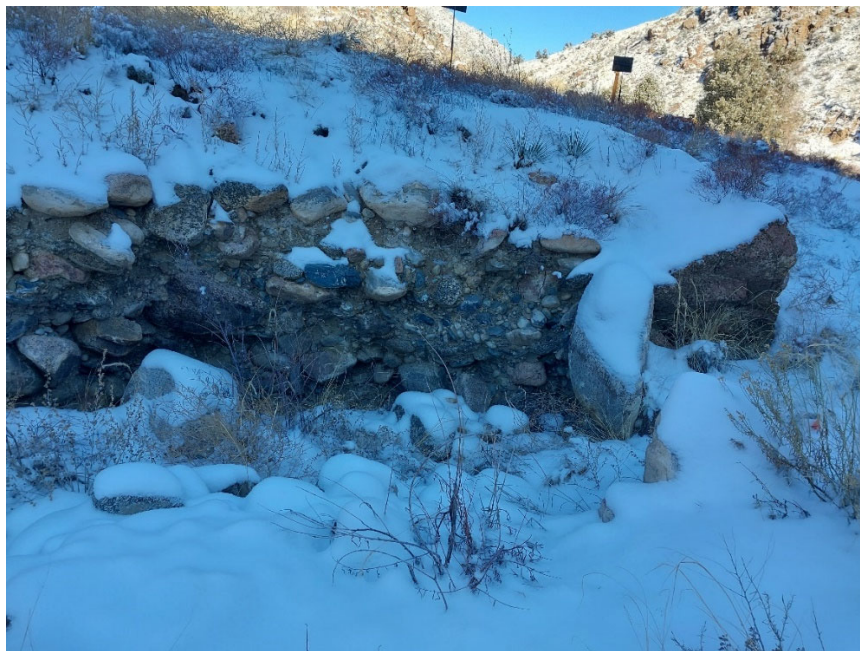
Photo #4: View of the upstream pit area looking to the northeast.

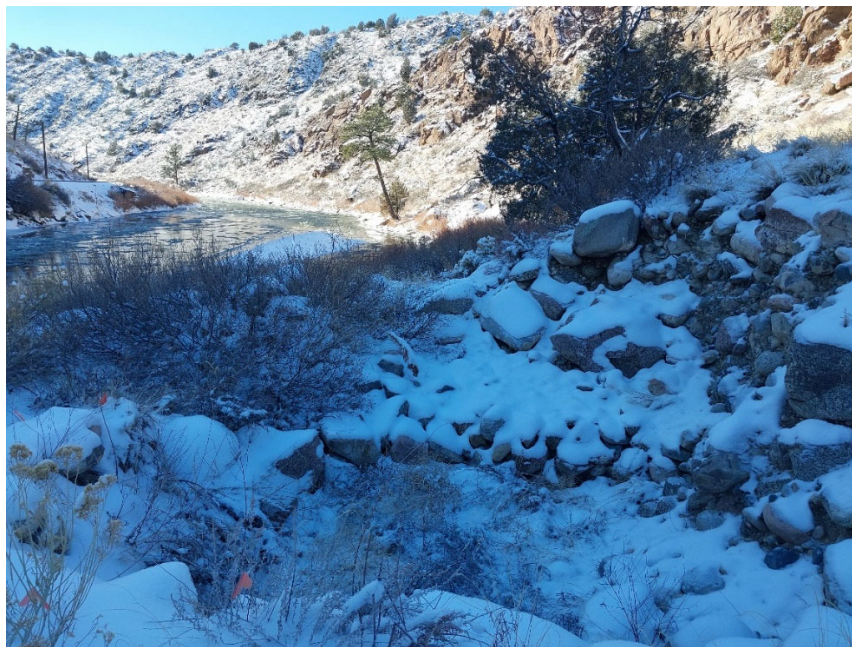
Photo #5: View of the downstream pit, looking to the southwest.

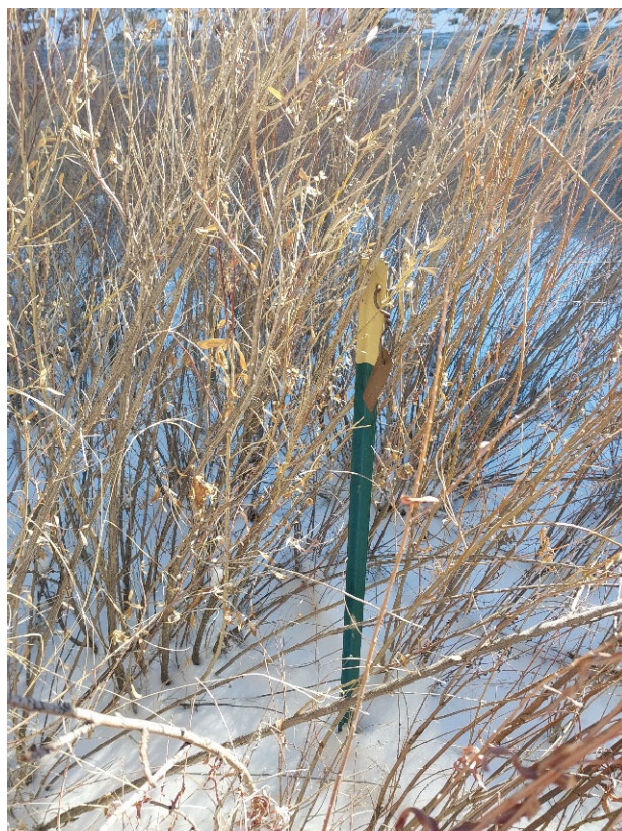
Photo #6: Permit boundary marker located at the south end of the permitted area; an example of the t-posts used

to mark the permit boundary.

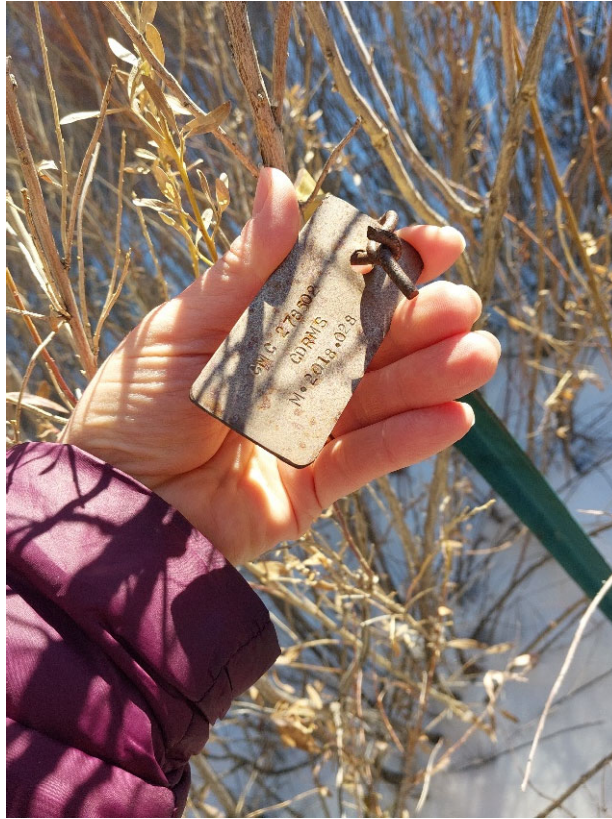
Photo #7: Example of the identifying tags that are attached to the tops of the t-posts.

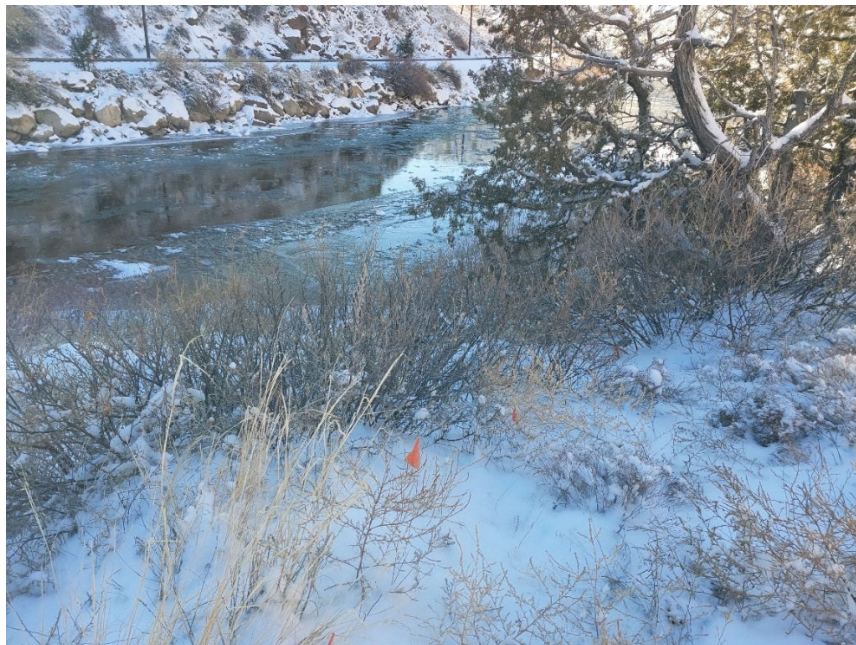
There did not appear to be any negative impacts on fish and wildlife. Mr. Lovette did point out an area along the southern portion of the permit where beaver activities have caused the riverbank to move inland, see Photo #8. He is monitoring this section to make sure he is maintaining the 20-foot offset from the river.

Photo #8: View of the portion of the bank that has been migrating inland due to beaver activity on the river.

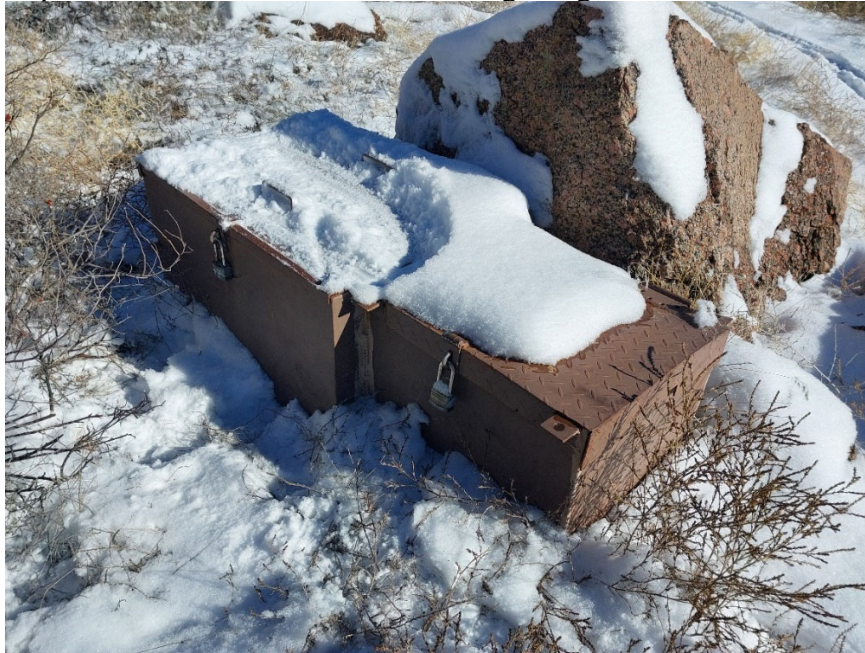
There are no processing facilities for this operation. There is a metal locker box that is kept on site to store hand tools, see Photo #9.

Photo #9: The metal locker kept on site to store hand tools, located near the western t-post of the site, on the west side of the access trail.

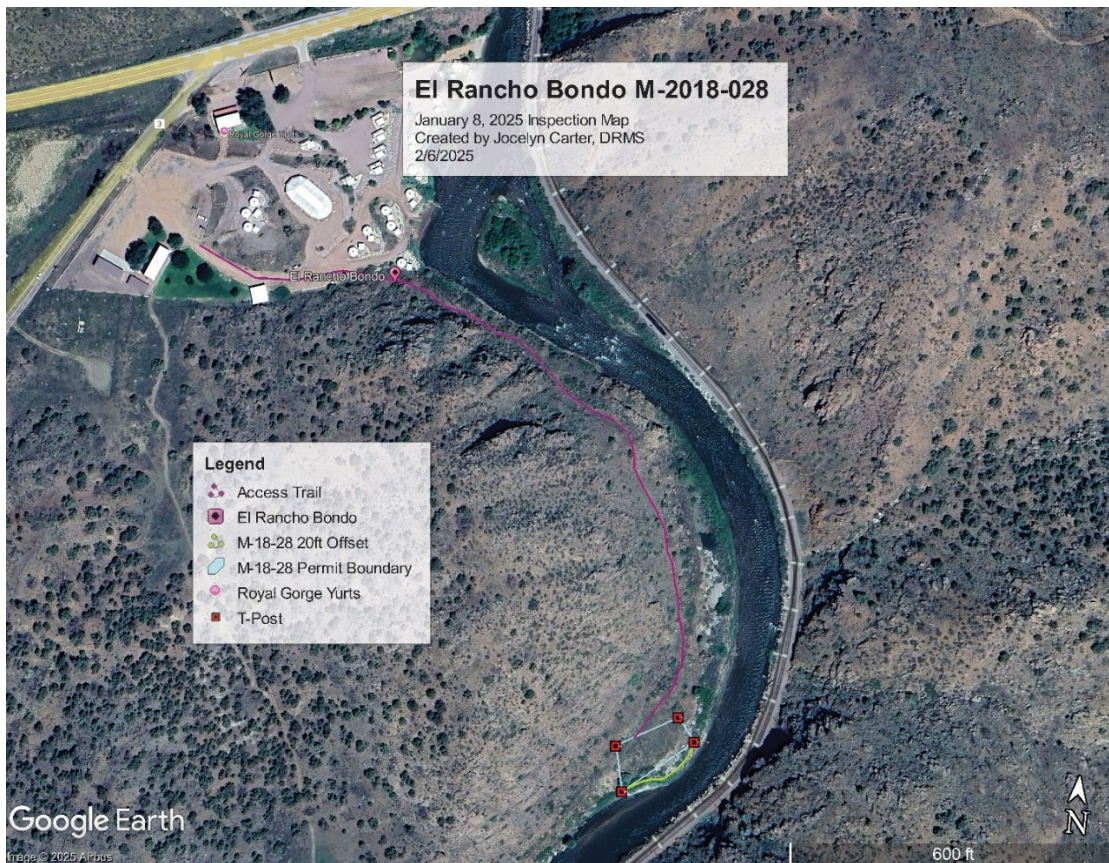
Figure 1: Map showing the permit and the surrounding areas. The red point labeled El Rancho Bondo shows the approximate location of the posted mine sign. The Purple line shows the path taken from the parking area behind the Royal Gorge Yurt business down to the permitted area. The light blue line shows the approximate permit boundary with the red squares indicating where the t-posts marking the boundary are located. The green

line shows the approximate 20-foot river offset boundary the operation maintains.
