Passiflora NOI P2024011- Inspection Report

MINERALS PROGRAM INSPECTION REPORT

MINE NAME: Passiflora	MINE/PROSPECTING ID#: P-2024-011	MINERAL: Silver, Base metals	COUNTY: Custer
INSPECTION TYPE: Mineral Prospect Inspection	WEATHER: Windy	INSP. DATE: February 7, 2025	INSP. TIME: 10:30am
OPERATOR: Viscount Colorado Holdings, LTD	OPERATOR REPRESENTATIVE: Christina Ricks	TYPE OF OPERATION: MP - Mineral Prospecting

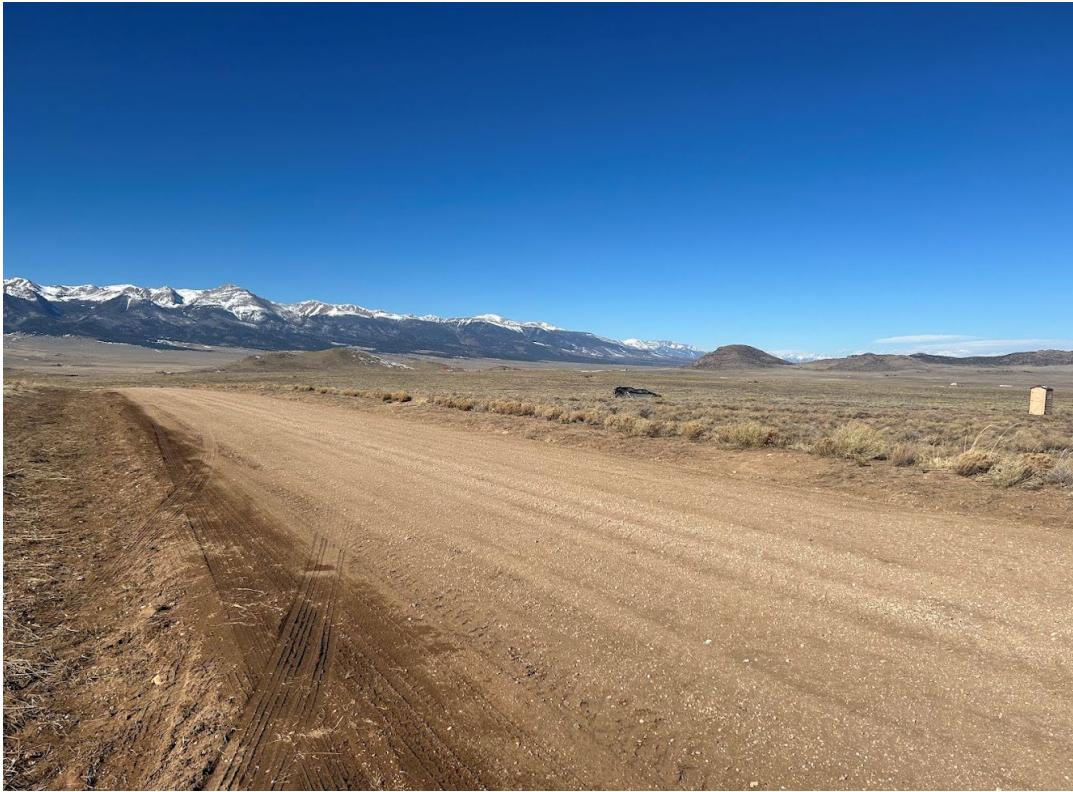
Photo 1: View of County Road 240 to the south of the drilling project, facing west.

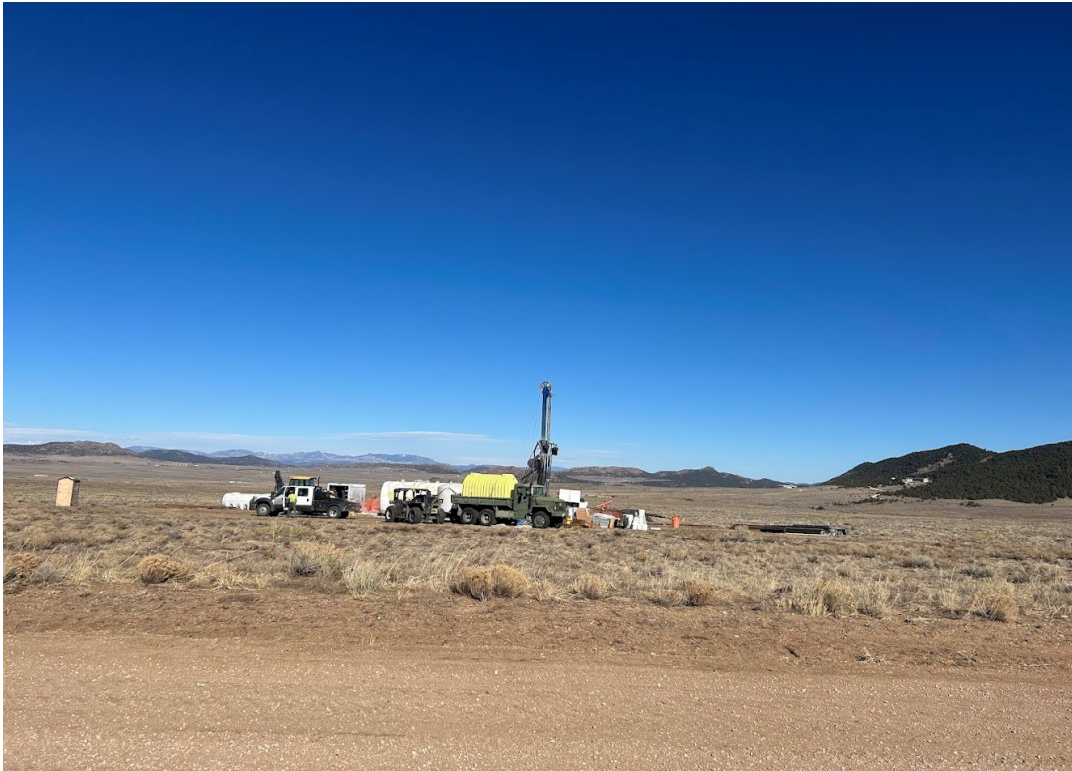
Photo 2: View of the drilling project and County Road 240, facing north.

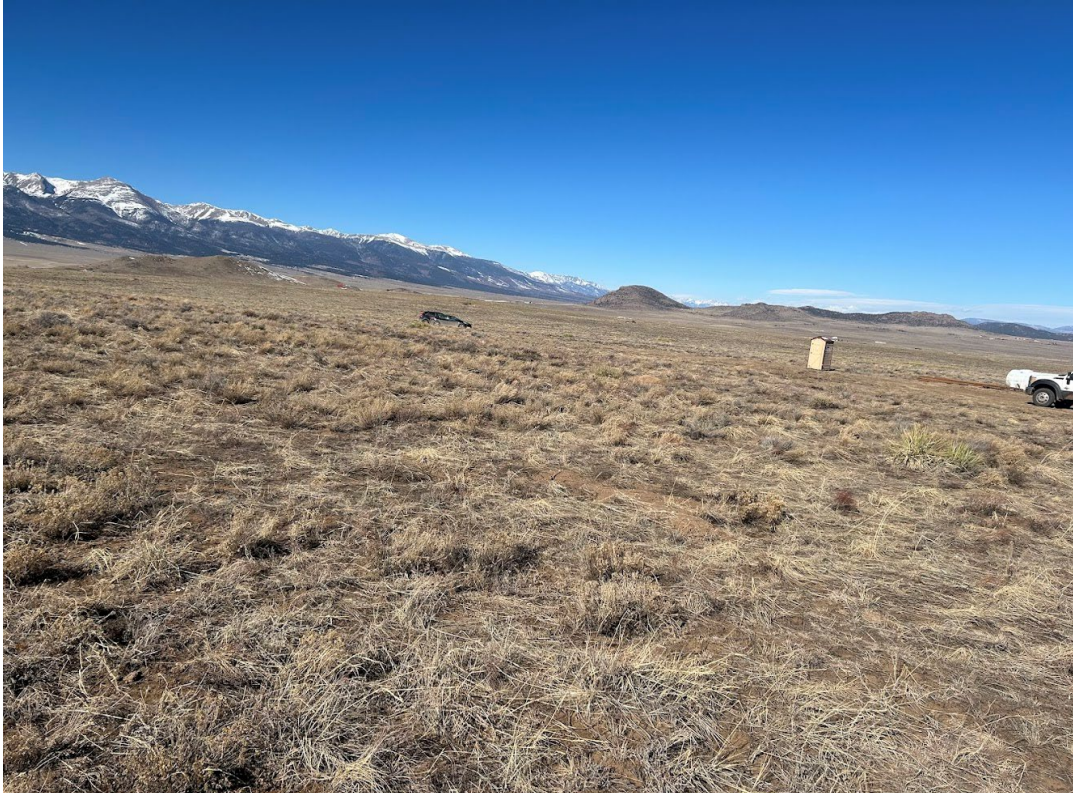
Photo 3: Native vegetation, facing west.

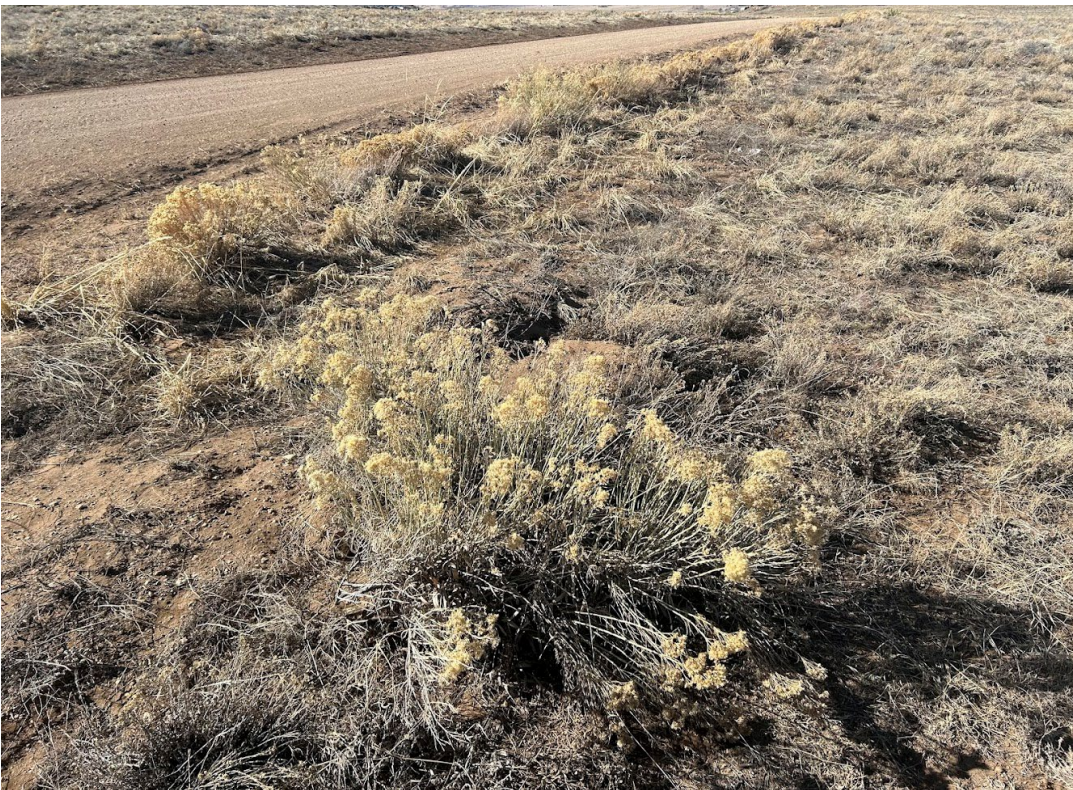
Photo 4: Native vegetation along County Road 240, facing southwest.

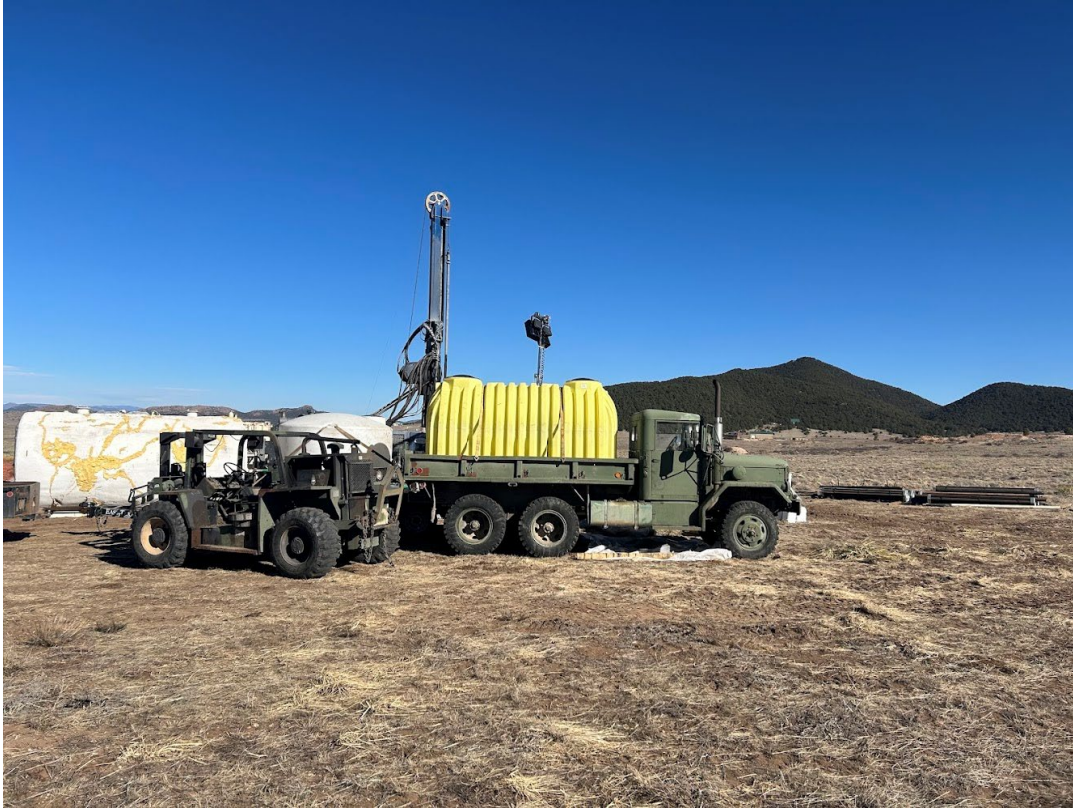
Photo 5: View of trucks, drill rig, drilling piping, facing east.

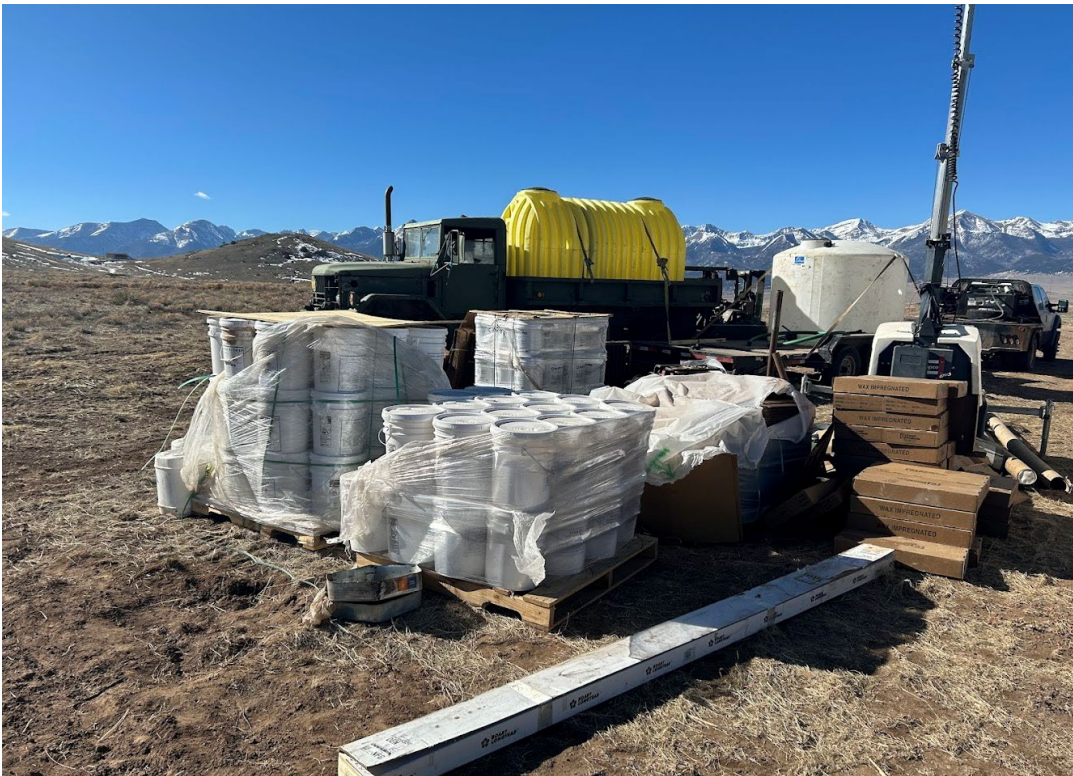
PROBLEM: The Operator is storing drilling fluids without secondary containment.

Photo 6 shows dozens of white plastic buckets situated on pallets in the staging area. According to the Operator, these buckets contain drilling fluids. The Division notes that storage using pallets is inadequate as secondary containment. This has been cited as a problem. Please provide Material Safety Data Sheet(s) (MSDSs) to clarify the nature of the drilling fluids. If the fluids are considered hazardous, then the Operator will be required to implement secondary containment structures.

Photo 6: View of the containers with drilling fluids, utility truck, and lights, facing west.

CORRECTIVE ACTIONS: All storage tanks, petroleum and any hazardous materials on site for any period of time shall have appropriate secondary containment. Please clarify the nature of the drilling fluids using Material Safety Data Sheets (MSDSs). Please supply photo documentation that any fuel or hazardous materials containers are stored properly - including applicable secondary containment structures by the corrective action date.

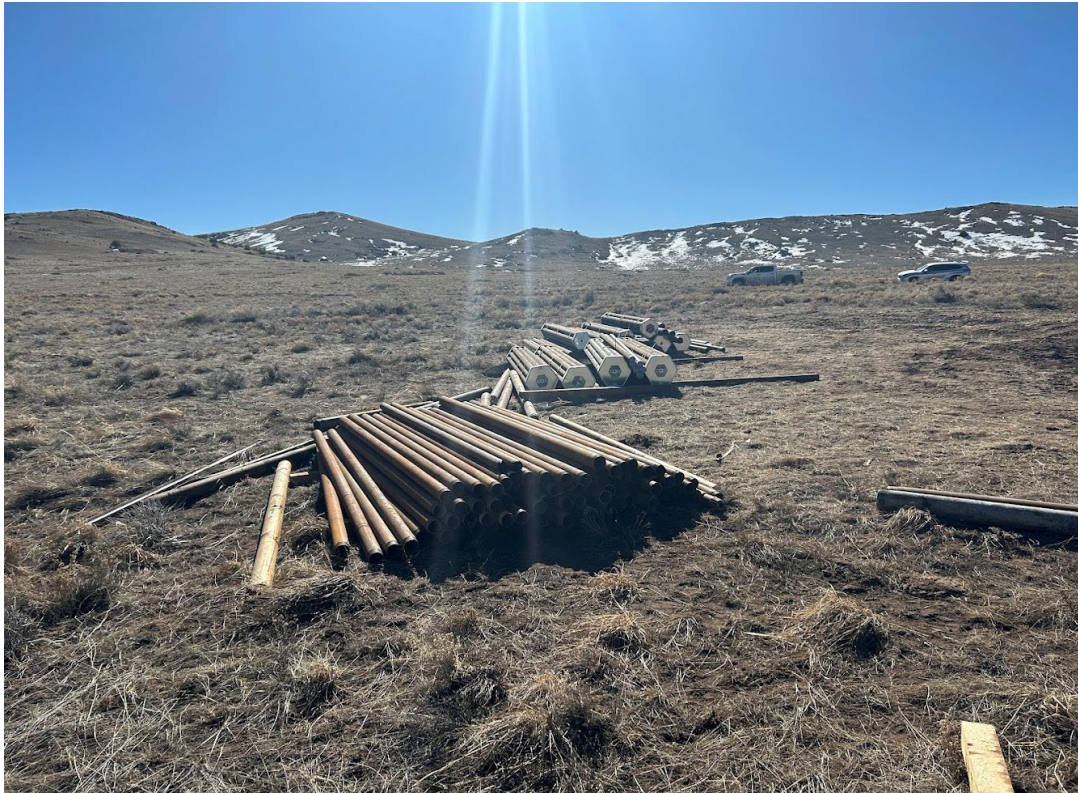
Photo 7: Drilling piping storage, facing south.

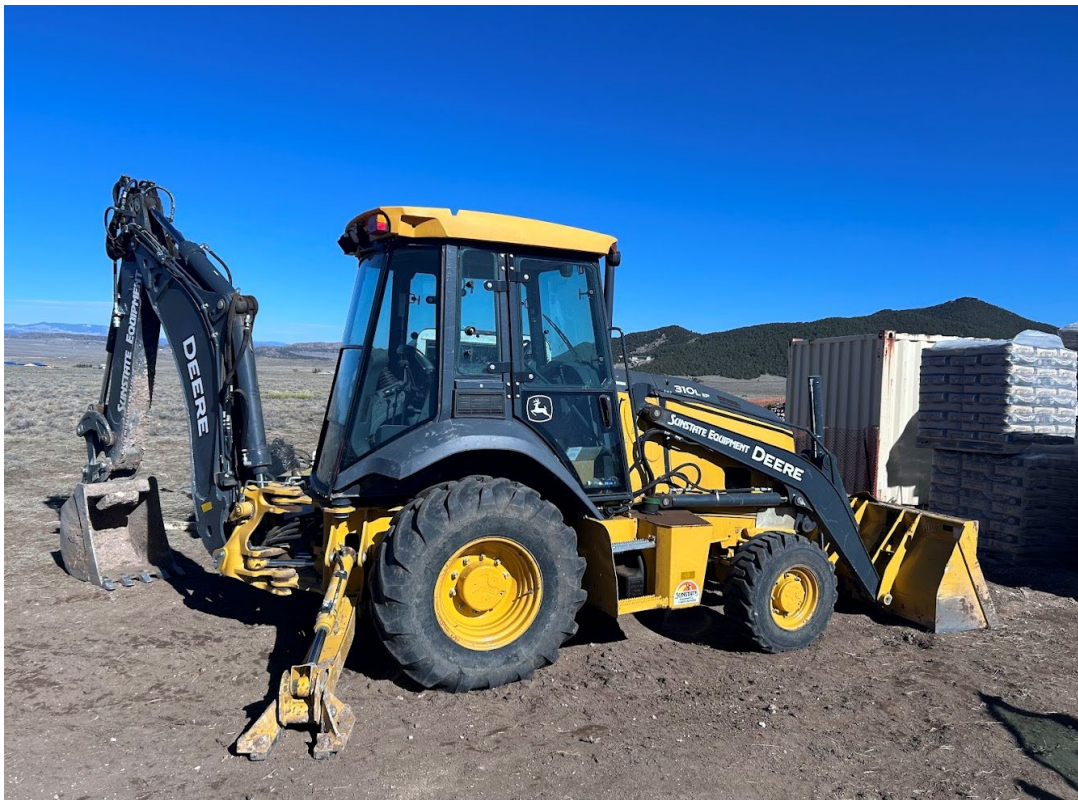
Photo 8: Excavator and loader combo equipment within permit area, facing south.

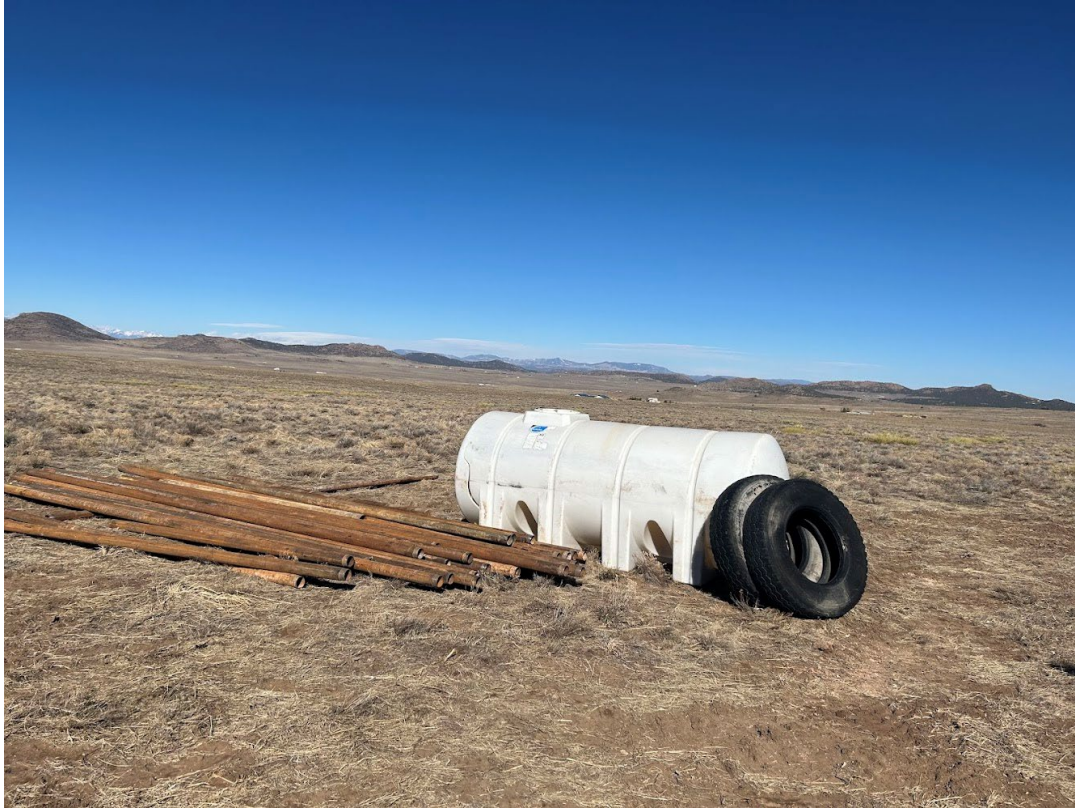
The Passiflora NOI project is approved to drill one borehole to a maximum depth of 5,000 feet. The Division had received a compliant and photo documentation of drilling equipment in the middle of County Road 240. During the time of the inspection, no equipment was located in the road or any evidence of fluid spills (see Photos 1-2). According to the Operator, approximately 1,000 gallons of water spilled from the water truck along County Road 240. This water came from the empty water container located outside of the utility trailer (see Photo 9).

Photo 9: Empty water storage container, tires, and drilling piping along the northern extent of permit area, facing north.

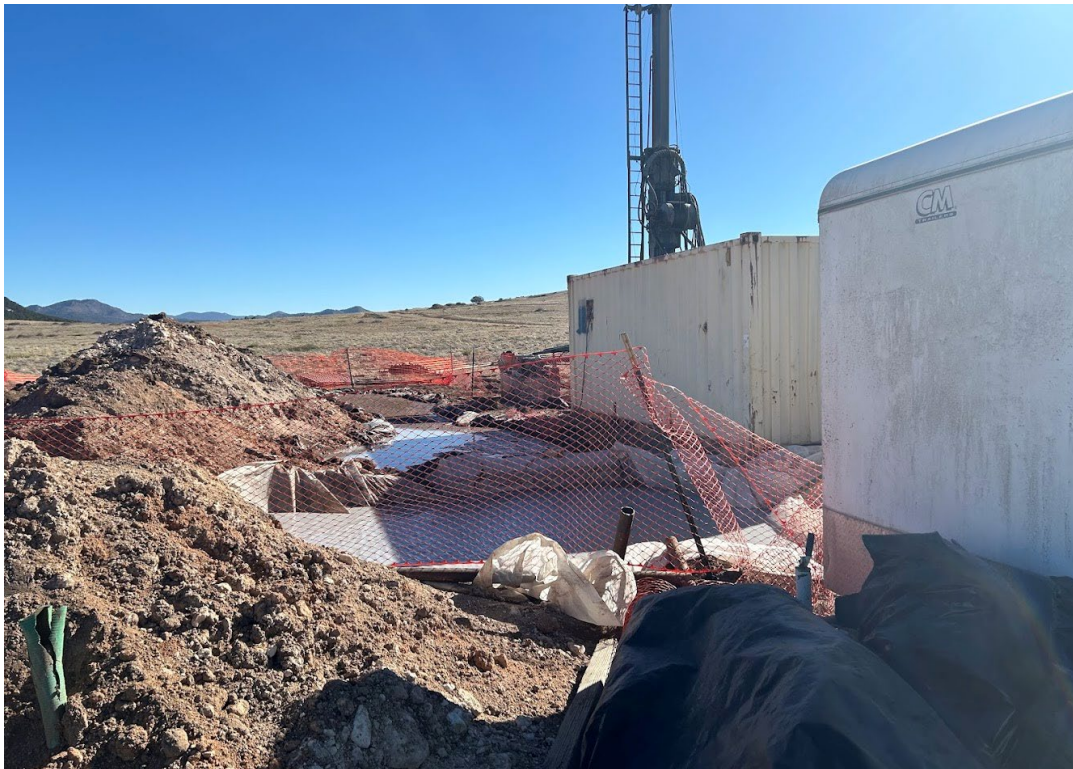
The Operator is approved to use mud pits for drilling operations. Mud pits were observed adjacent to the north of the drill rig (see Photos 10-11). The mud pits were sealed off using snow fencing. According to the Operator, the mud pits are approximately eight feet in depth. A topsoil stockpile was observed adjacent to the east of the mud pits (see Photo 12). According to the Operator, approximately eight (8) to ten (10) inches of topsoil was encountered when the mud pits were dug. Overburden stockpiles were observed to the north of the mud pits (see Photos 11-12). At the time of inspection, the Operator had drilled to a depth of 1,665 feet. In addition, the Operator stated they are only using the overhead lights at half power at night due to complaints regarding light pollution.

Photo 10: View of two mud pits contained within snow fencing, facing east.

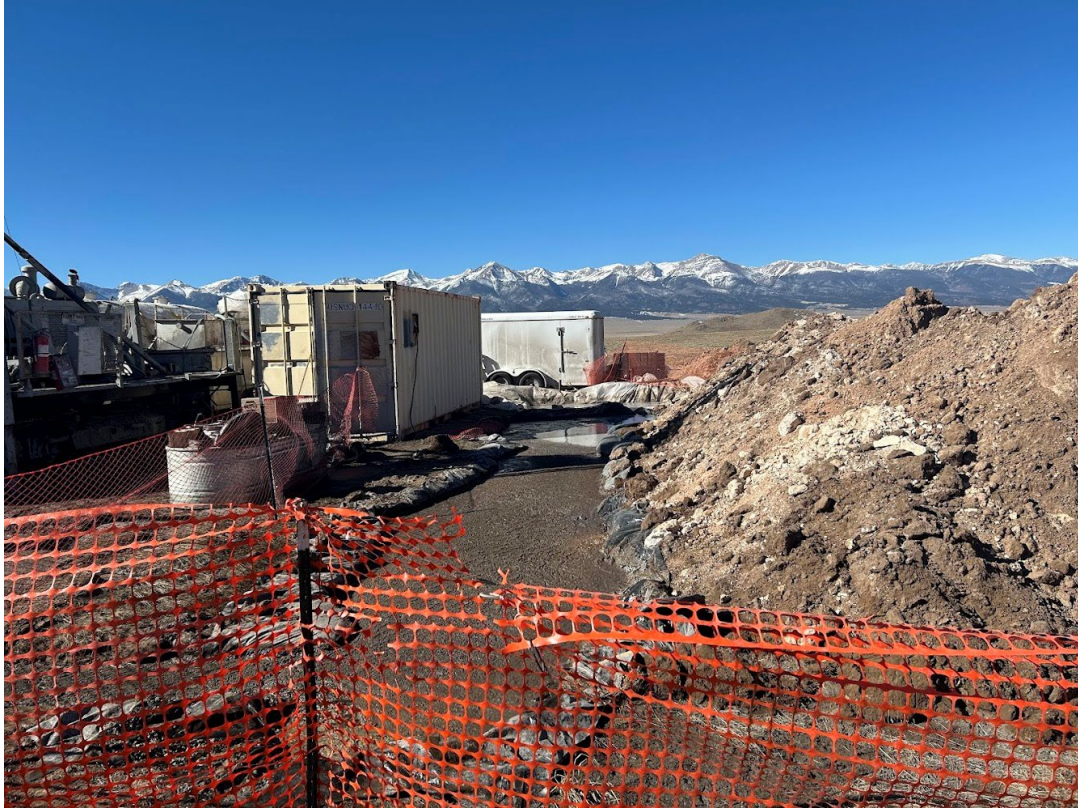
Photo 11: View of the mud pits, overburden stockpiles to the north, storage container, and horse trough containing machinery fluids.

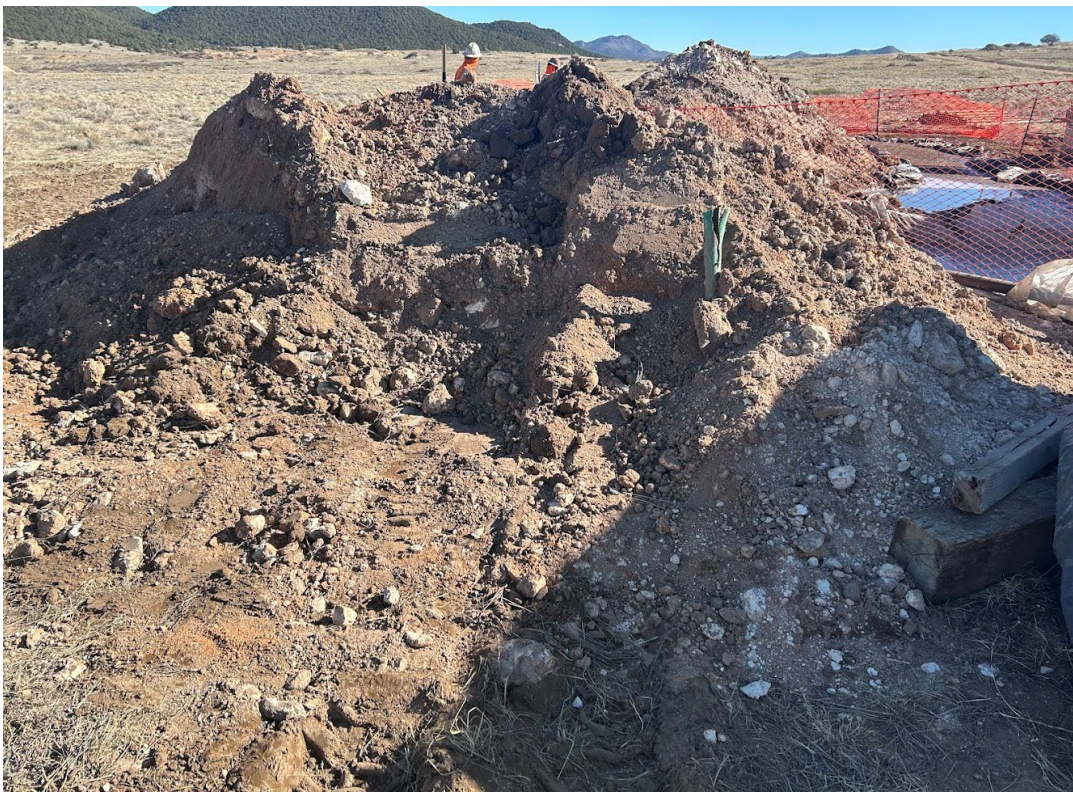
Photo 12: View of overburden stockpiles to the north of the mud pits.

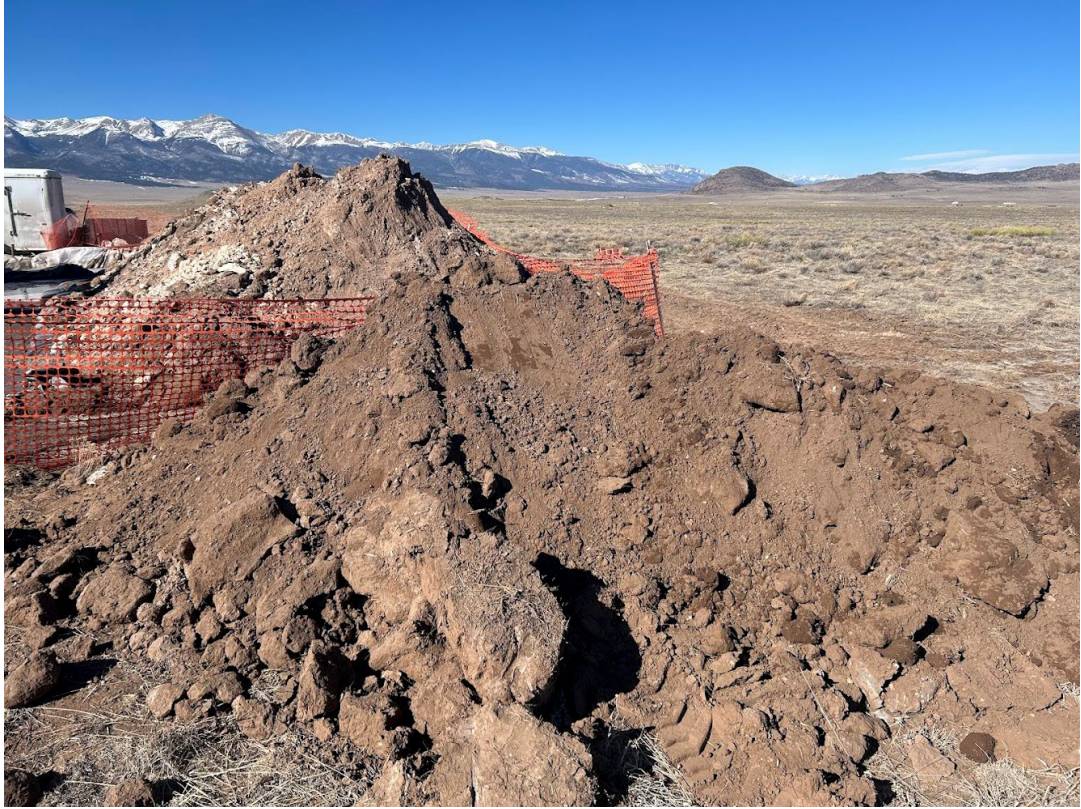
Photo 12: View of the topsoil stockpile and overburden stockpiles, facing west.

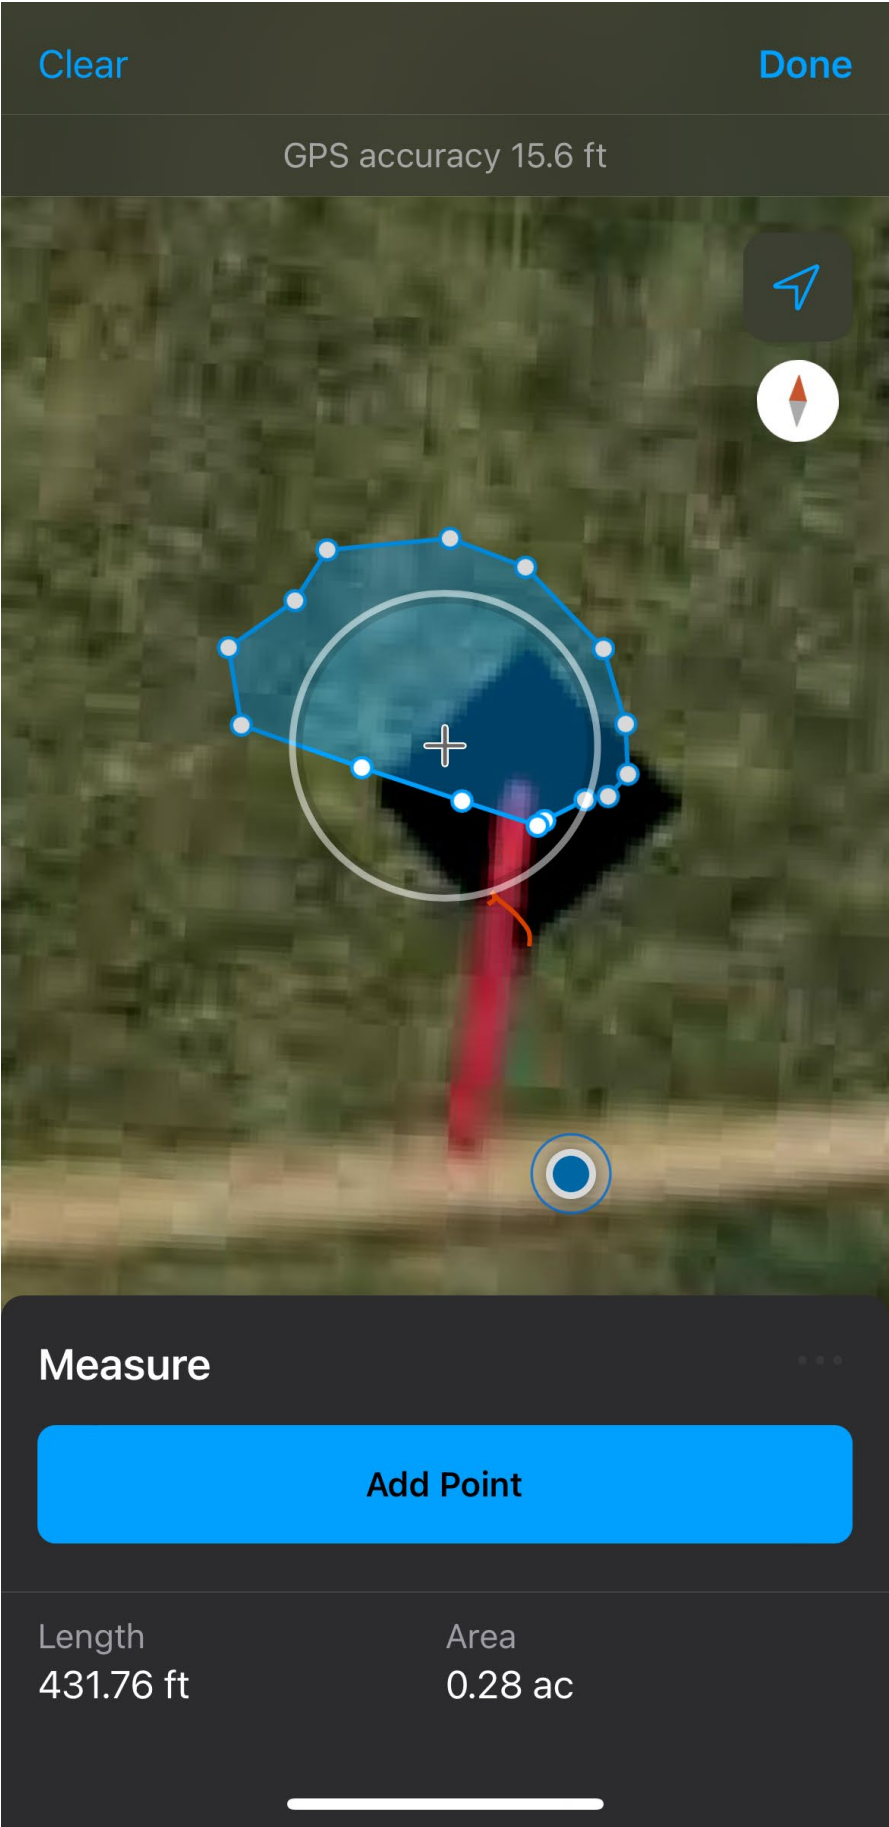
Considering the drill rig, mud pits, stockpiles, drilling equipment, it appears that approximately 0.28 acres have been disturbed (see Photo 13 showing disturbed area polygon). This is slightly larger than what the operator had indicated would be disturbed during the operation. However, the entire affected area will be required to be reclaimed in accordance with the approved plan. This measurement did not include minor vehicular

Photo 13: Imagery of affected acreage polygon collected using Arc Field Maps.
Collected on 2/7/2025.

disturbance connecting the drilling area and County Road 240. The Operator must take precautions to minimize the drilling disturbance pursuant to Rule 5.3.1. The BLM inspection report indicated that an "after action report" will need to be submitted by the Operator to reflect the additional disturbance. The Division requests a copy of this report once it is submitted to the BLM.
