MINERALS PROGRAM INSPECTION REPORT
PHONE: (303) 866-3567

MINE NAME: Rifle Gravel Pit #1	MINE/PROSPECTING ID#: M-2021-052	MINERAL: Gravel and sand	COUNTY: Garfield
INSPECTION TYPE: Surety-Related Inspection	WEATHER: Clear	INSP. DATE: January 28, 2025	INSP. TIME: 09:00
OPERATOR: Western Slope Materials, LLC	OPERATOR REPRESENTATIVE: Sean Mello	TYPE OF OPERATION: 112c - Construction Regular Operation

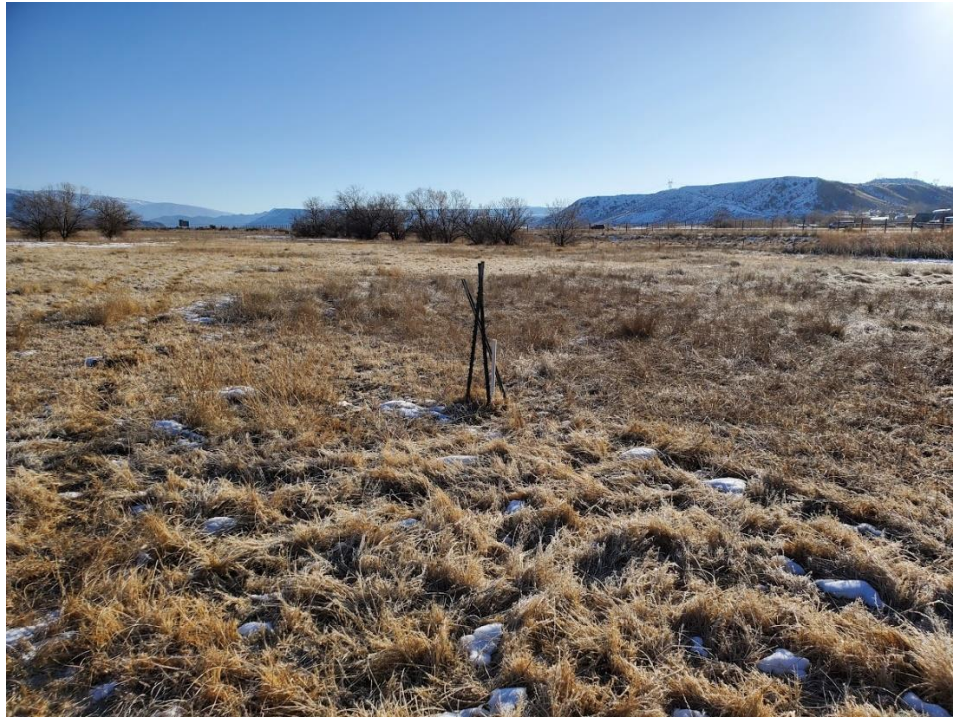
There is no groundwater exposed within the permit boundary. Groundwater monitoring wells were observed in the permit area (Photo 1). There are wetlands within the permit boundary that may be a result of seepage from the Last Chance Ditch Tailwater Ditch. The operator plans on making repairs to the ditch to better define wetlands before mining. The water in the ditch was partially frozen at the time of the inspection (Photo 2).

Photo 1 – View to the east of groundwater monitoring well.

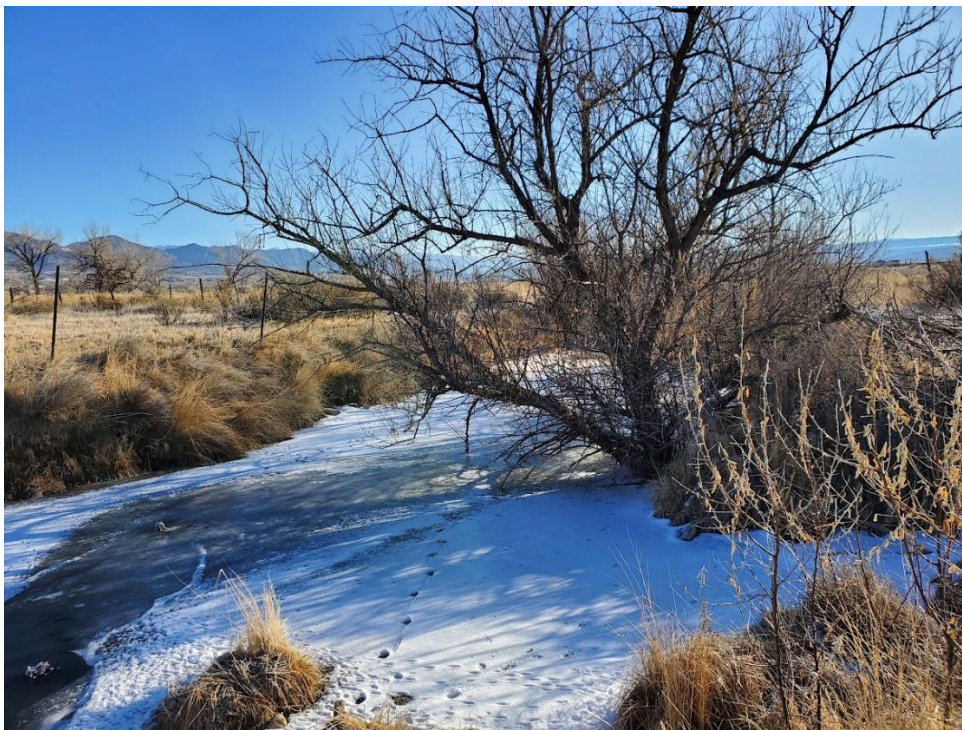
Photo 2 – View to the northeast of Last Chance Ditch.

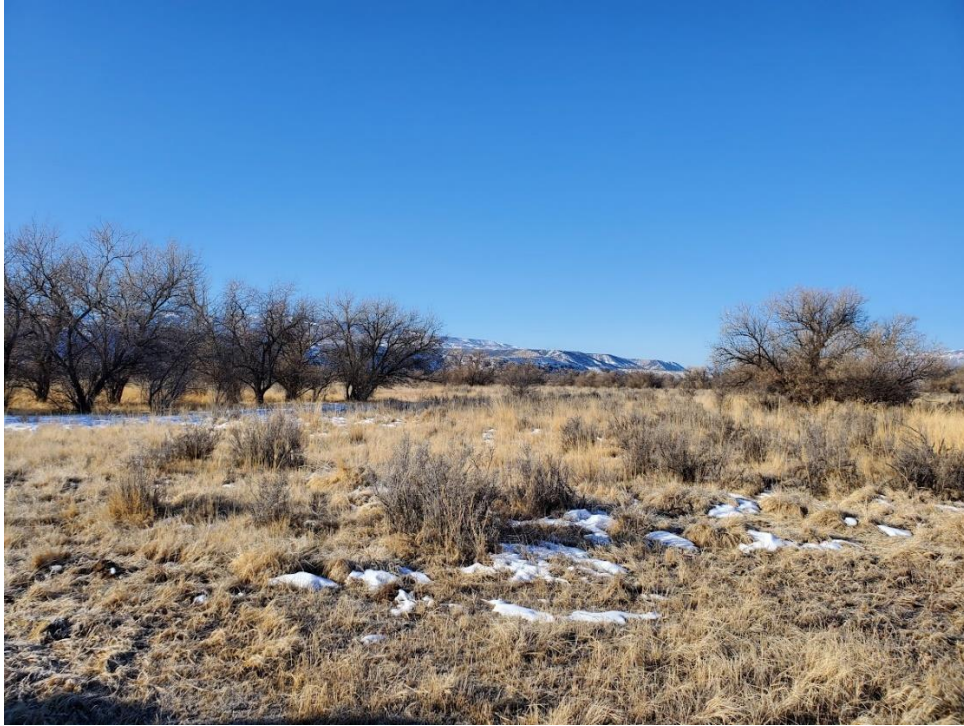
No activity has taken place at the site - the permit is still undisturbed (Photo 3). Western Slope Materials has stated that they plan to submit a revision to change the Mining and Reclamation Plans once the SO process is finalized.

Photo 3 – View to the southwest of undisturbed ground across the permit area.

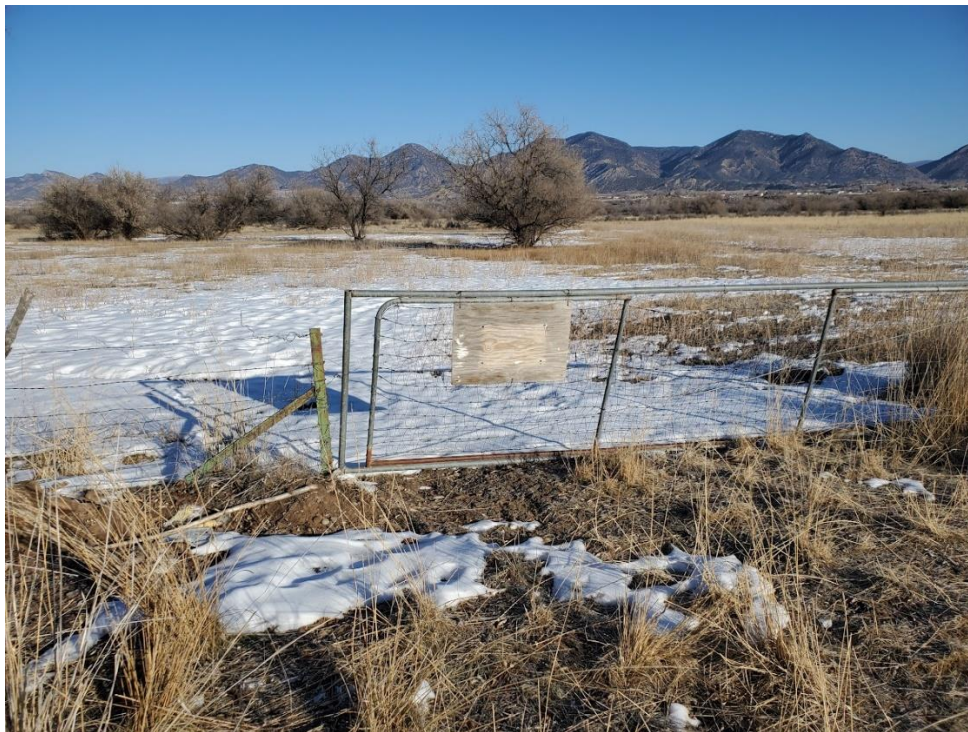
PROBLEM/POSSIBLE VIOLATION: Problem: The mine identification sign was not posted at the entrance of the mine site. This is a problem for failure to post a mine identification sign as required by Section 3.1.12(1) of the rule. The Operator shall, at the entrance of the mine site post a sign, which shall be clearly visible from the access road, with a minimum size equaling one hundred and eighty-seven (187) square inches, such as eleven (11) inches in height and seventeen (17) inches in width, with appropriate font size, with the following: the name of the Operator, a statement that a reclamation permit for the operation has been issued by the Colorado Mined Land Reclamation Board; and the permit number.

As noted above the mine identification sign was missing at the time of inspection. It was likely knocked down by weather (Photo 4). The affected area boundary markers are in place and in compliance with Rule 3.1.12. The permit boundary is marked with fence lines.

Photo 4 – View to the north of missing Mine ID sign at the entrance to the site.

CORRECTIVE ACTIONS: The operator shall, at the entrance of the mine site, post a sign which shall be clearly visible from the access road with the following: the name of the operator, a statement that a reclamation permit for the operation has been issued by the Colorado Mined Land Reclamation Board; and the permit number. The operator shall submit photo documentation that a proper sign has been posted by the corrective action date.

CORRECTIVE ACTION DUE DATE: 3/20/25
