February inspection reports

PERMIT INFORMATION

Permit Number: C-1982-056 Mine Name: Foidel Creek Mine Operator: Twentymile Coal, LLC Operator Address: Ms. Miranda Kawcak 29515 Routt County Road No. 27 Oak Creek, CO 80467	County: Routt Operation Type: Underground Permit Status: Active Ownership: Private
	Operator Representative Present: Kevin Copeland
Operator Representative Signature: (Field Issuance Only)

Inspection Start Date: February 18, 2025 Inspection Start Time: 10:00 Inspection End Date: February 18, 2025 Inspection End Time: 12:00		Inspection Type: Coal Partial Inspection Inspection Reason: Normal I&E Program Weather: Cloudy	
Joint Inspection Agency: None		Joint Inspection Contacts: 	
Post Inspection Agency: None		Post Inspection Contacts: 	
Inspector(s): Brock Bowles	Inspector's Signature:

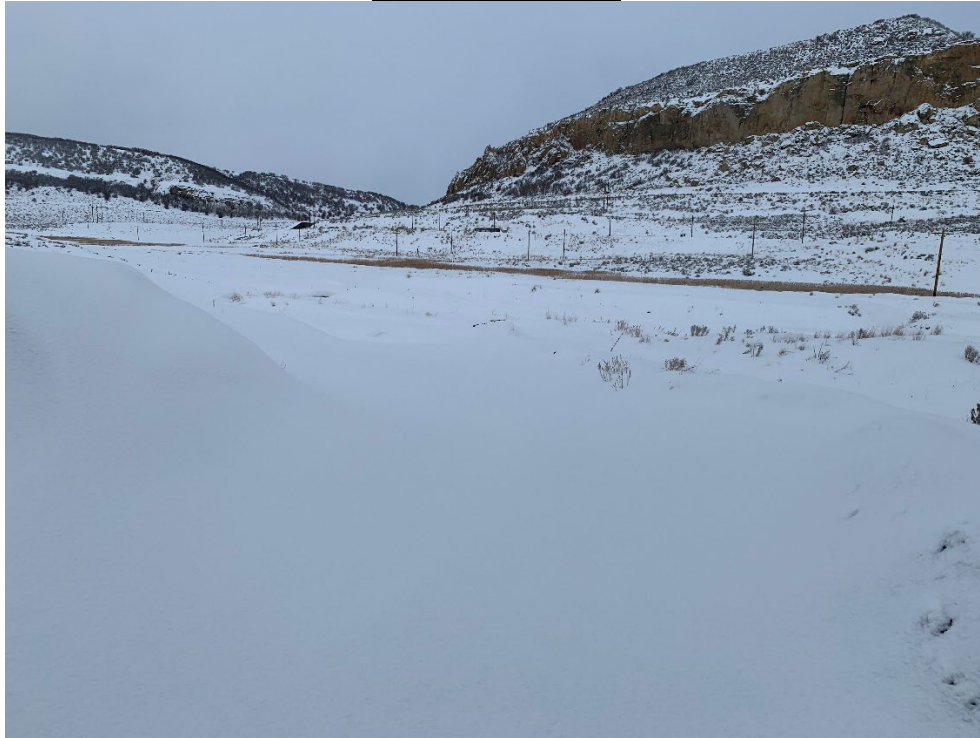
The B Ponds were snow covered and the discharge point was also snow covered (photo 1). The sump above Ponds B was buried in snow.

Photo 1- Pond B discharge location, facing northwest toward Foidel Creek

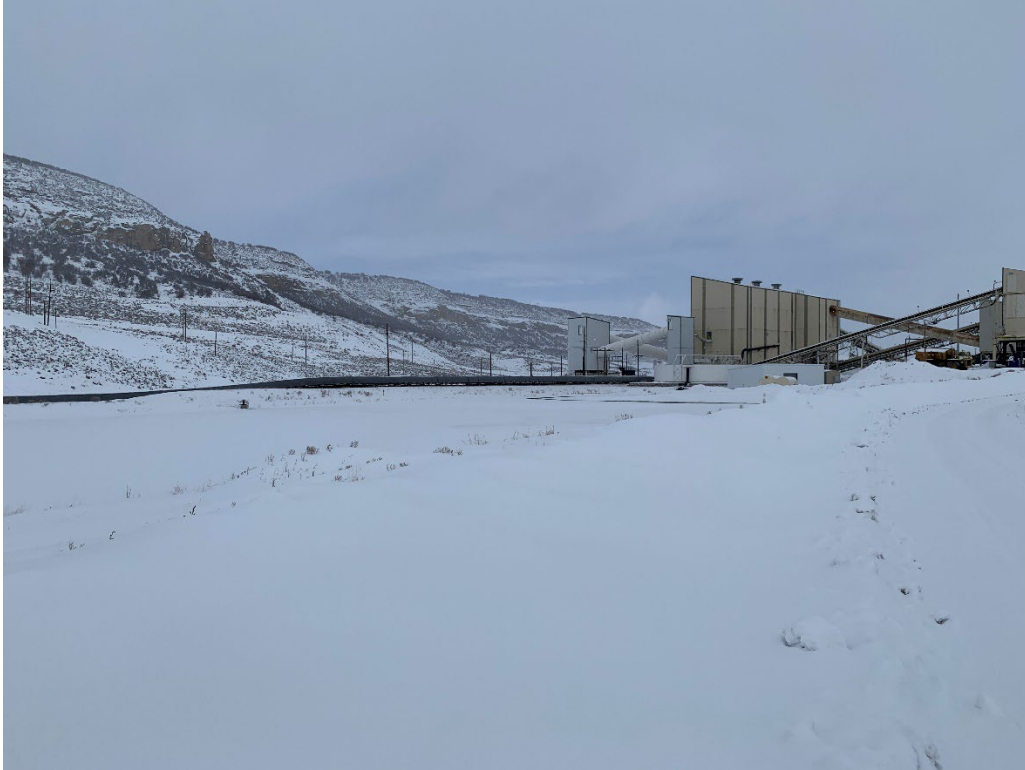
Pond D was snow covered. The wash plant was discharging water into the pond on the east side (photo 2). Water was passing through the discharge point. The pit pond was free of ice.

Photo 2 – Pond D, facing east

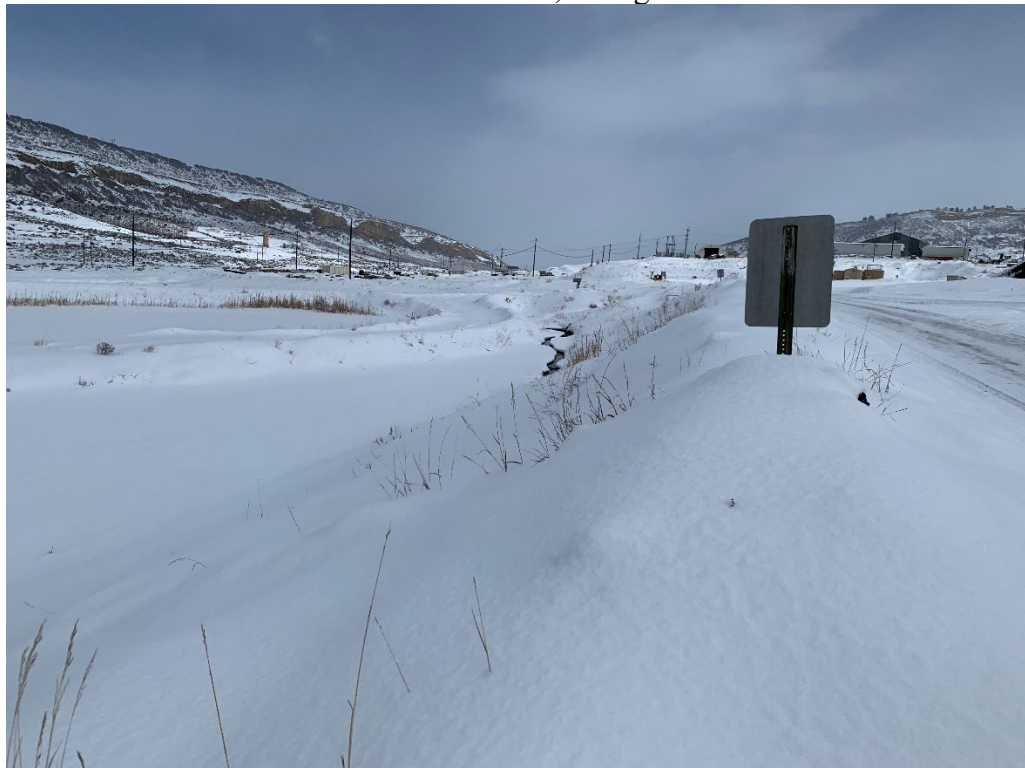
Pond E was snow covered (photo 3). The inlet on the east side of the pond was melted indicating some inflow to the pond. Mr. Copeland said the pond was discharging when he snowshoed to the discharge point last week.

Pond 3- Pond E, facing east

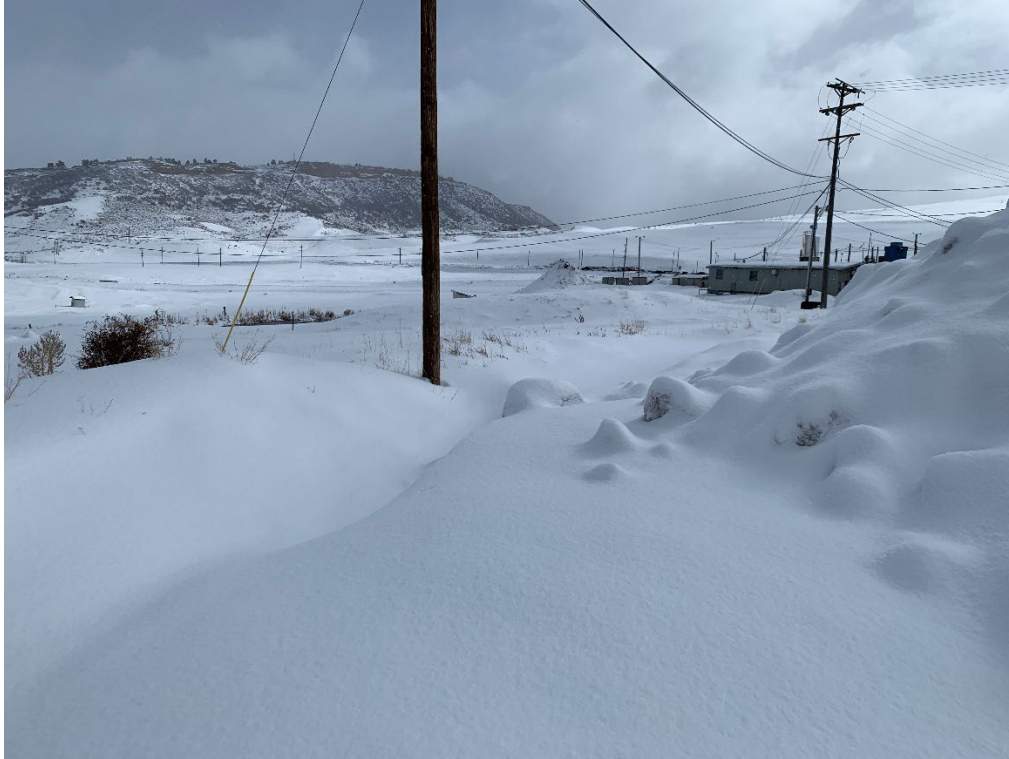
Ditch E-1 behind the maintenance shop has been cleaned (photo 4). The large snow pile noted in the January 2025 inspection report has been removed allowing for the proper operation of Ditch E-1.

Photo 4- Ditch E-1 behind the warehouse is cleared

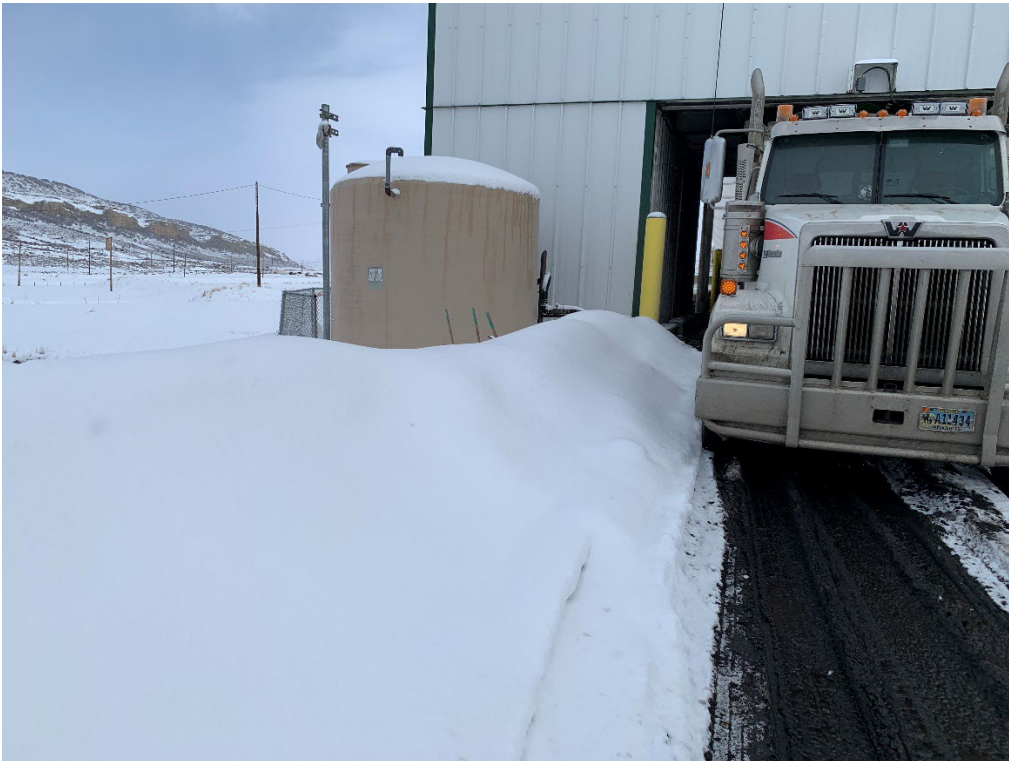
The berm on the west side of the stoker coal loadout facility was in place and containing runoff contained as designed (photo 5).

Photo 5 – Berm by stoker coal load out
