MINERALS PROGRAM INSPECTION REPORT
PHONE: (303) 866-3567

MINE NAME: Gunnison River Gravel Pits	MINE/PROSPECTING ID#: M-2009-048	MINERAL: Sand and gravel	COUNTY: Mesa
INSPECTION TYPE: Surety-Related Inspection	WEATHER: Clear	INSP. DATE: February 12, 2025	INSP. TIME: 14:30
OPERATOR: CW Construction, LLC	OPERATOR REPRESENTATIVE: Tim Loncarich	TYPE OF OPERATION: 112c - Construction Regular Operation	
REASON FOR INSPECTION: Surety Release Requested	BOND CALCULATION TYPE: Complete Bond	BOND AMOUNT: \$91,664.00	
DATE OF COMPLAINT: NA	POST INSP. CONTACTS: None	JOINT INSP. AGENCY: None	
INSPECTOR(S): Amy Yeldell	INSPECTOR'S SIGNATURE:

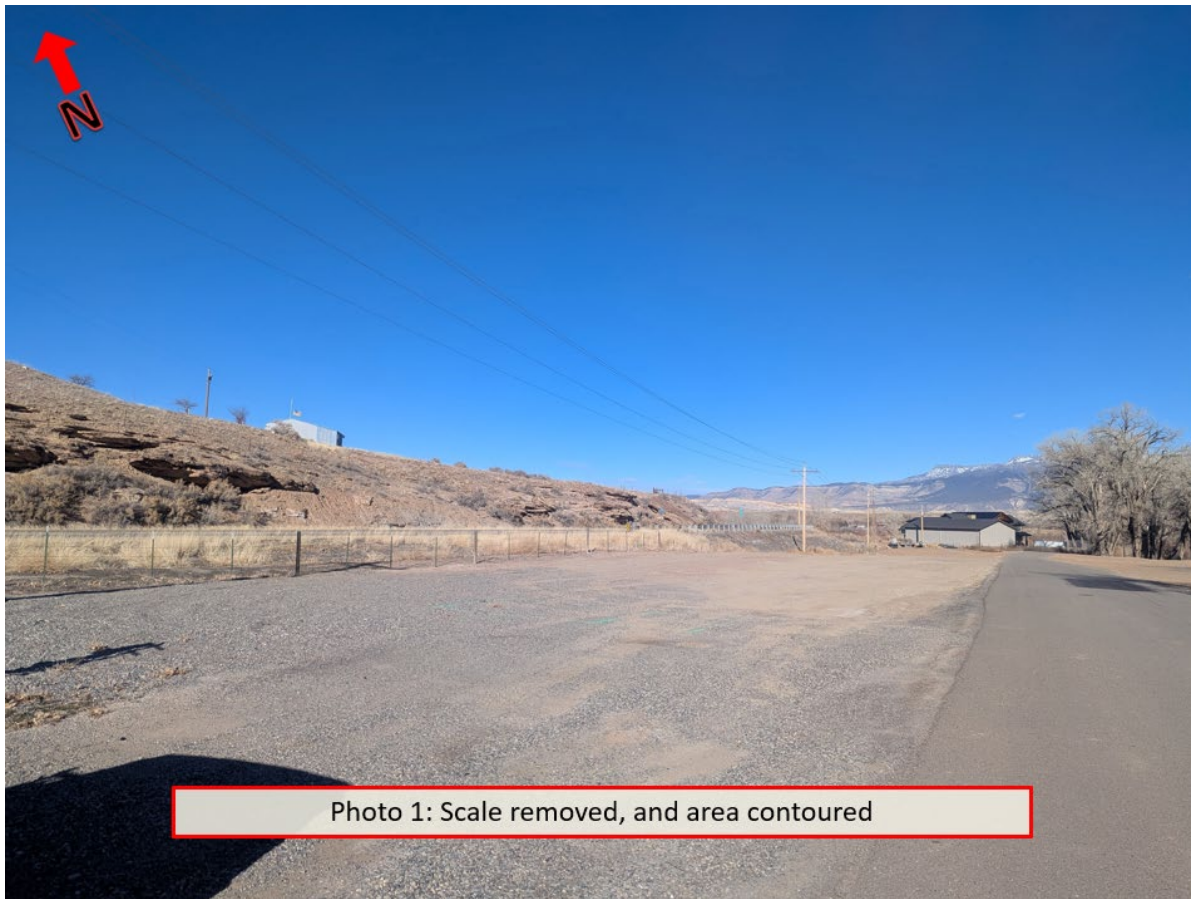
Contouring has been completed near the entrance where the scale was. Positive drainage that blends with the surrounding contours has been established. It's worth noting that major grading has occurred on the southeast side of the access road. Photo One. This is independent of the mining operation.

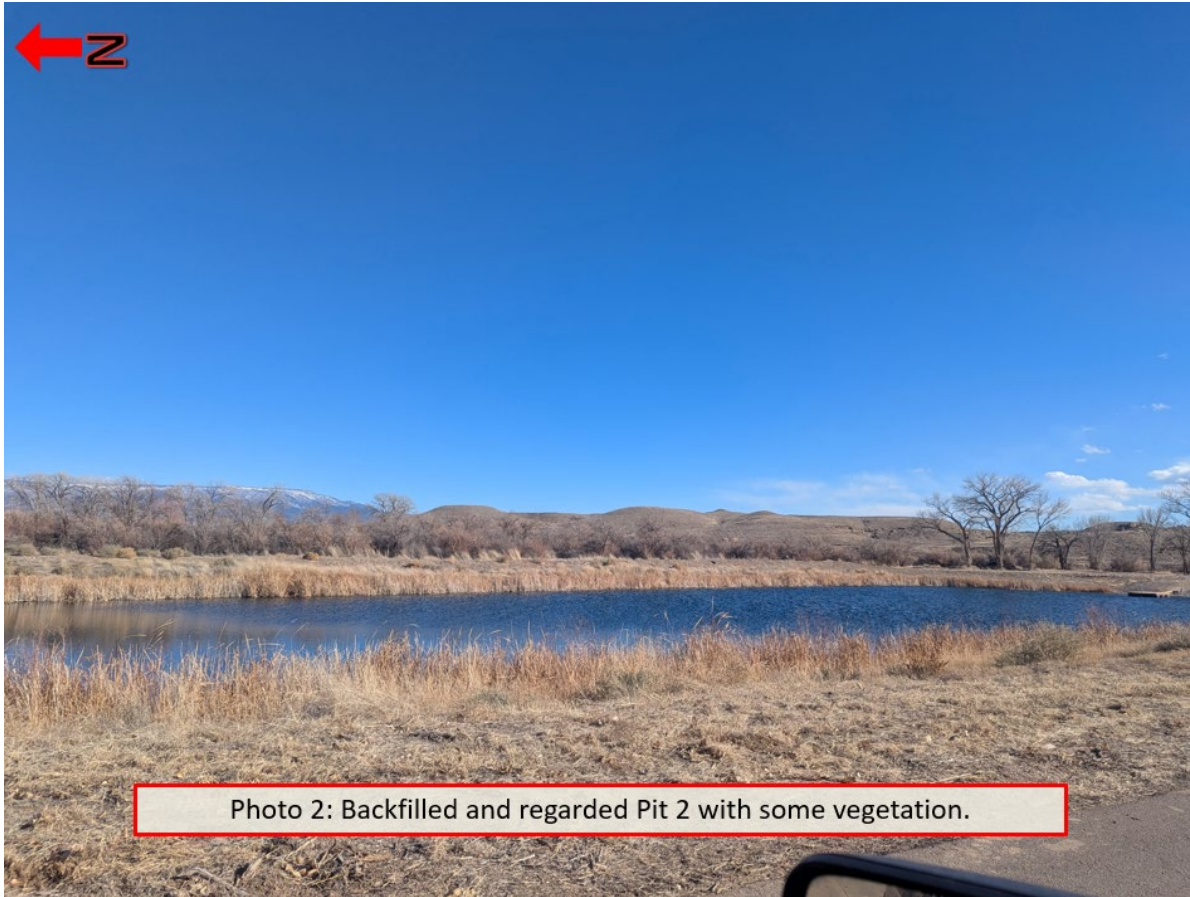
All backfilling and grading have been completed at Pit 2. Photo Two

Pit 2 was revegetated a number of years ago with varied degrees of success. The Division did not closely evaluate vegetation success around the pond given that its winter and vegetation is dormant. From the road vegetation appeared to be established near the water line but decreased in cover as you moved away from the water. The upland rangeland areas were sparse and weedy. Additional reclamation measures will likely be necessary to meet the minimum vegetation thresholds for release. Photo Two

Photo 2: Backfilled and reggraded Pit 2 with some vegetation.

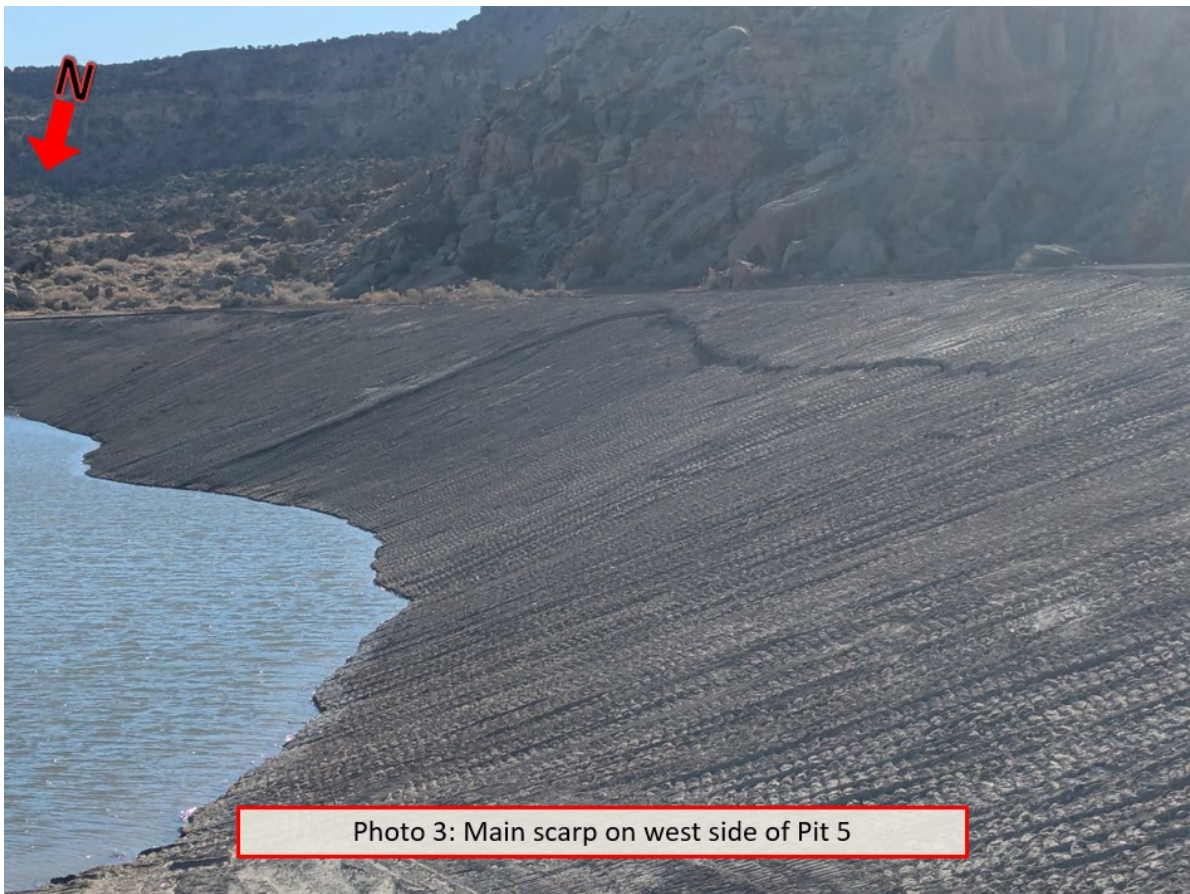
PROBLEM: Placement of backfill material and grading was not completed in a manner that avoids unacceptable settling and voids per Rule 3.1.5(9)(f). Furthermore, overburden was not adequately compacted for stability. For these reasons slope stability with regards to backfilling and grading is cited as an inspection problem.

Backfilling and grading were completed in late 2024 for Pit 5. Upon cessation of pumping the pit has begun to fill and lower soils along the toe slope have become saturated. This in combination with time appears to have resulted in differential settling (horizontal cracks). To some extent this is to be expected and natural. But it also could be exacerbated by improper compaction of backfilled areas and/or utilizing poor backfill materials which results in voids over time. Most notable a large scarp is present on the west side of the pit which is approximately 100 yards long by 4 inches wide and in excess of 24 inches deep. Photos three through five. The slip surface is approximately 18 inches lower than the head of the scarp at its deepest point and is gradually less towards the edges. Several smaller secondary slumps were also observed within the main scarp. No toe bulge was observed but is likely present below the water level. Additional layered slumps were observed to the south of the main scarp, photo six. Several smaller settling cracks were observed throughout the other highwalls of Pit 5, Photo Seven. These cracks varied in length but were generally only a few inches wide and less than 24 inches deep with no drop in the slip surface.

Photo 3: Main scarp on west side of Pit 5

CORRECTIVE ACTIONS: All slopes in Pit 5 with surface cracking shall be regraded and compacted to a sufficient depth to removed differential settling expressions and ensure sufficient compaction to prevent future occurrences to the extent practical. Pursuant to Rule 3.1.5(7) and the approved Reclamation Plan all slopes shall be no steeper than a 3H: 1V. Where insufficient material is present on site to complete contouring additional inert fill may need to be imported to establish proper grade. If import material is brought in topsoil may also be required to provide sufficient vegetative growth material. Additionally, until slope stability issues are resolved pumping should resume as needed to maintain current water levels within Pit 5. Both written and photographic documentation of the above mentioned actions shall be completed and submitted to the Division by the corrective action due date.

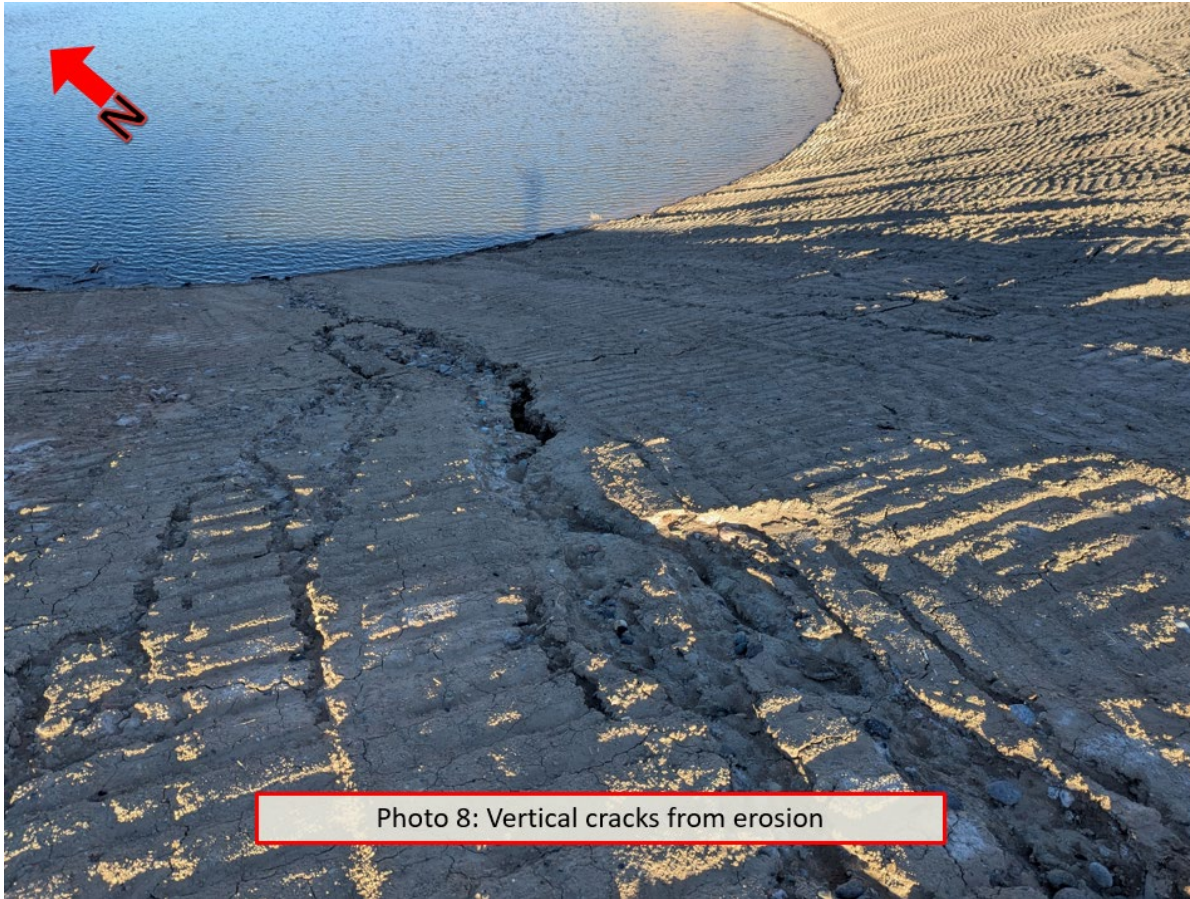
Additionally, some vertical erosional cracks were observed on the far south side of Pit 5 as well as on the west side near the outlet of the culvert under the road, Photo Eight. These cracks or erosional features appear to be the direct result of a point source discharge eroding the slope. There is no potential for offsite impacts as water is draining into the pond however overtime if left untended it could result in undercutting of the pond slope requiring an extensive repair process. Where possible point source discharges should be avoided. Where unavoidable these areas should be armored and/or water ponded to dissipate energy and erosion potential. While completing slope regrading work associated with the settling problems, please also address any erosional cracks through grading.

Photo 8: Vertical cracks from erosion

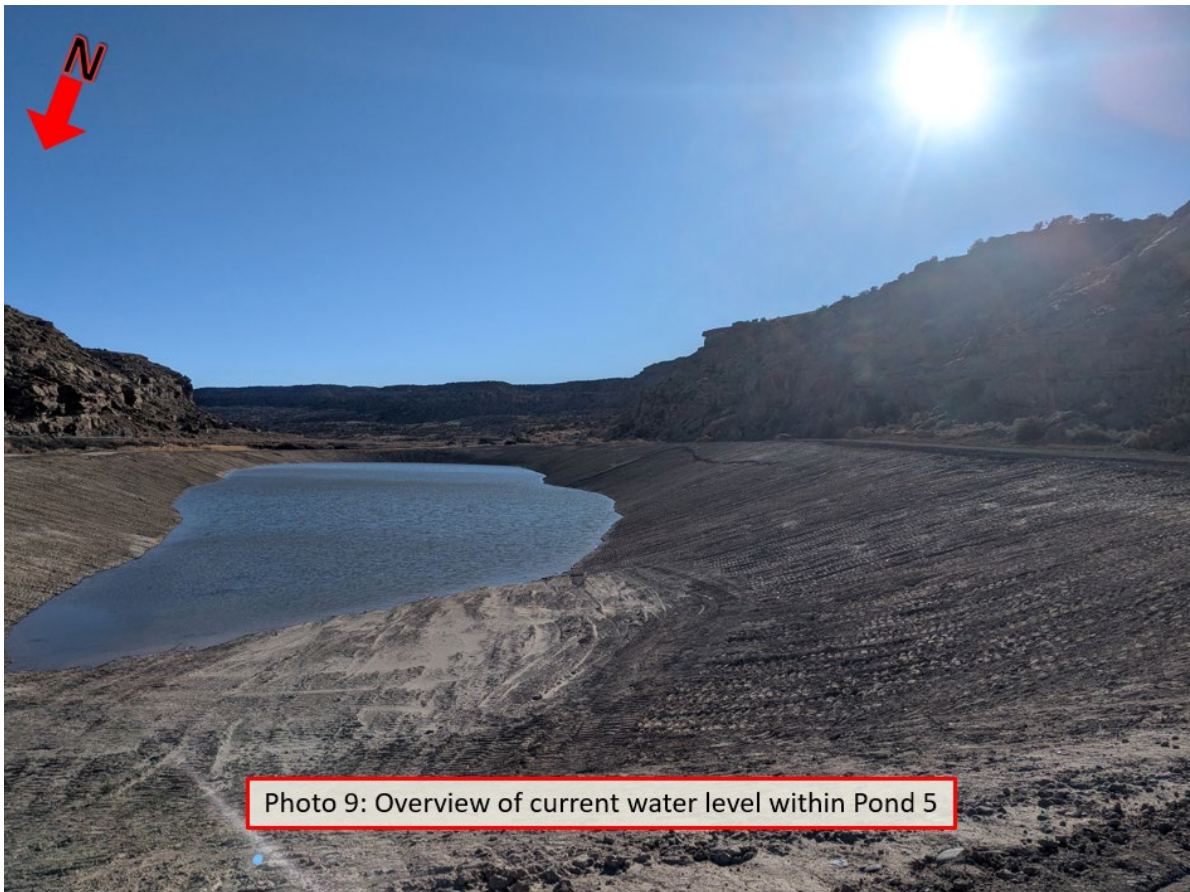
Pumping on Pit 5 ceased in December of 2024. The pond has filled approximately 25 feet so far at its deepest point. The water is anticipated to rise an additional 20 feet before equalizing with the ground water table.

Photo 9: Overview of current water level within Pond 5

Until stability concerns are resolved (see backfill and grading problem) pumping should be resumed as necessary to maintain the current water levels. Cessation of pumping shall require written approval from the Division once problems are resolved to the Divisions satisfaction. Photo Nine.

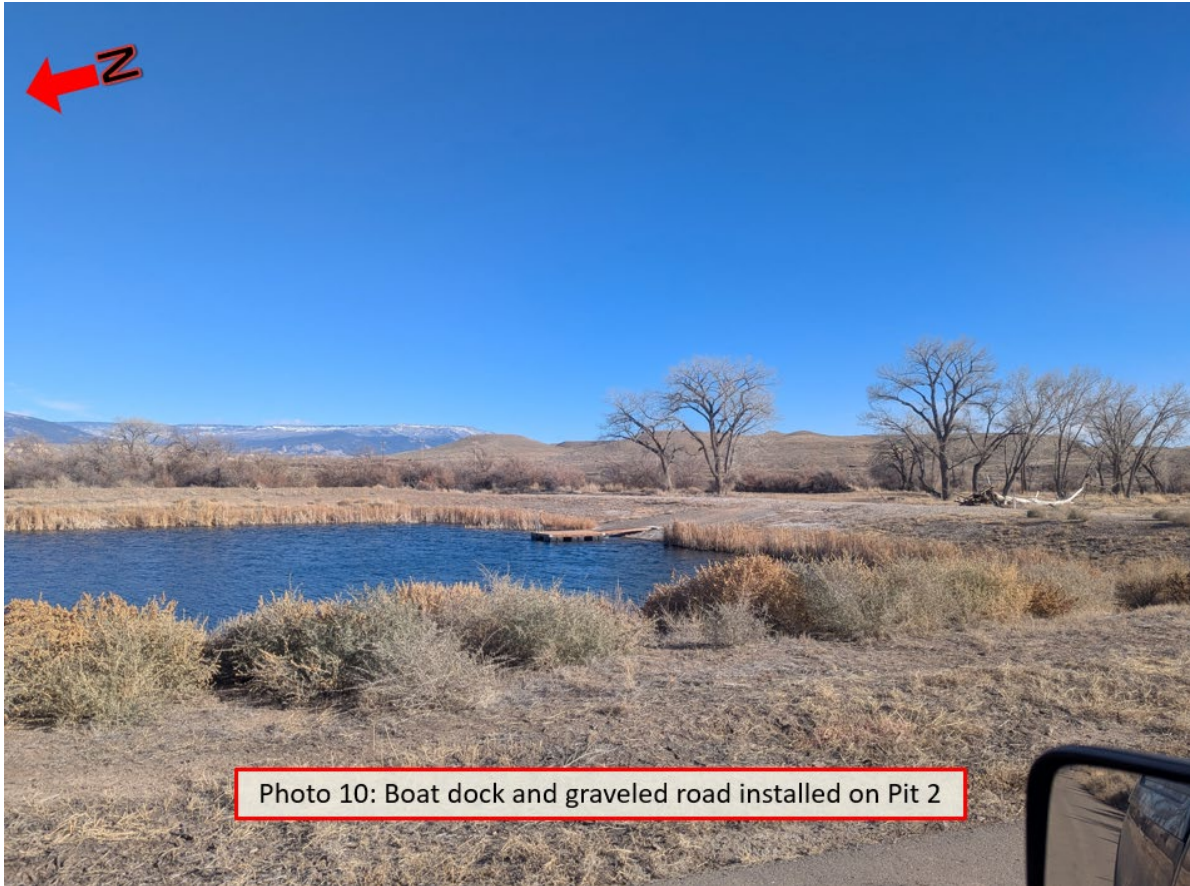
A boat dock and graveled single-track road has been installed on the south side of Pit 2 within the affected lands, Photo Ten. A house was also constructed on the north side of Pit 2 where the pond was backfilled, approximately 0.69 ac. The pit was last inspected in 2021 and neither feature was present. Based on satellite imagery from the Mesa County Assessors website the house appears to be constructed in 2024. Photo Eleven. These features are not a part of the approved Reclamation Plan. A technical revision incorporating these features into the final reclamation configuration must be submitted.

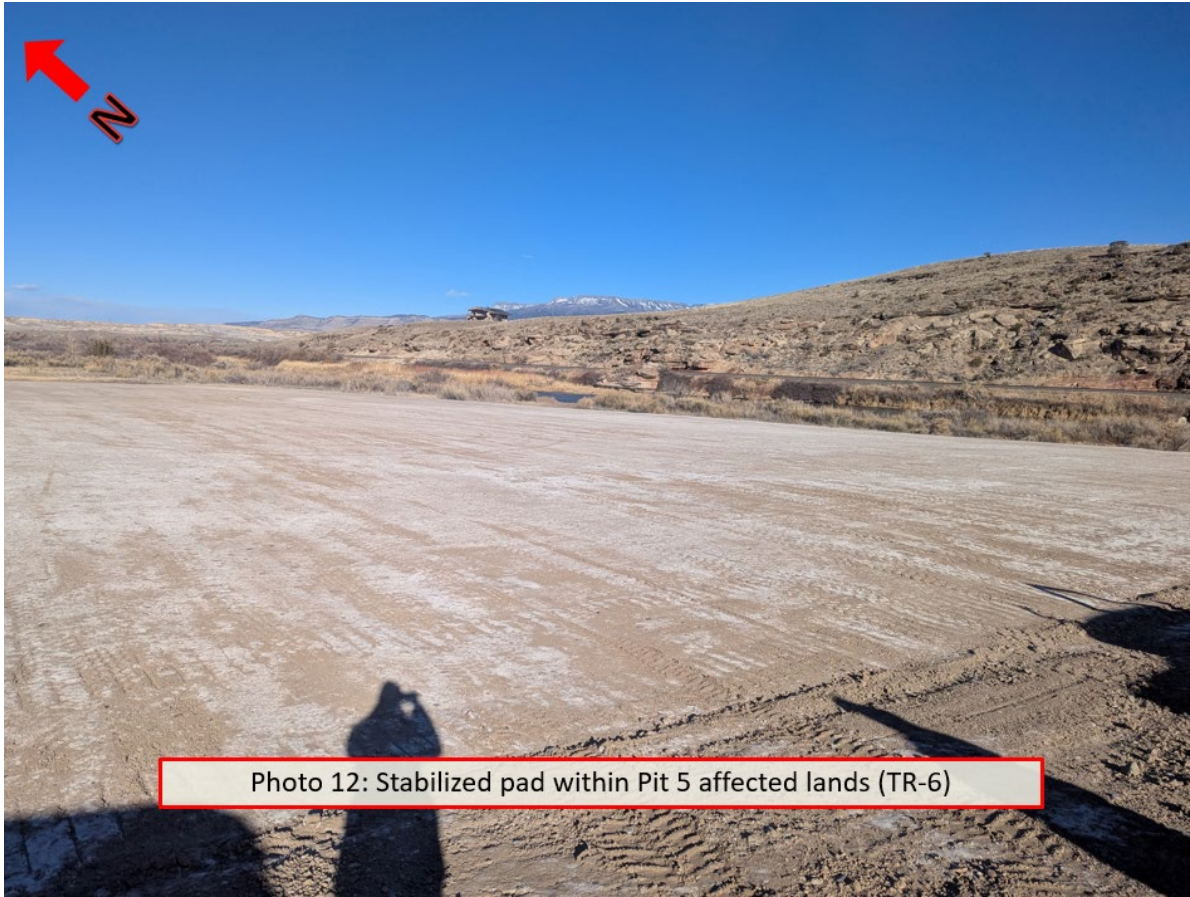
Under TR-6 a stabilized building pad was approved to be constructed on the north side of Pit 5 per the landowner's requests, Photo Twelve. This pad has been completed. While this area is permitted no building shall take place unless the Reclamation Plan is modified accordingly.

Photo 12: Stabilized pad within Pit 5 affected lands (TR-6)
