MINERALS PROGRAM INSPECTION REPORT
PHONE: (303) 866-3567

MINE NAME: Yocam Pit	MINE/PROSPECTING ID#: M-1999-060	MINERAL: Gravel	COUNTY: Las Animas
INSPECTION TYPE: Monitoring	WEATHER: Windy	INSP. DATE: February 12, 2025	INSP. TIME: 10:00
OPERATOR: Las Animas County	OPERATOR REPRESENTATIVE: Brian Heguy	TYPE OF OPERATION: 112c - Construction Regular Operation

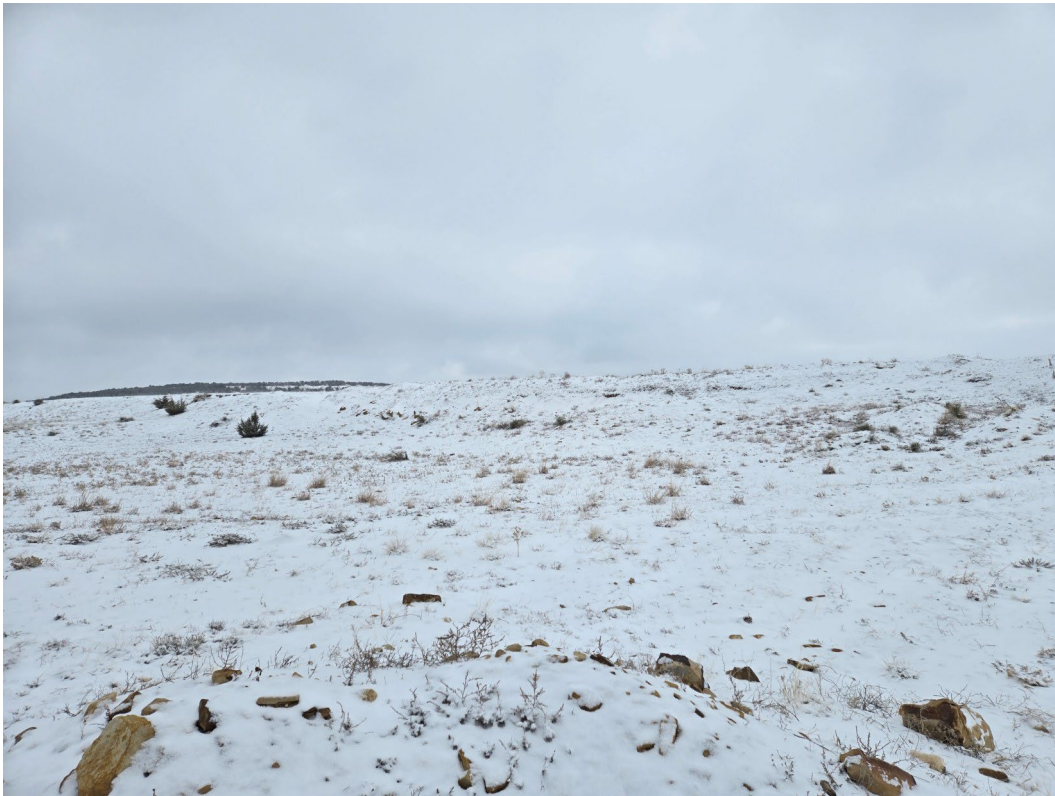
As mentioned in the Division's 2019 inspection report, the disturbed area along the northwest side of the site appears to have been partially reclaimed. The area appears to have at least been backfilled, graded, and may have been seeded (Photo 1). No recent reclamation has been conducted at this site.

Photo 1: Looking at the north slopes in the partially reclaimed, previously 110c area.

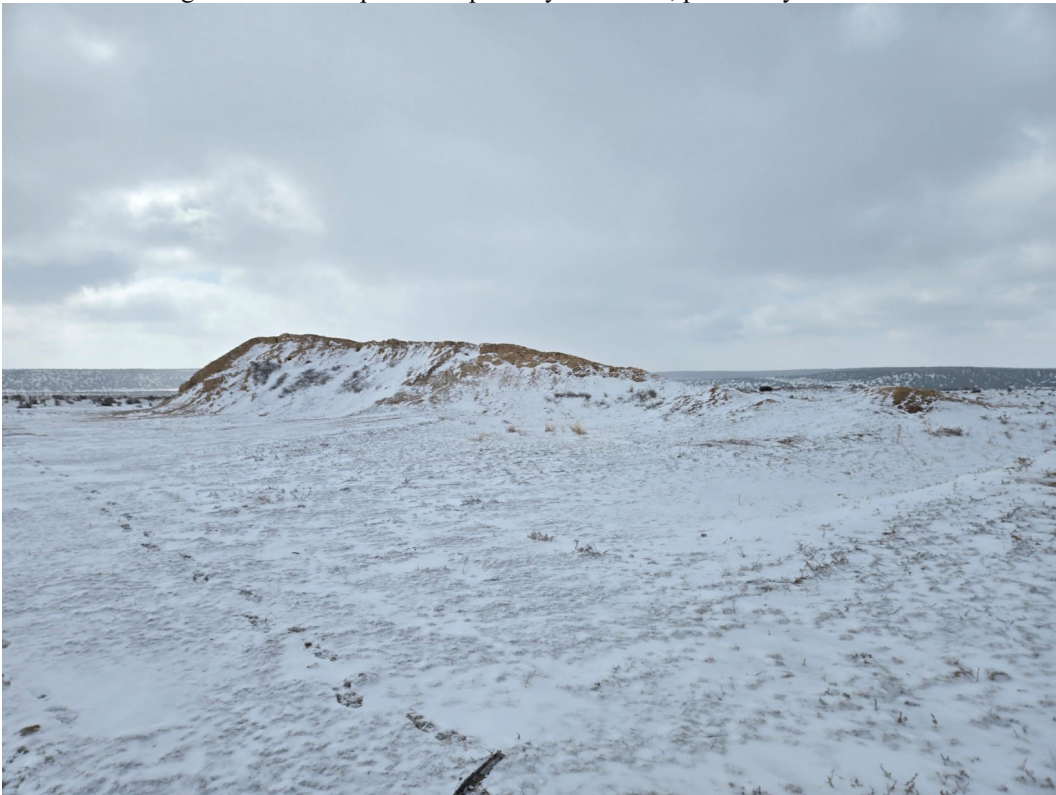
Photo 2: Looking along the backside of the eastern disturbance.

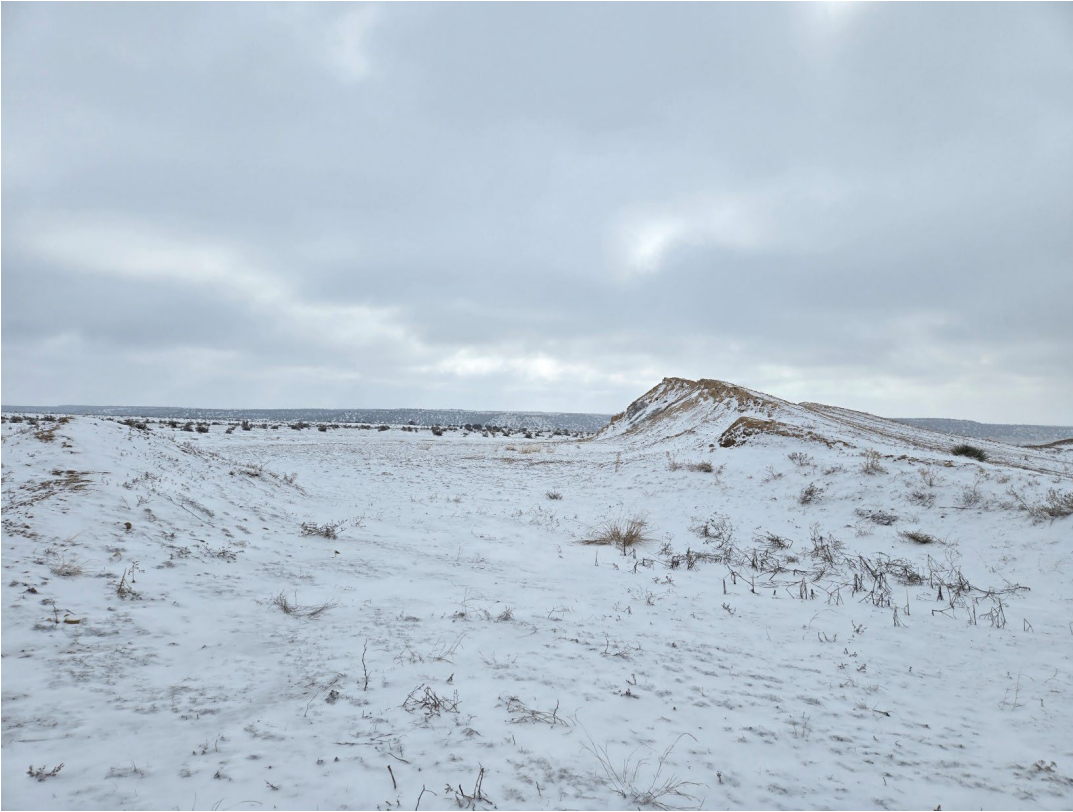
Photo 3: Looking east at the portion of the material along the eastside of the active area, removed between 2016 and 2020 (see Figure 1).

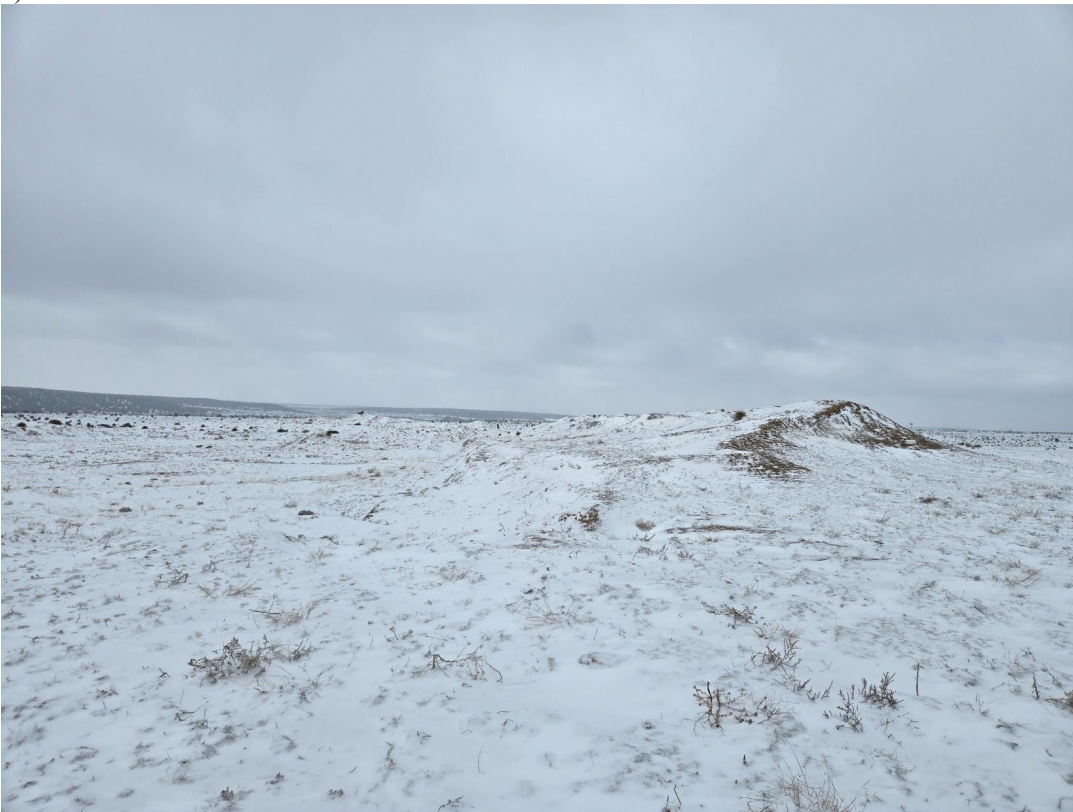
Photo 4: Looking along what may be a topsoil stockpile on the north side of the active pit area.

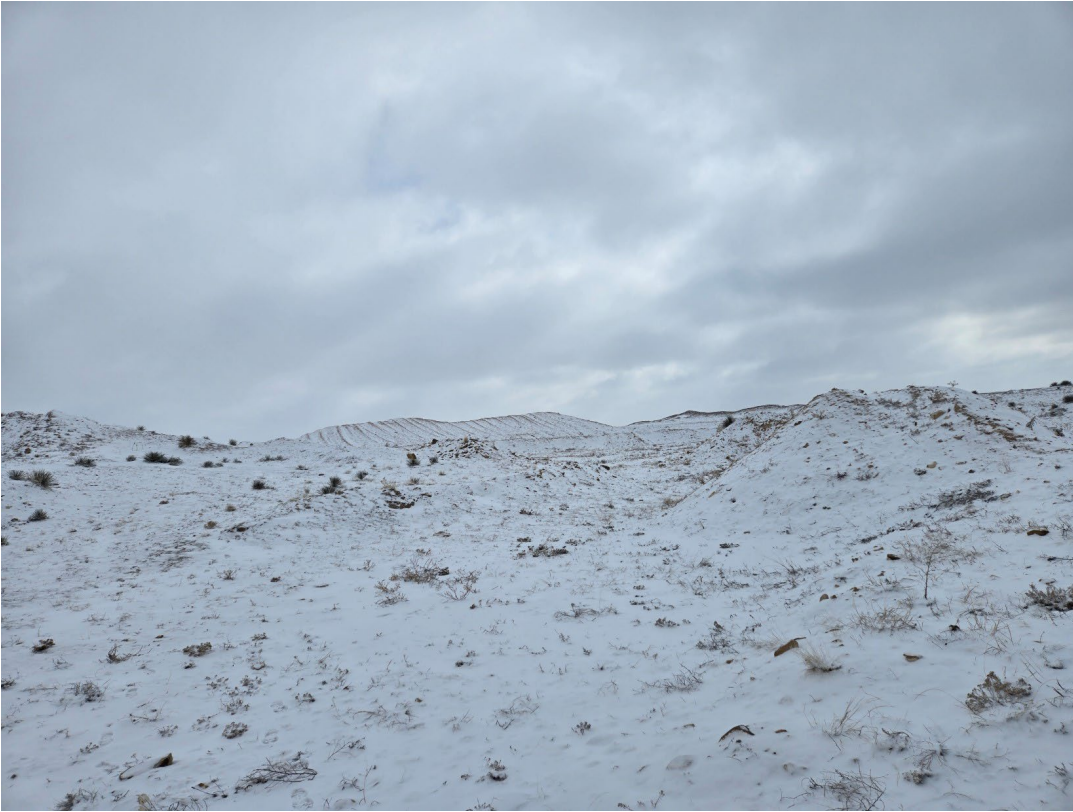
Photo 5: Looking into the pit from where the partially reclaimed 110c area intersects with the active mining area.

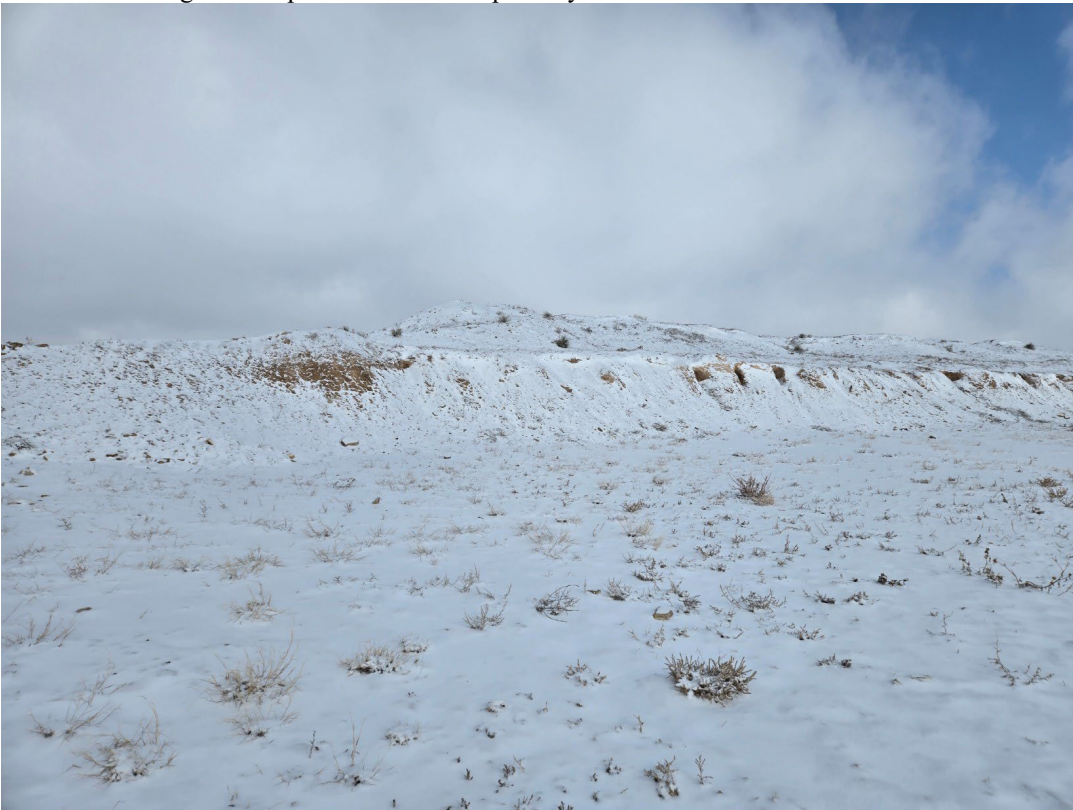
Photo 6: Looking at the north side slopes within the pit.

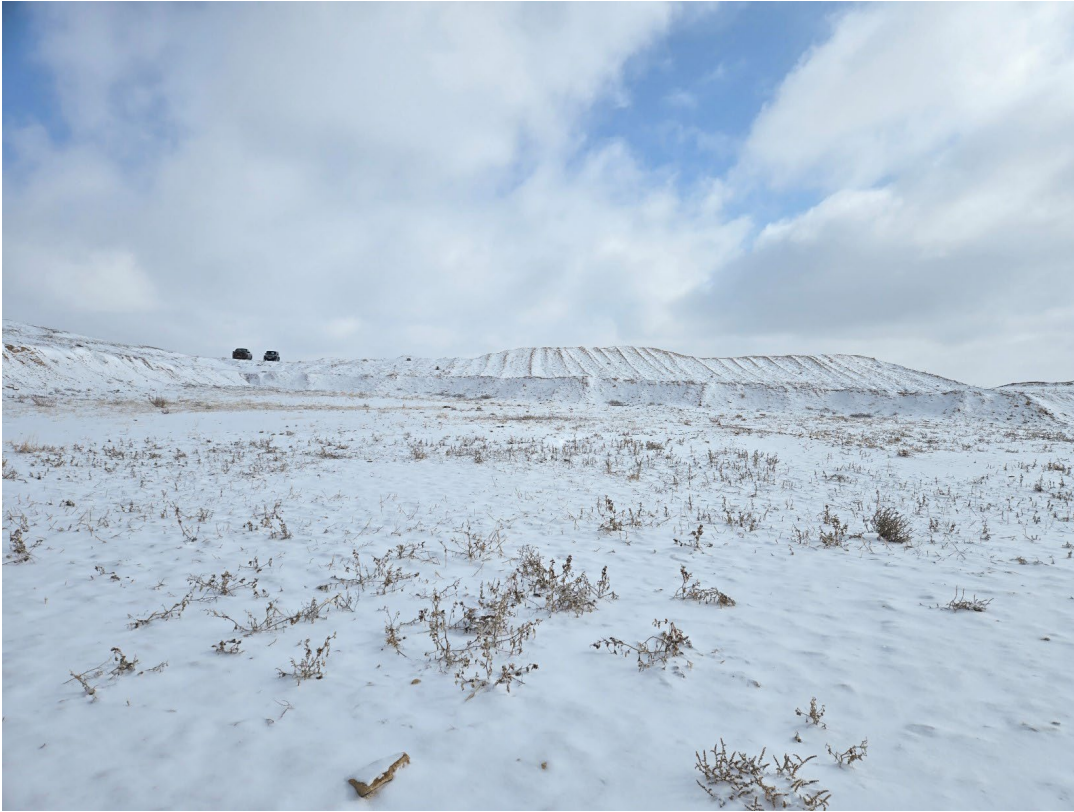
Photo 7: Looking east at the eastern pit slopes, and the material pushed and piled above and back from the pit walls.

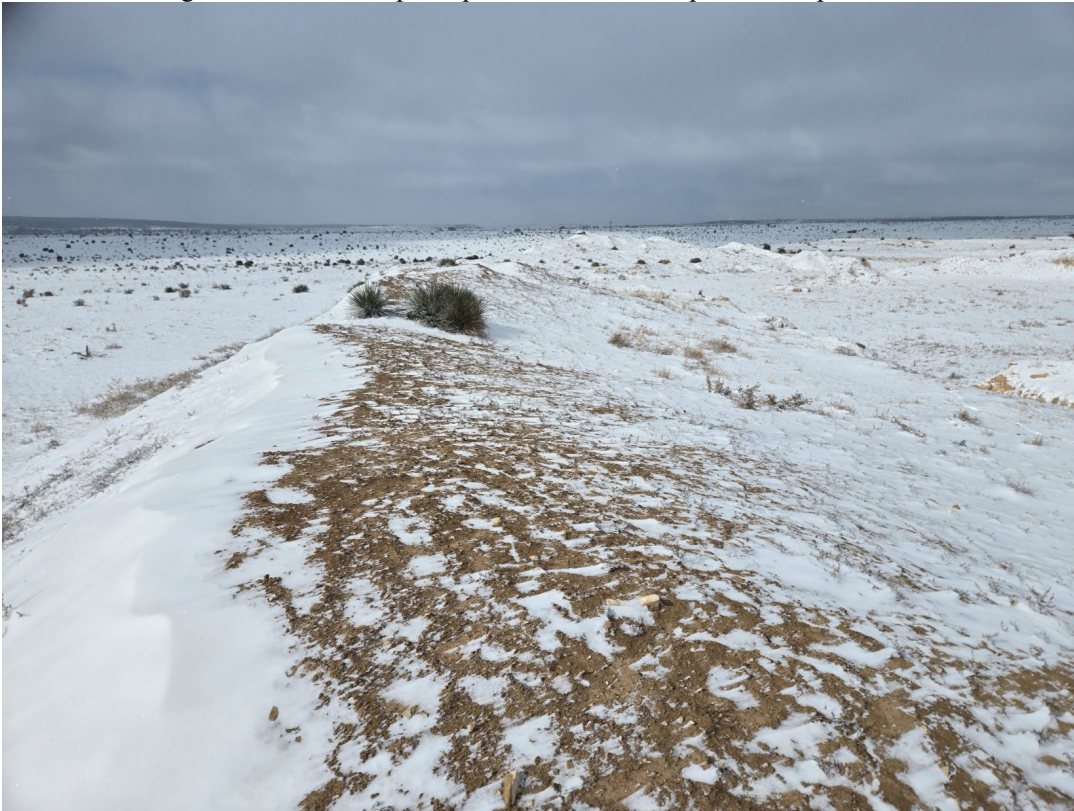
Photo 8: Looking west along what appears to be topsoil on the south side of the pit.

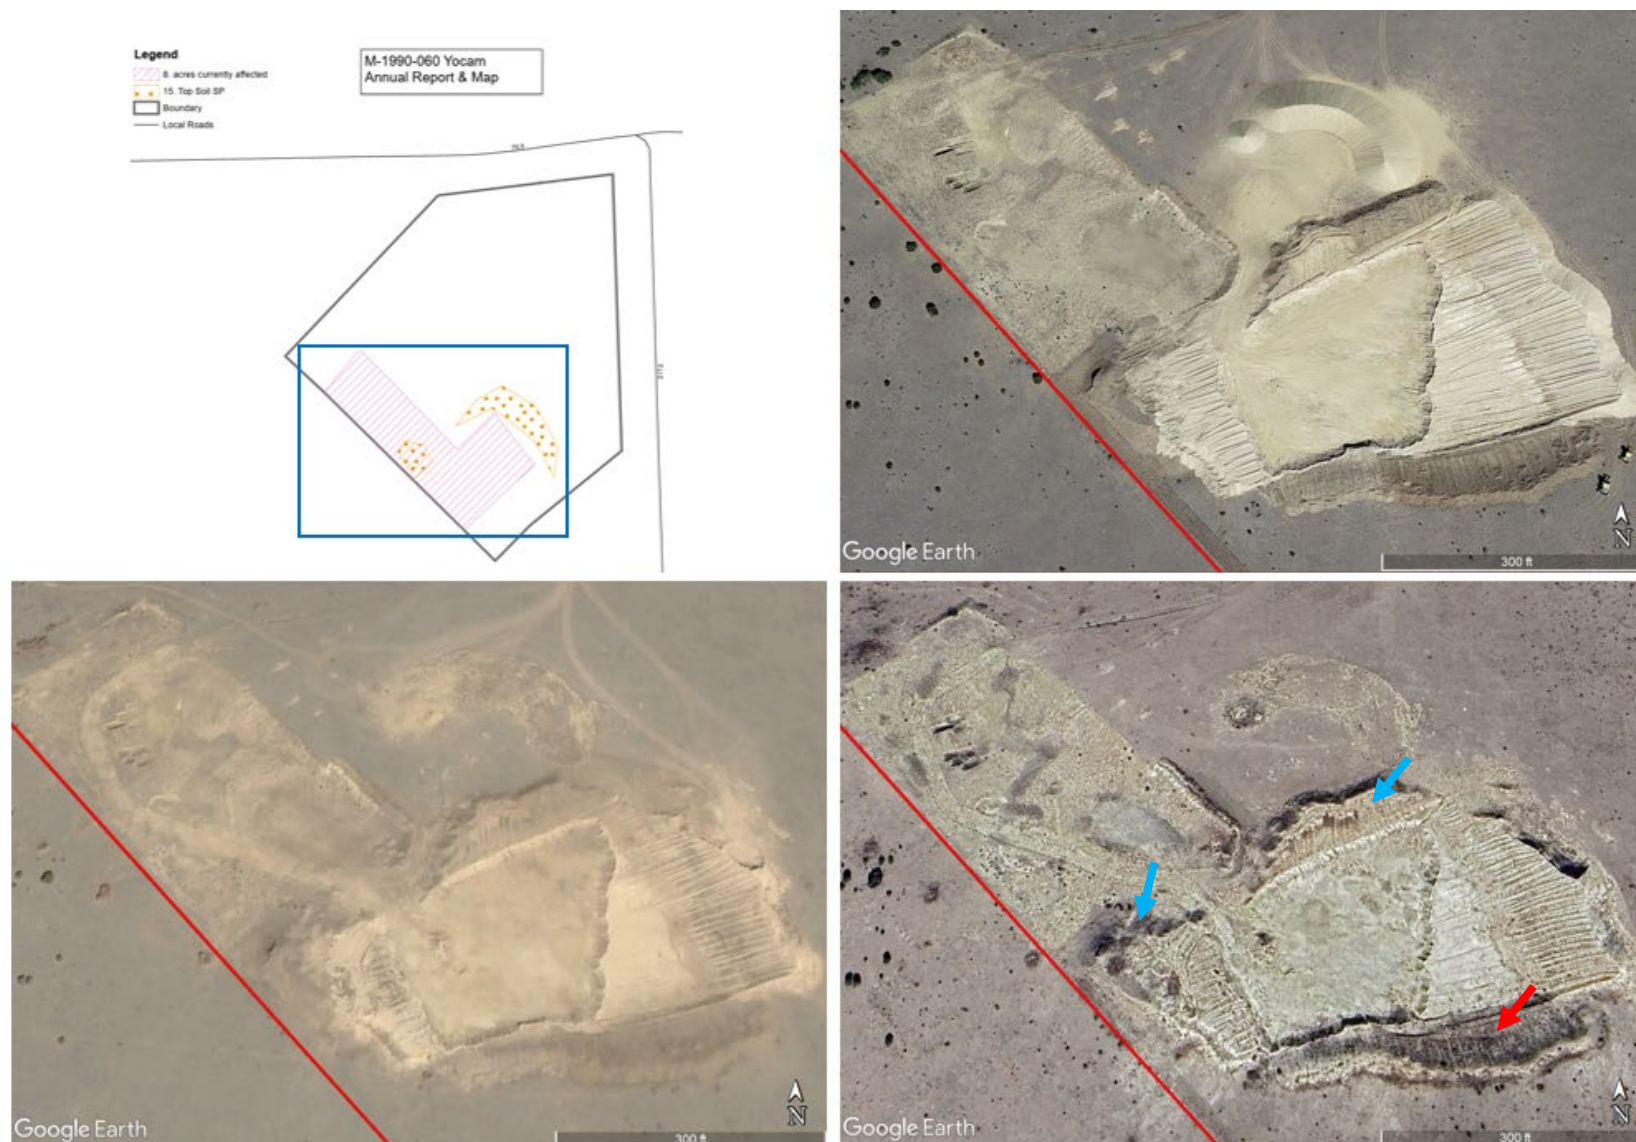
The Division found that the recent annual report maps were inadequate. The topsoil locations depicted on the 2018-2023 inspection report maps appear to be inaccurate when compared with aerial imagery and field observations (see the topsoil section below). **Please update the topsoil locations on the 2025 annual report submittal for the 2024 annual reporting period.**

The topsoil pile locations have been depicted as being in both in a crescent shape around the east side of the active pit area, and in a circular pile located to the northwest of the northwest corner of the active pit area (see Figure 1). However, during the inspection, the Operator and the inspector believe that the material on the south side of the active pit is topsoil (Photo 8). Upon looking at aerial images, it also appears that there may be some topsoil placed on the north side of the active pit (Figure 1). The Operator shall update the topsoil pile locations on the 2025 annual report map submission for the 2024 annual reporting period.

Figure 1: Figure highlighting discrepancies between the annual map submissions and field observations. (Top Left): Photo from the Operator's annual report map, submitted for the 2023 annual reporting period. The blue box indicates the approximate location focused on in the rest of the images. (Top Right): Aerial image dated March 2016. Product material appears to be placed to the north of the pit, and along the east side. (Bottom Left): Image taken March 2020. Some of the material on the east side, and all the material in the north has been removed. (Bottom Right): Image taken October 2023. Material onsite appears unchanged since the 2020 image was taken. The red arrow indicates where the Inspector and the Operator believed the topsoil to be in the field. The blue arrows indicate where, after reviewing aerial imagery, the inspector believes additional topsoil may be.
