MINERALS PROGRAM INSPECTION REPORT

MINE NAME: Unwin Gravel Pit	MINE/PROSPECTING ID#: M-1998-011	MINERAL: Gravel	COUNTY: Las Animas
INSPECTION TYPE: Monitoring	WEATHER: Windy	INSP. DATE: February 12, 2025	INSP. TIME: 11:32
OPERATOR: Las Animas County	OPERATOR REPRESENTATIVE: Brian Heguy	TYPE OF OPERATION: 110c - Construction Limited Impact

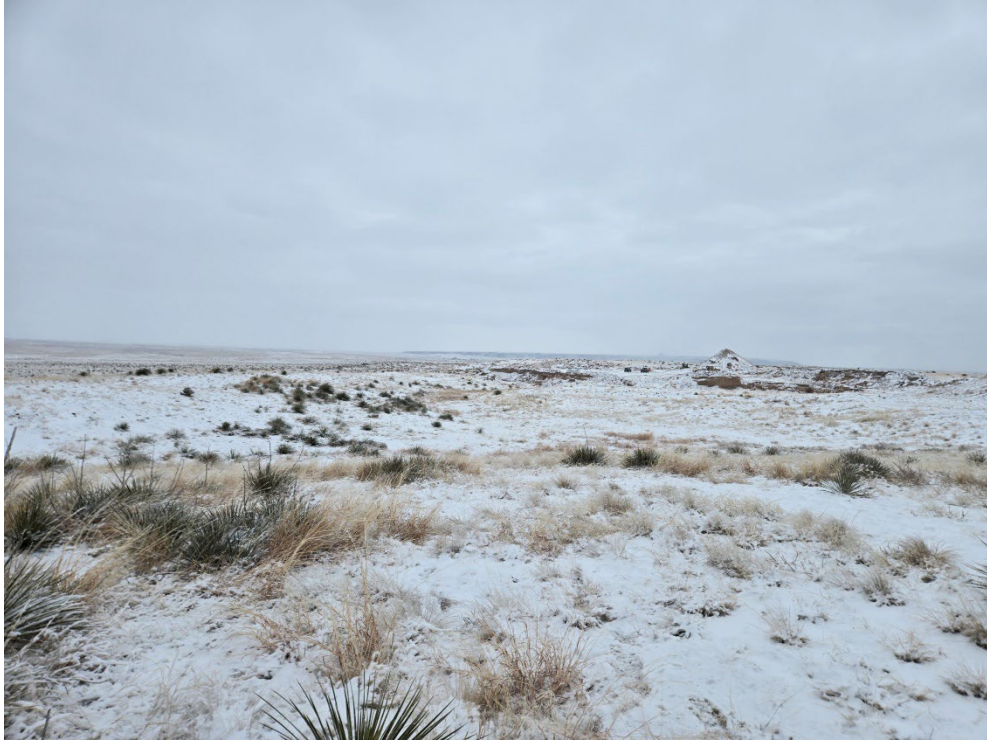
When reviewing annual report maps submitted throughout the life of this site, it appears that nearly all the land has been disturbed by the Permittee, including all of the pre-existing disturbance within the permit boundary. The far east and far west areas have also been subsequently backfilled and graded (Figure 2; Photos 1-2). The 2024 annual report states that 0.7 acres have been backfilled, however the inspector believes the area that has been partially reclaimed is greater than 0.7 acres. The area on the far east side has gentle slopes that may meet the 4H:1V requirements of the reclamation plan, but the area in the west side will need to be graded to a flatter slope to meet the requirements.

Photo 1: Looking east across some of the backfilled and graded area along the west side.

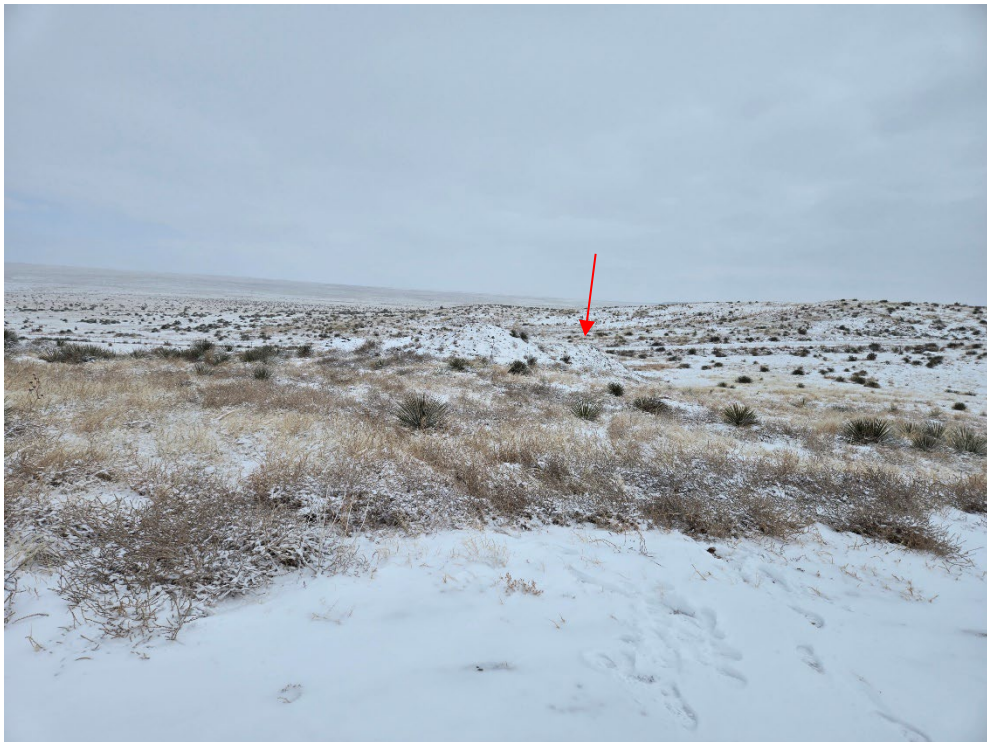
Photo 2: Looking east at the northern edge (arrow) of the backfilled and graded area on the east side.

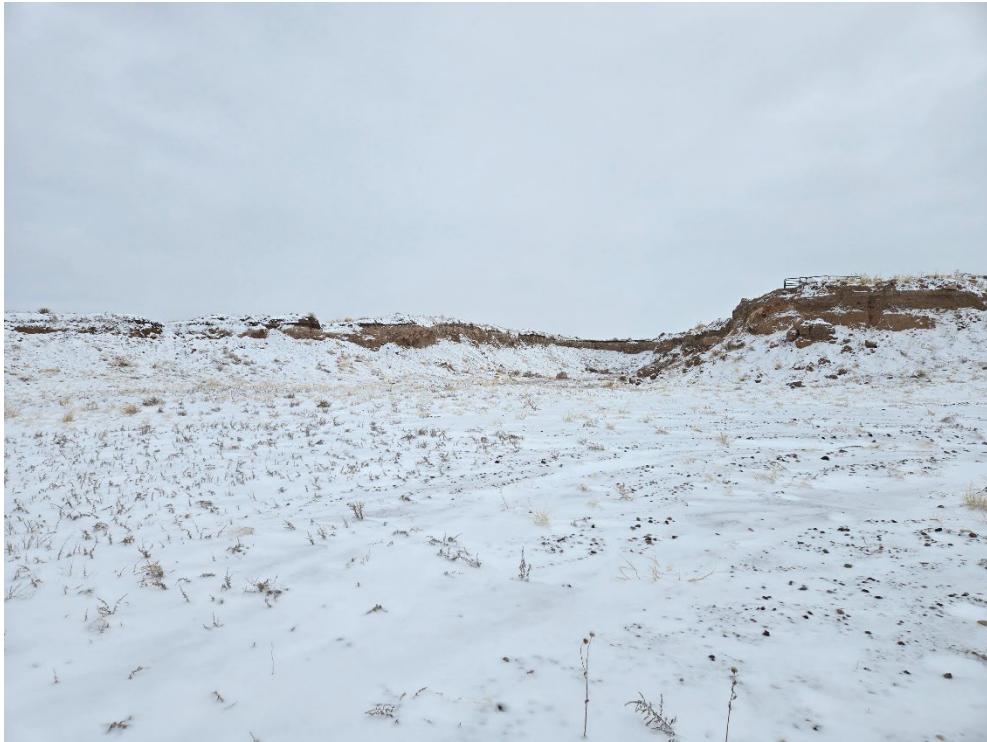
The annual report submitted in 2024 indicates that there are currently 8.3 acres of disturbance, including mining and un-reclaimed/unreleased reclamation areas. The current pit is located central to the permit area (Photos 3-7). The disturbance along the southern side of the permit shall not extend any further south, as the berms around the pit are along the southern boundary (see Map 1). The processing area is located on the southeast side of the permit (Photo 7). The Operator stated that the last time crushing took place at the site was either in 2018 or 2019. However, they had been hauling material in the weeks leading up to the inspection. The site was granted intermittent operation status in 2013, and therefore is acting in compliance with the permit. There is a product stockpile located within the processing area that has slowly been removed offsite (Photo 8). Equipment for hauling and loading was observed in the processing area, and an old piece of equipment was observed on the west boundary (Photo 9). The Operator stated that the equipment on the west side has been there for many years, is no longer used, and will be removed offsite prior to final reclamation. Some of the annual report maps throughout the years state that the previously backfilled and graded areas may be re-disturbed by excavating through them at a deeper depth. As mentioned in the Division's 2020 inspection report, the current mine plan indicates a maximum excavation depth of 15 feet. The current depth of the pit appears to be at 15' or greater. If the Operator intends to excavate deeper, a technical revision to the mine plan to allow for a deeper pit will be required.

Photo 3: Looking south from within the pit.

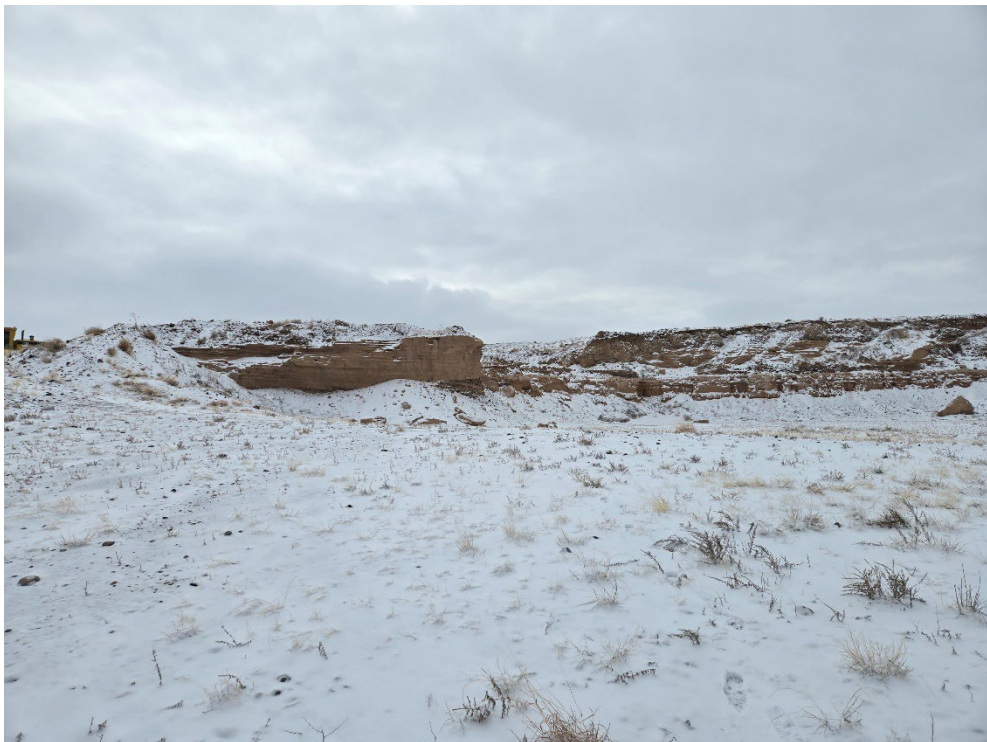
Photo 4: Looking southeast from within the pit.

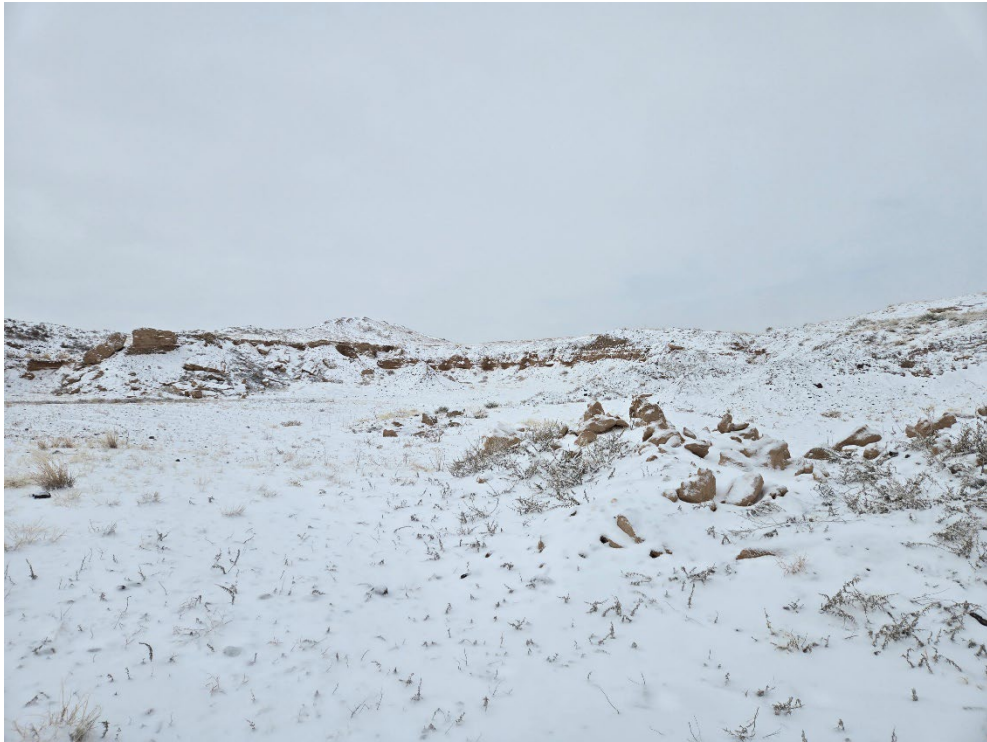
Photo 5: Looking south from within the pit.

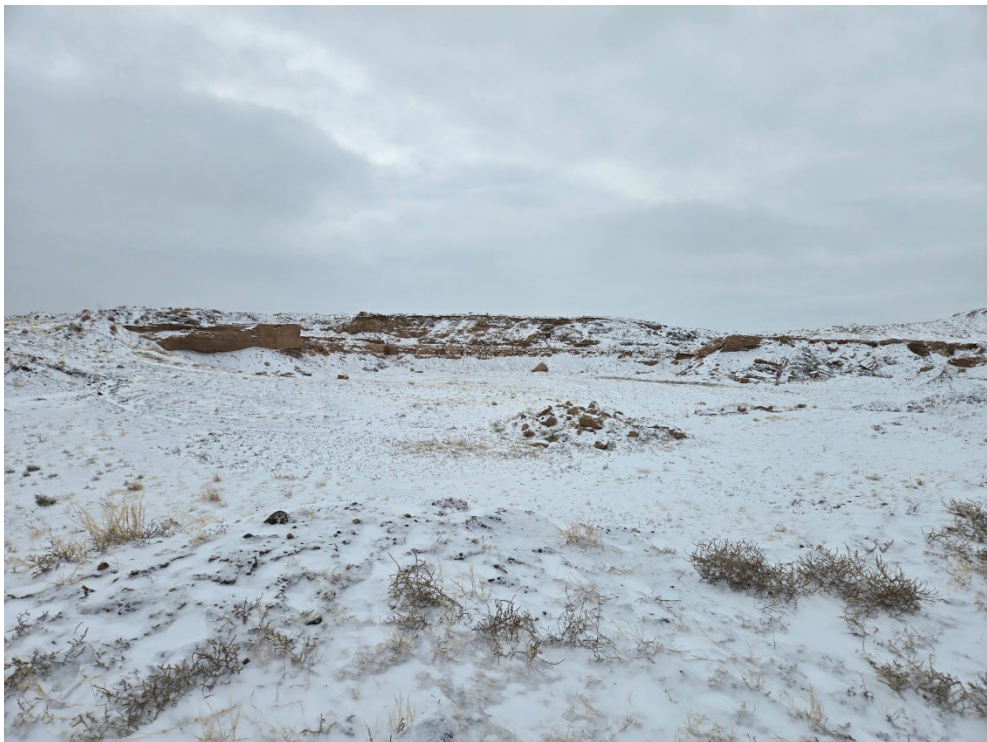
Photo 6: Looking west from within the pit.

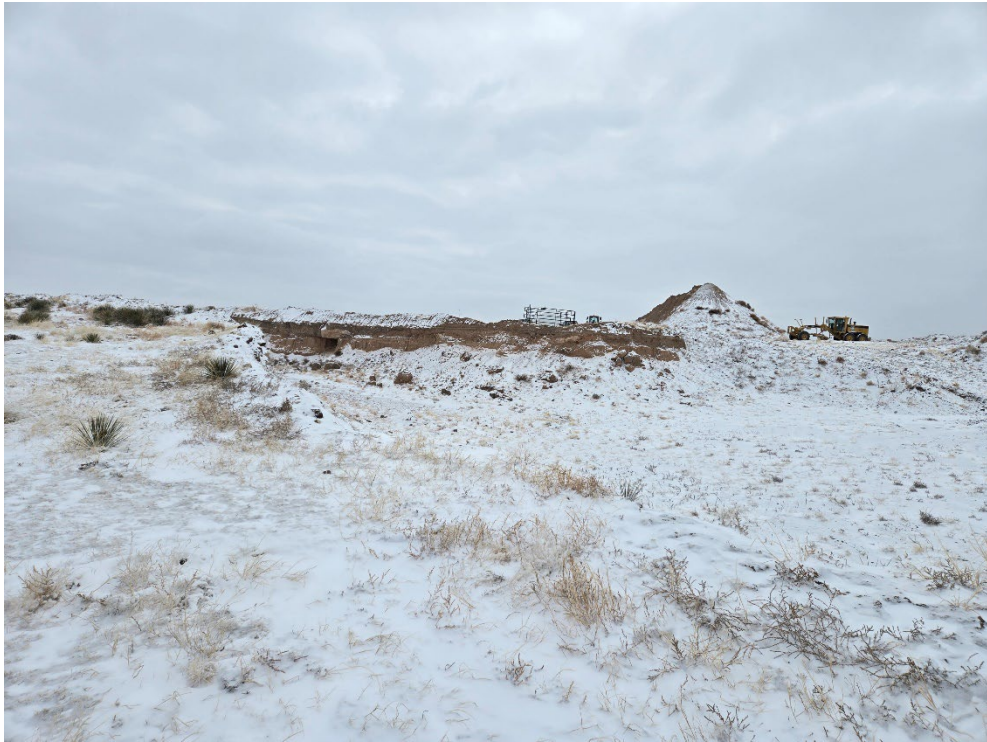
Photo 7: Looking southwest from above the northside of the pit.

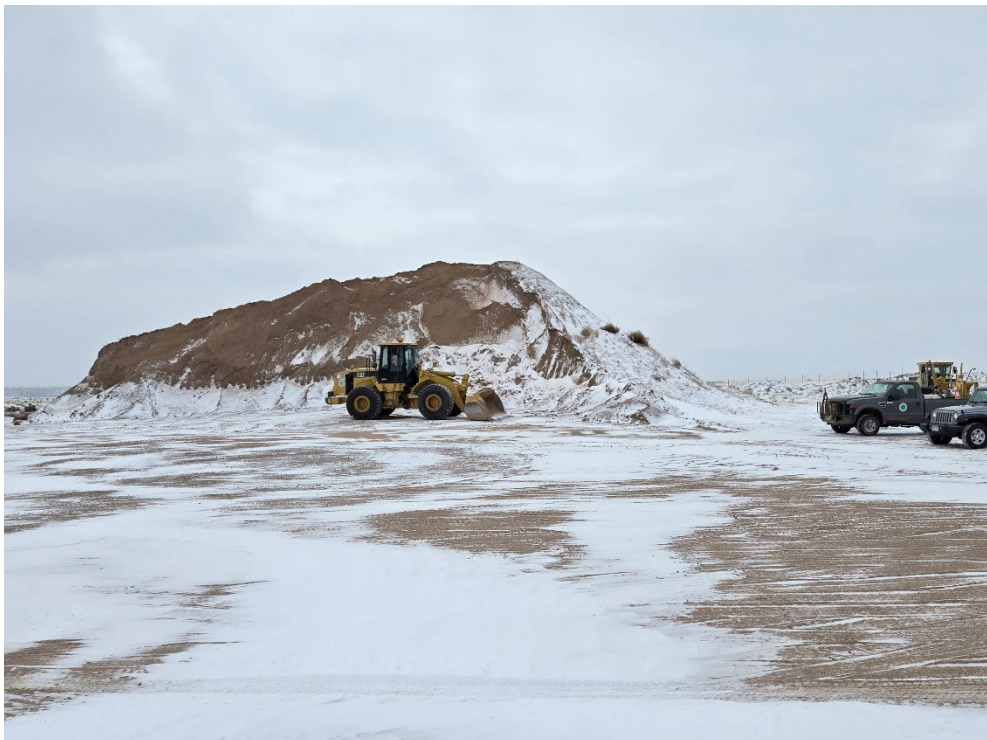
Photo 8: Looking southwest at the remaining stockpile and current equipment.

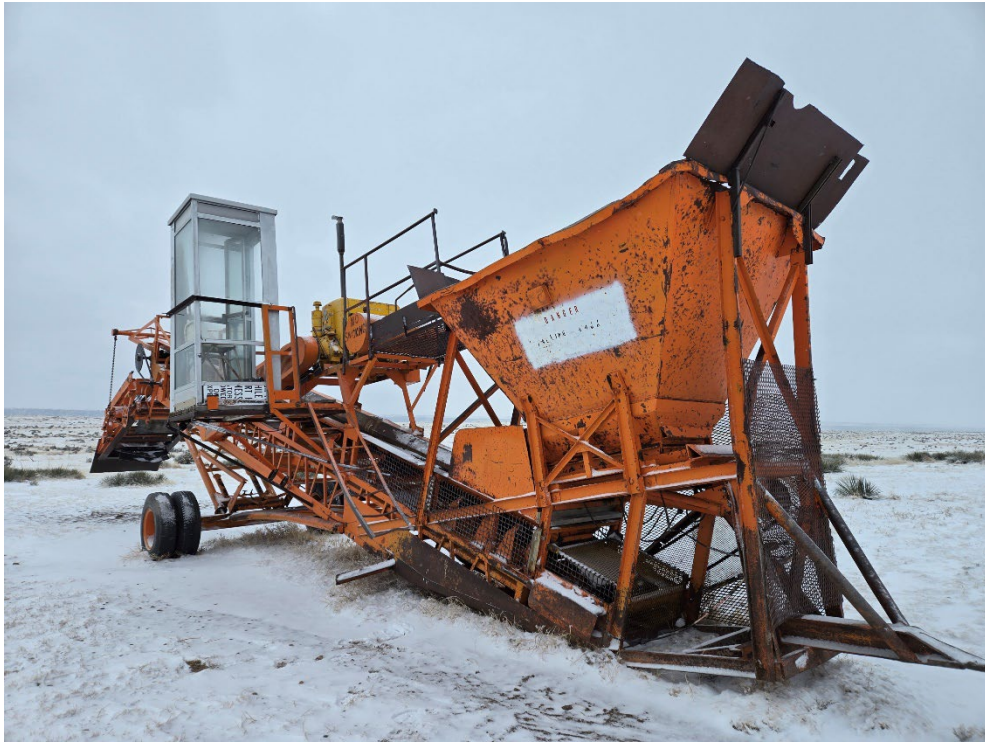
Photo 9: Old equipment on west side that is no longer used.

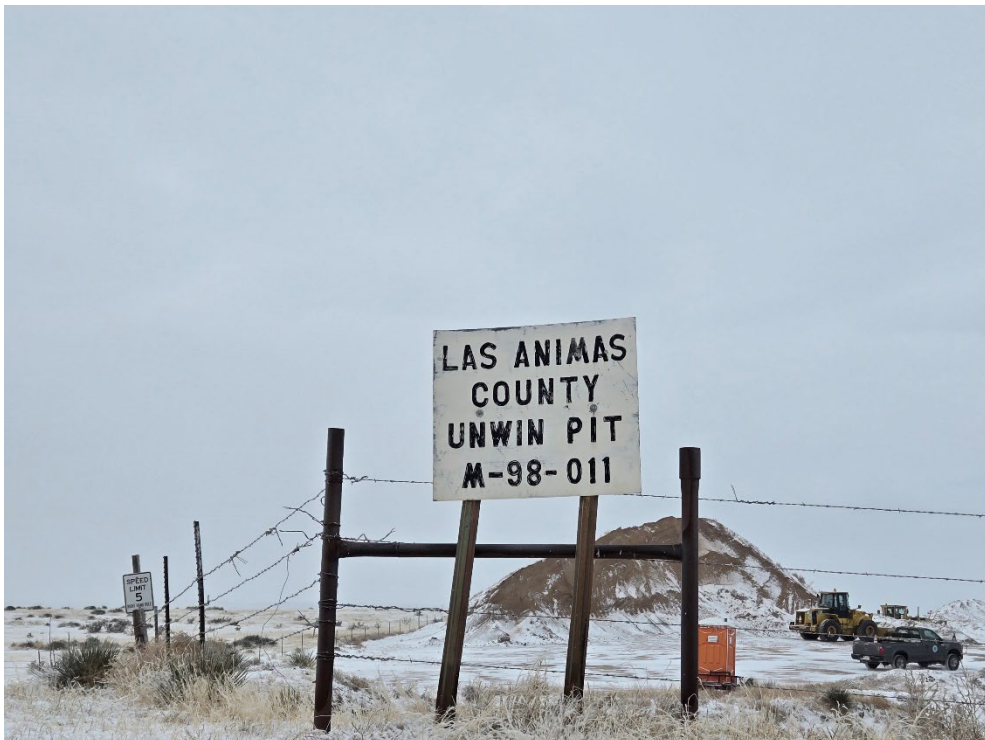
The mine sign was posted at the entrance to the site in compliance with Rule 3.1.12(1) (Photo 10). The Operator and inspector walked along the permit boundary and identified one permit boundary marker that had been dislodged (Photo 11) and found two additional markers (Photos 12-13) that appear to be in the orientations depicted on the approved mining plan map. However, most of the marker missing. **This has been cited above as a problem.** The Operator shall replace the permit boundary markers in the locations depicted on the approved mining plan map per the survey directions and provide the Division with photo evidence and/or GPS coordinates by the corrective action date.

Photo 10: Mine sign posted near the entrance to the site.

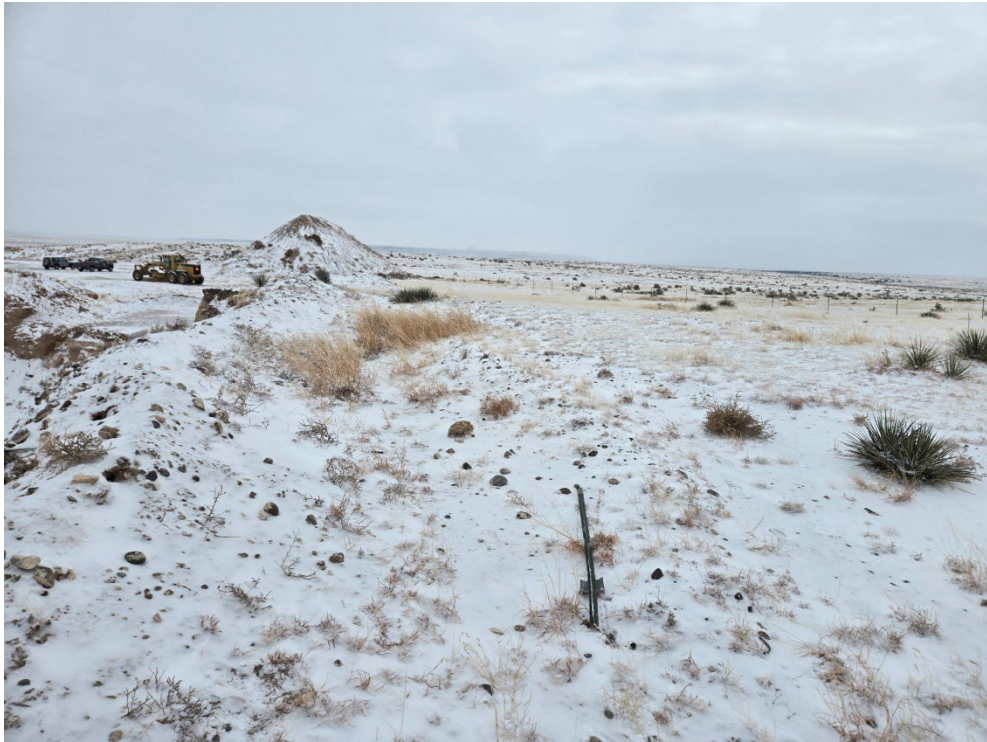
PROBLEM: Many of the affected area boundary markers are missing. This is a problem for failure to maintain boundary markers around the affected area as required by Section 3.1.12(2) of the rule.

Photo 11: Permit boundary marker that's been dislodged along the southside of the permit along the southern boundary.

CORRECTIVE ACTIONS: The Operator shall refer to the original survey conducted for the operation and replace the boundary markers in the correct location(s). The Operator shall provide proof to the Division that this has been done by the corrective action date.

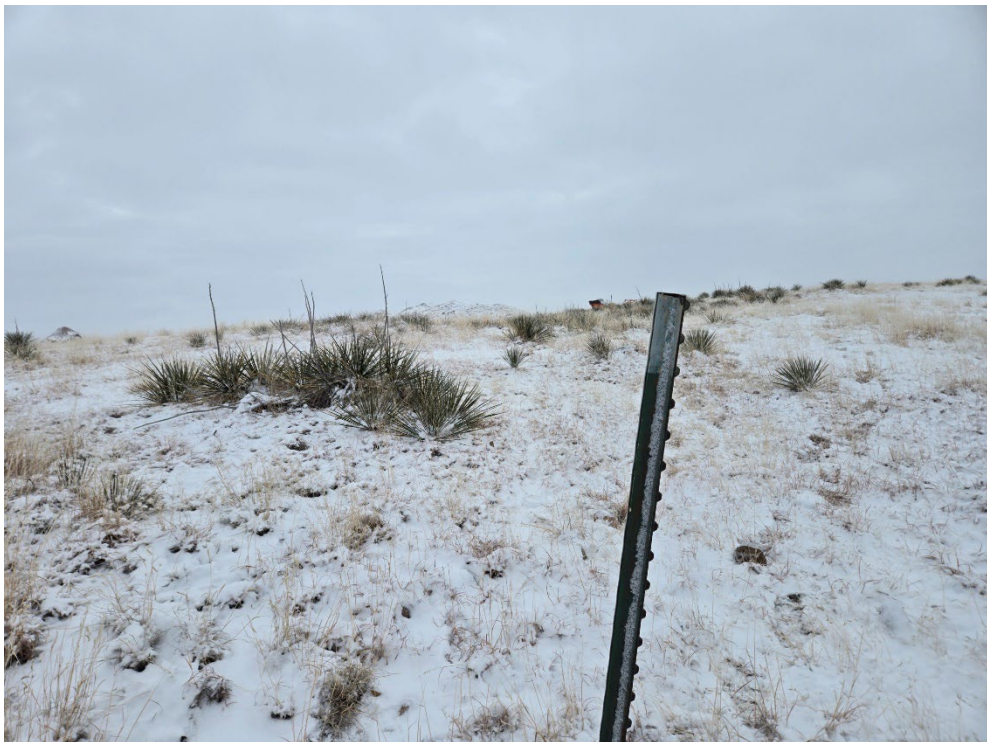
Photo 12: Looking south at the northwest permit boundary marker.

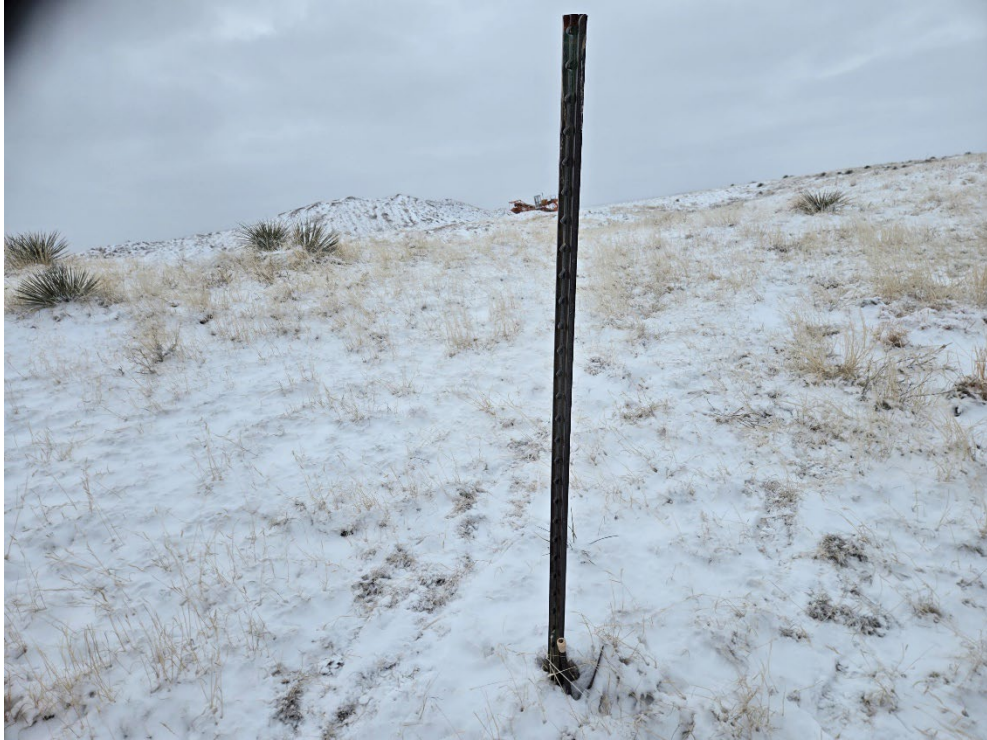
Photo 13: Looking south at the permit boundary marker on the north side.

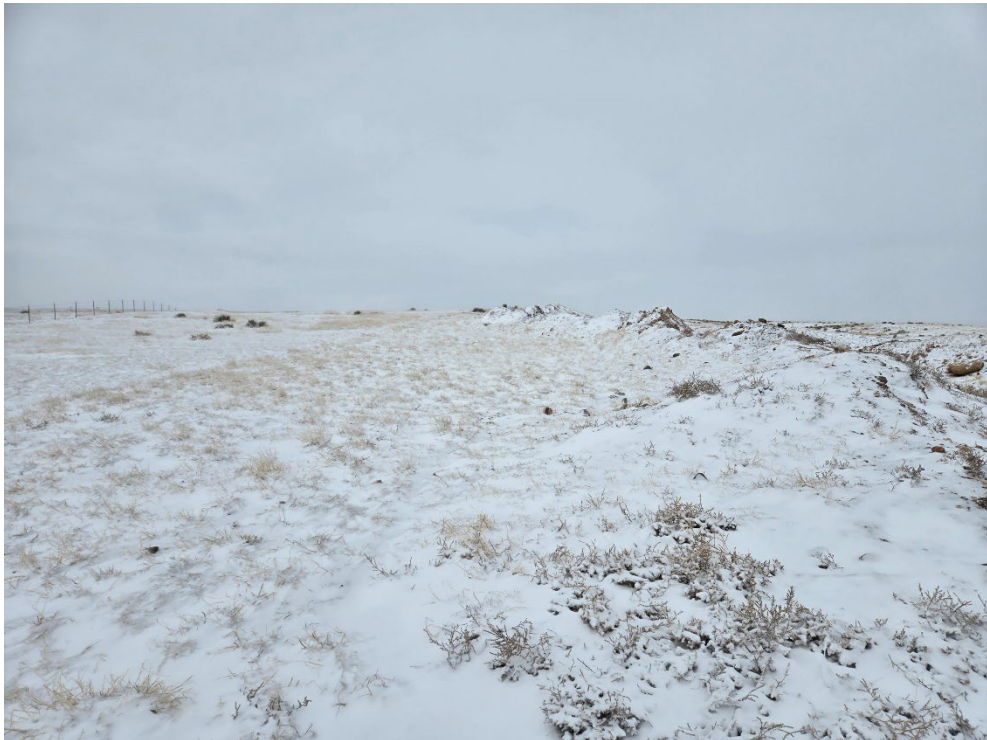
During the inspection, the Operator and Inspector believed that the topsoil may be the material located along the southwest boundary (Figure 2; Photo 14). Upon post inspection review, the annual report maps from 2015 – 2024 depict five small topsoil piles located around the perimeter of the permit boundary (Figure 2). However, when looking at aerial imagery and inspection photos, it appears that at least one of the piles (far east side pile) no longer exists. Due to the snow cover, it was difficult to determine whether or not the other smaller piles around the pit consisted of topsoil material. The **Operator shall ensure** that the topsoil pile locations depicted on the 2025 annual report map submittal match the actual locations.

Photo 14: Looking west along the southern boundary. The boundary appears to be made of topsoil.

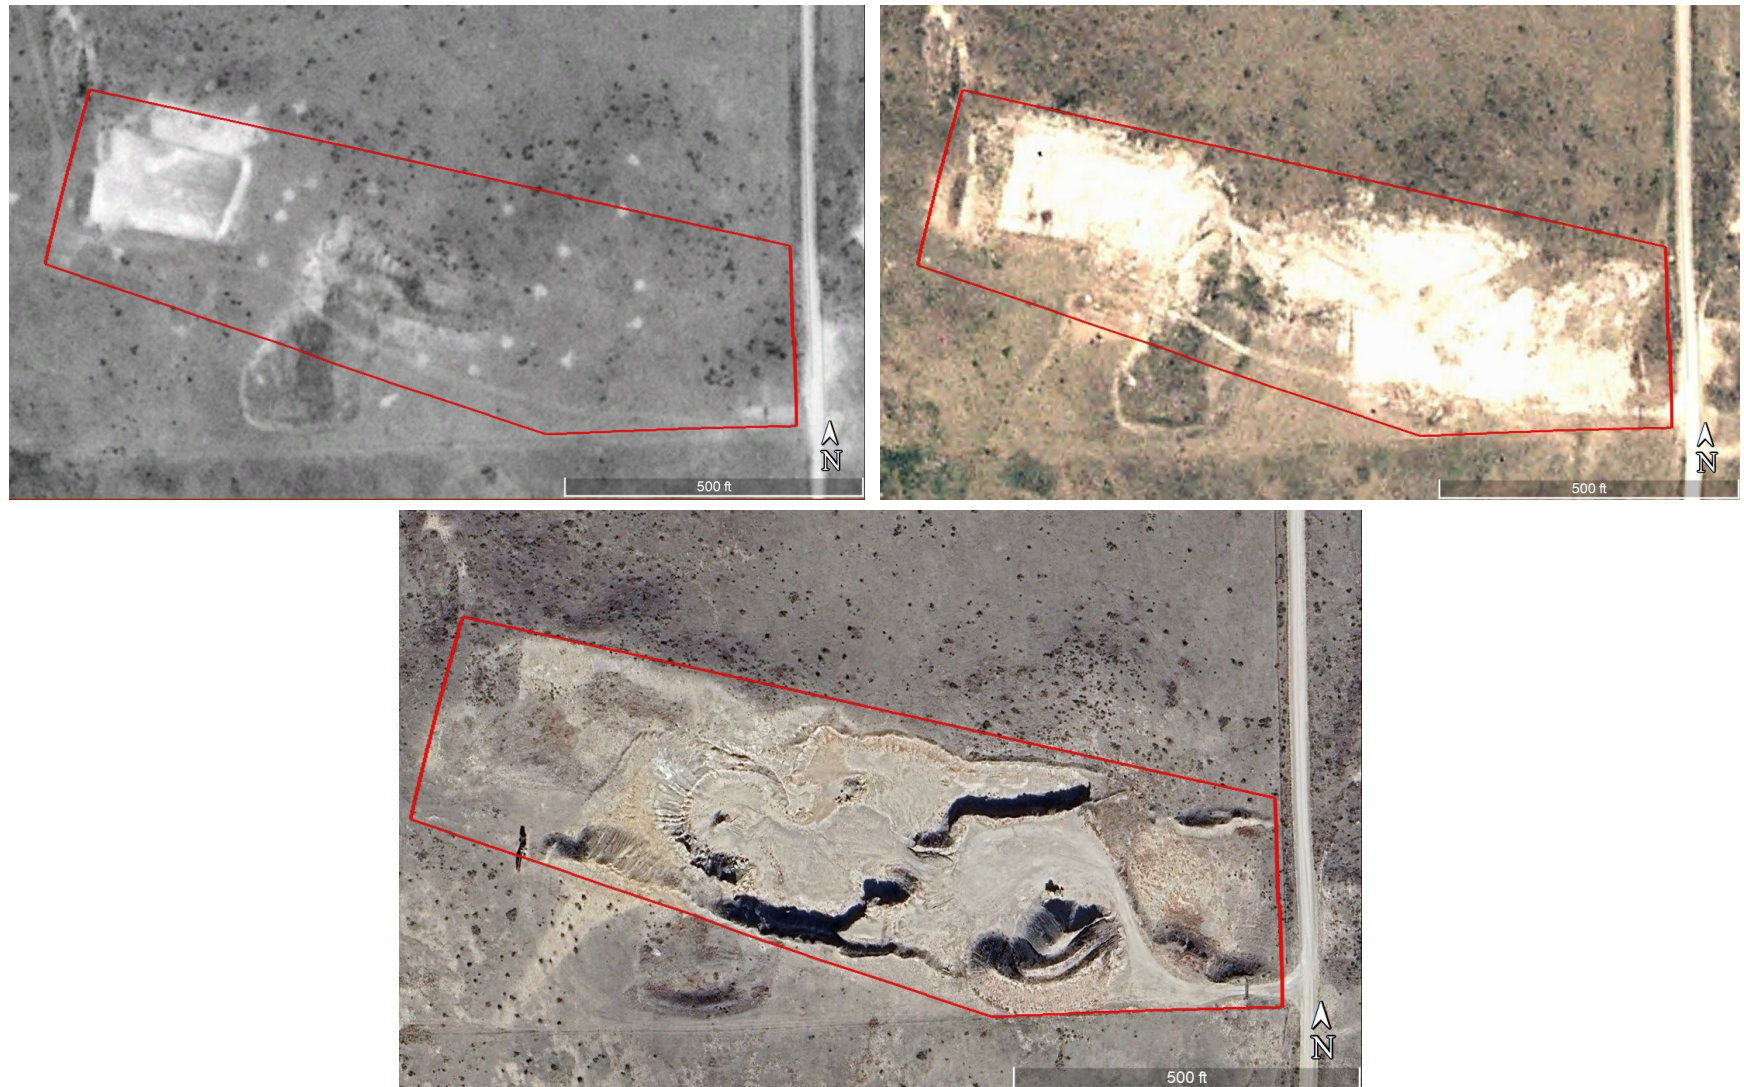
During the inspection, the Operator stated that they were unsure if any reclamation had been conducted at the site. Upon post-inspection follow up, it appears that the site has gone through various cycles of disturbance, reclamation, and re-disturbance. In the Division's 1998 inspection report, conducted shortly after the site was permitted, the inspector observed pre-existing mining disturbance that the Permittee planned to mine through. From looking at aerial imagery available in Google Earth Pro, the 1998 image appears to depict new permitted disturbance in the western portion of the permit area, and some pre-existing reclaimed disturbance within the central portion of the permit and beyond the southern border (Figure 1).

Figure 1: (Top left) 1998 aerial image. On the west side of the permit boundary, mining operations began. In the middle and extending past the southern boundary is pre-existing mining disturbance. (Top right) 2005 disturbance across the site has been conducted from west to east. (Bottom) 2023 active mining is staying central to the permit and gradually moving back to the west. Mining should not extend further south as the southern disturbance is along the boundary.

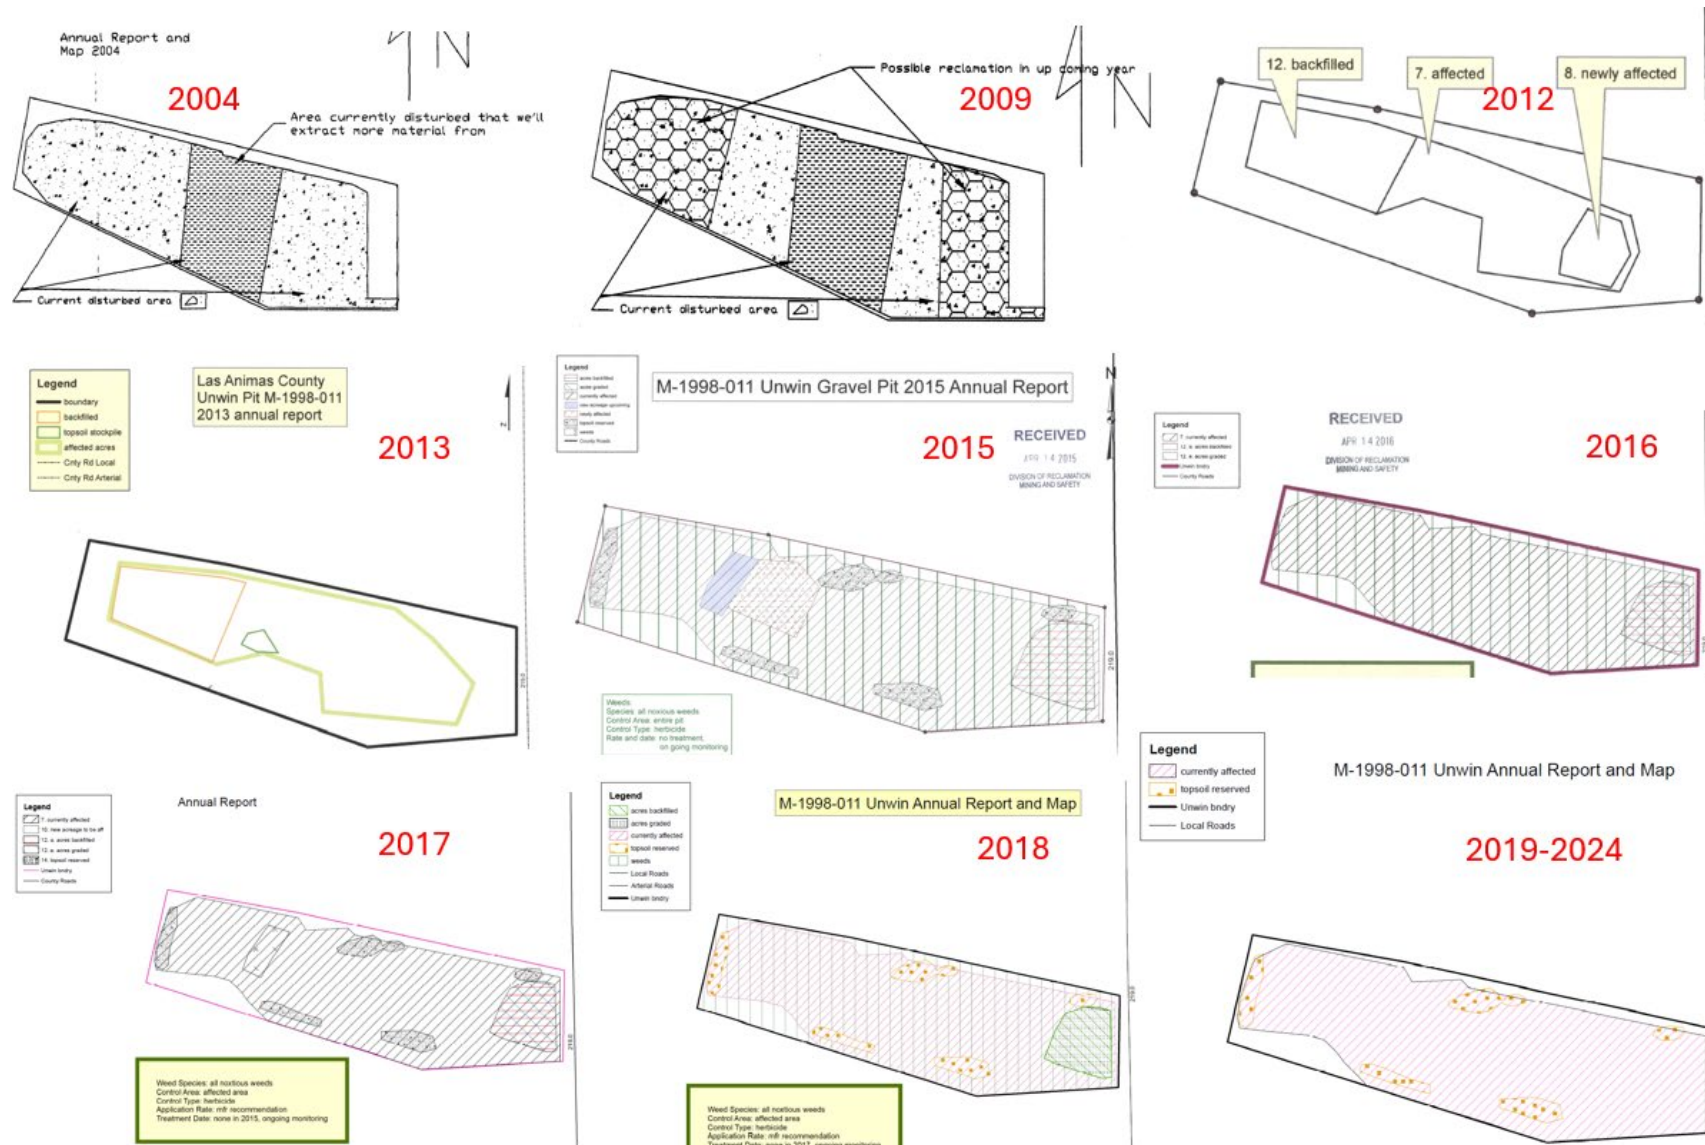
The Division found that the recent annual report maps appear to be inaccurate. The topsoil locations depicted on the 2019-2024 inspection report maps submissions appear to be inaccurate when compared with aerial imagery and field observations (see the topsoil section below). **Please update the topsoil locations on the 2025 annual report submittal for the 2024 annual reporting period.**

Figure 2: Figure highlights how mining has been conducted across the site throughout the life of the permit as depicted by the Operator's annual report maps. The full maps for those included in the figure above are enclosed with this report. In summary: Mining extended from west to east. The west and east sides have been partially backfilled and graded. Mining intends to re-disturb all of the current disturbance by mining deeper, according to the maps. Since 2017, five topsoil piles have been located around the site, but the topsoil pile on the west side (see Figure 1 above) appears to no longer exist.
