STATE OF
COLORADO

Bowie #1 inspection report for Feb 2025

Permit Number: C-1981-038 Mine Name: Bowie No. 1 Mine Operator: Bowie Resources, LLC Operator Address: Mr. Basil R Bear P.O. Box 1488 Paonia, CO 81428	County: Delta Operation Type: Underground Permit Status: Active Ownership: Private
	Operator Representative Present: None
Operator Representative Signature: (Field Issuance Only)

Inspection Start Date: February 20, 2025 Inspection Start Time: 09:50 Inspection End Date: February 20, 2025 Inspection End Time: 11:30		Inspection Type: Coal Complete Inspection Inspection Reason: Normal I&E Program Weather: Cloudy	
Joint Inspection Agency: None		Joint Inspection Contacts: 	
Post Inspection Agency: None		Post Inspection Contacts: 	
Inspector(s): Robert Zuber, P.E.	Inspector's Signature:

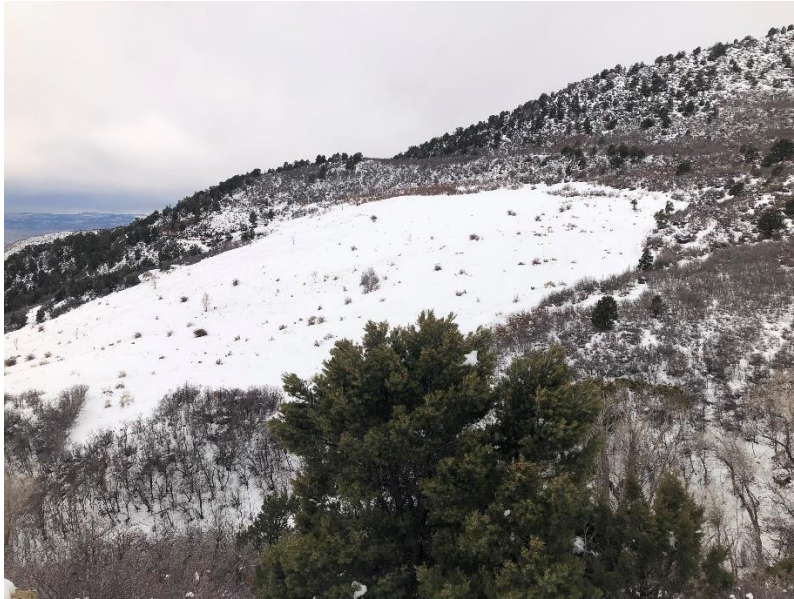
No erosion was seen at the West Mine, including the reclaimed road.

West Mine – road along north side

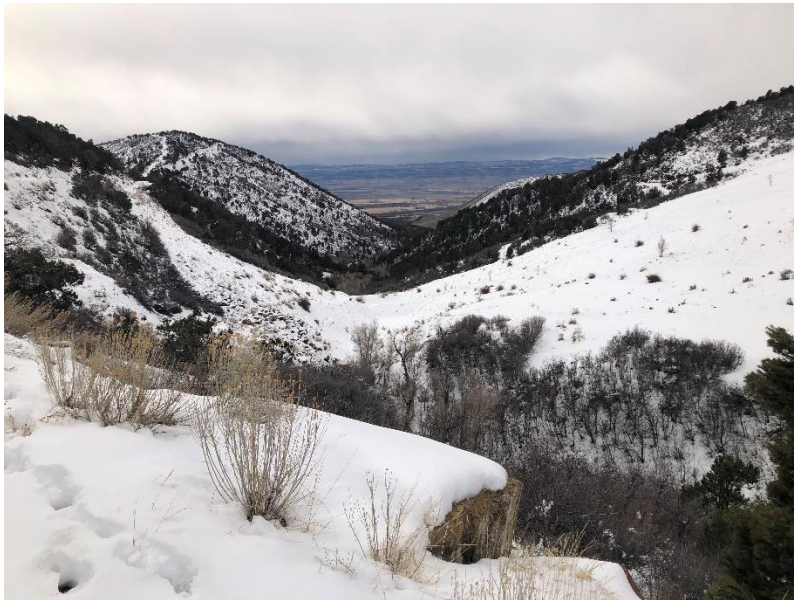
The ponds at the loadout and the Coal Storage Area (near Black Bridge Road and the highway) contained no water. The ponds at the West Mine contained several inches of snow. No discharge was observed. No problems were identified with embankments, spillways, or other aspects of these ponds.

West Mine ponds

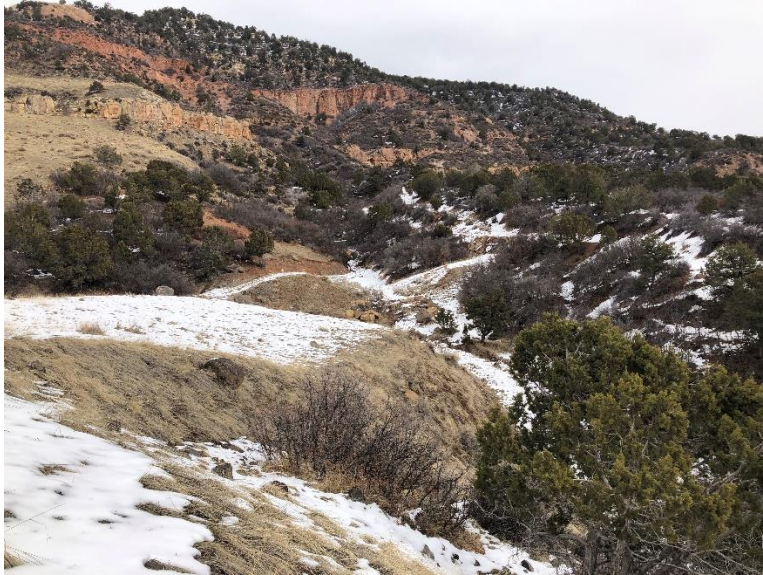
No problems were identified with the reclamation in the area of Ponds 1, 2, 3, and 4 (East Mine).

Reclaimed Pond 1 at East Mine

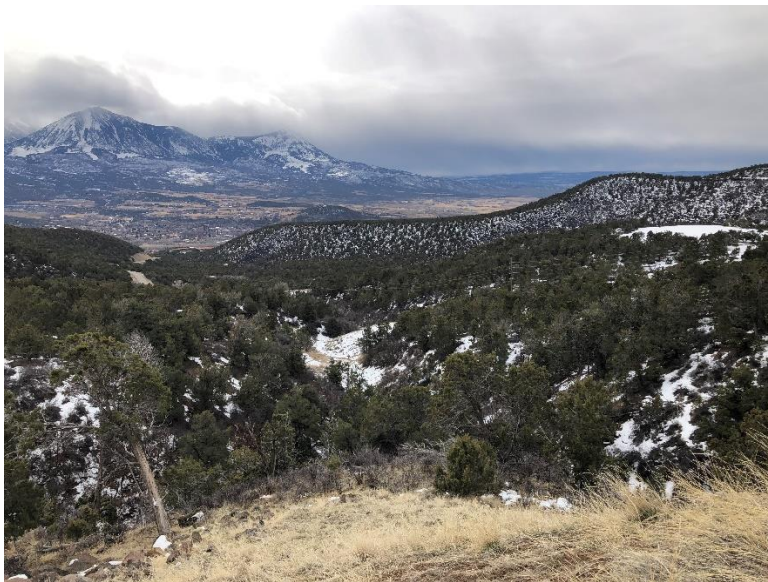
Area near reclaimed Ponds 3 and 4 at East Mine

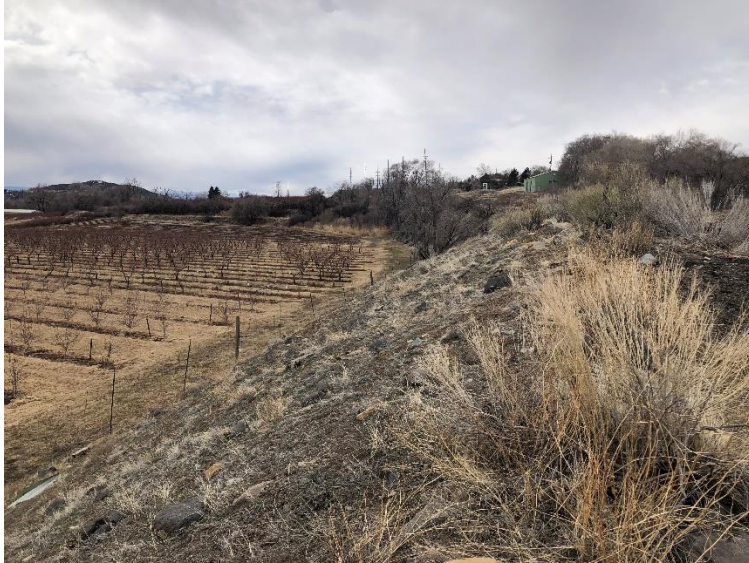
No erosion was seen at the loadout, including the steep slope between the loadout and the orchard below. The trestle across the river appears stable.

Loadout slope above orchard

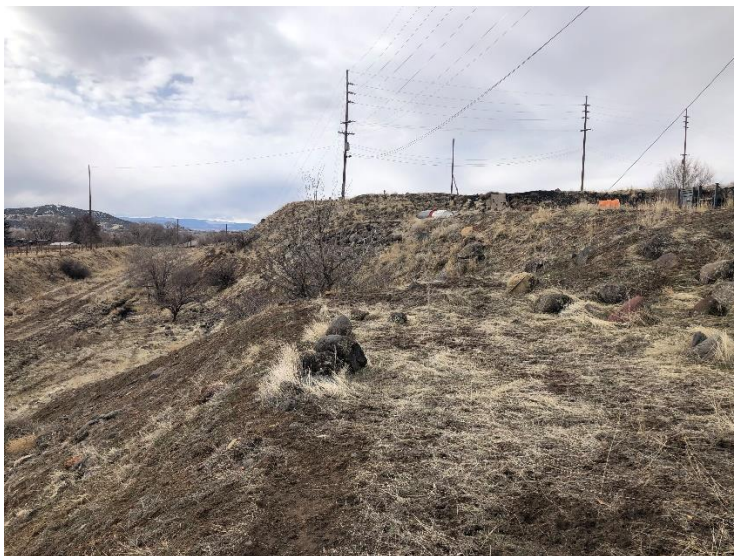
Slope near southwest corner of loadout
