### MINERALS PROGRAM INSPECTION REPORT

<b>MINE NAME:</b> Orphan View Gravel Pit	<b>MINE/PROSPECTING ID#:</b> M-2013-016	<b>MINERAL:</b> Borrow material for construction, gravel and sand	<b>COUNTY:</b> Huerfano
<b>INSPECTION TYPE:</b> Monitoring	<b>WEATHER:</b> Clear	<b>INSP. DATE:</b> February 13, 2025	<b>INSP. TIME:</b> 12:50
<b>OPERATOR:</b> Huerfano County	<b>OPERATOR REPRESENTATIVE:</b> Dustin Hribar	<b>TYPE OF OPERATION:</b> 112c - Construction Regular Operation

The Orphan View Gravel Pit was inspected by Amber Gibson with the Division of Reclamation, Mining and Safety (Division/DRMS). The inspection was completed as part of the Division's routine monitoring inspection program. The site was previously inspected by the Division on October 7, 2020 as part of an acreage release request. Dustin Hribar (representing the Operator - Huerfano County) accompanied me during the inspection. The weather was cool and the sky was clear.

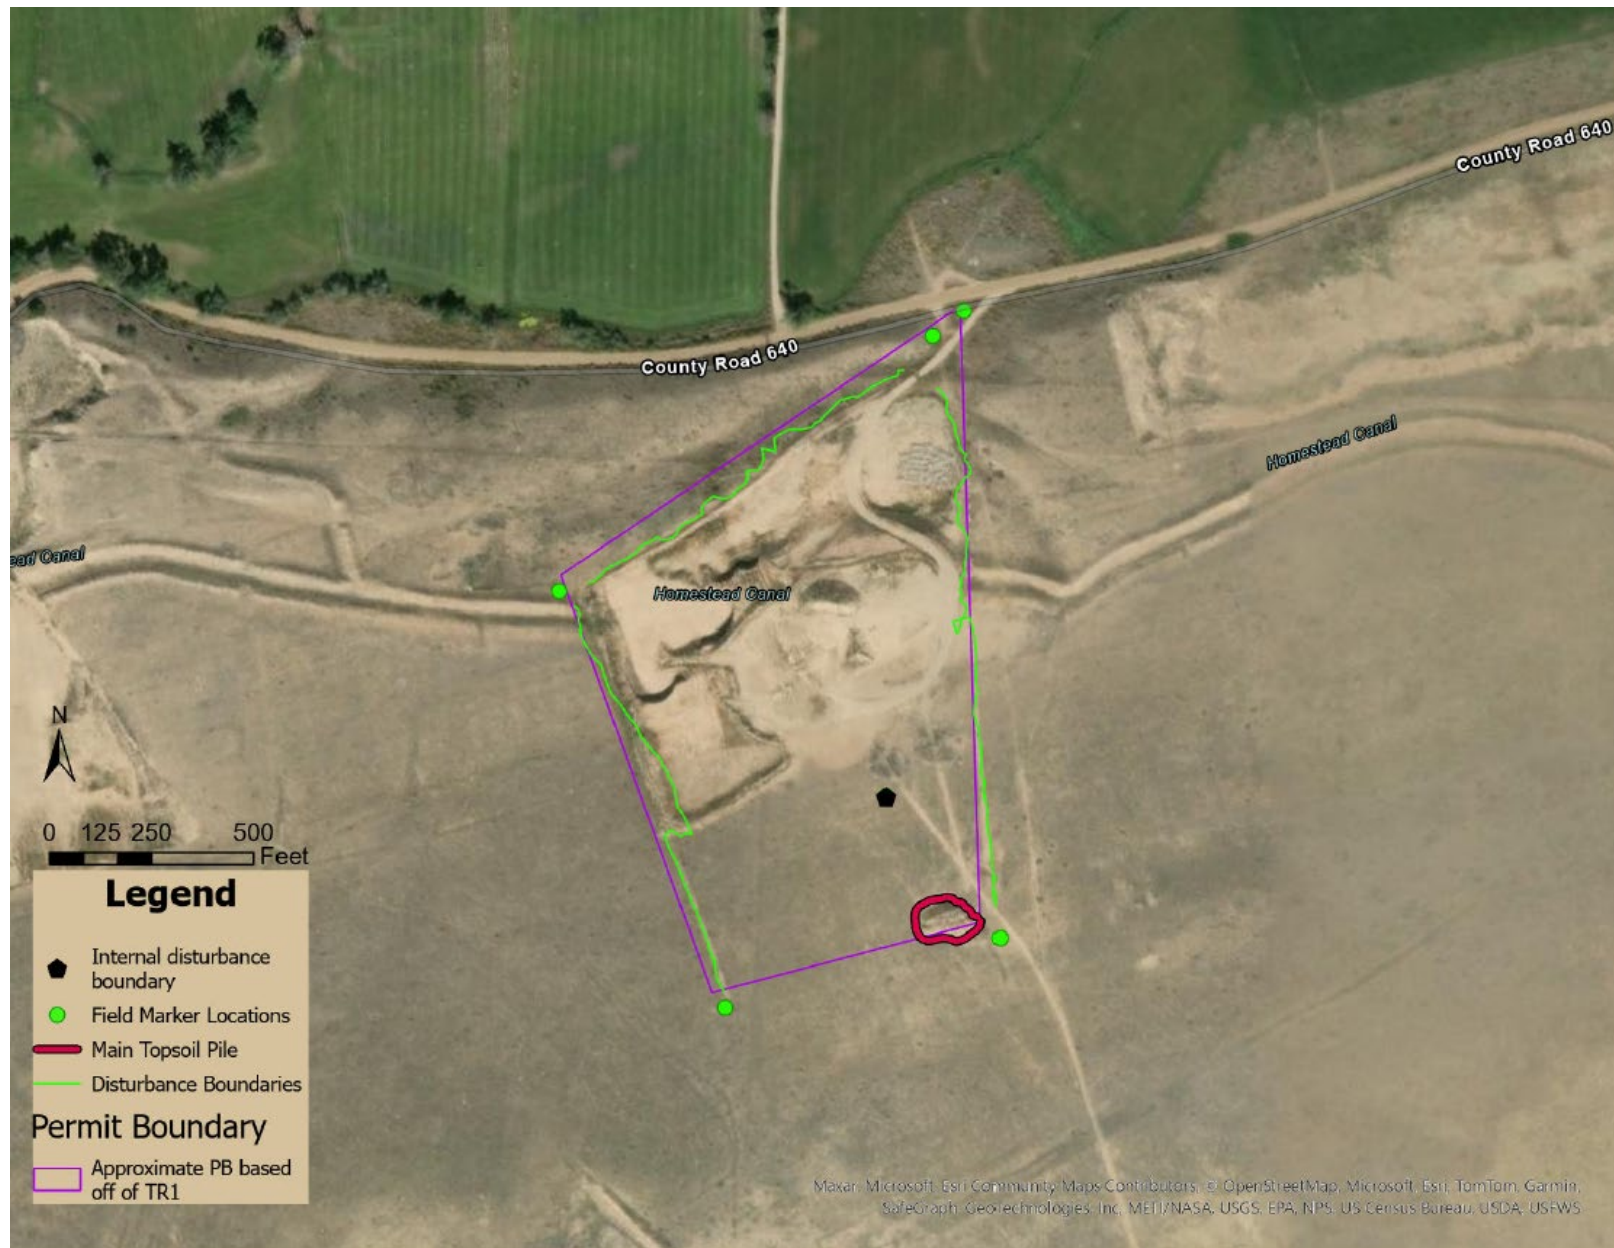
Lastly, when looking at aerial imagery, it appears that sometime between September 2013 and September 2019, a new entrance to the site was being utilized. This entrance can be seen on the aerial images included with the TR1 maps and in recent imagery Map 1. The original entrance extends directly south from County Road 640 into the pit via a pre-existing road (Figure 1). The new entrance is approximately 83 feet east of the old entrance and enters the pit at a northeast to southwest orientation (Photos 14-15). The new entrance is located within the same parcel as the rest of the mining operation. When asked about the new road, the Operator stated that there is a pipe that runs underneath the original entrance, and to prevent damage to it, the new entrance was created.

**Map 1:** Inspection map generated in ArcGIS Pro for the February 13, 2025 inspection of the Orphan View Gravel Pit, permit no. M-2013-016. The features included on the map were collected using the Esri Field Maps application during the inspection. The permit boundary shown is based off the coordinates provided with TR1.

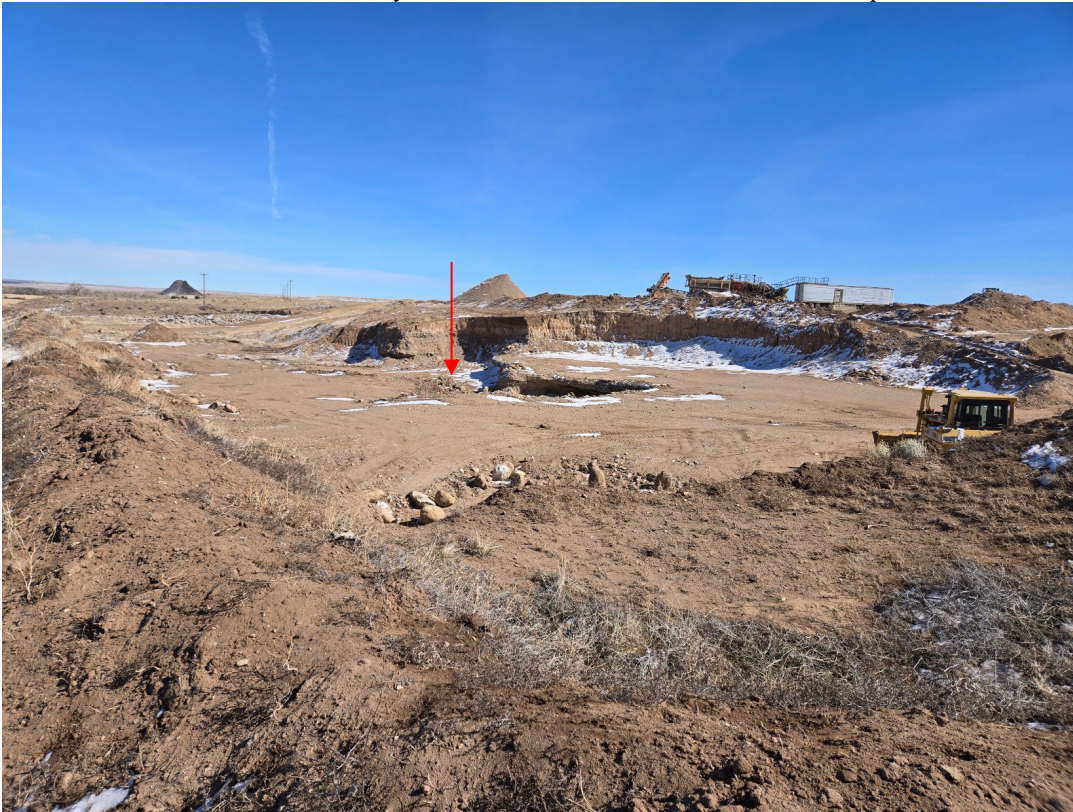
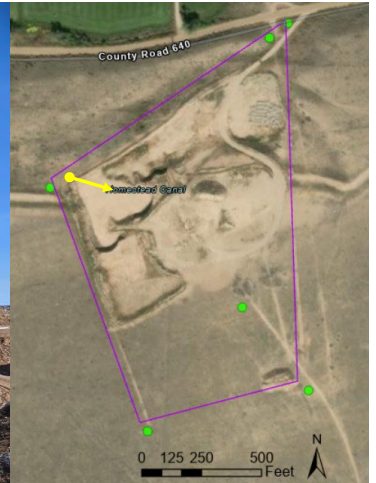
Mining at this site had originally been at a depth of about 12' that was limited to the location of a bedding plane consisting of dense clay/sandy material that was difficult to dig past (Photo 3). Now, equipment has been used on the northern side of the pit that can break through this plane to reach the material below to reach a depth around 15'. Additionally, once broken and allowed to be exposed to the elements, the material from the thick plane can be broken up and incorporated with the product. The Operator stated that right now, the plan is to continue southward at the shallower depth and possibly go back through at the deeper depth in the future. The approved mine plan states that the depth of the deposit ranges from 12 feet to about 18 feet deep. Therefore, the depth of the pit is in compliance with the approved mining plan.

**Photo 1:** Looking across the pit floor at the 12' depth. The arrow points to where mining has gone to a depth of about 15'.

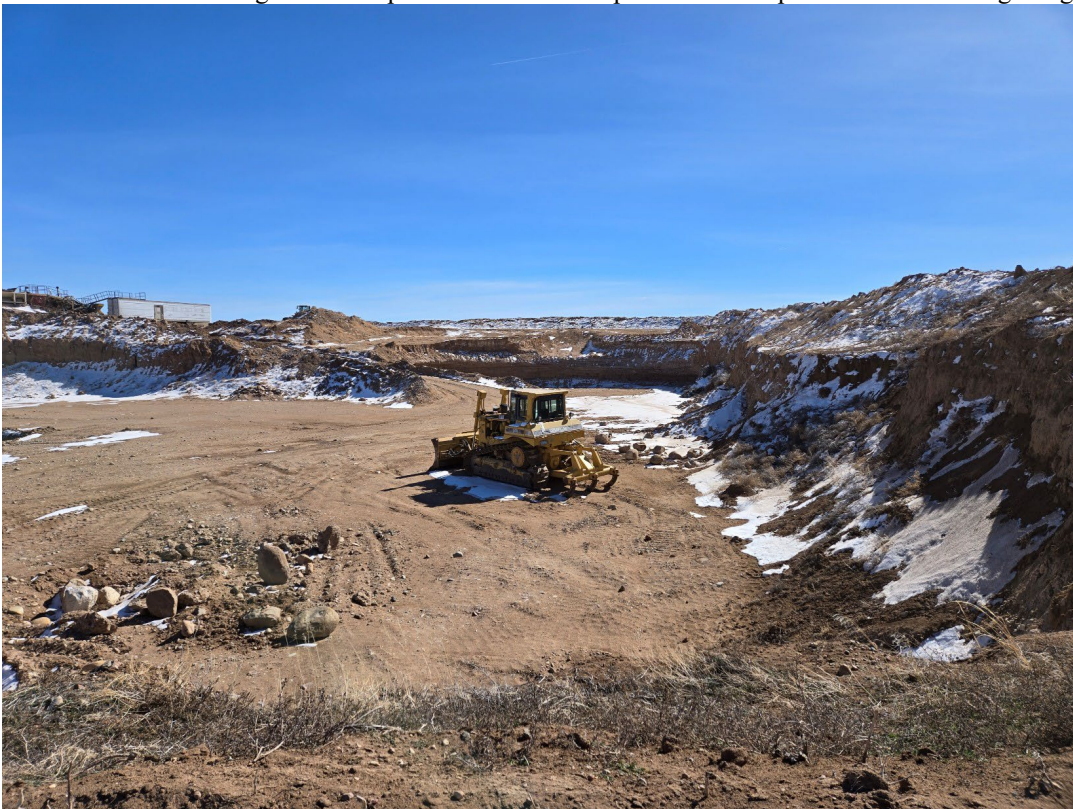
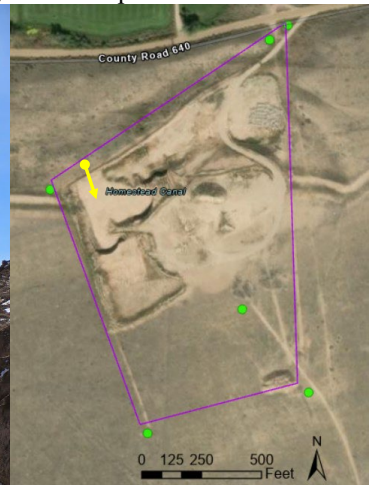
Mining at this site has extended from the northeast corner to the northwest corner, and is gradually moving south (Photos 1-3). Currently, the processing area is located on the south side of the pit. Some portable equipment, and a product stockpile, was observed onsite at the time of the inspection (Photos 4-6). There is a topsoil pile located in the southeast corner of the permit boundary. The Operator has created a low earthen berm along the west and part of the eastern boundary to delimitate the edges of the permit (Photo 7 and Photo 12). There is an abandoned canal, the Homestead canal, that runs east to west through the northern side of the pit (Photo 8). During the inspection, an area in the northeast corner of the site held a lot of broken-up concrete material (Photos 9-10). The Operator stated that the concrete was from another project, is only temporarily being stored onsite, and will be hauled off soon to be used for riprap on another project.

**Photo 2:** Looking south across the pit in the direction that mining is currently proceeding.

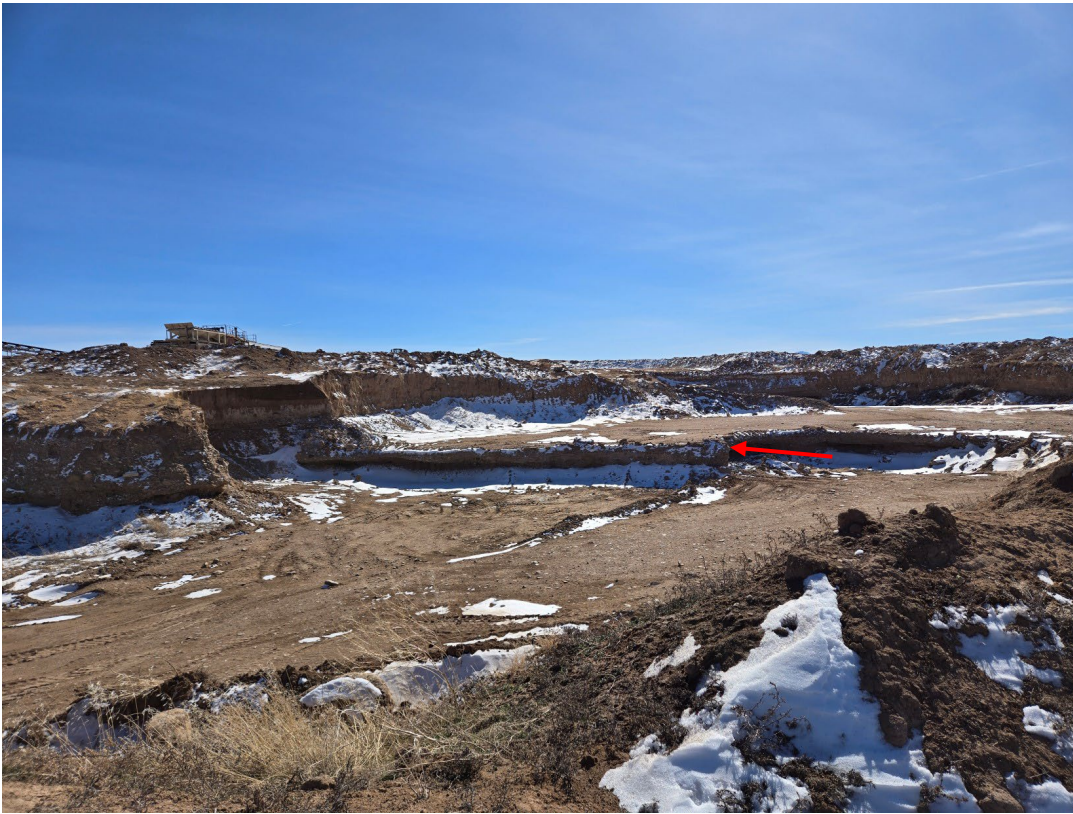
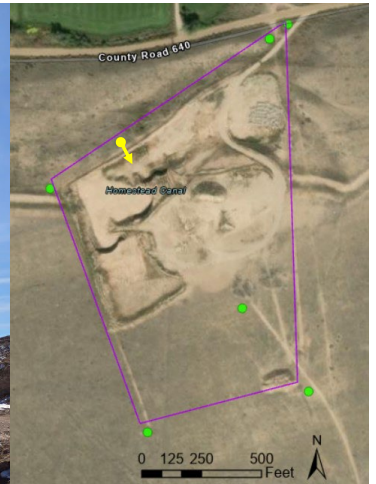
**Photo 3:** The arrows point to the bedding plane of dense material that has been dug through in the northern portion of the pit.

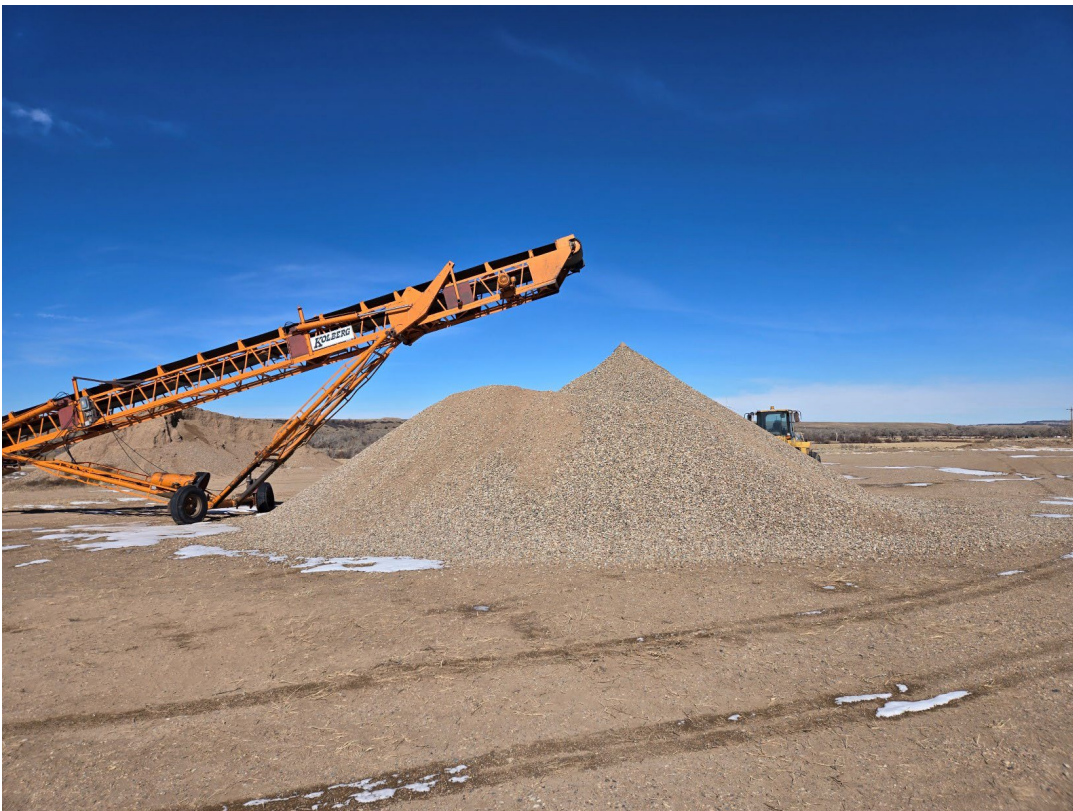
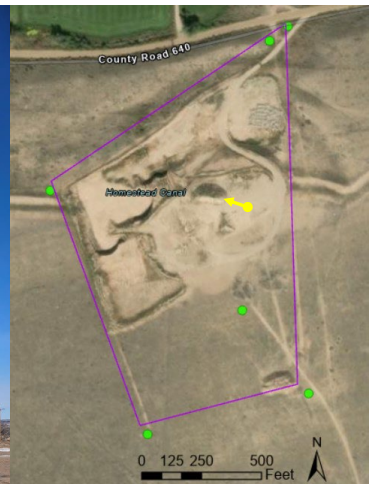
**Photo 4:** Product stockpile within the processing area.

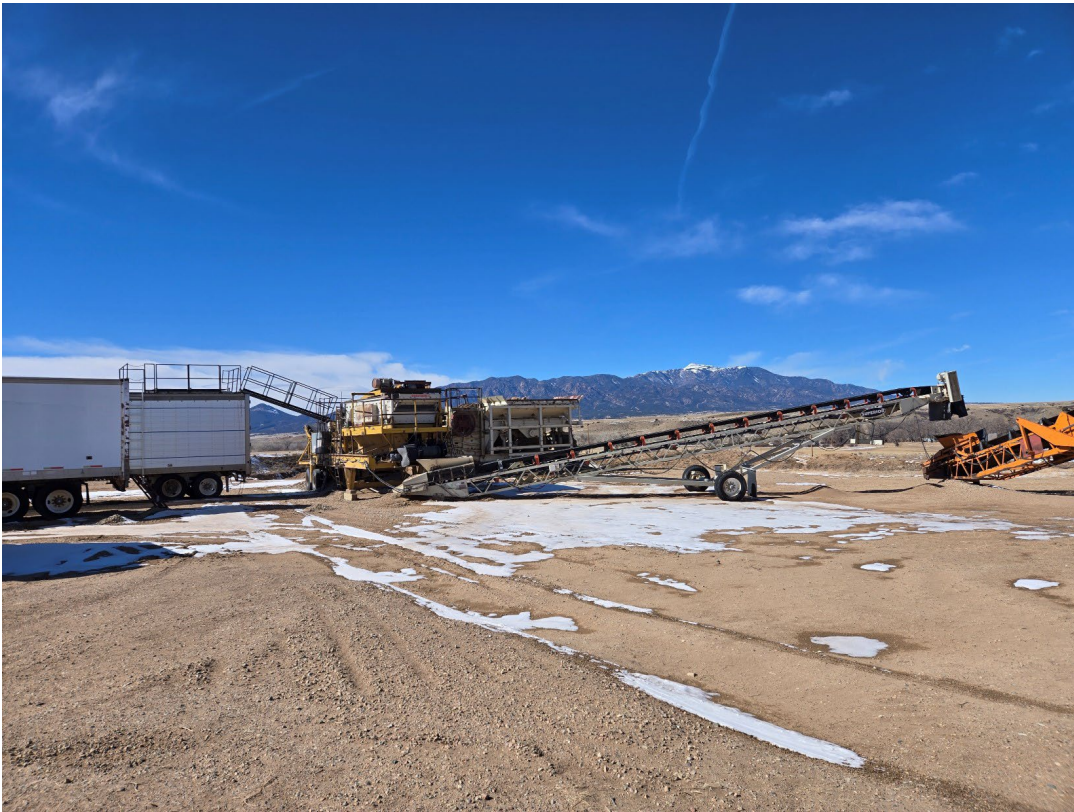
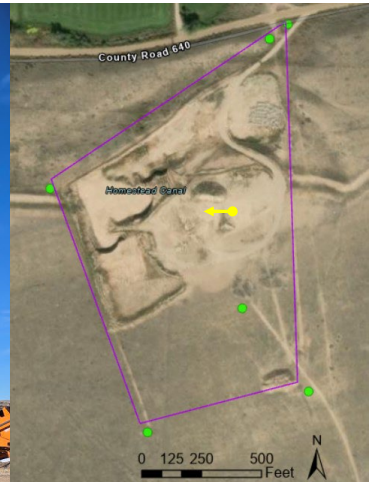
**Photo 5:** Equipment within the processing area.

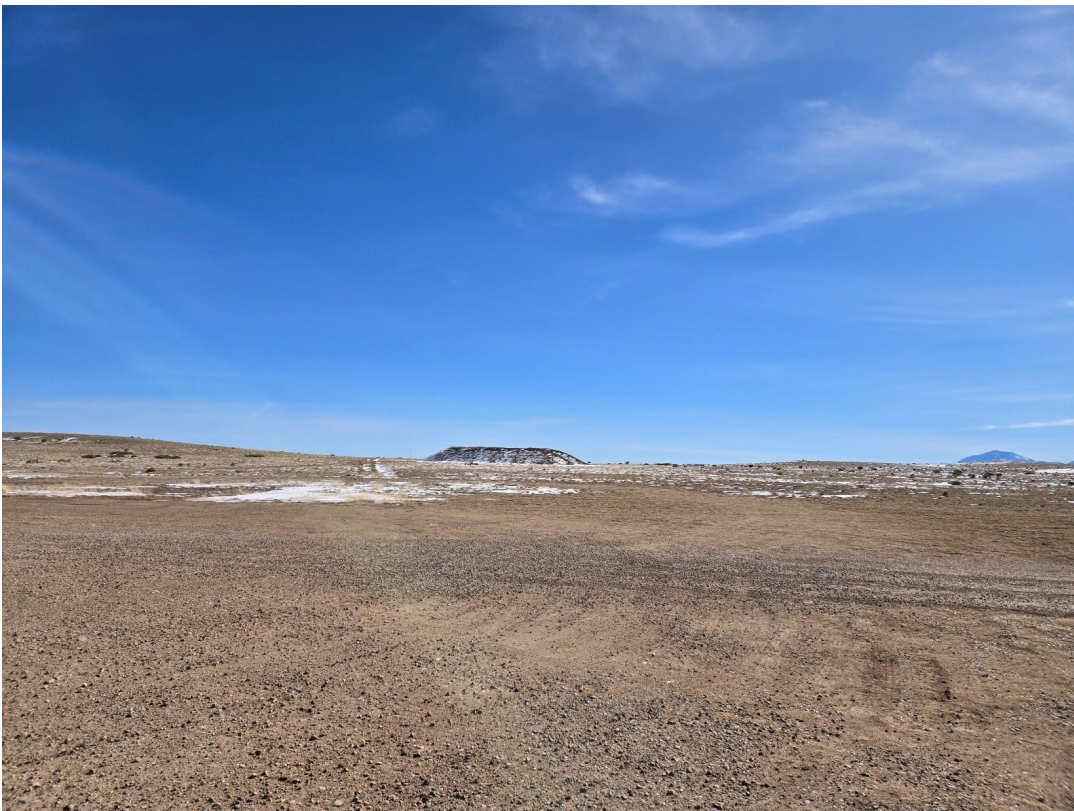
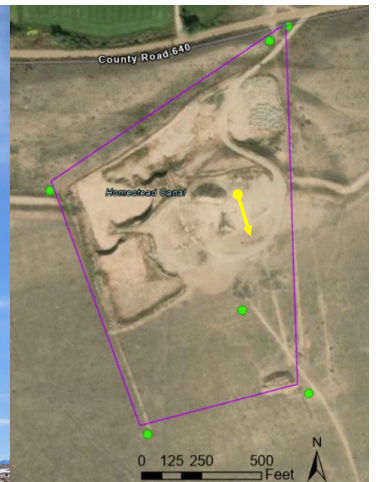
**Photo 6:** Looking southeast at the end of the truck turn around area.

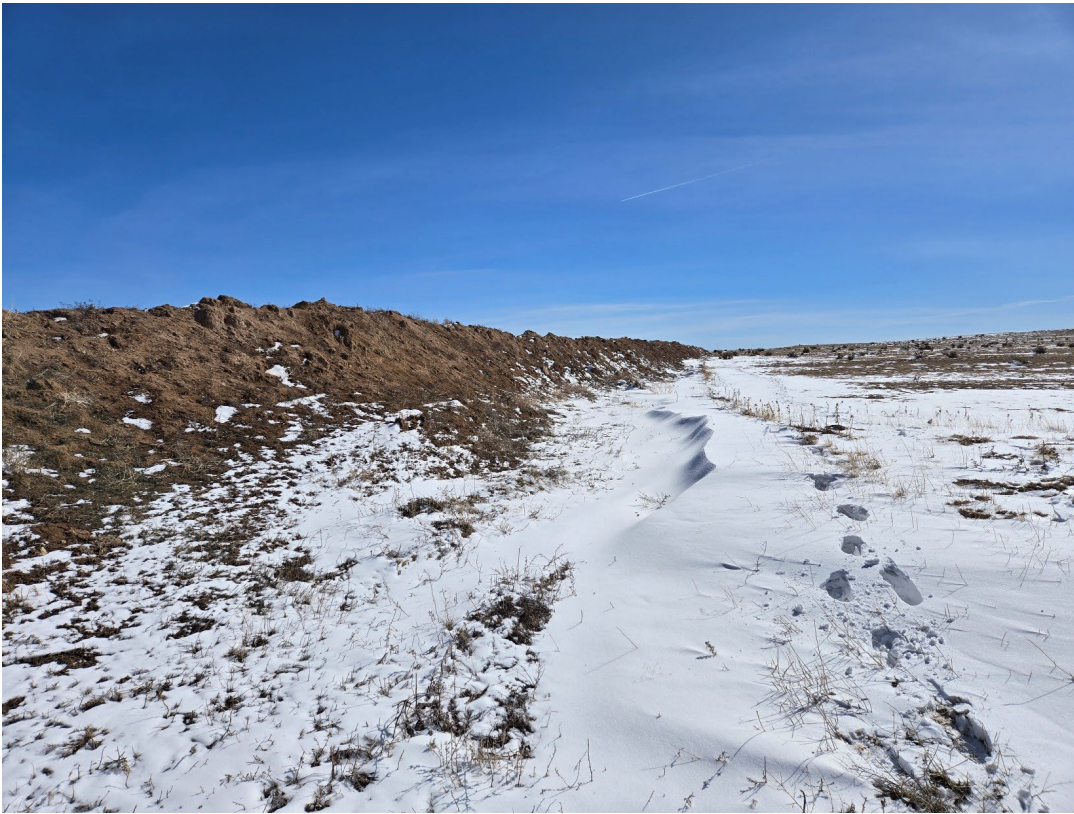
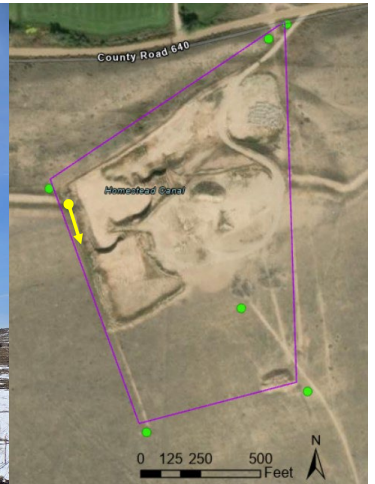
**Photo 7:** Looking south along the berm lining the west side of the permit boundary.

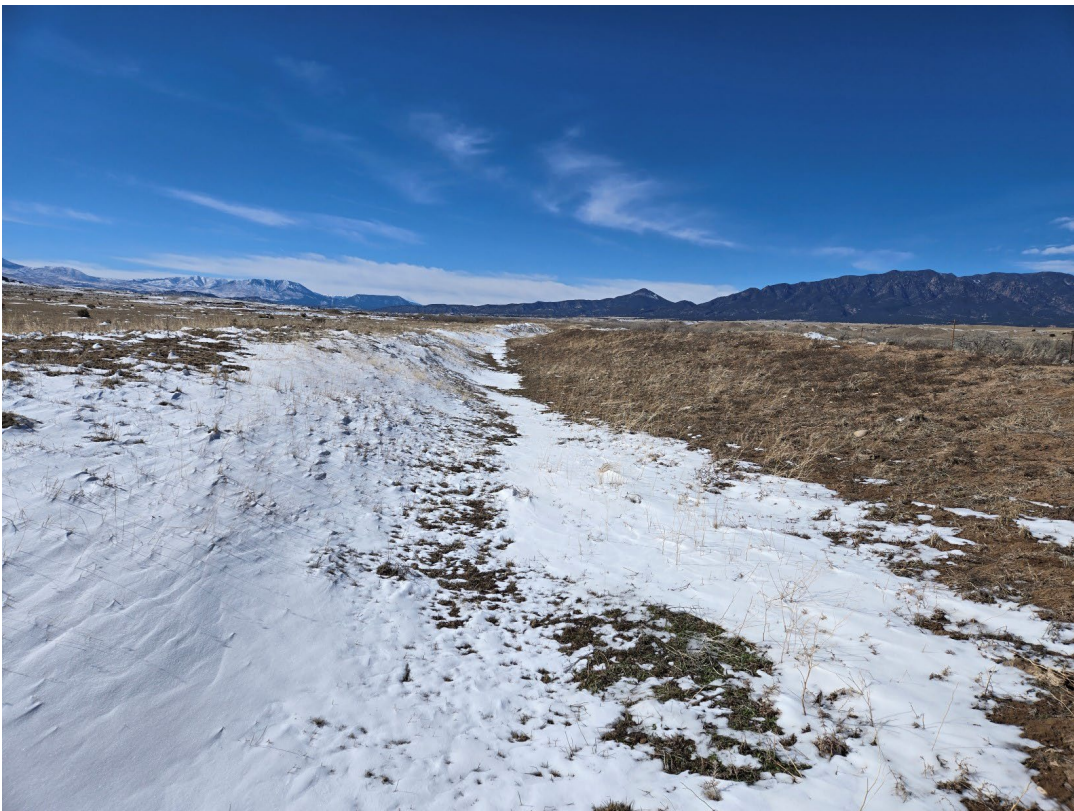
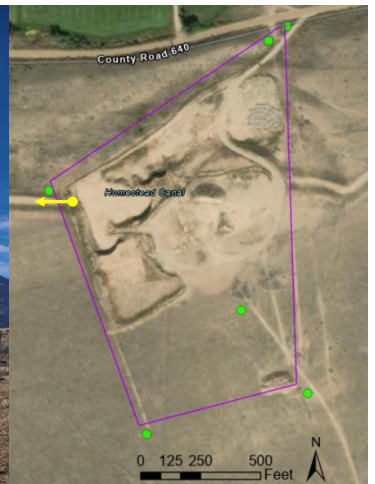
**Photo 8:** Looking east along the abandoned Homestead Canal.

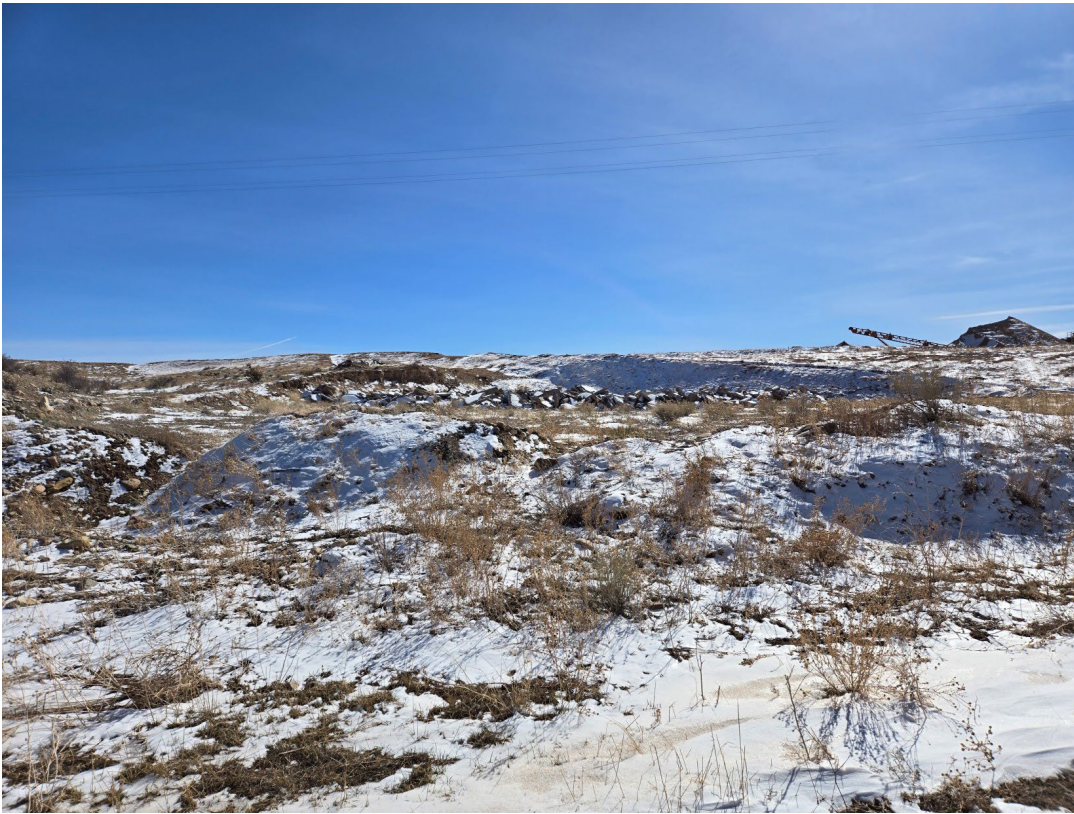
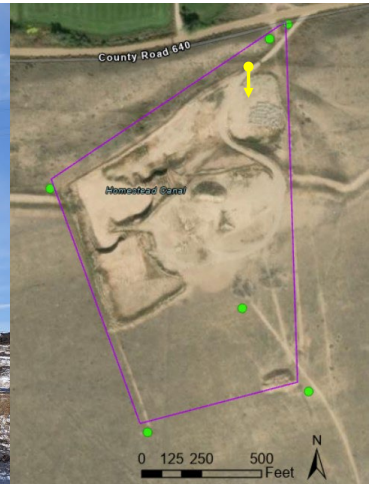
**Photo 9:** Looking south at the basin in the northeast portion of the permit area that is temporarily storing concrete material.

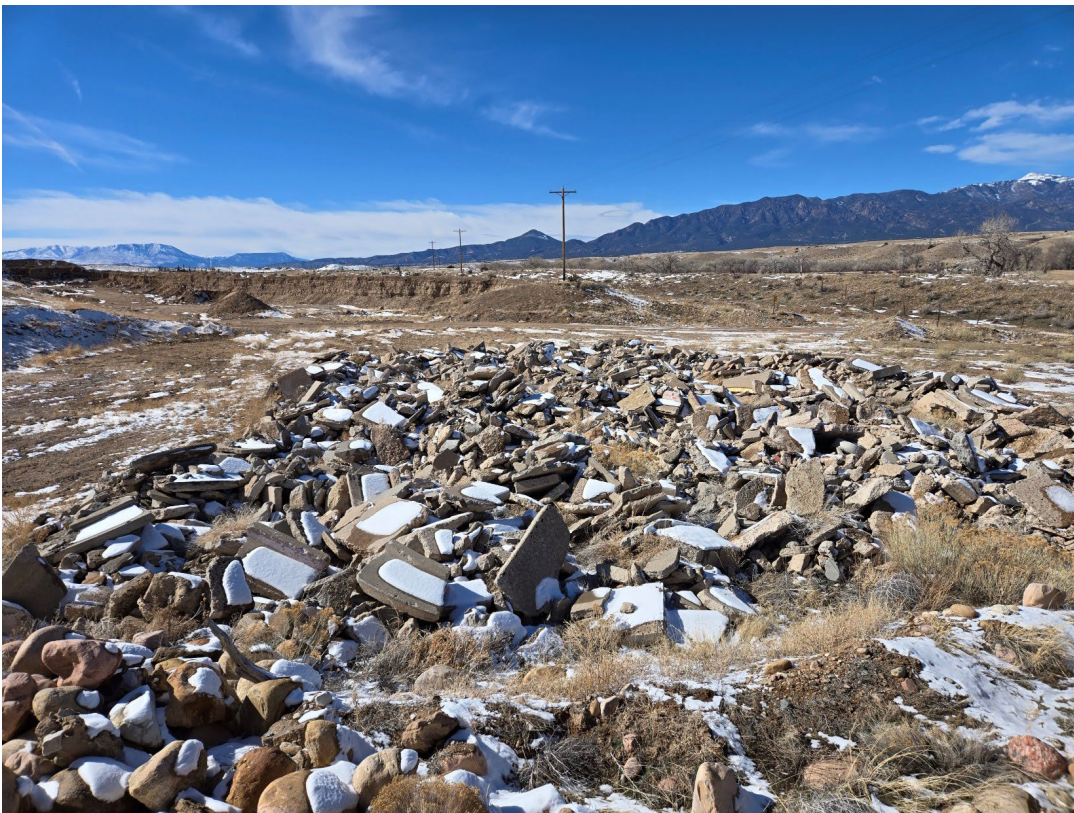
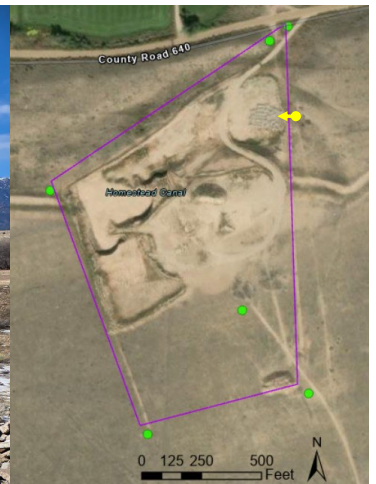
**Photo 10:** Looking west at the basin in the northeast portion of the permit area that is temporarily storing concrete material.

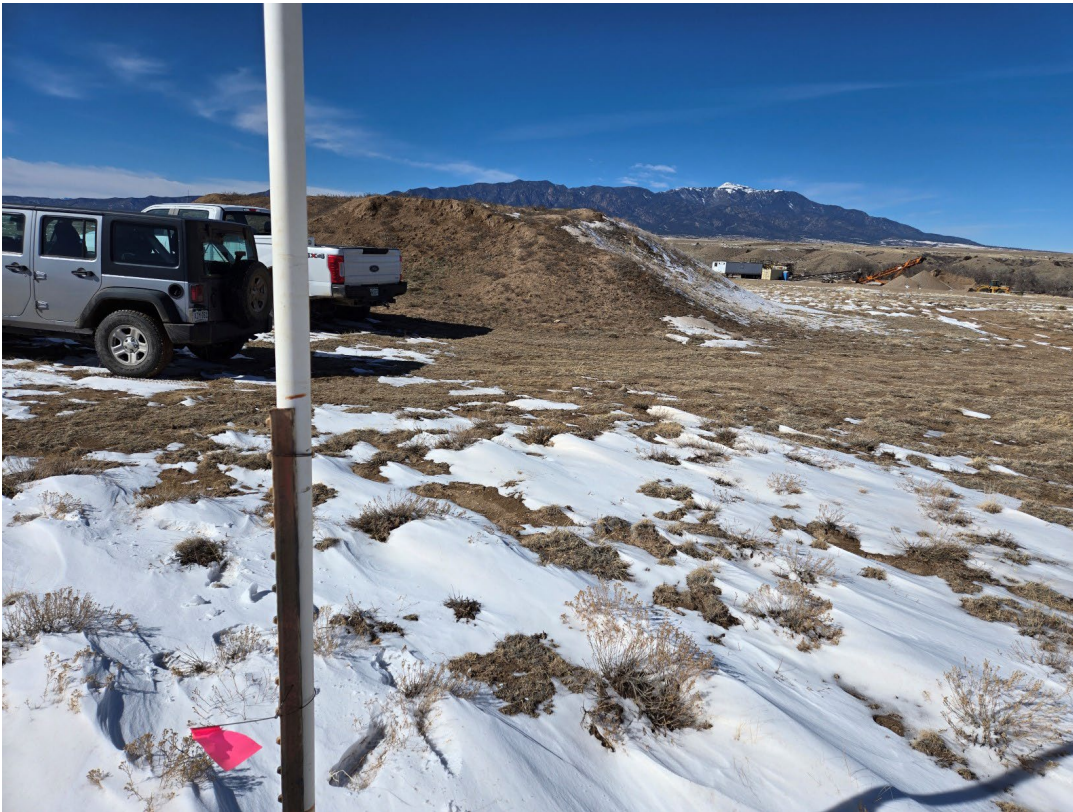
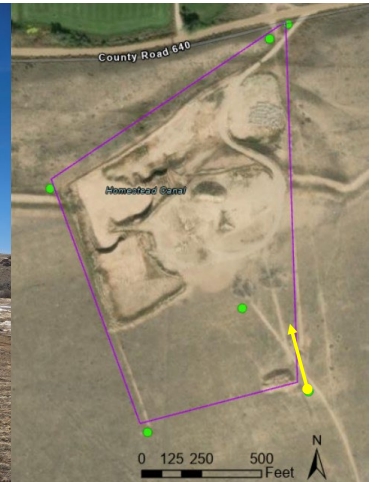
**Photo 11:** Looking northwest at the southeast permit boundary marker.

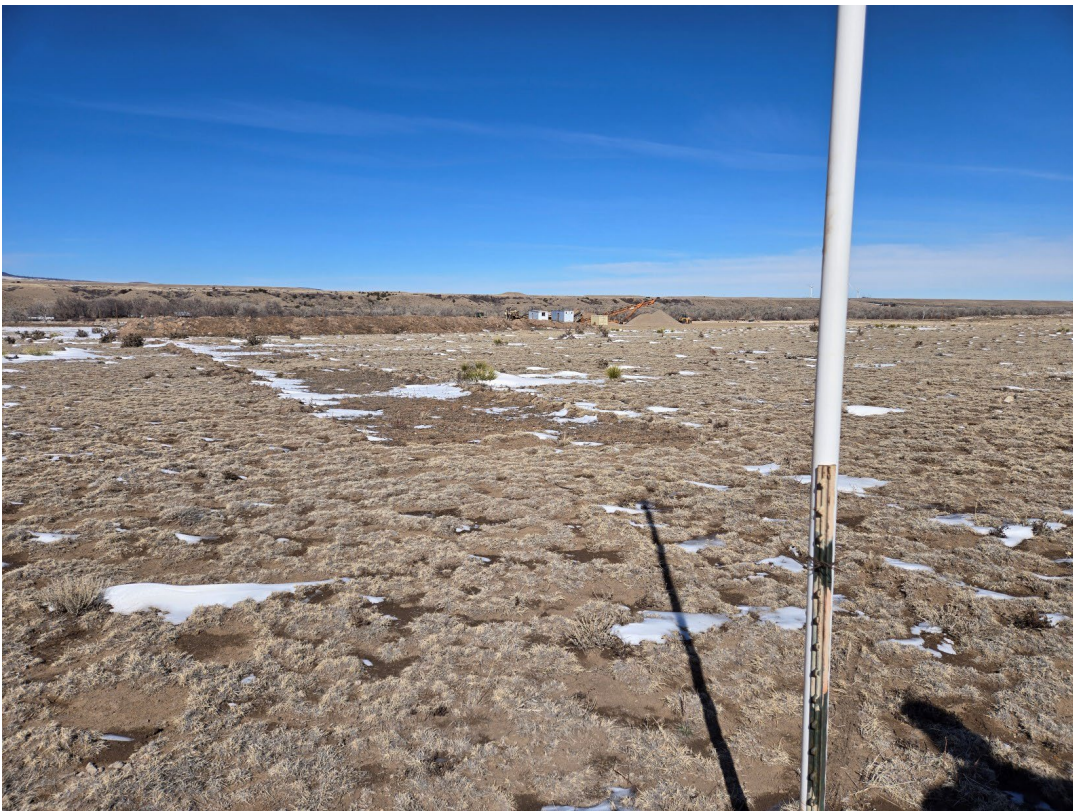
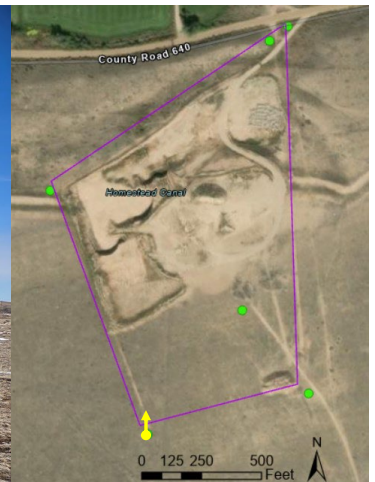
**Photo 12:** Looking northeast at the southwest permit boundary marker. The low earthen berm lining the west side of the permit boundary is shown in this photo.

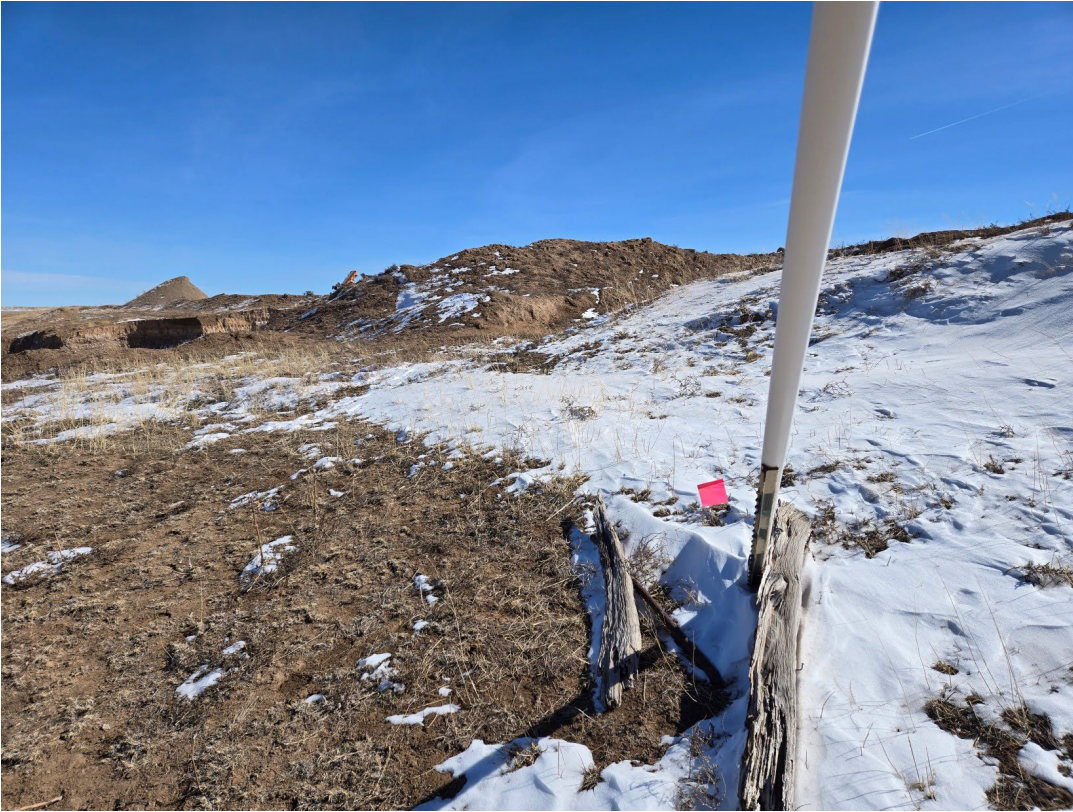
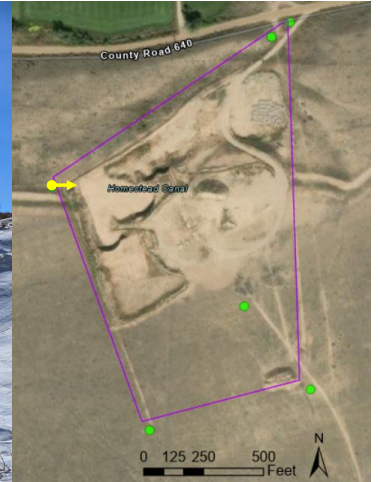
**Photo 13:** Looking southeast at the northwest permit boundary marker.

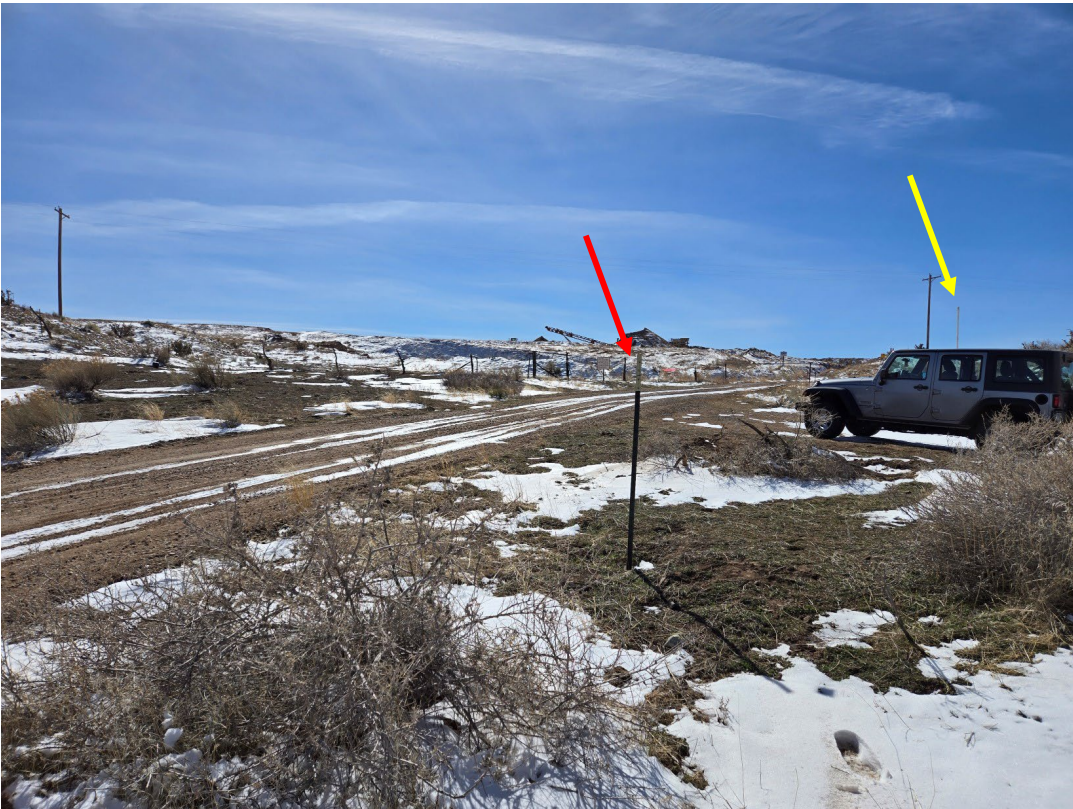
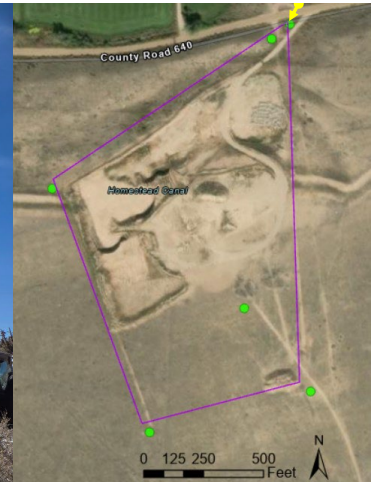
**Photo 14:** The red arrow points to the northeast permit boundary marker. The yellow arrow points to the north permit boundary marker.

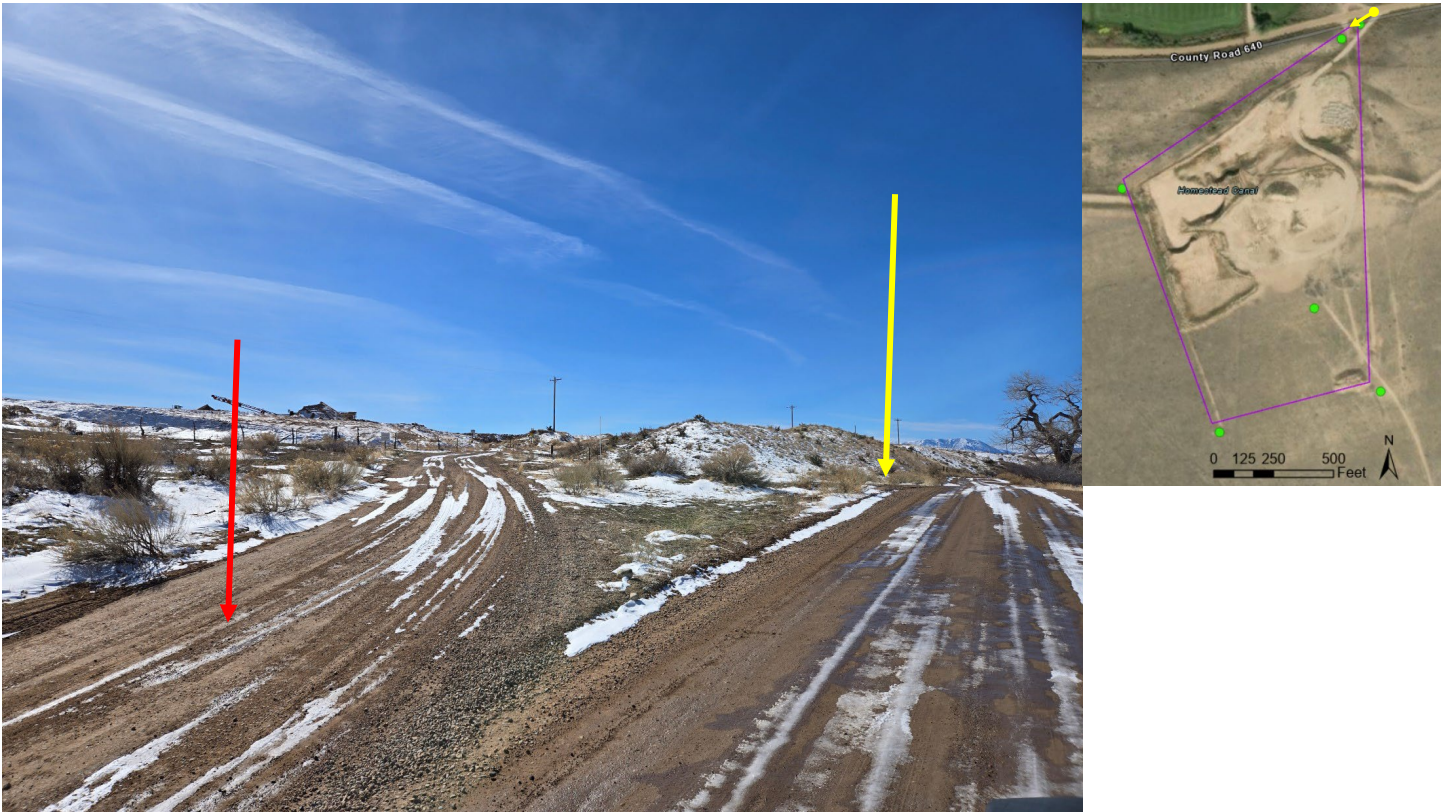
**Photo 15:** The red arrow points to the new entrance. The yellow arrow points to the original permitted entrance.

Due to the various issues highlighted above, this has collectively been **cited as a problem**. Because these issues are due both to mistakes made by the Operator and by the Division, this shall be remedied through a Technical Revision. The Operator shall submit a Technical Revision application that provides updated mining and reclamation plan maps where the permit boundary matches the boundary in the field, with the exception of the

entrance location. The entrance road must be included within the permit boundary. The permit boundary shall equal the approved 16.8 acres. Additionally, because highwalls are present onsite, but are not included in the current mining plan, the mining exhibit shall be updated to reflect current operations and how the mining at the site is planned to be conducted moving forward. A technical revision application with the required changes shall be received by the Division by the corrective action date.

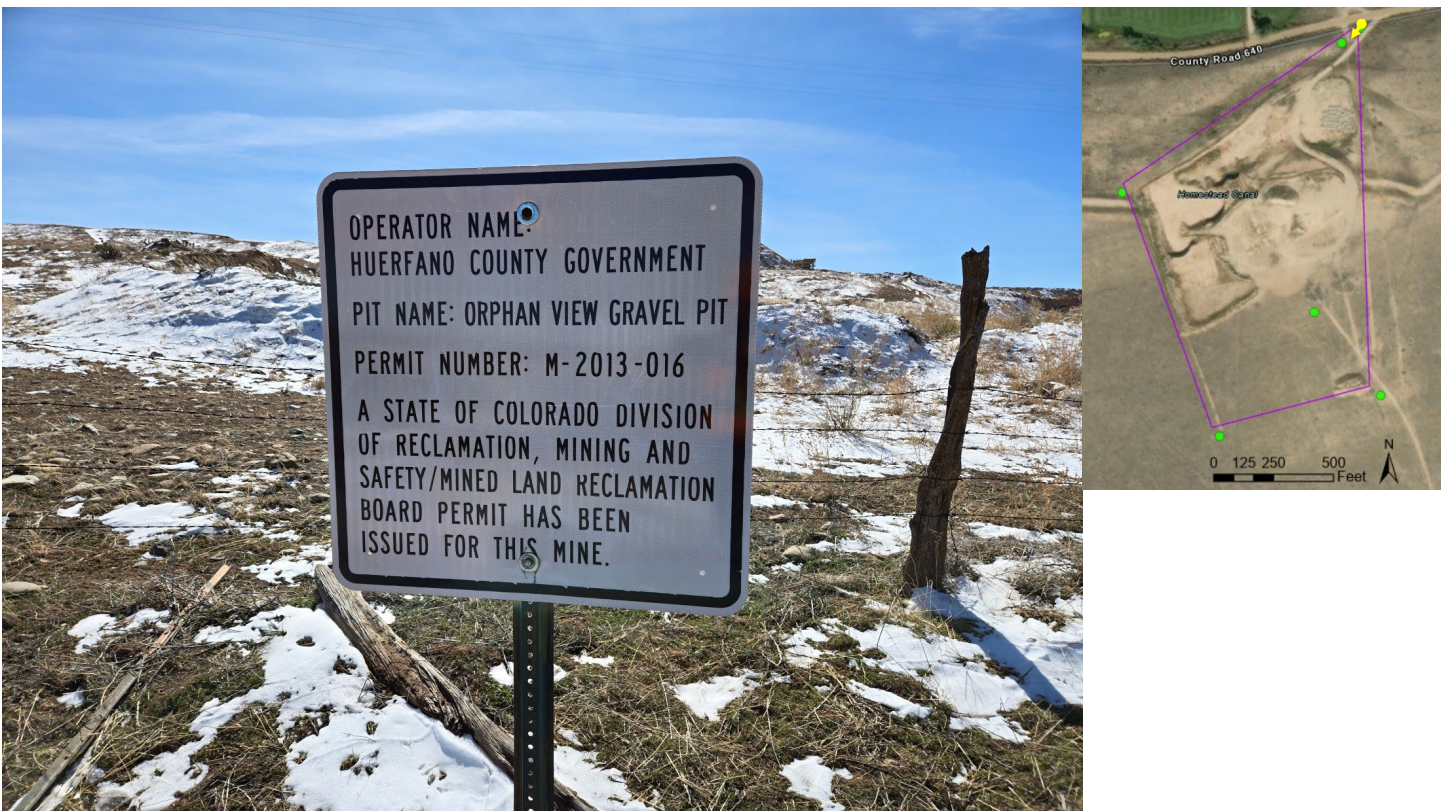
A mine sign was posted at the entrance to the site (Photo 16) in compliance with Rule 3.1.12(1).

**Photo 16:** Mine sign posted at the entrance gate to the site.

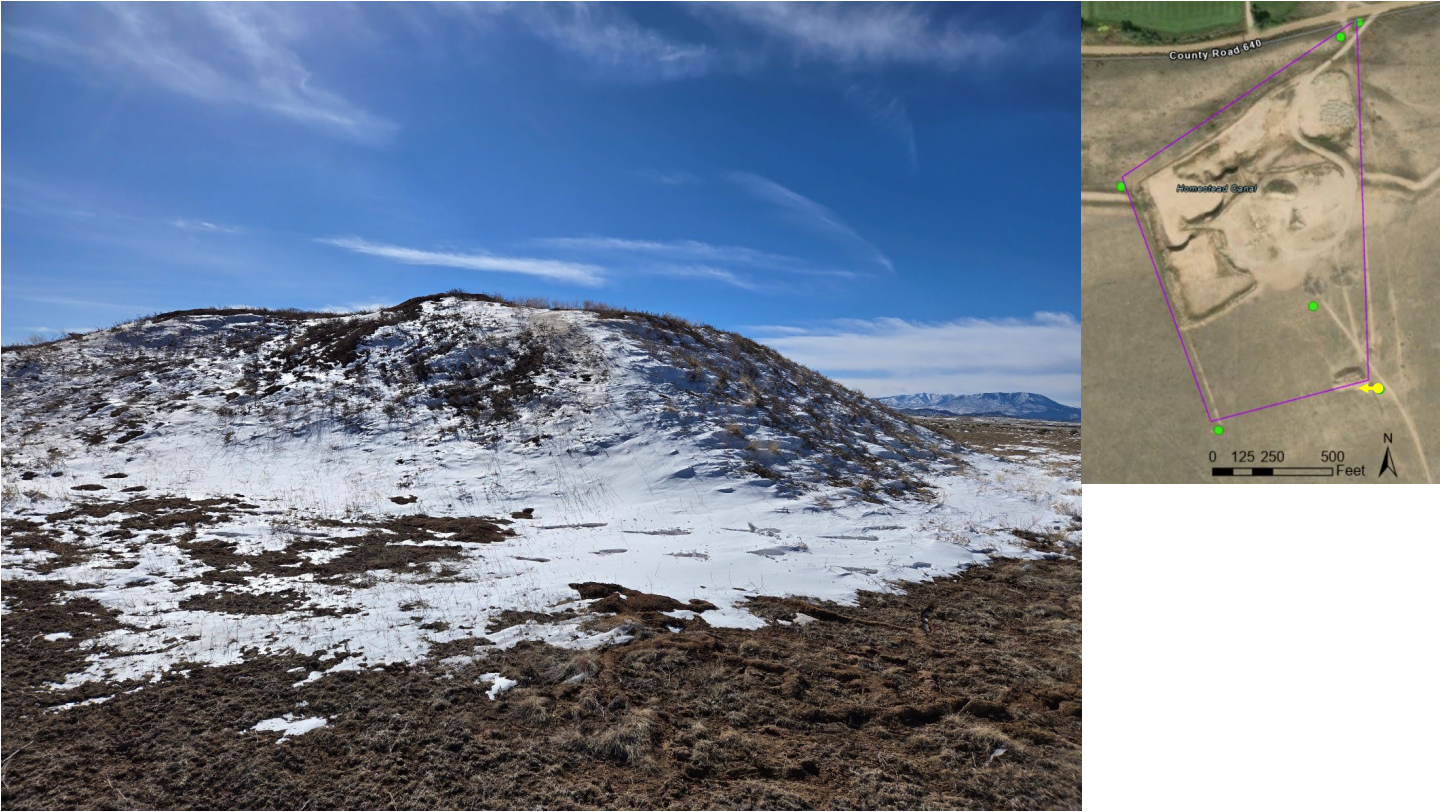
A topsoil stockpile is located at the southeast corner of the site (Photo 17). Additional smaller topsoil piles were observed above and behind the pit walls within the current disturbance. The Operator stated that there is an abundance of available topsoil at this site. The topsoil piles appeared to be stable at this time.

**Photo 17:** Main topsoil pile located in the southeast corner of the site.
