### MINERALS PROGRAM INSPECTION REPORT

<b>MINE NAME:</b> Orphan View Gravel Pit	<b>MINE/PROSPECTING ID#:</b> M-2013-016	<b>MINERAL:</b> Borrow material for construction, gravel and sand	<b>COUNTY:</b> Huerfano
<b>INSPECTION TYPE:</b> Monitoring	<b>WEATHER:</b> Clear	<b>INSP. DATE:</b> February 13, 2025	<b>INSP. TIME:</b> 12:50
<b>OPERATOR:</b> Huerfano County	<b>OPERATOR REPRESENTATIVE:</b> Dustin Hribar	<b>TYPE OF OPERATION:</b> 112c - Construction Regular Operation

The Orphan View Gravel Pit was inspected by Amber Gibson with the Division of Reclamation, Mining and Safety (Division/DRMS). The inspection was completed as part of the Division's routine monitoring inspection program. The site was previously inspected by the Division on October 7, 2020 as part of an acreage release request. Dustin Hribar (representing the Operator - Huerfano County) accompanied me during the inspection. The weather was cool and the sky was clear.

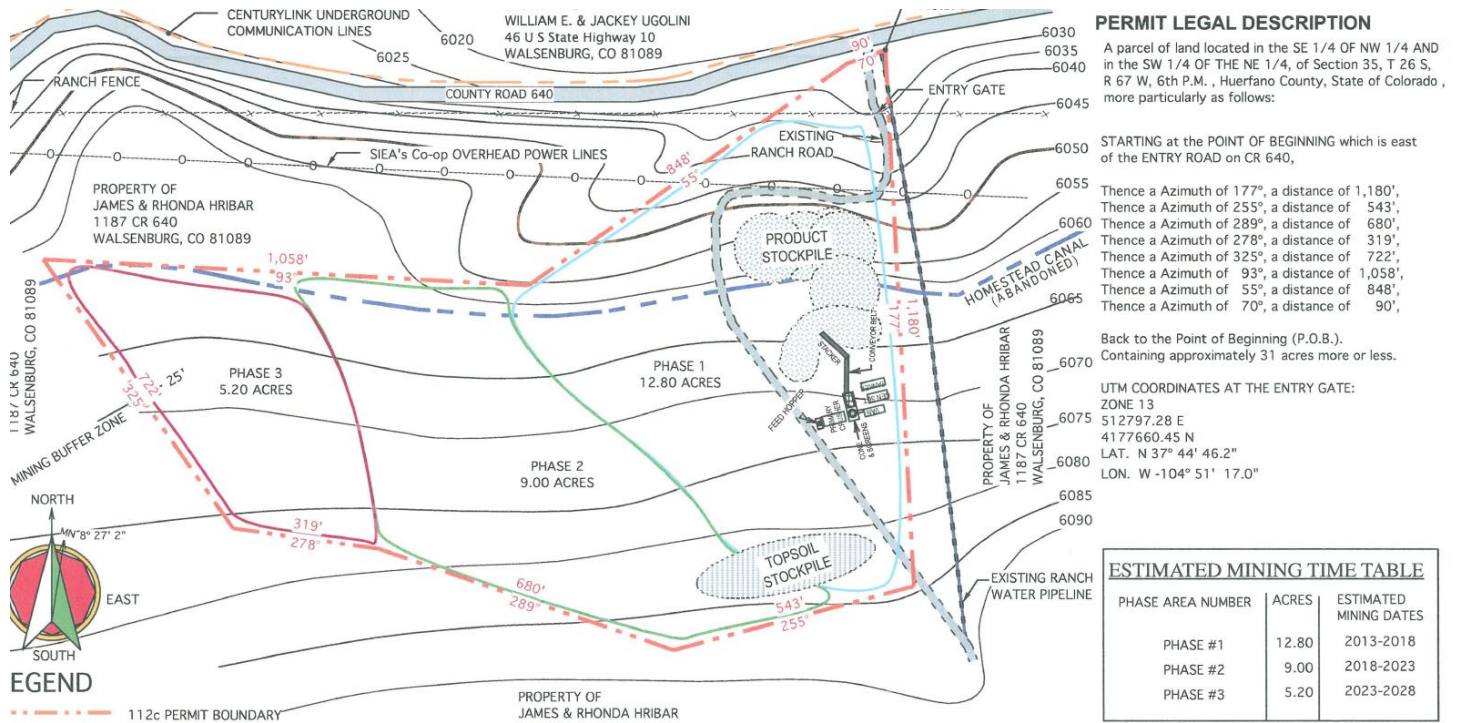
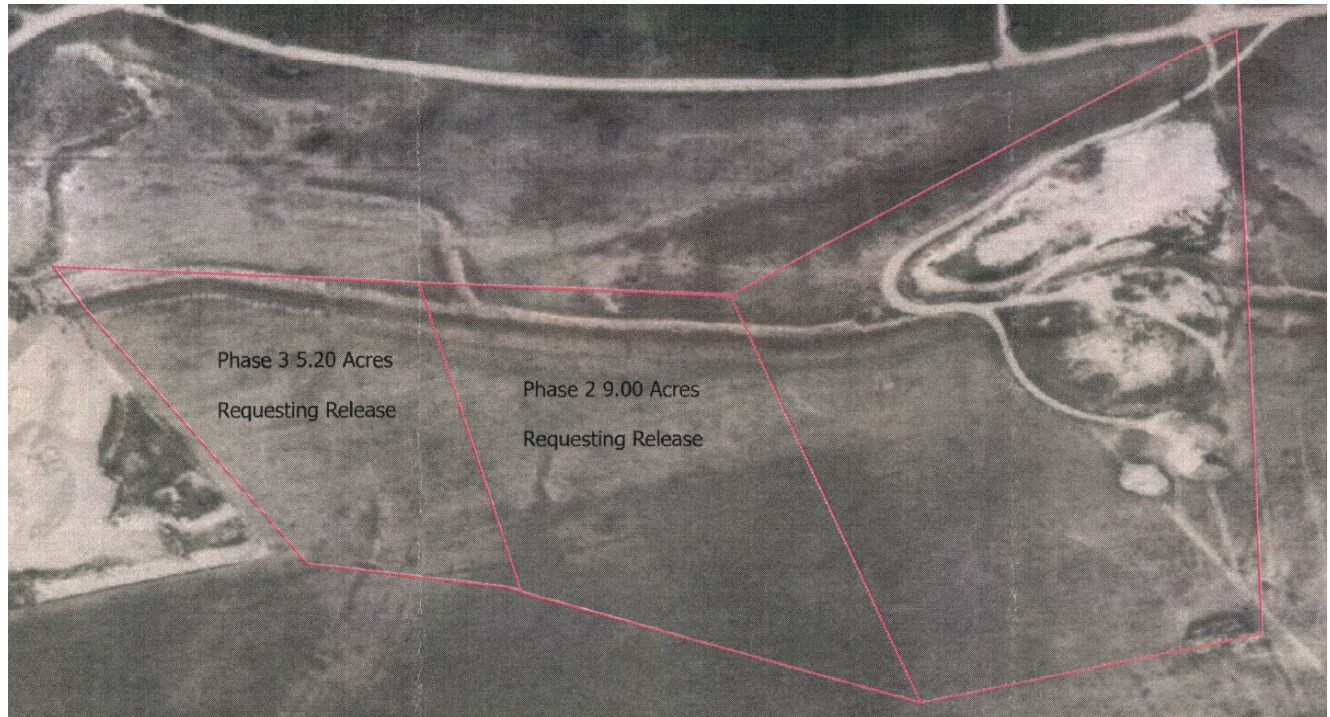
During the pre-inspection permit review, a few discrepancies were identified that occurred during the AR1/TR1 process. First, the shape of the phase boundaries were simplified on the acreage release description map submitted with TR1 (see Figure 1). Also, the phases were assumed to equal the acreages shown for each phase on the original mining plan map (Figure 1). However, the acreages shown on the original mining plan map correspond with the estimated acres to be mined, which does not equal the total acreage at the site.

Per the original phasing (see Table 1 above) the total mining area within each phase totaled 27 acres. When AR1 was requested and subsequently approved, Phases 1 and 2 were assumed to total 14.2 acres, which was subtracted from the *total* acreage of 31 acres, to equal the current 16.8 acres. Due to the changes in the phase boundaries, and the misunderstanding with the mining and phase acreages, the current permit boundary as depicted on the new mining plan map submitted with TR1 encompasses less than 16.8 acres. On the TR1 map, coordinates were provided for the southeast, southwest, northwest, and partially northeast new corner markers (see the Operator's current mining map enclosed with this report). The longitude coordinate for the NE permit marker was cut-off and not included on the current map. However, based on the three coordinates included, and the aerial image included with the current map, the Division estimates that the current boundary depicted on the map equals approximately 16 acres. Additionally, of the 16.8 acres, 12.8 acres is still the approved acreage (reported on file) to be disturbed at any one time. Due to the change in shape, this no longer appears to correspond with the current operating plan.

**Figure 1:** (Top) Photo from the original mine plan map. The red solid line indicates the minable acreage in Phase 3, the green solid line indicates the minable acreage in Phase 2, and the light blue solid line indicates the mineable acreage in Phase 1. (Bottom) The acreage release reference map submitted with TR1, where the phase boundaries were unknowingly simplified/altered.

Due to the various issues highlighted above, this has collectively been **cited as a problem**. Because these issues are due both to mistakes made by the Operator and by the Division, this shall be remedied through a Technical Revision. The Operator shall submit a Technical Revision application that provides updated mining and reclamation plan maps where the permit boundary matches the boundary in the field, with the exception of the
