Roadside Portals Mine, C-1981-041, February Partial Inspection Report

PERMIT INFORMATION

Permit Number: C-1981-041 Mine Name: Roadside Portals Operator: Snowcap Coal Company, Inc Operator Address: Ms. Tonya Hammond P. O. Box 443 Grand Junction, CO 81502	County: Mesa Operation Type: Underground Permit Status: Active Ownership: Private
	Operator Representative Present: Tonya Hammond
Operator Representative Signature: (Field Issuance Only)

INSPECTION INFORMATION

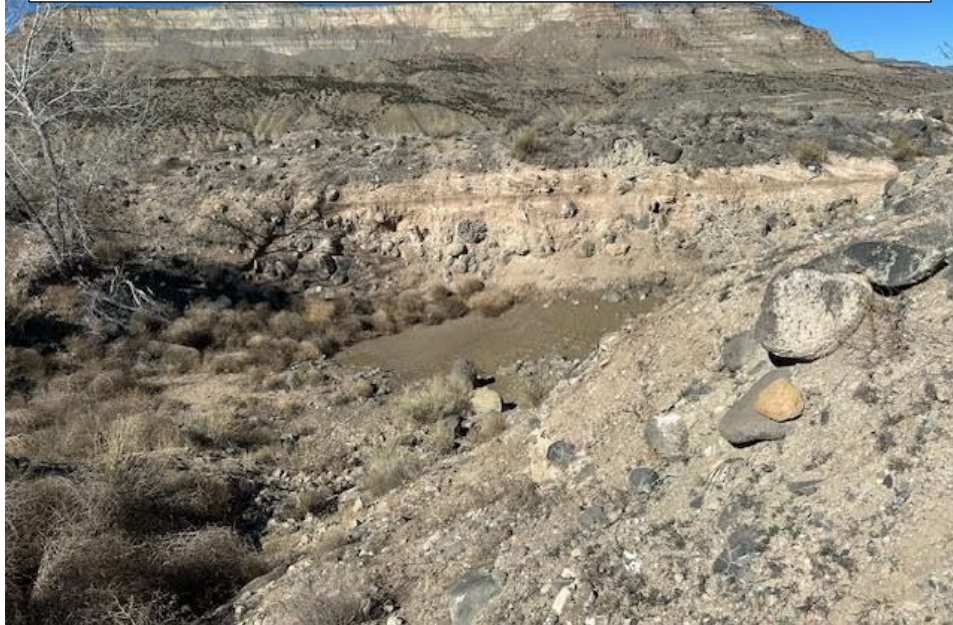
At the time of the inspection, the bottom of the Carey pit was muddy (Photo 1). The Carey pit is in the southwest corner of what is commonly referred to as Tract 71. This area is touching the southwestern permit boundary. The inlet from the landowner's buried pipeline into the pit was dry. There was no indication of recent water application to the open trench (Photo 2).

Photo 1: Looking west from the permit boundary to the Carey Pit.

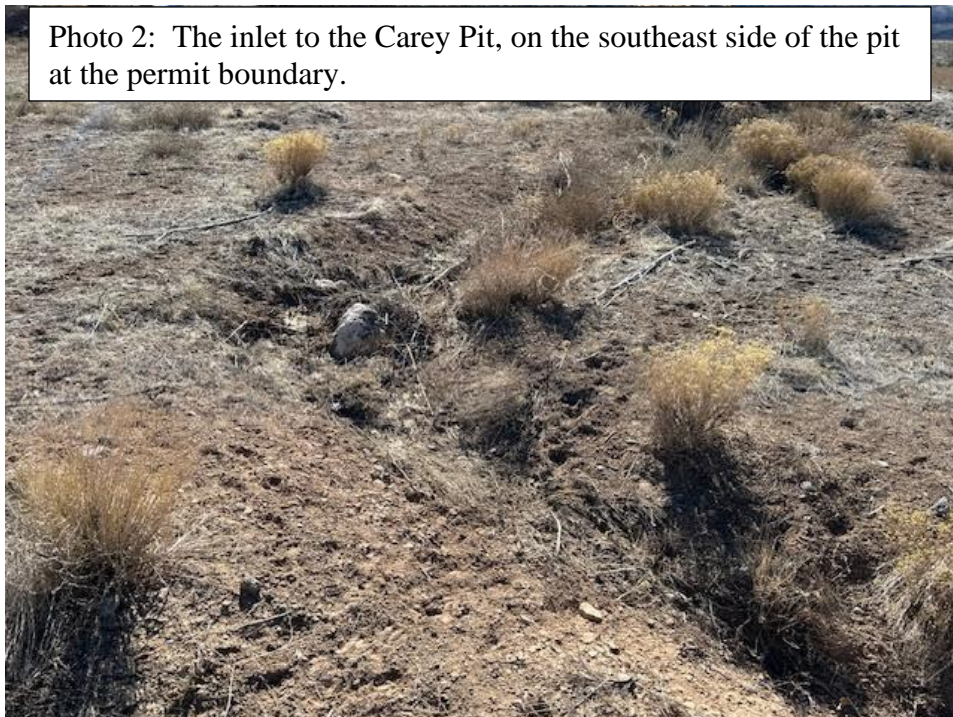
Photo 2: The inlet to the Carey Pit, on the southeast side of the pit at the permit boundary.

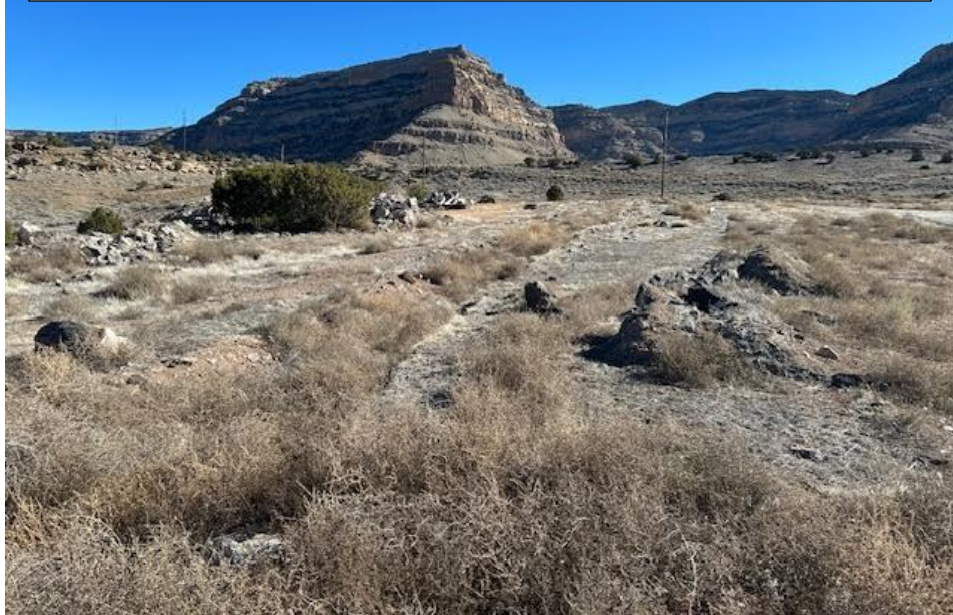
The landowner has a series of open trenches within the northern and eastern parts of Tract 71 and within the mine permit boundary. The trenches' northern portion is directly north of the TR-69 repair area's disturbance boundary (Photo 3). The trenches are connected via a PVC pipe to the buried pipeline in the southeastern portion of Tract 71. There was no indication of recent application of water in the landowner's trenches. The trenches were observed to be dry.

Photo 3: The eastern portion of the landowner's trench on Tract 71.

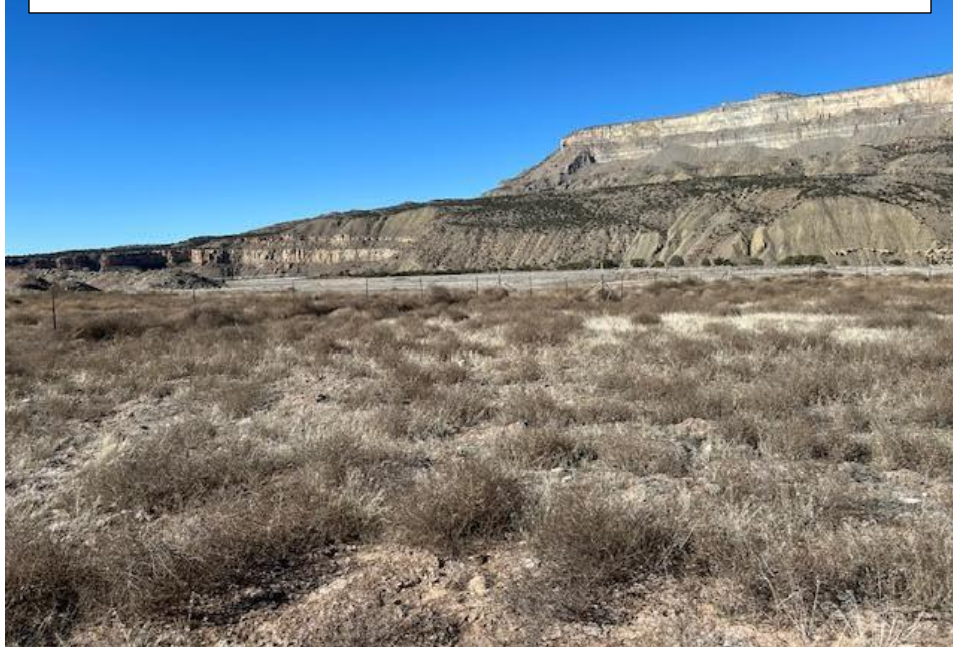
The TR-69 Repair Area is the only remaining permitted disturbance within the permit boundary. The TR-69 Repair Area is approximately 0.4 acres in size. During the inspection, the TR-69 Repair Area was covered with vegetation and was stable (Photos 4, 5 and 6). Vegetation at the site is still dormant for the winter season. There were no indications of differential settling or erosion identified. The sediment logs were observed to be in place at the down-gradient portions of the disturbed area (Photo 7). The sediment logs were in good condition and there were no off-site impacts seen. The disturbed area has a fence surrounding it with a mine identification sign clearly posted on the southeast corner. The fence was in good repair and the sign was clearly legible.

Photo 4: The southern portion of the TR-69 Repair Area.

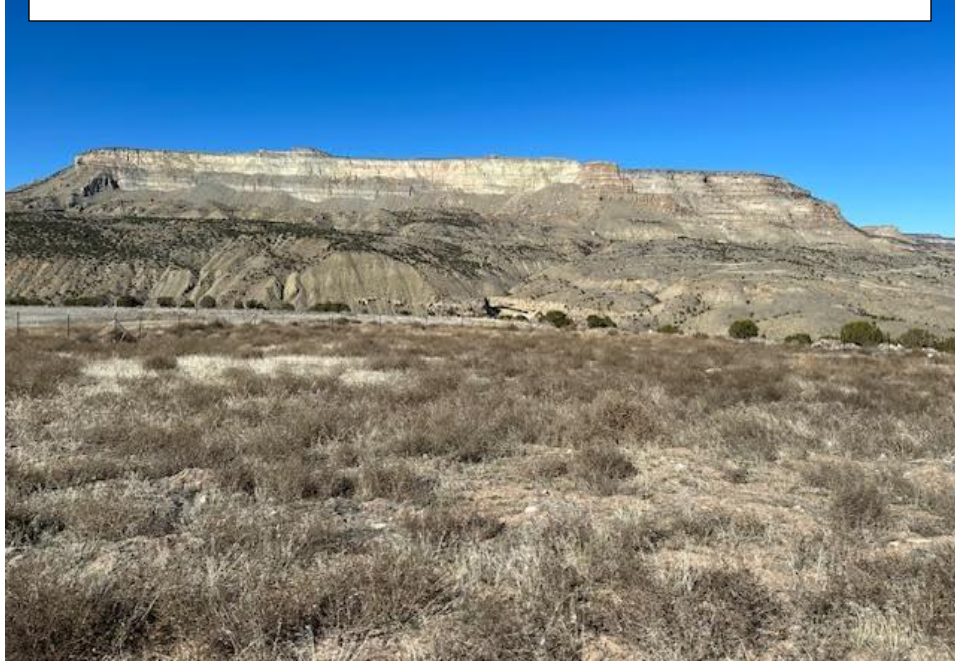
Photo 5: The central portion of the TR-69 Repair Area.

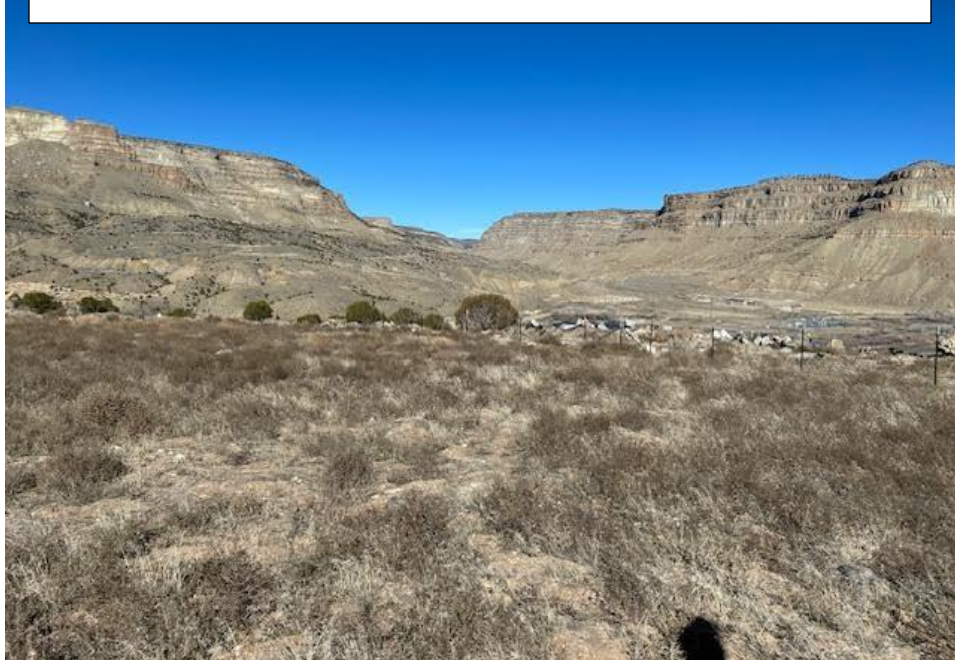
Photo 6: The northern portion of the TR-69 Repair Area.

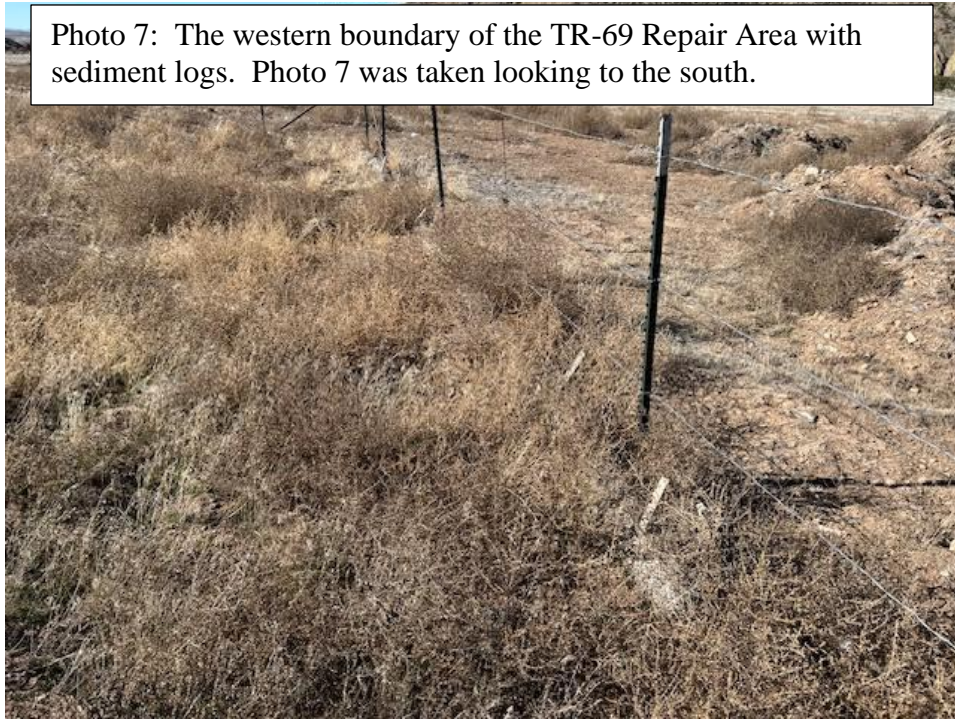
Photo 7: The western boundary of the TR-69 Repair Area with sediment logs. Photo 7 was taken looking to the south.
