### MINERALS PROGRAM INSPECTION REPORT

<b>MINE NAME:</b> Bijou Clay Mine	<b>MINE/PROSPECTING ID#:</b> M-1997-007	<b>MINERAL:</b> Clay (general)	<b>COUNTY:</b> Elbert
<b>INSPECTION TYPE:</b> Surety Release Inspection	<b>WEATHER:</b> Windy	<b>INSP. DATE:</b> February 13, 2025	<b>INSP. TIME:</b> 09:50
<b>OPERATOR:</b> The Denver Brick Company	<b>OPERATOR REPRESENTATIVE:</b> Richard Murphy	<b>TYPE OF OPERATION:</b> 112c - Construction Regular Operation

<b>REASON FOR INSPECTION:</b> Surety Release Requested	<b>BOND CALCULATION TYPE:</b> Complete Bond	<b>BOND AMOUNT:</b> \$196,124.37
<b>DATE OF COMPLAINT:</b> NA	<b>POST INSP. CONTACTS:</b> None	<b>JOINT INSP. AGENCY:</b> None
<b>INSPECTOR(S):</b> Ursula Armstrong Amy Eschberger	<b>INSPECTOR'S SIGNATURE:</b>

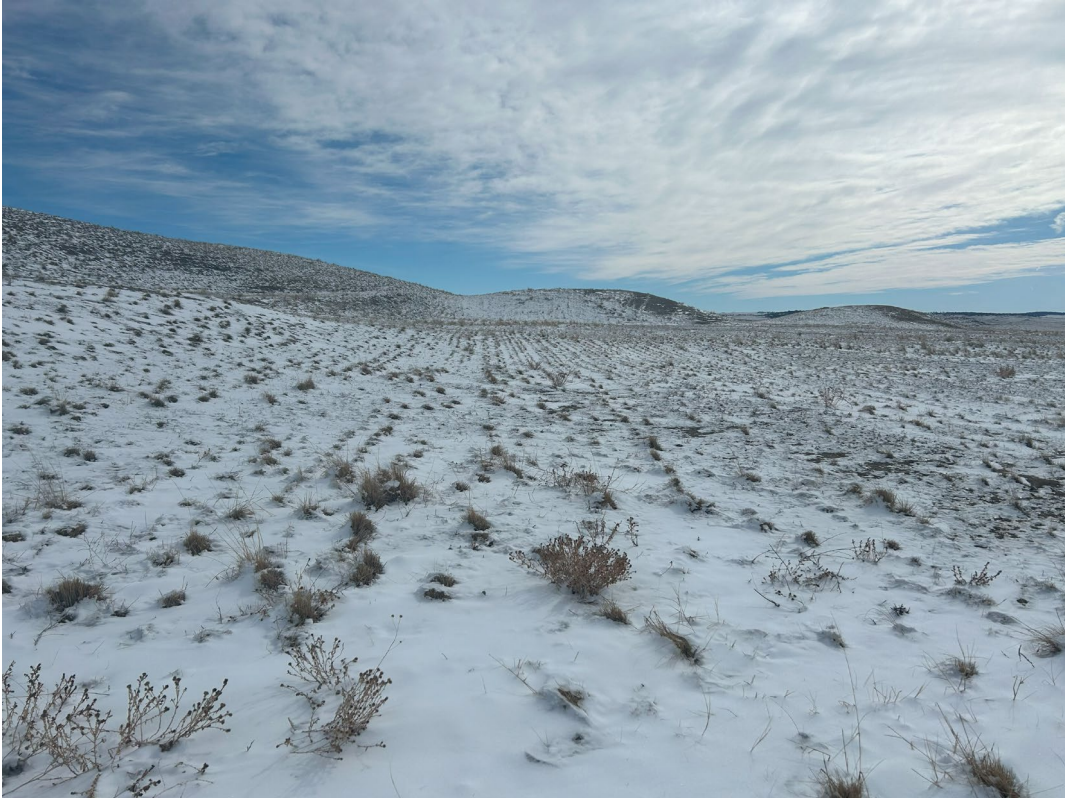
**Photo 1:** Area just beyond the entrance of the mine, looking east. Rows of clumps of grass are seen.

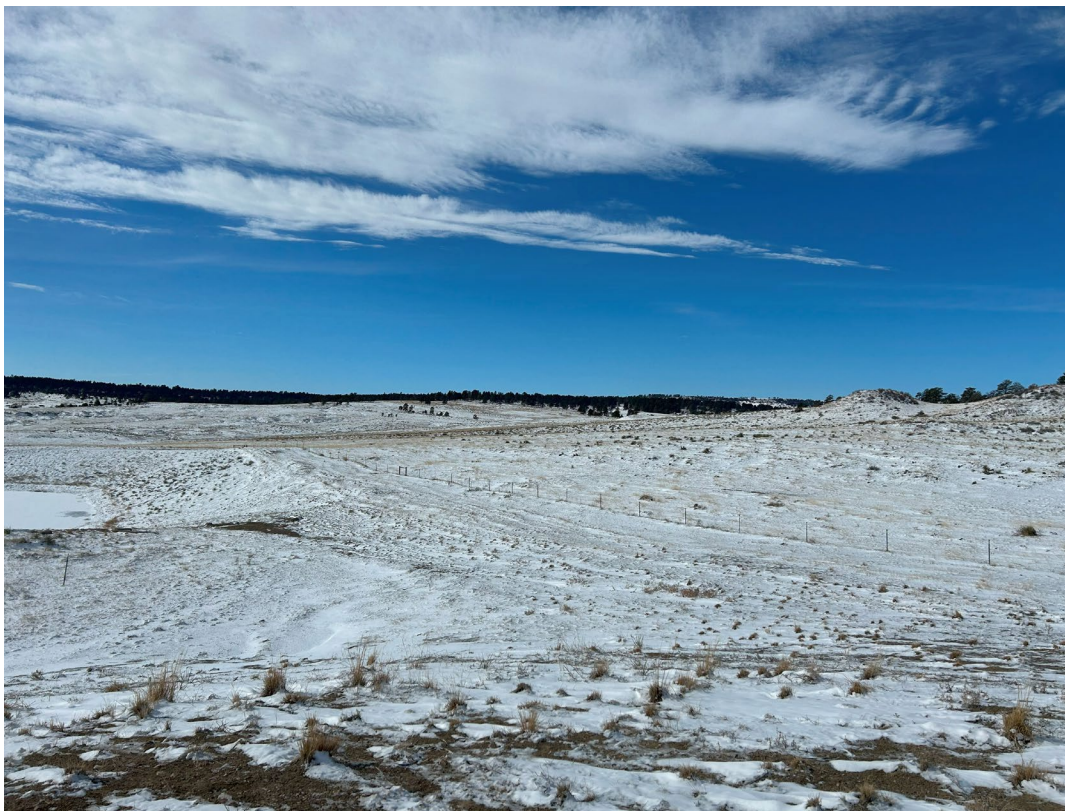
**Photo 2:** Looking south at the southwestern boundary of the site.

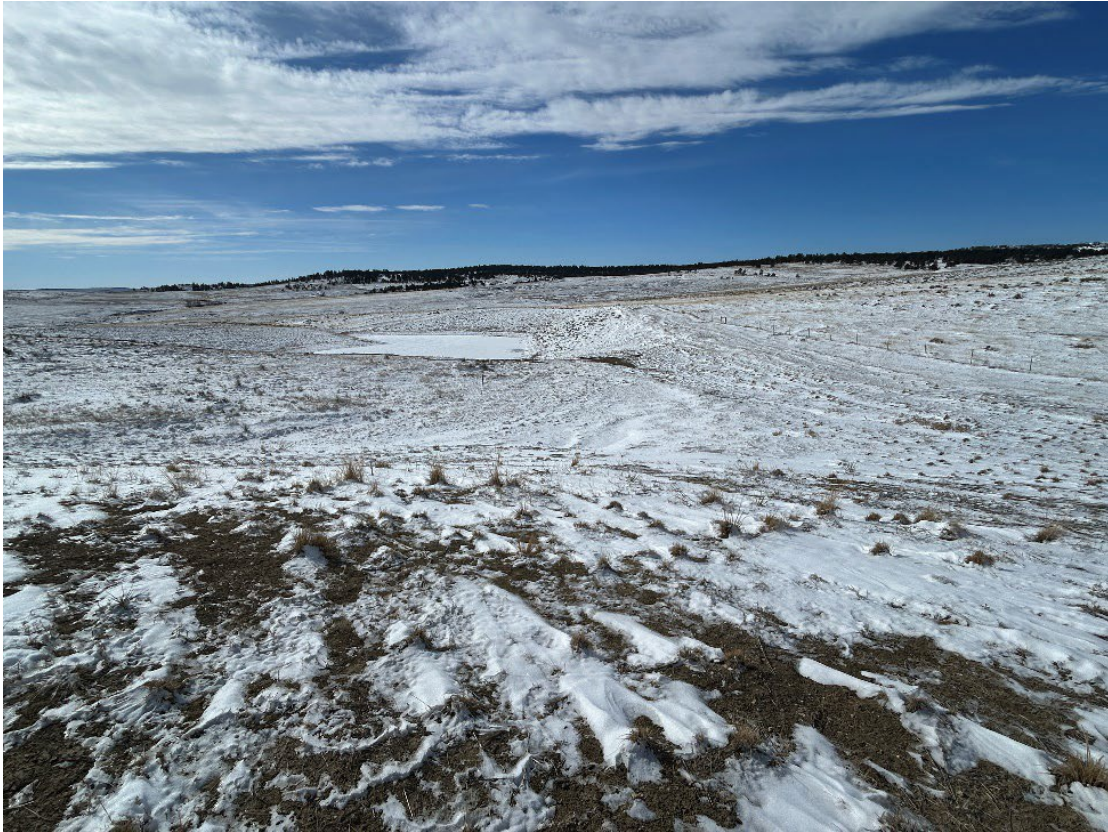
Vegetation at the site includes grasses found in the approved seed mixture. Dense stands of established grasses were observed in some areas, particularly in the earlier reclaimed phase 2 and phase 3 areas. However, scattered bare patches were observed throughout the site, particularly at the top of graded slopes. These bare patches appear to be contributing to the erosion issues observed at the site. The Division would like to remind the operator of Rule 3.1.10(1), which states in those areas where revegetation is part of the Reclamation Plan, land shall be revegetated in such a way as to establish a diverse, effective, and long-lasting vegetative cover that is capable of self-regeneration without continued dependence on irrigation, soil amendments or fertilizer, and is at least equal in extent of cover to the natural vegetation of the surrounding area. During the inspection, the landowner recommended planting in late May to June for ideal growth. The Division again recommends that the operator reseed any bare areas as soon as practicable and closely monitor the growth of desired vegetation to ensure the affected lands are revegetated in accordance with Rule 3.1.10(1).

**Photo 3:** Looking south at the reclaimed Phase 1 area of the site. Note the bare ground (in the foreground).

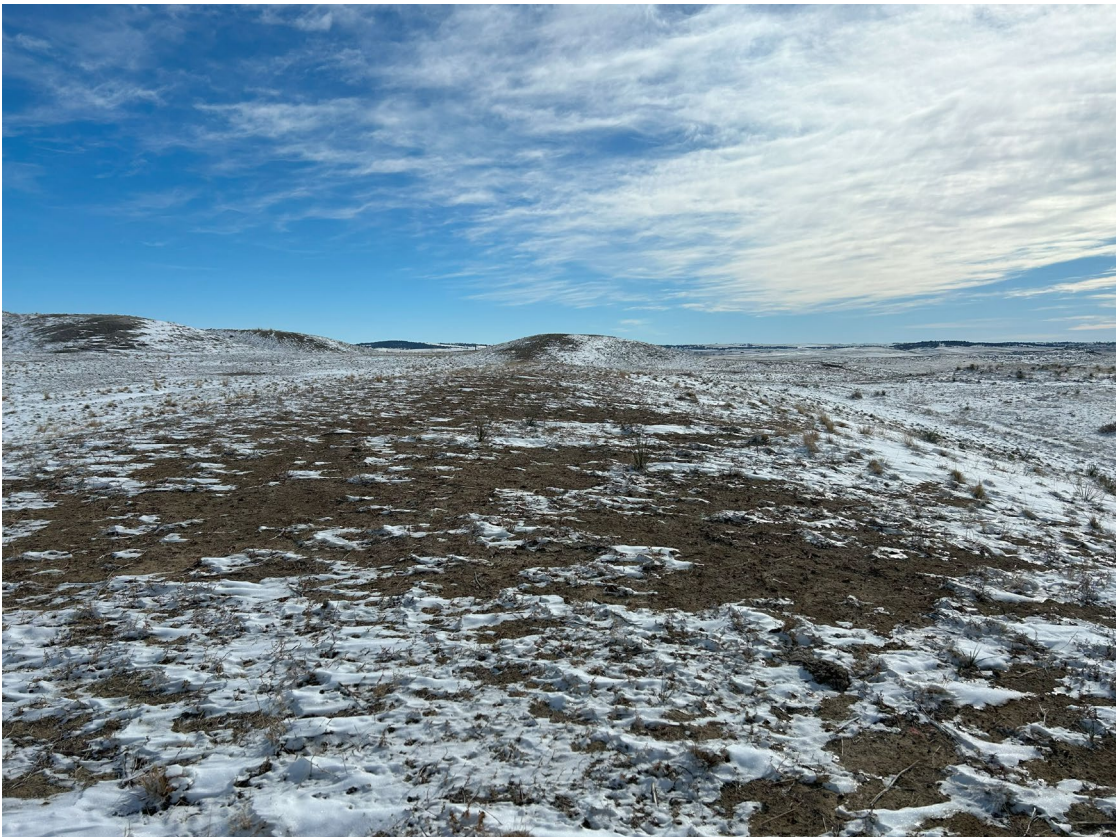
**Photo 4:** In the central area of the site, looking east. None of planted vegetation has spread to this area.

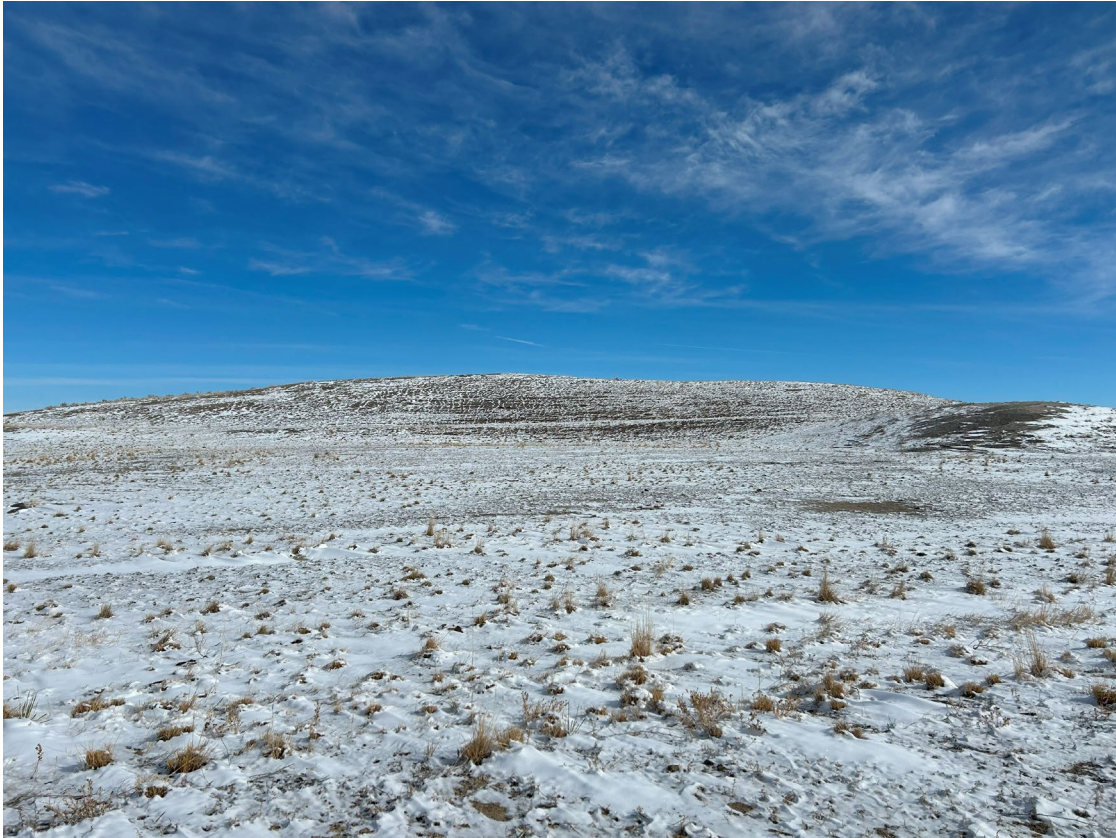
**Photo 5:** Looking north towards the phase 4 pit. Bare ground is seen along the graded slopes.

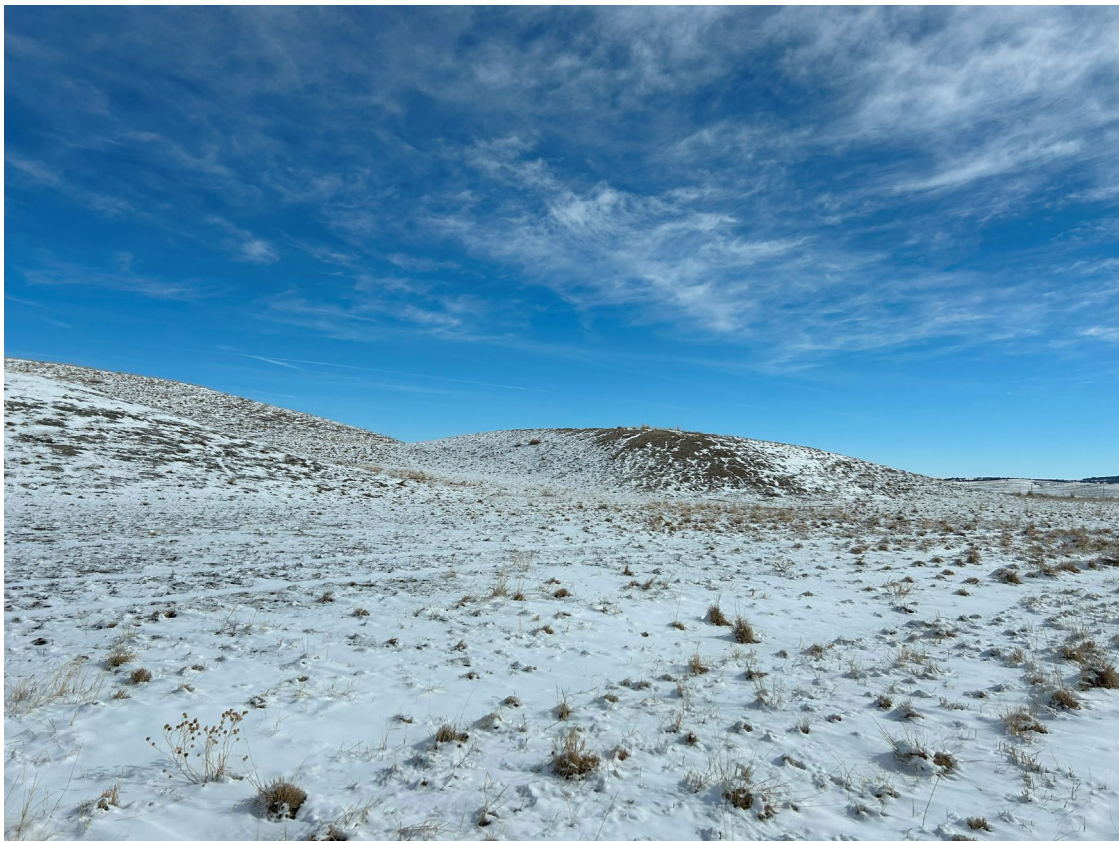
**Photo 6:** Looking north in phase 4 pit, the slopes have erosion and lack of vegetation.

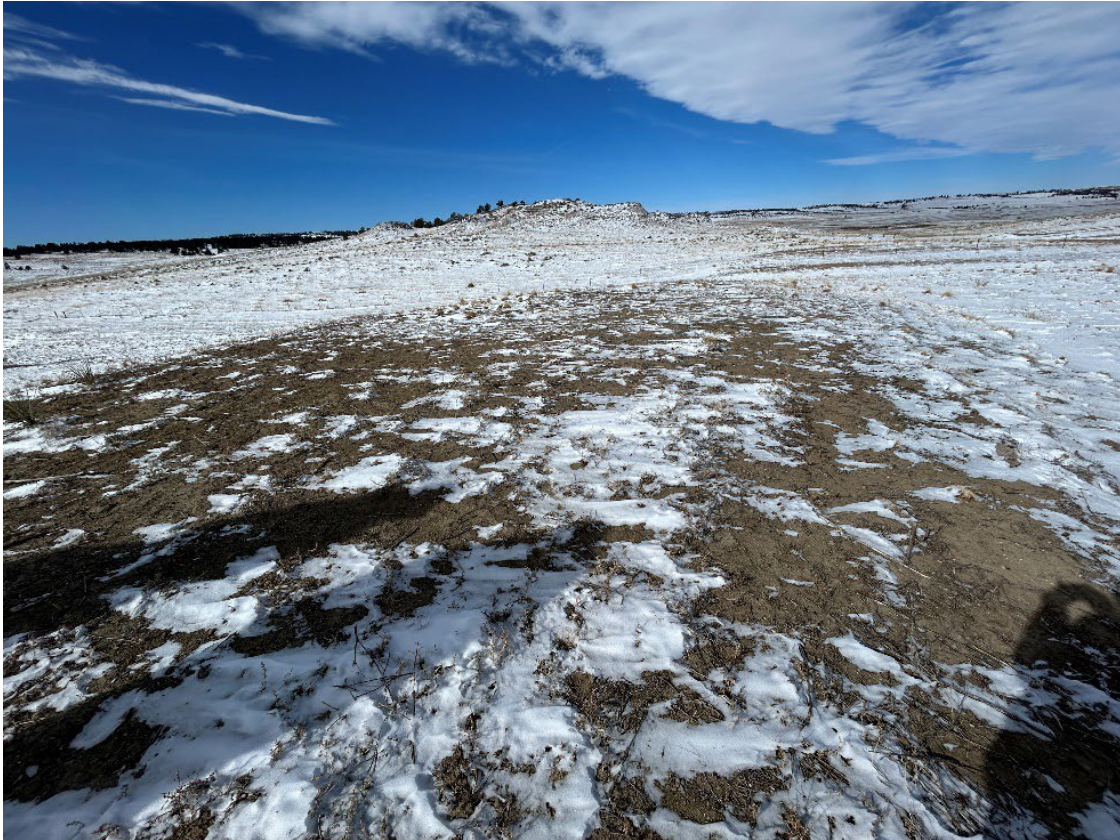
**Photo 7:** Looking west at the central area of the site.

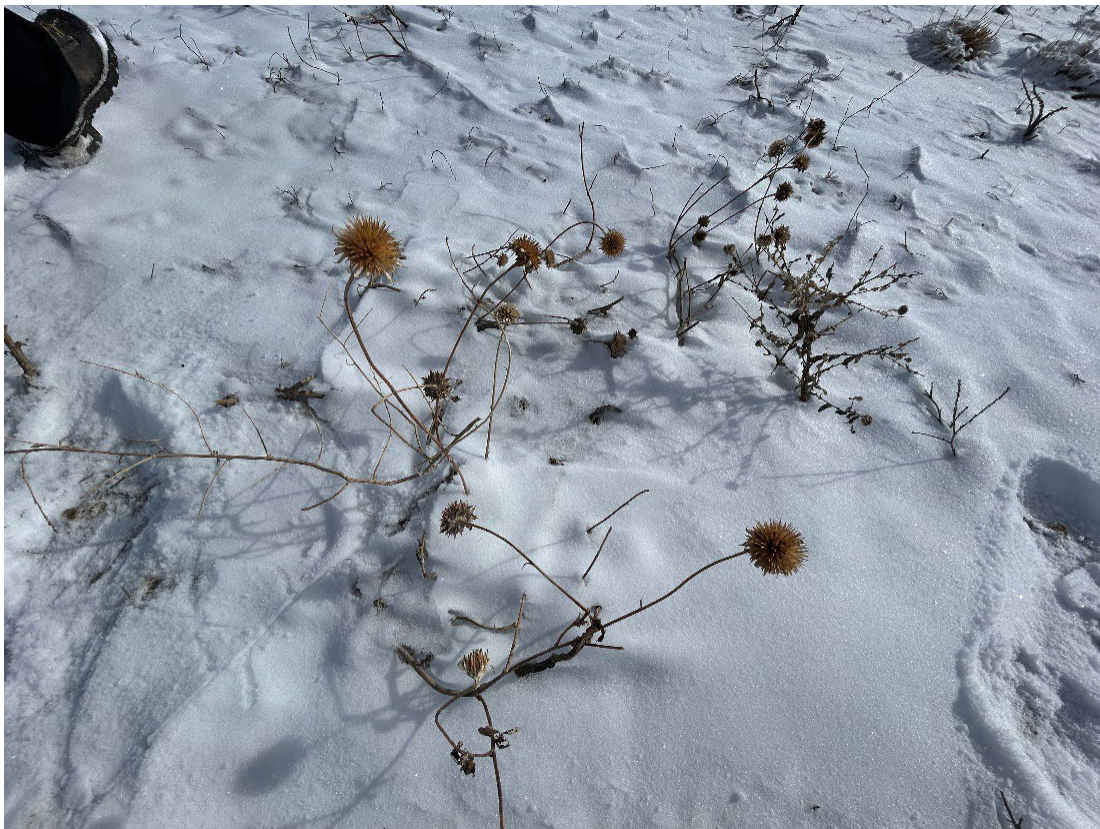
**PROBLEM #2:** There are state-listed noxious weeds present on site. This is a problem for failure to employ weed control methods for state listed noxious weed species within the permitted area, and to reduce the spread of weeds to nearby areas as required by Rule 3.1.10(6).

State-listed noxious weed species were observed during the inspection, including Canada Thistle and Diffuse Knapweed. **The weeds are cited as a problem in this report (see Problem #2). The operator will need to submit evidence that noxious weeds are being treated in accordance with the approved weed management plan.** Evidence includes, but is not limited to, an invoice for service, receipt of chemical purchase, and/or images of sprayed plants. If the weed control plan needs to be revised, the operator shall develop a new plan in consultation with the county extension agency or weed control district office and submit this revised plan in the form of a Technical Revision. This revision should include specific control measures to be applied, a schedule for when control measures will be applied, and a post-treatment monitoring plan.

**Photo 8:** Canada thistle located near the mine entrance.

**CORRECTIVE ACTIONS:** By the corrective action due date, the operator shall implement the approved weed control plan and provide proof to the Division that this has been done. Proof shall be in the form of an invoice for service, receipt of chemical purchase, and/or images of sprayed plants. If the weed control plan needs to be revised, the operator shall develop a new plan in consultation with the county extension agency or weed control district office and submit this revised plan in

the form of a Technical Revision, with the associated fee of \$216.00, by the corrective action due date. This revision should include specific control measures to be applied, a schedule for when control measures will be applied, and a post-treatment monitoring plan.

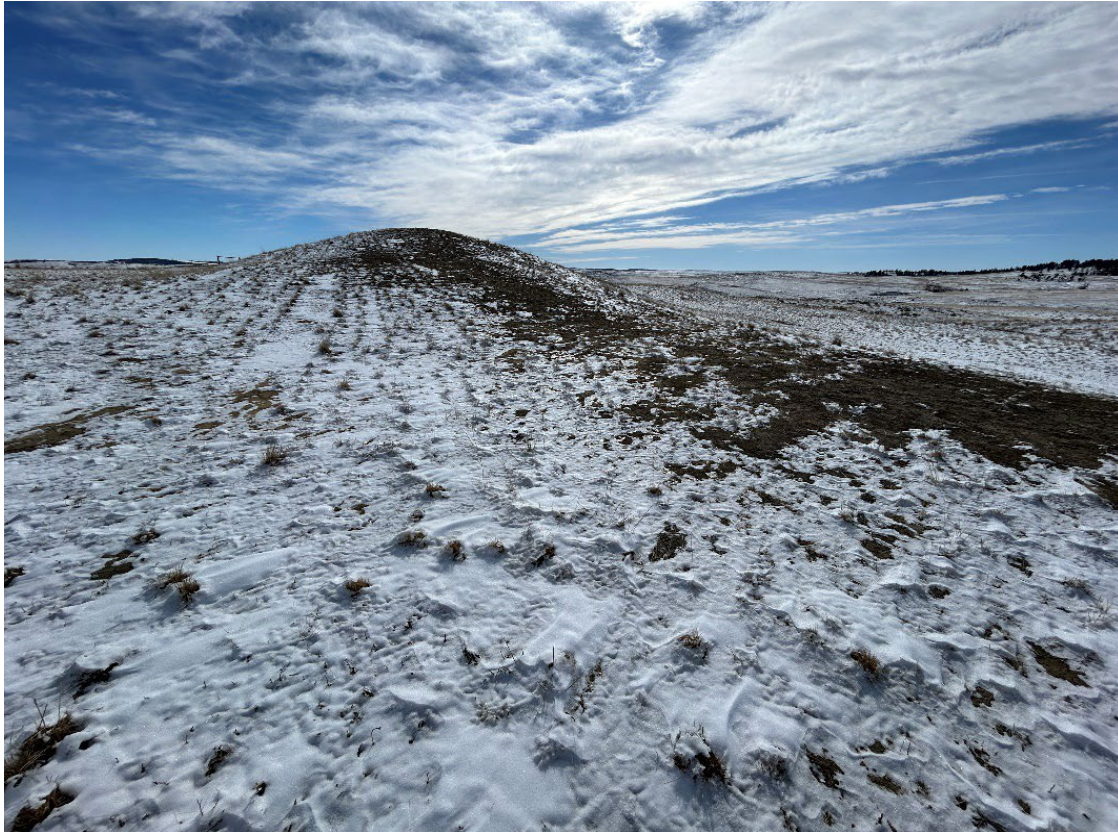
**Photo 9:** Looking east at one of the graded slopes that is lacking vegetation.

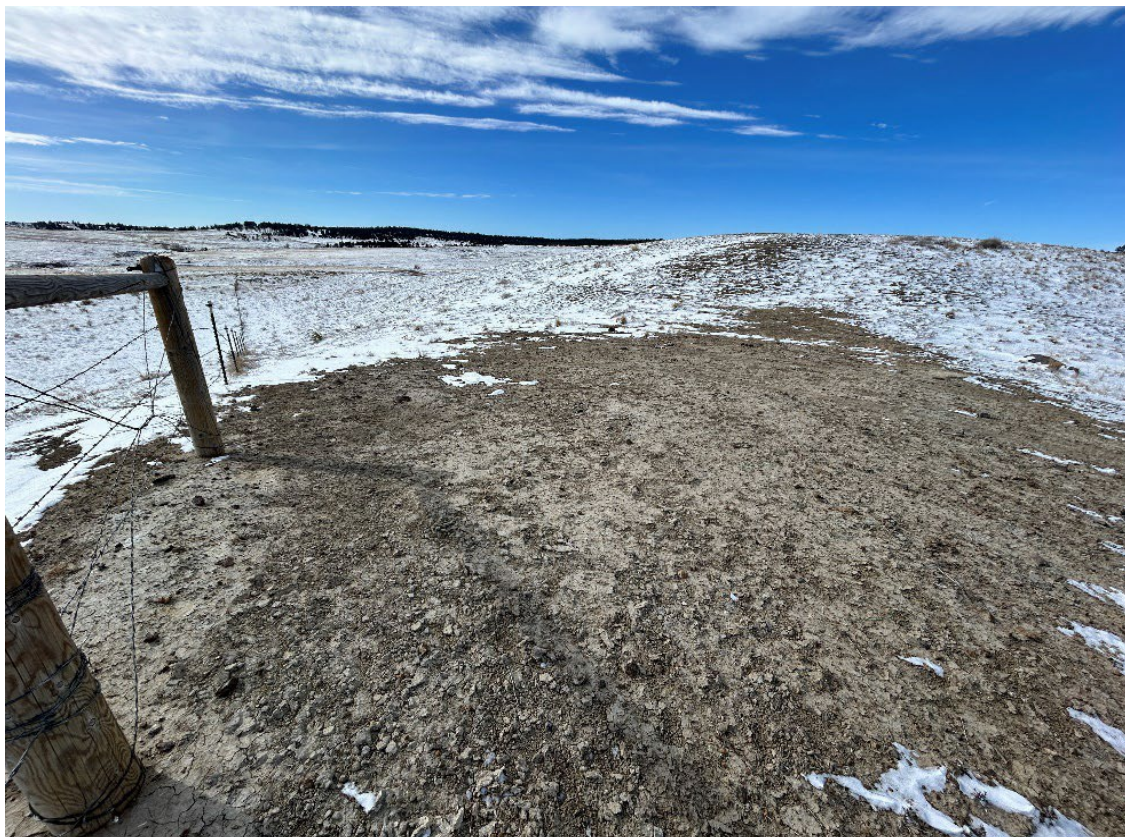
**Photo 10:** Standing at the eastern mine permit fence looking south, a large area of bare ground is seen.

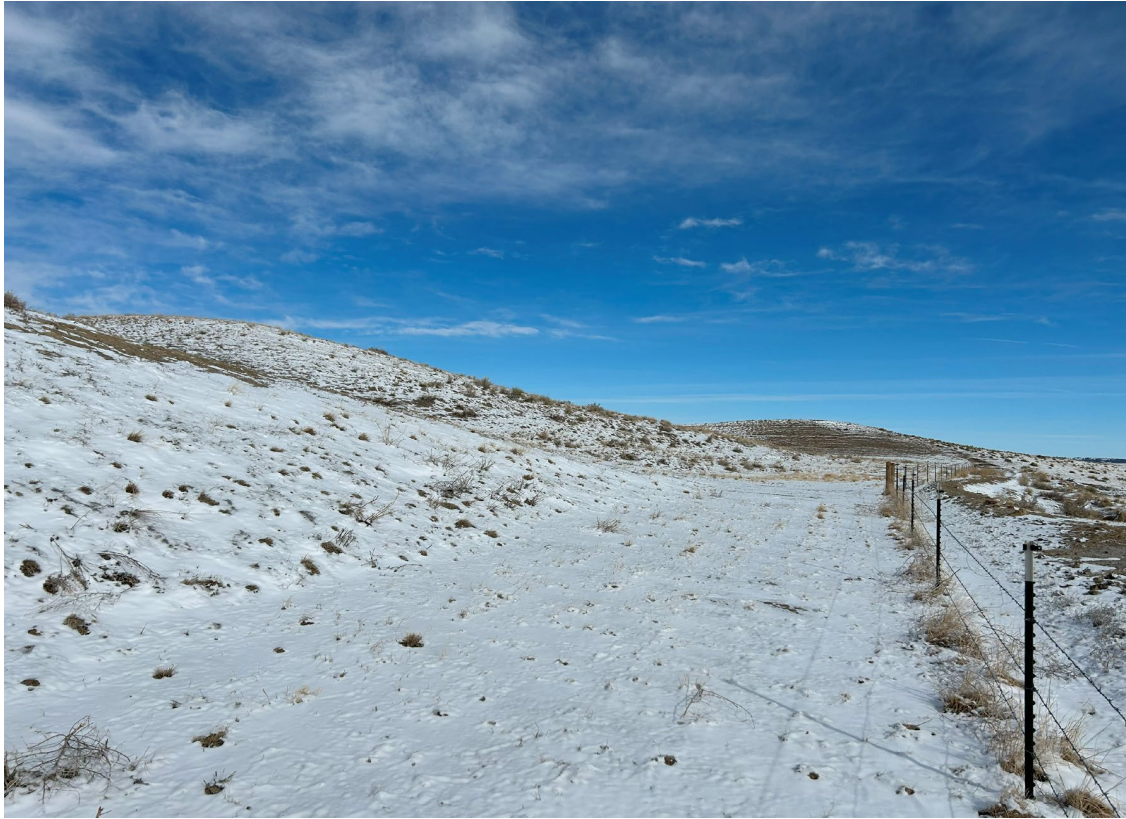
**Photo 11:** Looking north along the eastern permit boundary, identified by the fence.

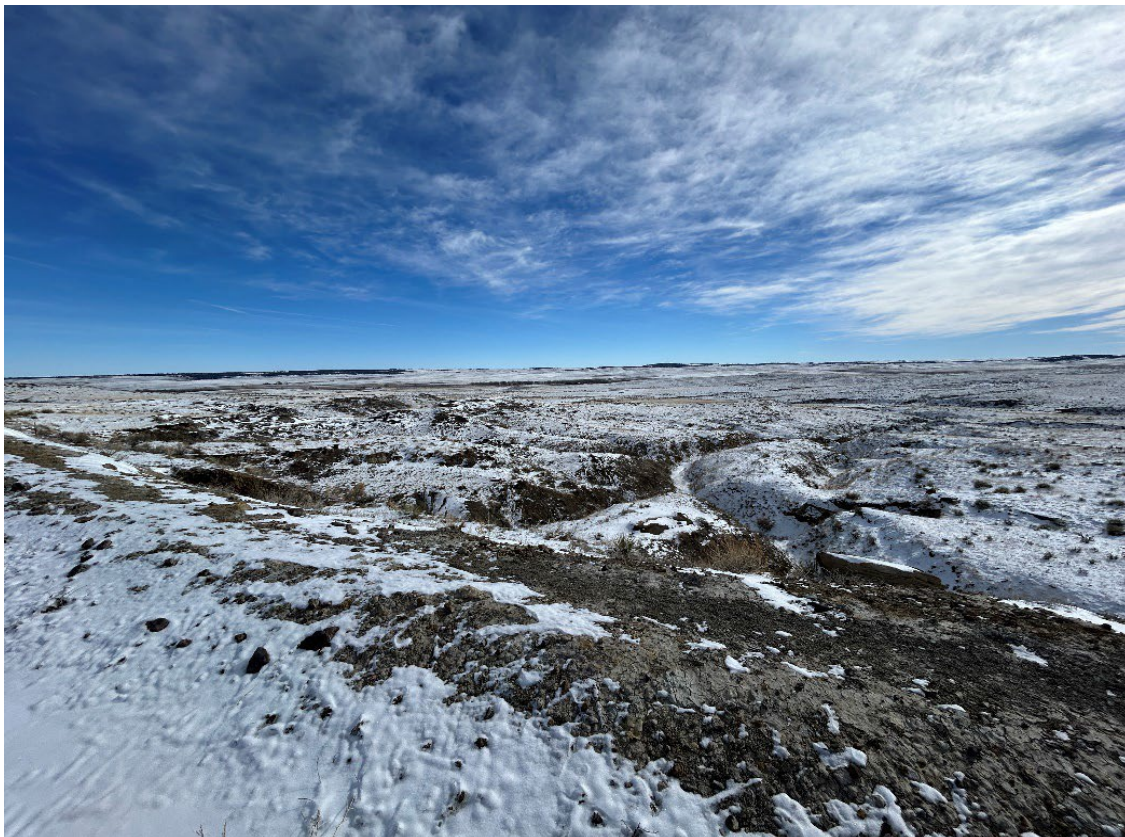
**Photo 12:** Area just beyond the permit area, looking east.

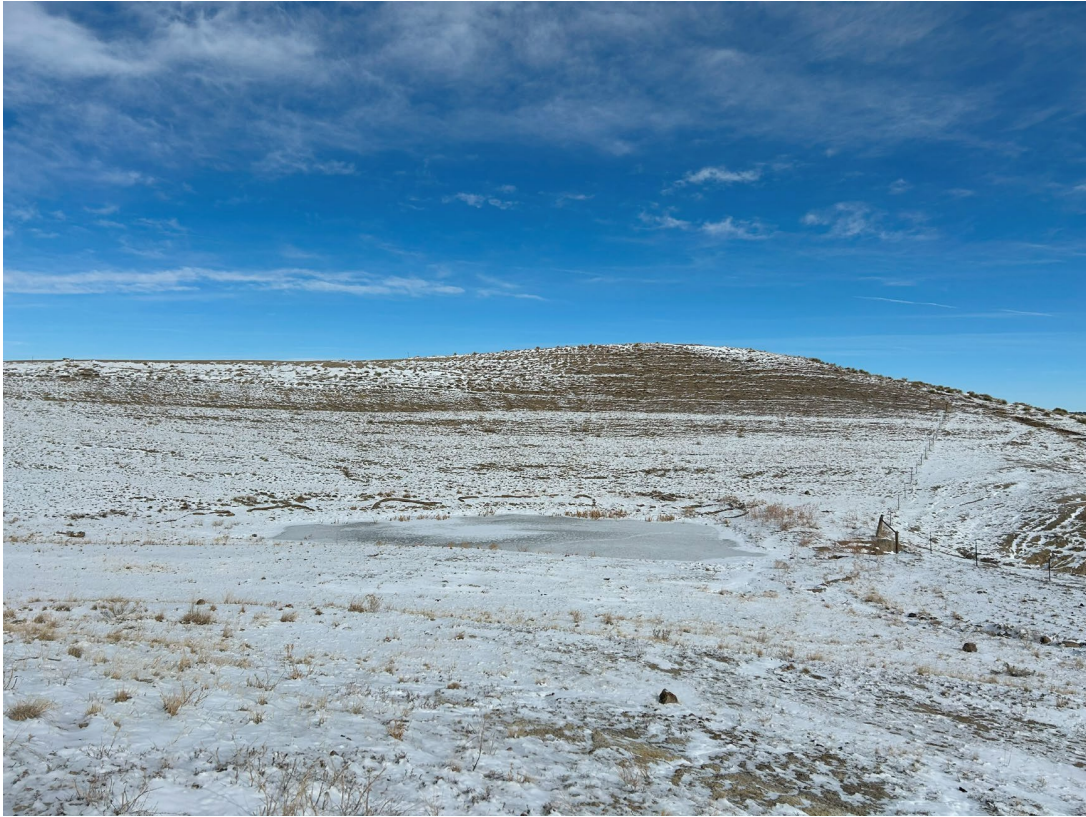
**Photo 13:** View looking north across phase 3 mining area. Note small pond on pit floor.

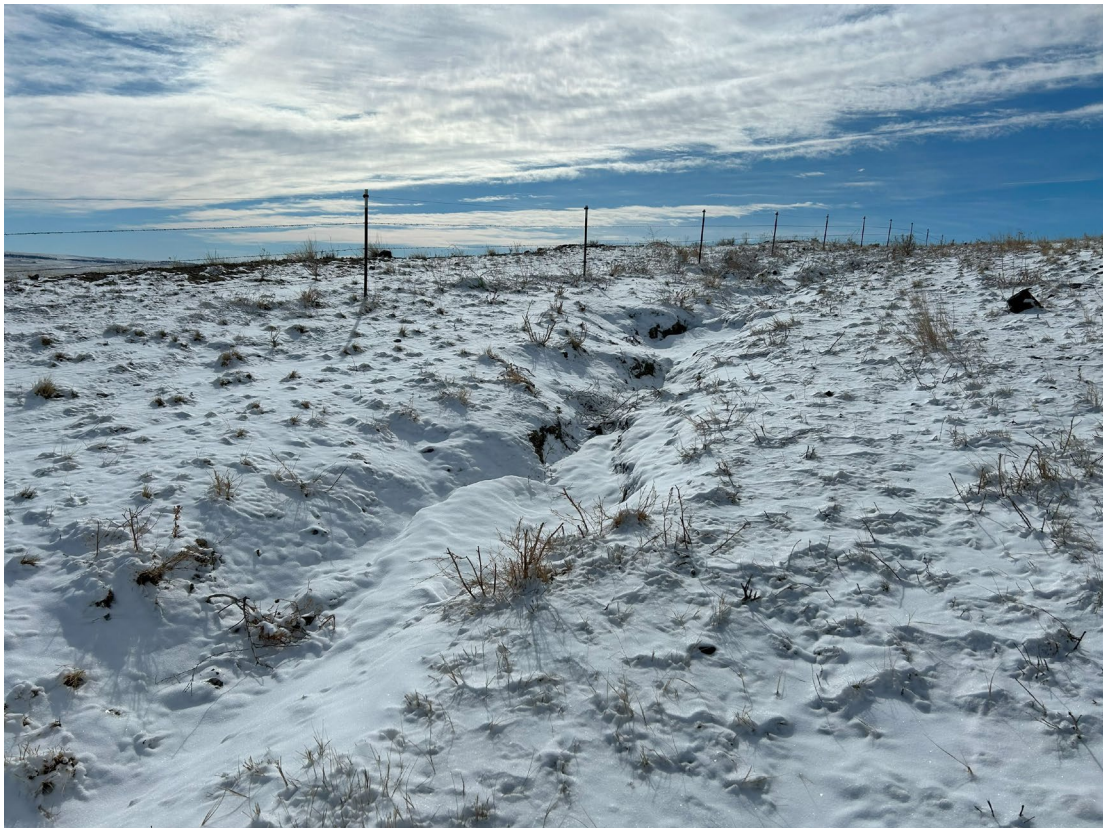
**PROBLEM #1:** Erosion gullies and rills were observed along the western edge of the site and across slopes leading to the pit floors. There is a significant erosion feature along the eastern permit boundary in the Phase 3 area, which is associated with a detention basin that remains on the pit floor. This is a problem at this time for failure to protect the affected land from erosion pursuant to C.R.S. 34-32.5-116(4)(j) and Rule 3.1.6(3).

At the time of the inspection, the weather was cold and clear, and the site had a snow covering. During the inspection, erosion in the form of rills and gullies were observed throughout the site. Erosion ruts and gullies were observed along the western edge of the site, mainly along the access road and across graded slopes leading to the pit floors. In the northeastern portion of the permit area, a significant erosional feature was observed along the eastern edge of the Phase 3 mining area. The pond that lies on the pit floor receives all water runoff from the slopes in that area of the site. The water from this pond leaves the affected land and enters a natural ephemeral drainage that runs off site. The drainage from this pond has created a large erosion gully. The Division cited a problem for the erosion damage in its September 18, 2023 inspection report. On December 14, 2023, the Division abated this problem after the operator provided evidence the erosion had been repaired, and the disturbed areas reseeded. However, after conducting this inspection, it is clear the work completed to address this issue is not effectively managing stormwater at the site, and there is a high risk of off-site damage occurring. Pursuant to C.R.S. 34-32.5-116(4)(j) and Rule 3.1.6(3), all surface areas of the affected land, including spoil piles, shall be stabilized and protected so as to effectively control erosion. Additionally, Rule 3.1.5(3) requires all grading be done in a manner to control erosion and siltation of the affected lands, to protect areas outside the affected land from slides and other damage. **The erosion damage is cited as a problem in this report (see Problem #1). The operator will need to submit a Technical Revision (see enclosed form) to revise the reclamation plan and map to include an appropriate stormwater management plan for the site.** This plan shall include details for reconstructing the pond in Phase 3 so that it is appropriately sized to manage stormwater in the area with an outlet structure designed to safely discharge flows into the adjacent natural drainage without causing significant erosion and/or offsite damage. Additionally, the plan shall describe how the existing erosion gullies and ruts observed throughout the site will be repaired and the land reconstructed and stabilized to prevent future erosion damage. A detailed timeline for completion must be included with the plan. Refer to photos 14-17, 19, 20, 23, and 24 for images of some of the observed erosion features.

**Photo 14:** Looking southeast along eastern boundary at one of the several large paths of water runoff. This is just south of the significant gully.

**CORRECTIVE ACTIONS:** By the corrective action due date, the operator shall submit a Technical Revision, with the associated fee of \$216.00, to revise the reclamation plan and map to include an appropriate stormwater management plan for the site. This plan shall include details for reconstructing the pond in Phase 3 so that it is appropriately sized to manage stormwater in the area with an outlet structure designed to safely discharge flows into the adjacent natural drainage without causing significant erosion and/or offsite damage. Additionally, the plan shall describe how the existing erosion gullies and ruts observed throughout the site will be repaired and the land reconstructed and stabilized to prevent future erosion damage. A detailed timeline for completion must be included with the plan.

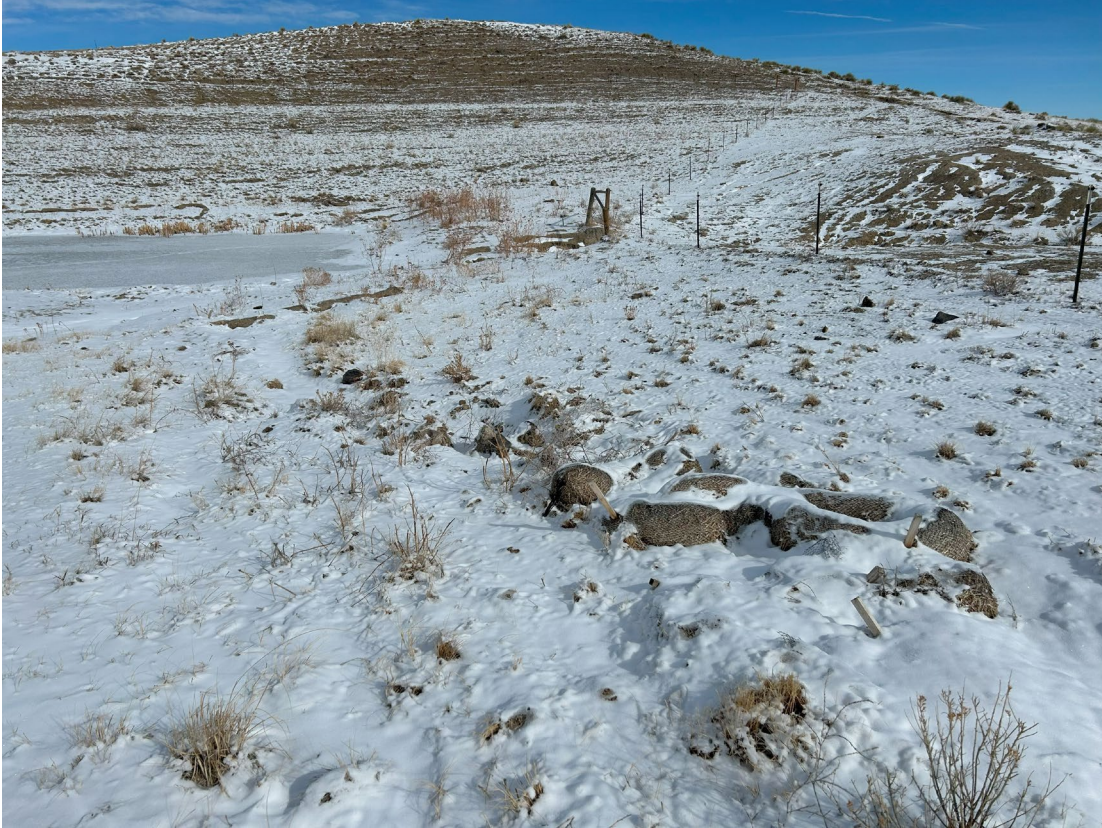
**Photo 15:** The same water runoff path seen in Photo 14, looking north towards the pond and gully. Straw wattles are seen.

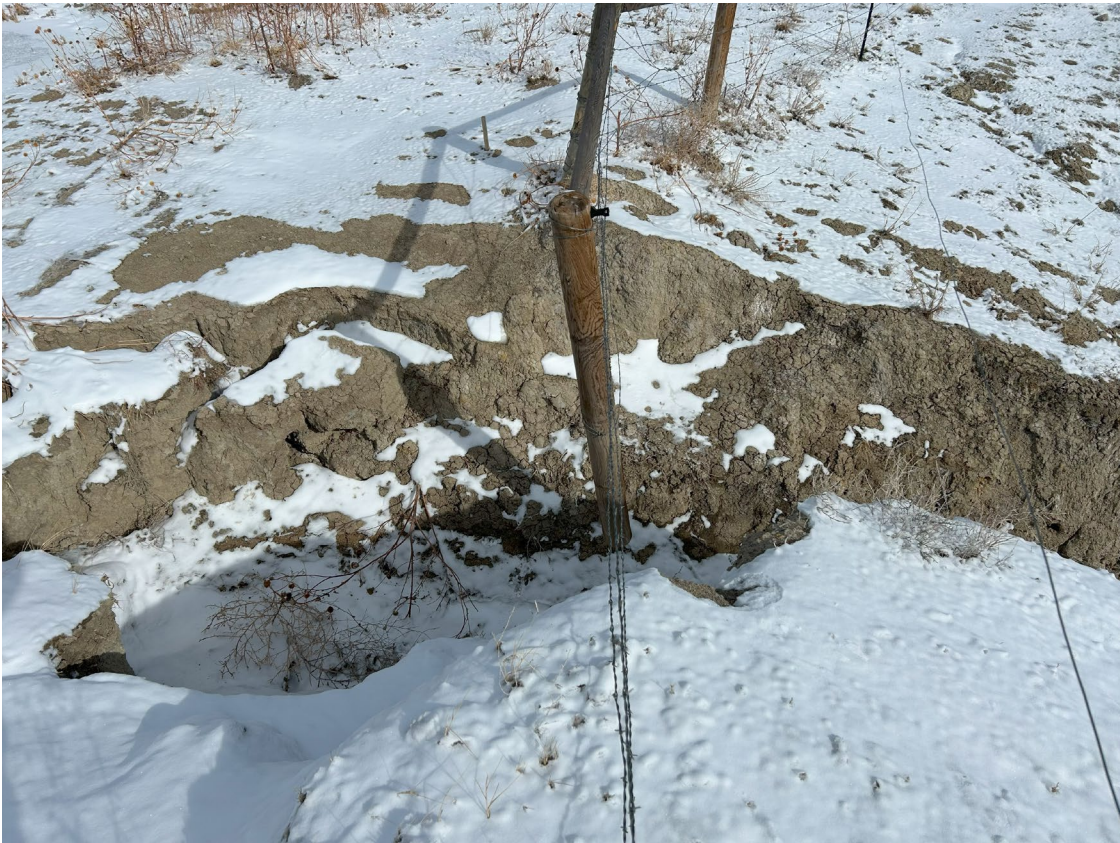
**Photo 16:** Looking directly down at the large gully along the eastern boundary, where the pond discharges into the natural drainage.

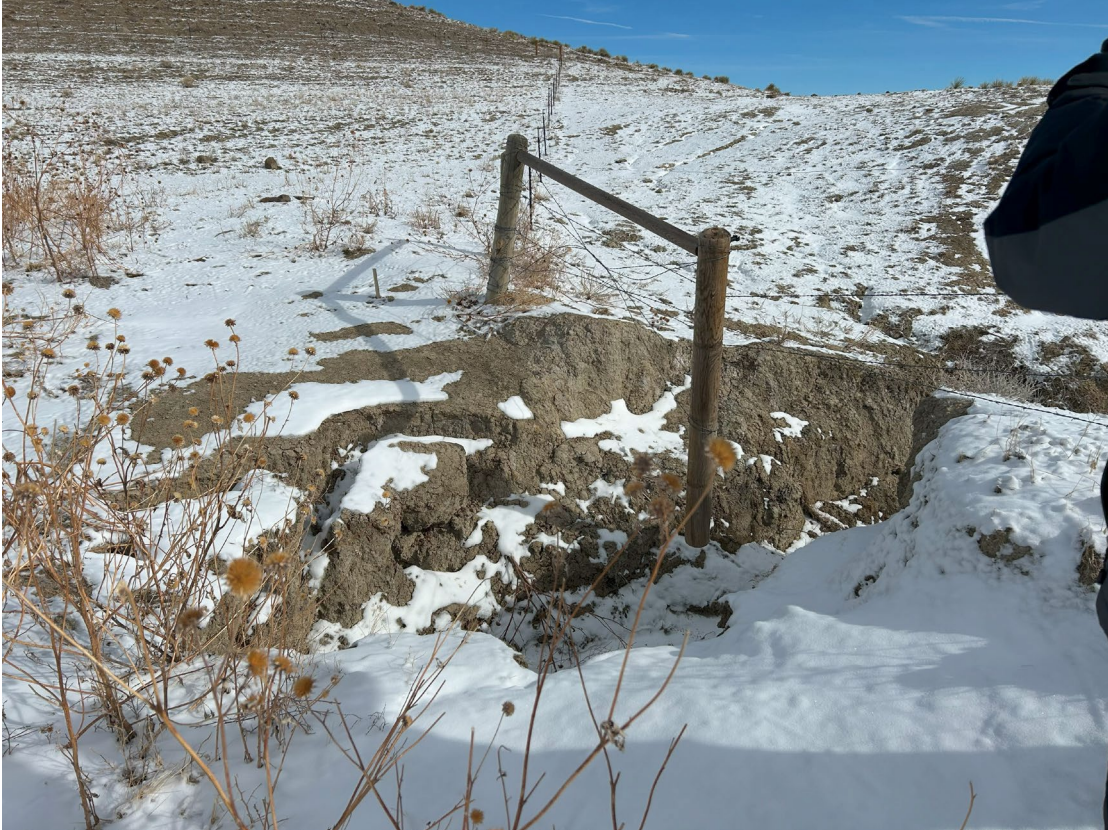
**Photo 17:** Looking northeast at the large gully along the eastern boundary. Canada thistle can be seen in the bottom left corner of the photo.

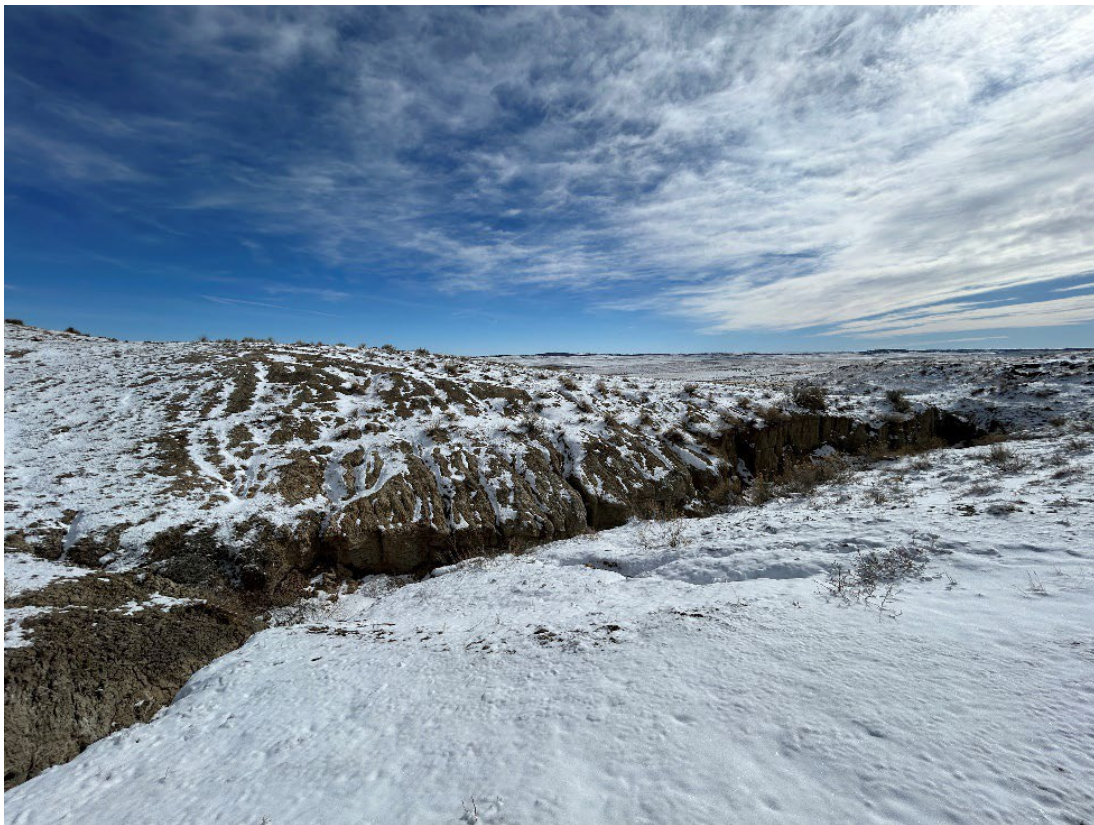
**Photo 18:** Looking east at natural drainage area just beyond the large gully on the eastern boundary.

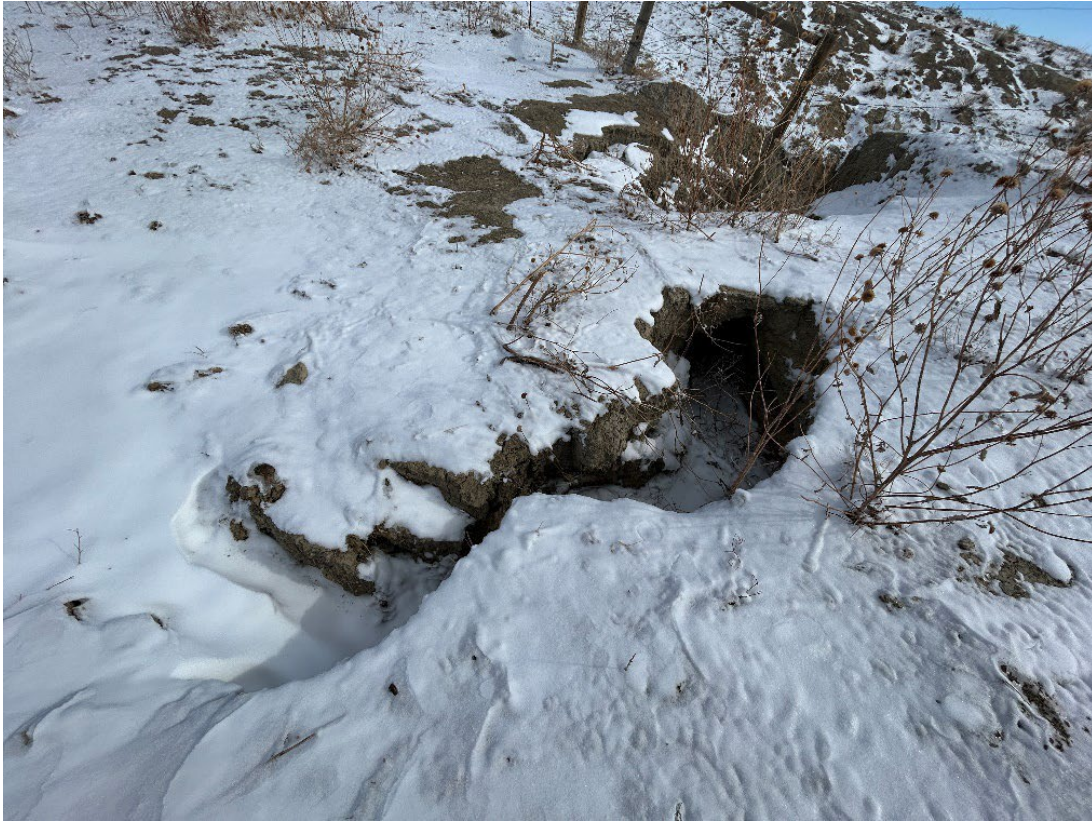
**Photo 19:** Looking down at erosion between the pond and the large gully on the eastern boundary.

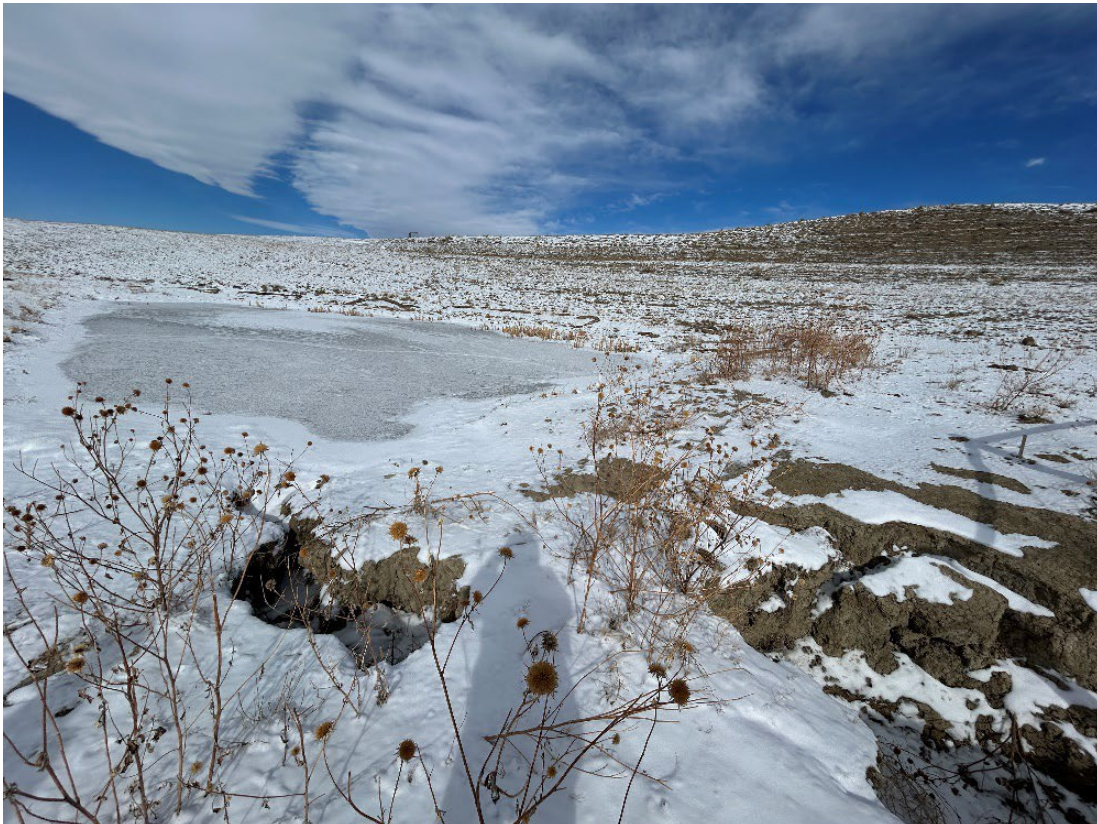
**Photo 20:** Looking west at the pond that contributes to drainage at the large gully on the eastern boundary. Canada thistle is seen in the bottom left corner of the photo.

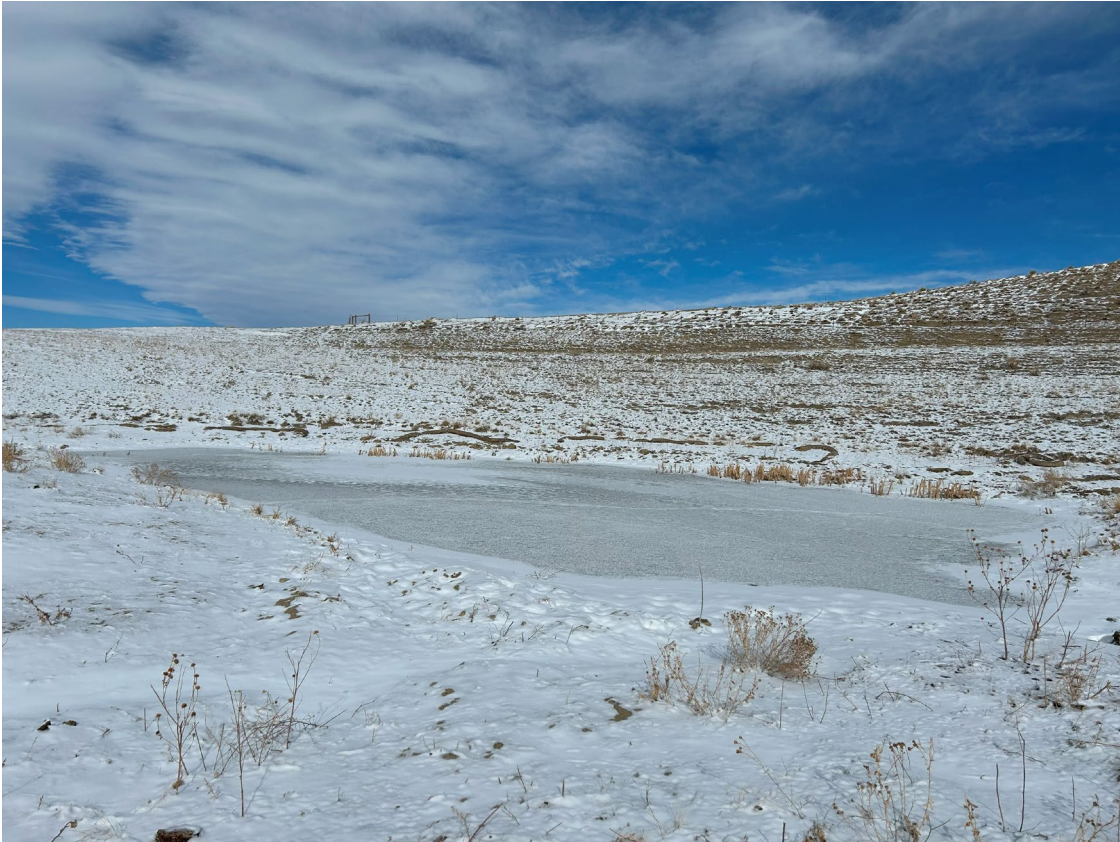
**Photo 21:** The pond at the bottom of the phase 3 pit, looking west.

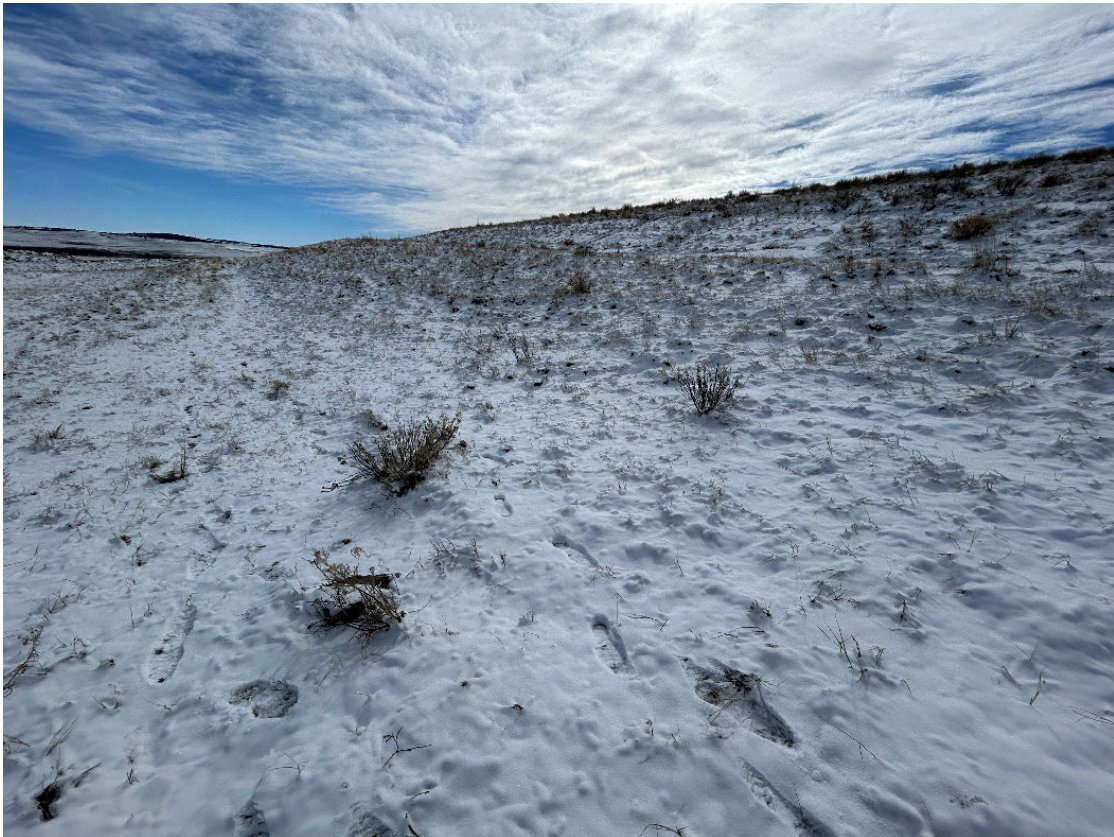
**Photo 22:** Looking east at one of the graded slopes.
