### MINERALS PROGRAM INSPECTION REPORT

<b>MINE NAME:</b> Bijou Clay Mine	<b>MINE/PROSPECTING ID#:</b> M-1997-007	<b>MINERAL:</b> Clay (general)	<b>COUNTY:</b> Elbert
<b>INSPECTION TYPE:</b> Surety Release Inspection	<b>WEATHER:</b> Windy	<b>INSP. DATE:</b> February 13, 2025	<b>INSP. TIME:</b> 09:50
<b>OPERATOR:</b> The Denver Brick Company	<b>OPERATOR REPRESENTATIVE:</b> Richard Murphy	<b>TYPE OF OPERATION:</b> 112c - Construction Regular Operation

<b>REASON FOR INSPECTION:</b> Surety Release Requested	<b>BOND CALCULATION TYPE:</b> Complete Bond	<b>BOND AMOUNT:</b> \$196,124.37
<b>DATE OF COMPLAINT:</b> NA	<b>POST INSP. CONTACTS:</b> None	<b>JOINT INSP. AGENCY:</b> None
<b>INSPECTOR(S):</b> Ursula Armstrong Amy Eschberger	<b>INSPECTOR'S SIGNATURE:</b>

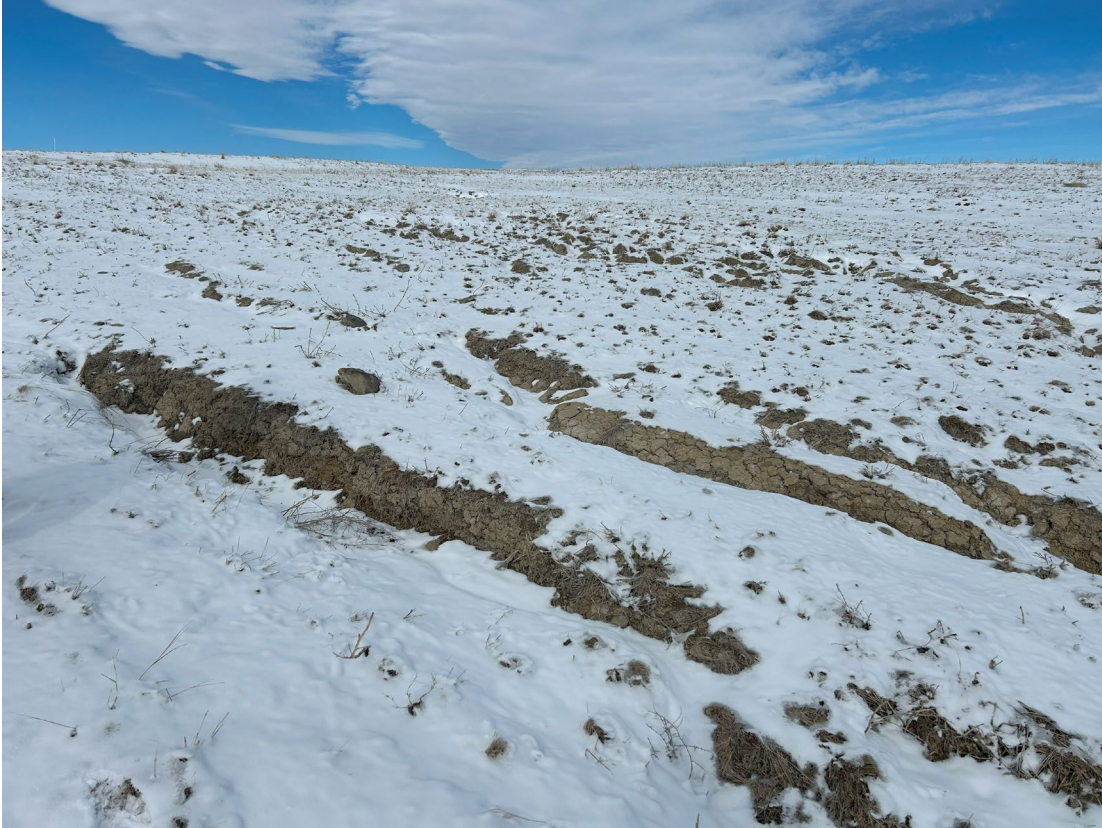
**PROBLEM #1:** Erosion gullies and rills were observed along the western edge of the site and across slopes leading to the pit floors. There is a significant erosion feature along the eastern permit boundary in the Phase 3 area, which is associated with a detention basin that remains on the pit floor. This is a problem at this time for failure to protect the affected land from erosion pursuant to C.R.S. 34-32.5-116(4)(j) and Rule 3.1.6(3).

At the time of the inspection, the weather was cold and clear, and the site had a snow covering. During the inspection, erosion in the form of rills and gullies were observed throughout the site. Erosion ruts and gullies were observed along the western edge of the site, mainly along the access road and across graded slopes leading to the pit floors. In the northeastern portion of the permit area, a significant erosional feature was observed along the eastern edge of the Phase 3 mining area. The pond that lies on the pit floor receives all water runoff from the slopes in that area of the site. The water from this pond leaves the affected land and enters a natural ephemeral drainage that runs off site. The drainage from this pond has created a large erosion gully. The Division cited a problem for the erosion damage in its September 18, 2023 inspection report. On December 14, 2023, the Division abated this problem after the operator provided evidence the erosion had been repaired, and the disturbed areas reseeded. However, after conducting this inspection, it is clear the work completed to address this issue is not effectively managing stormwater at the site, and there is a high risk of off-site damage occurring. Pursuant to C.R.S. 34-32.5-116(4)(j) and Rule 3.1.6(3), all surface areas of the affected land, including spoil piles, shall be stabilized and protected so as to effectively control erosion. Additionally, Rule 3.1.5(3) requires all grading be done in a manner to control erosion and siltation of the affected lands, to protect areas outside the affected land from slides and other damage. **The erosion damage is cited as a problem in this report (see Problem #1). The operator will need to submit a Technical Revision (see enclosed form) to revise the reclamation plan and map to include an appropriate stormwater management plan for the site.** This plan shall include details for reconstructing the pond in Phase 3 so that it is appropriately sized to manage stormwater in the area with an outlet structure designed to safely discharge flows into the adjacent natural drainage without causing significant erosion and/or offsite damage. Additionally, the plan shall describe how the existing erosion gullies and ruts observed throughout the site will be repaired and the land reconstructed and stabilized to prevent future erosion damage. A detailed timeline for completion must be included with the plan. Refer to photos 14-17, 19, 20, 23, and 24 for images of some of the observed erosion features.

**Photo 23:** Looking north at large rills on one of the slopes draining to the pond.

**CORRECTIVE ACTIONS:** By the corrective action due date, the operator shall submit a Technical Revision, with the associated fee of \$216.00, to revise the reclamation plan and map to include an appropriate stormwater management plan for the site. This plan shall include details for reconstructing the pond in Phase 3 so that it is appropriately sized to manage stormwater in the area with an outlet structure designed to safely discharge flows into the adjacent natural drainage without causing significant erosion and/or offsite damage. Additionally, the plan shall describe how the existing erosion gullies and ruts observed throughout the site will be repaired and the land reconstructed and stabilized to prevent future erosion damage. A detailed timeline for completion must be included with the plan.

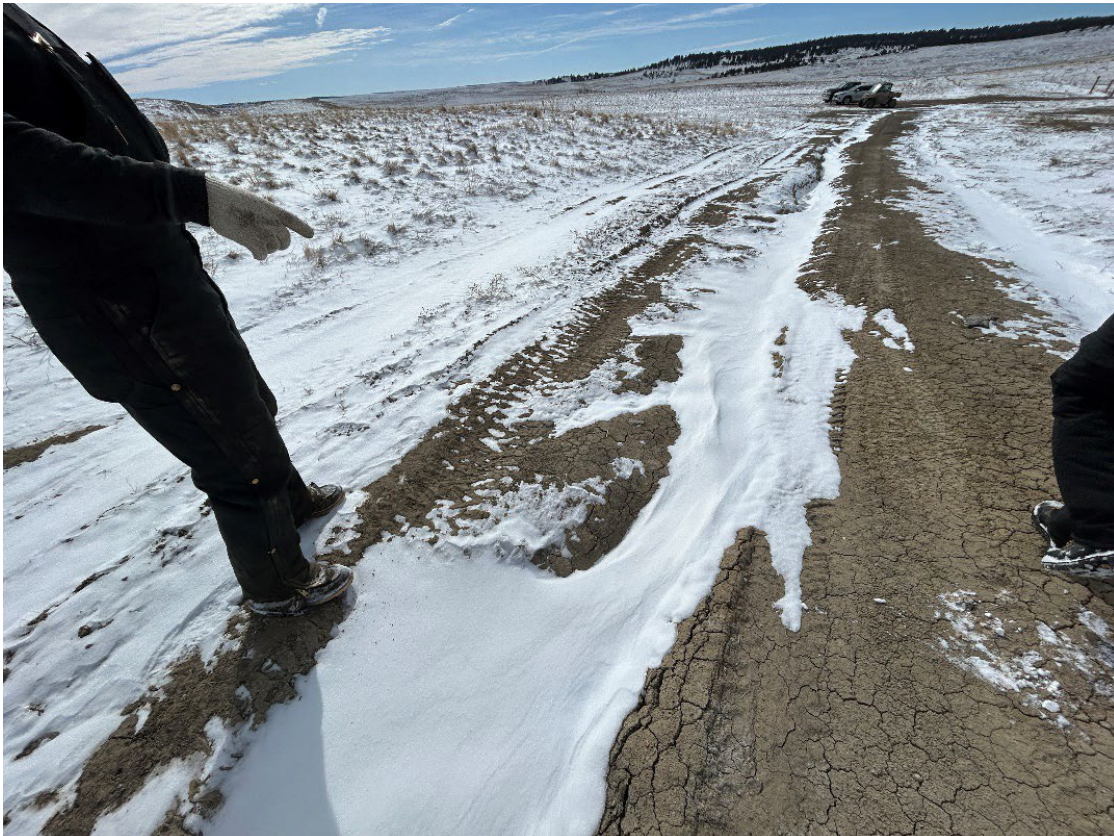
**Photo 24:** Erosion along the access road on the western boundary of the site, looking south.
