MINERALS PROGRAM INSPECTION REPORT
PHONE: (303) 866-3567

MINE NAME: Maverick Placer	MINE/PROSPECTING ID#: M-1979-206	MINERAL: Anhydrite, gypsum and	COUNTY: Fremont
INSPECTION TYPE: Monitoring	WEATHER: Clear	INSP. DATE: January 30, 2025	INSP. TIME: 09:00
OPERATOR: U S Soil Conditioning Company	OPERATOR REPRESENTATIVE: Mr. Joel Lionelle	TYPE OF OPERATION: 112c - Construction Regular Operation

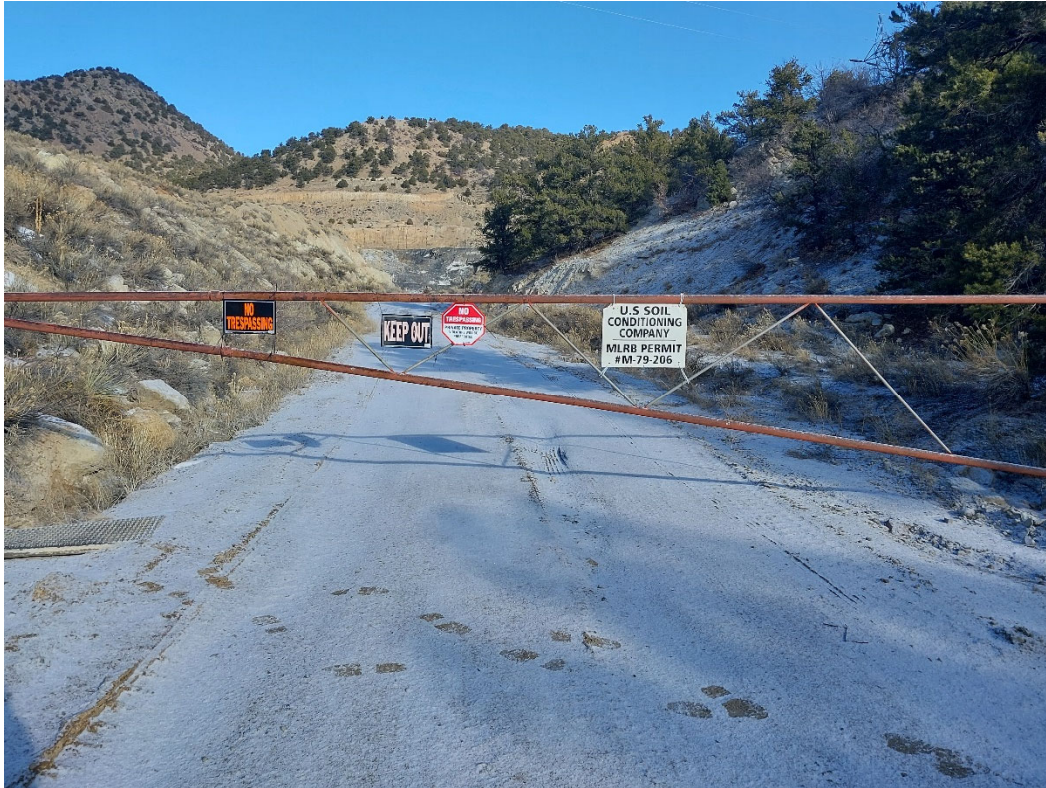
The permit sign was posted at the gate entrance of the quarry in accordance with Rule 3.1.12(1), see Photo #1. The permit boundary markers were not verified during the site inspection.

Photo #1: Mine sign posted at the gate entrance of the quarry in accordance with Rule 3.1.12(1).

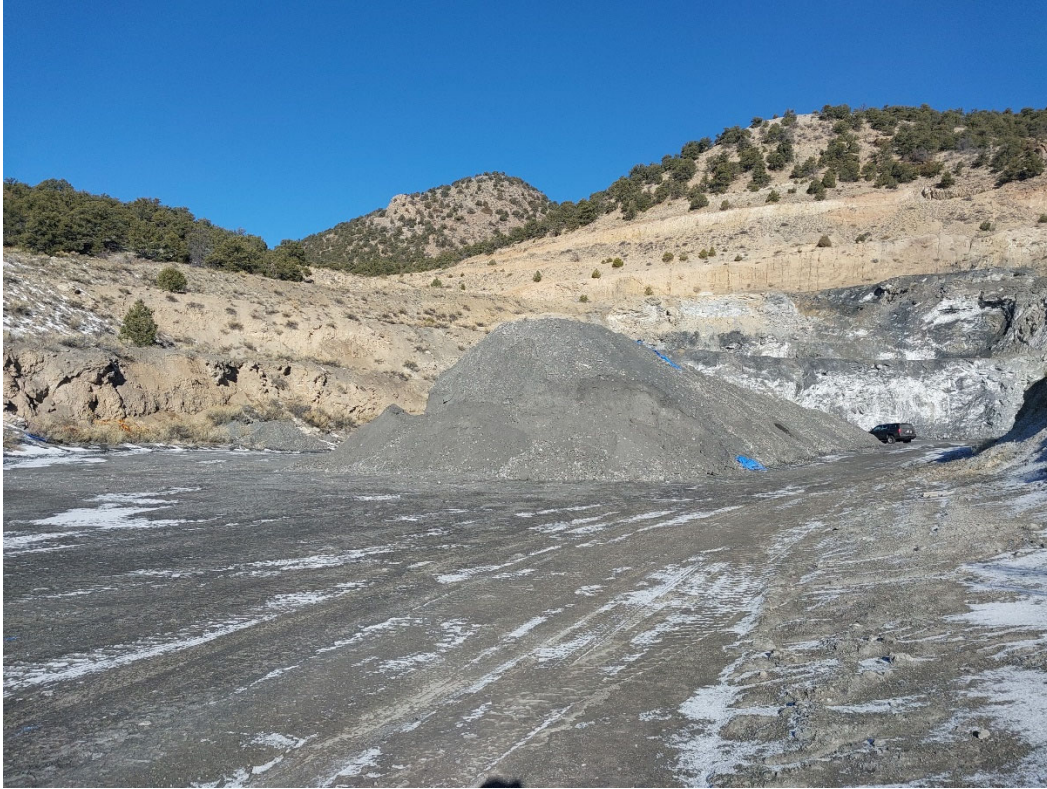
Mining activities were not taking place at the time of the inspection. The mining method utilized at the site is blasting; the quarry walls are blasted and the fragmented gypsite material is then stockpiled. According to Mr. Lionelle, the past activities on site have consisted of removing material from a product stockpile situated in the center of the pit floor to the processing facility. Recent issues with equipment at the facility has slowed the frequency at which material is moved for processing. A few scraps of blue tarp were observed on the stockpile and on an older stockpile located on the west side at the foot of the quarry wall. The tarp had been used to protect the material from the elements but has since been torn up by high winds. Mr. Lionelle stated he would have the scraps cleaned up as soon as possible.

Photo #2: View of the quarry, looking northwest. A stockpile of product material can be seen in the center of the photo. Pieces of a blue tarp can be seen on the side slopes of the stockpile.

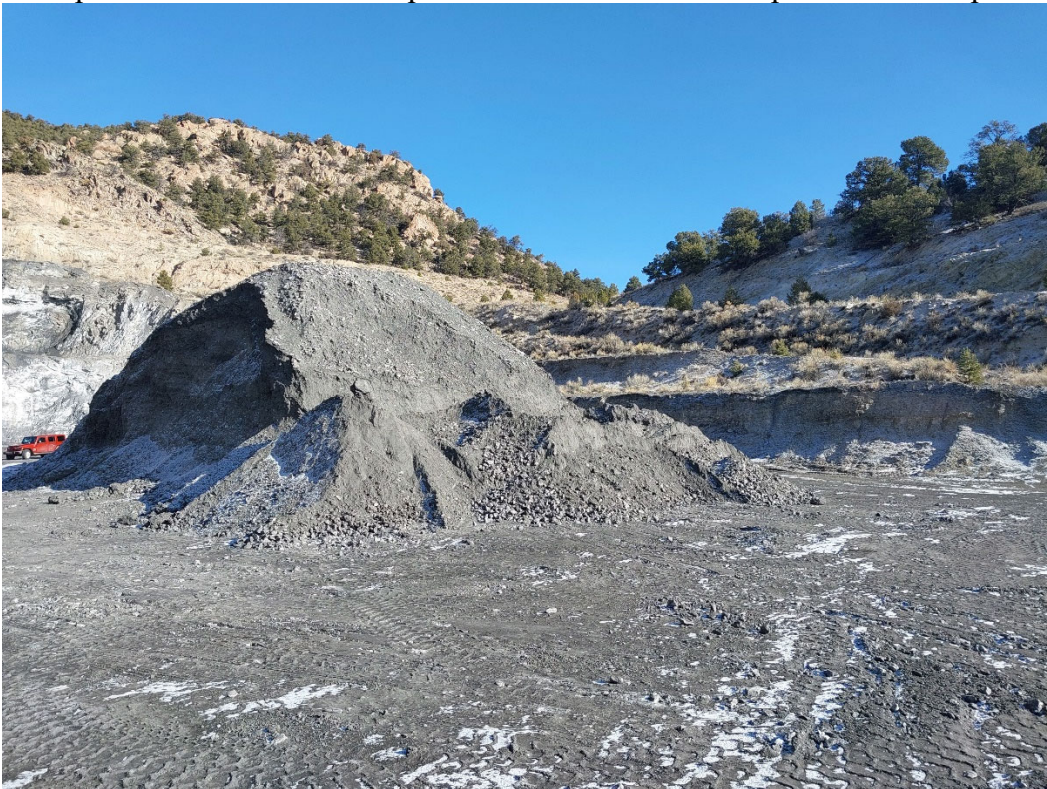
Photo #3: View of the quarry, looking northeast. A stockpile of product material can be seen in the center of the photo.

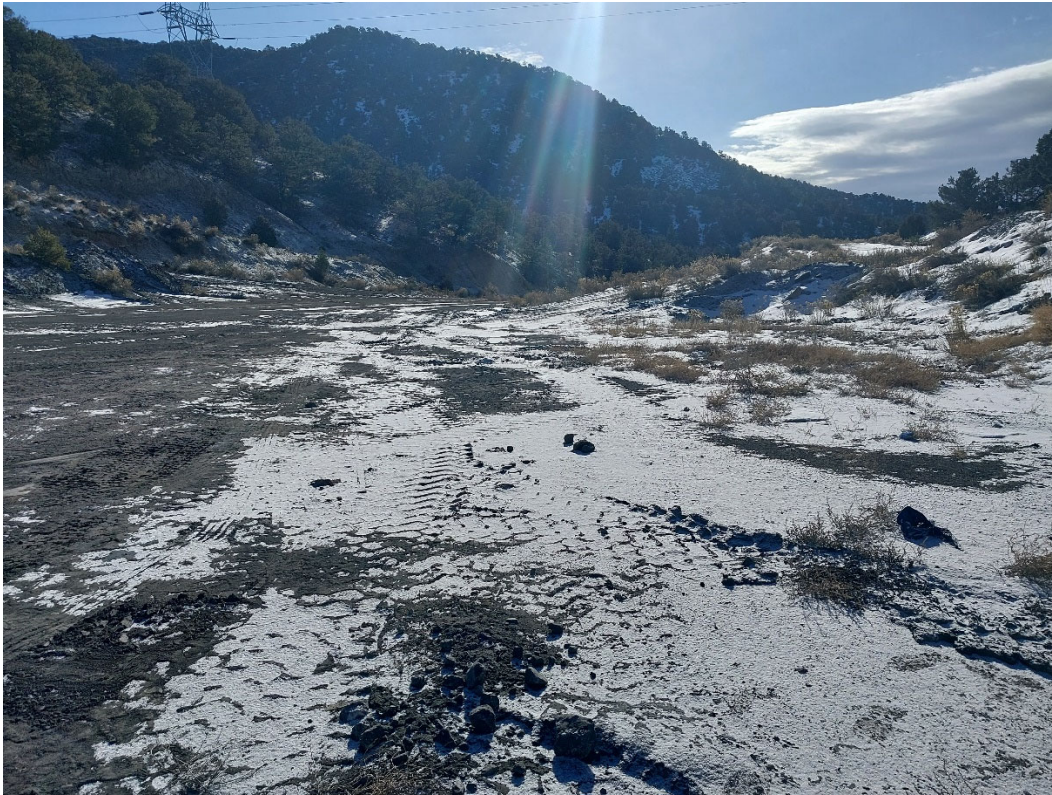
The road between the processing plant and the quarry appeared to be in good condition and is not a source of siltation in the nearby areas.

Photo #4: View of the road, looking south-southeast from the quarry.

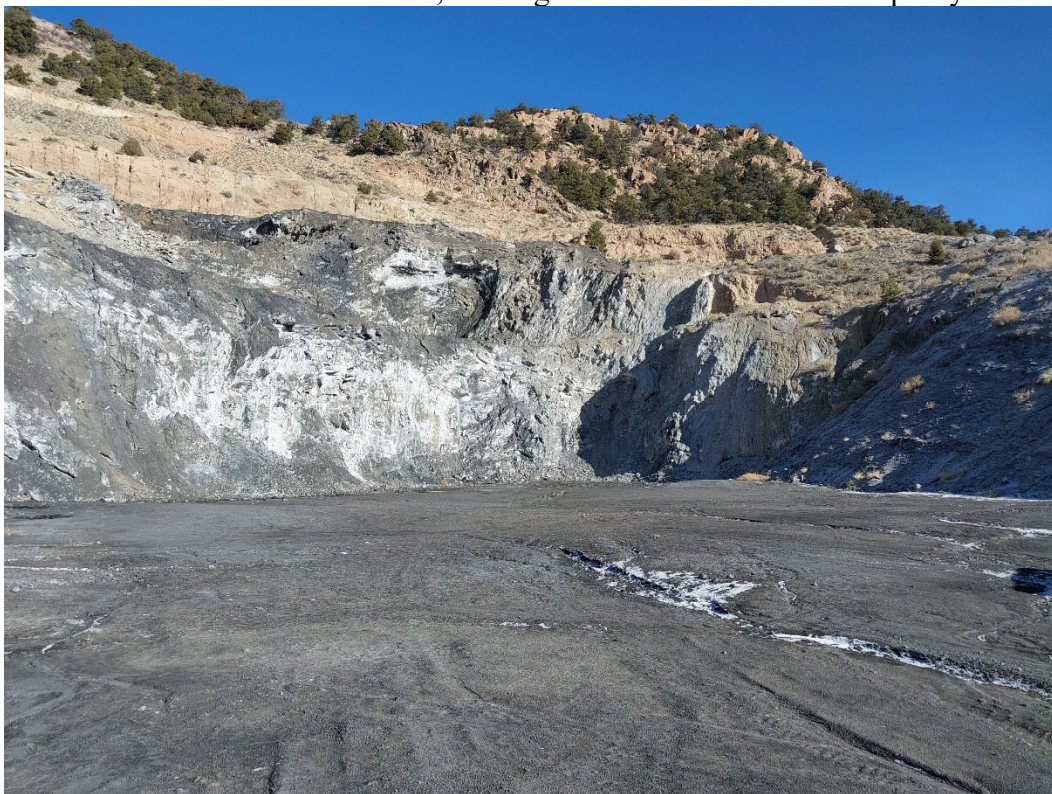
Photo #5: View of the highwall of the quarry, looking to the north.

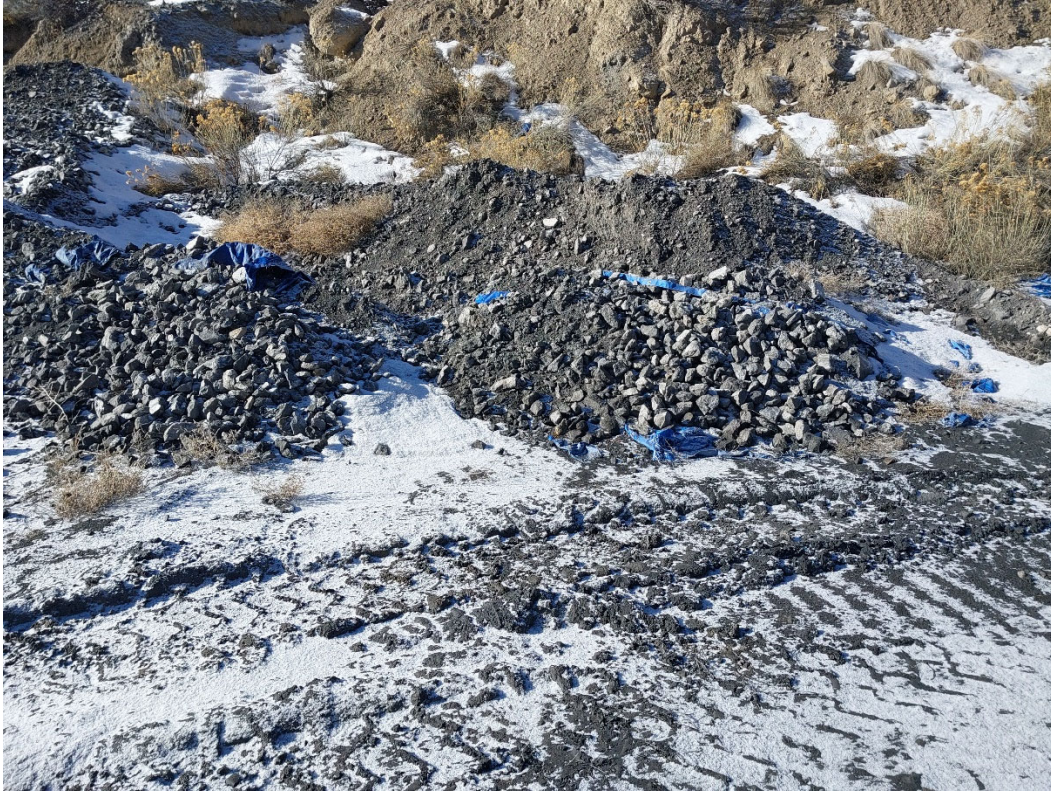
Photo #6: Pieces of blue tarp on remanence of previous product material viewed at the base of the western edge of the pit floor.
