**Inspection Report, February 20, 2025 Cresson Project M-1980-244**

**MINERALS PROGRAM INSPECTION REPORT**  
**PHONE: (303) 866-3567**

| <b>MINE NAME:</b><br>Cresson Project | <b>MINE/PROSPECTING ID#:</b><br>M-1980-244 | <b>MINERAL:</b><br>Gold and silver | <b>COUNTY:</b><br>Teller |

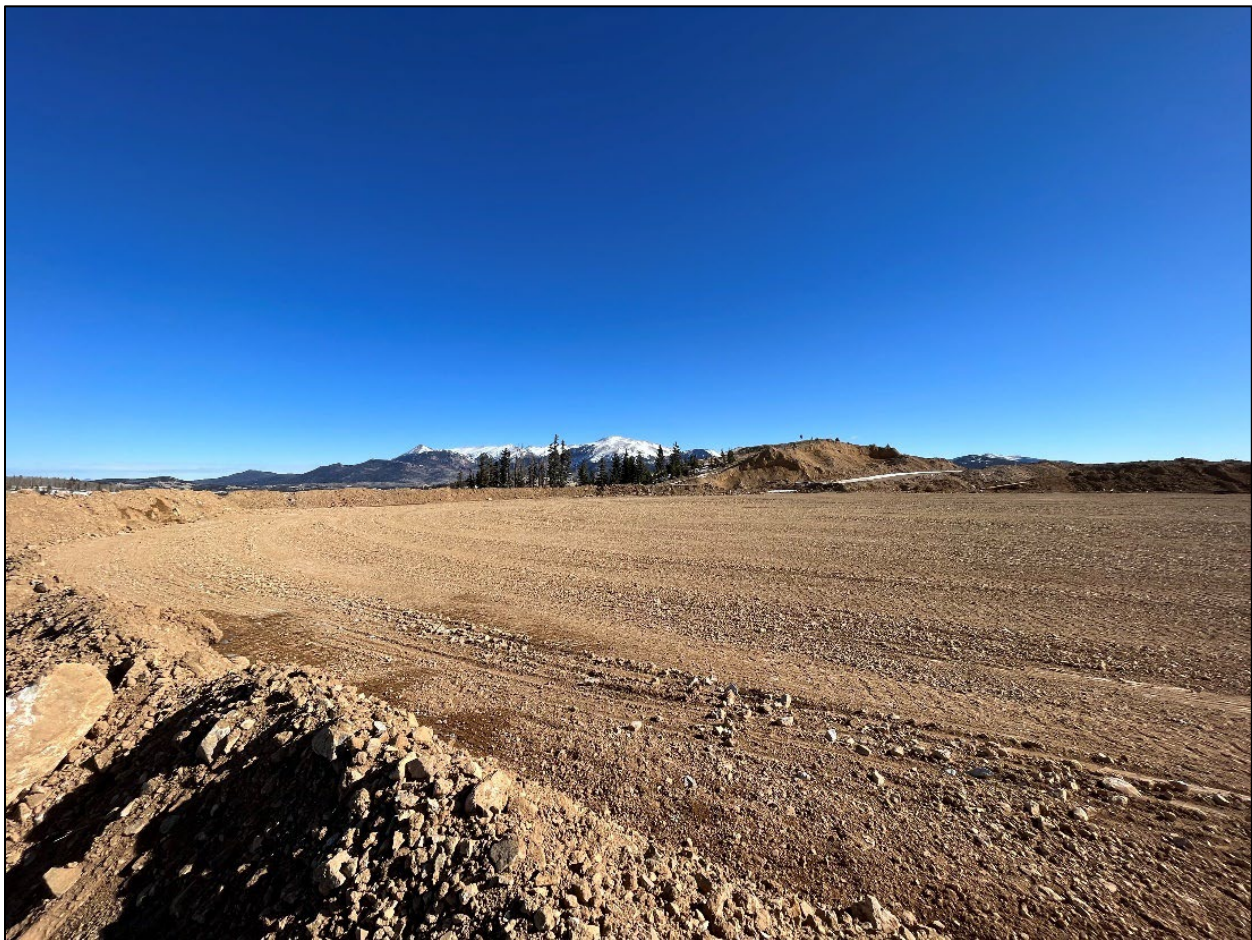
**Photo 1: View northeast of the temporary non-durable stockpile area.**

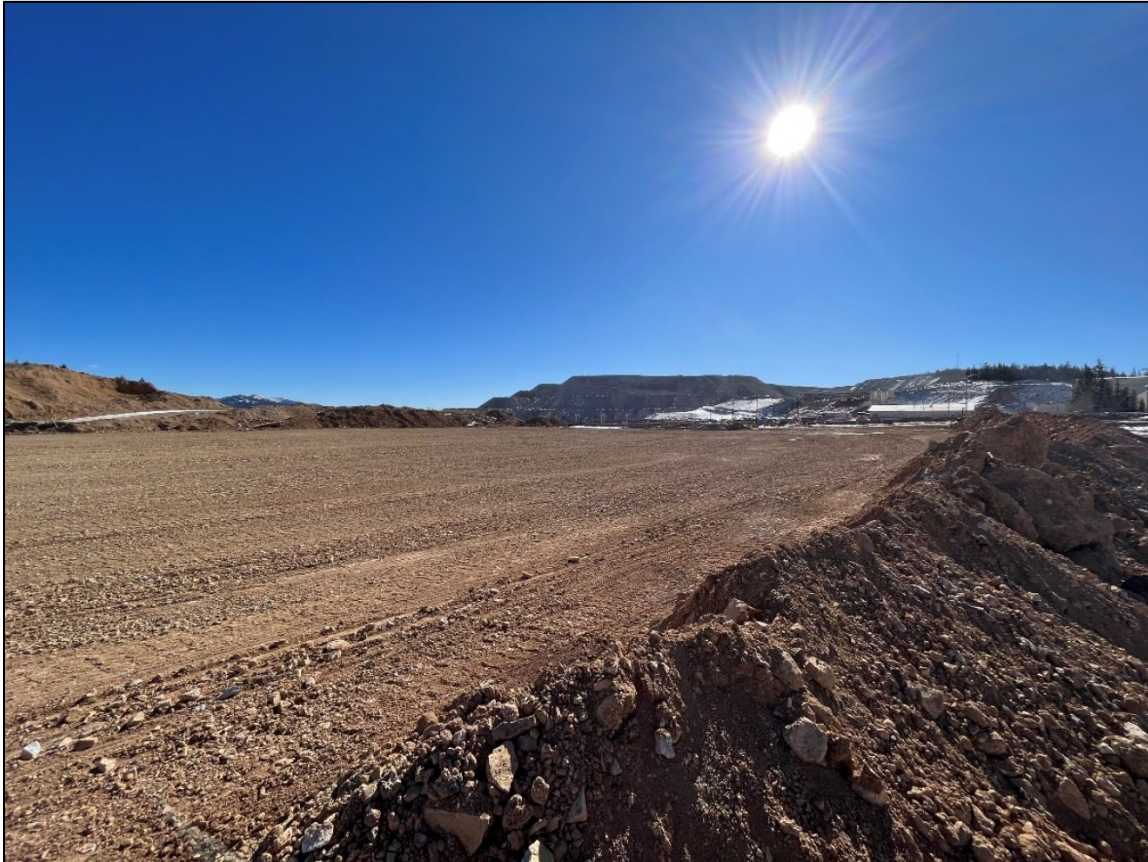
**Photo 2: View southeast of the temporary non-durable stockpile area.**

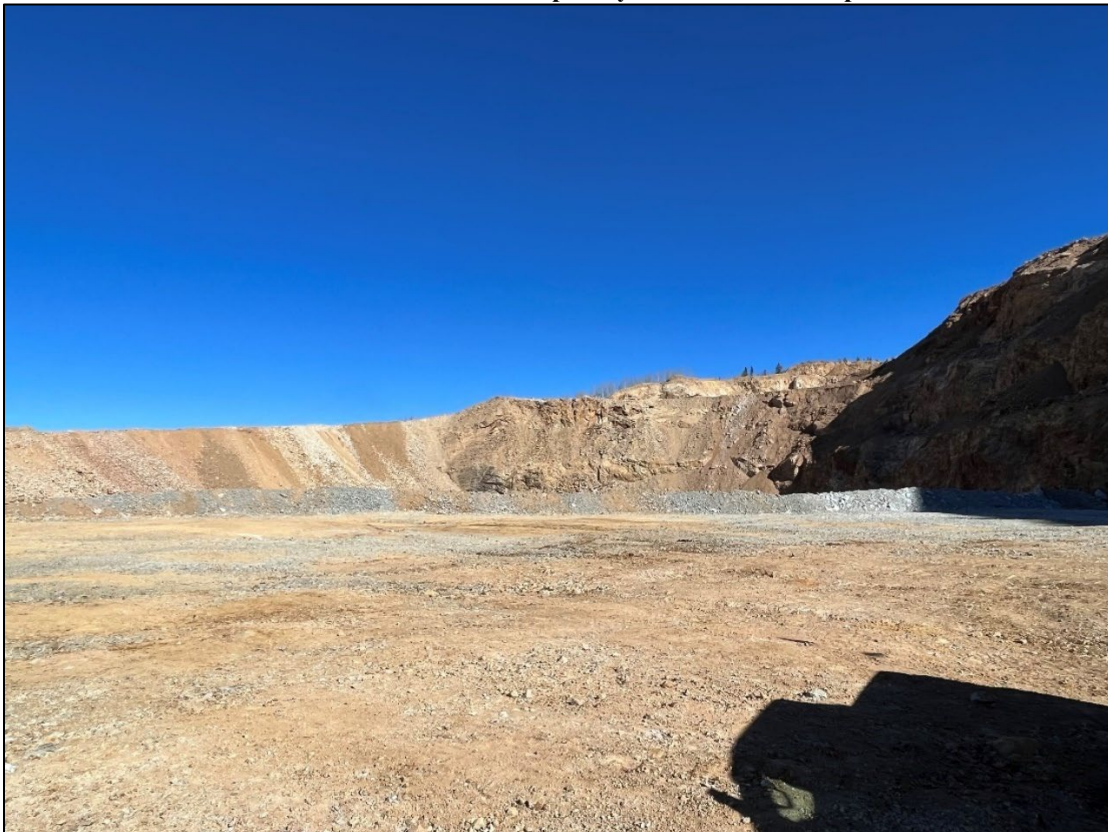
The Schist Island was viewed from above at a southern overlook (Photos 6 and 7) and from the active backfill area (Photos 3 and 5). NewFields representatives were present at the time of inspection and reconfirmed that each 5 or 10 ft lift has been signed off by a member of their team before the next lift was constructed. The low compaction backfill is currently situated to the south and high compaction to the north, both compaction areas are being added to simultaneously. As a result, the high and low compaction areas were more or less at the same elevation at the time of inspection, making distinction less obvious. From above, however, this was more clearly visible. Haul trucks were noted to be actively dumping in the low compaction area, adding to the current 10ft lift. Adits were being filled as the team progressed and the Division confirmed that the inclement weather SOP continues to be followed, requiring snow to be scraped off of the site before placement of fill and or compaction can progress. Material sizes were checked for specifications and found to be within the required limit. No large clumps of rock were observed (Photo 4). Schist Island Phase 2B, to the north, will continue to be mined down. A ramp that connected Globe Hill and Schist Island has been completed, improving the efficiency and transport time for load and dump operations.

**Photo 3: View of the northern end of the Schist Island backfill, looking at the high-grade compaction area.**

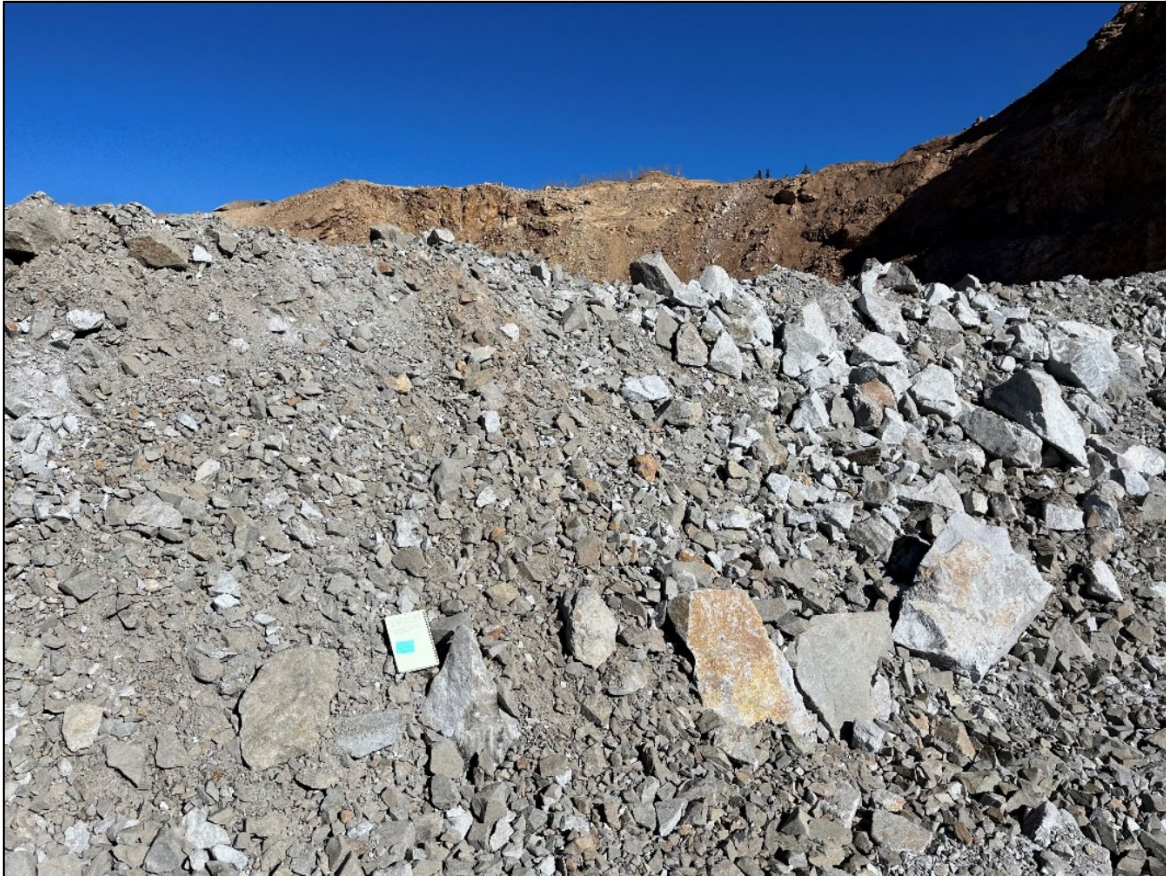
**Photo 4: High grade compaction material, size referenced with a 4.5 x 6 inch notebook.**

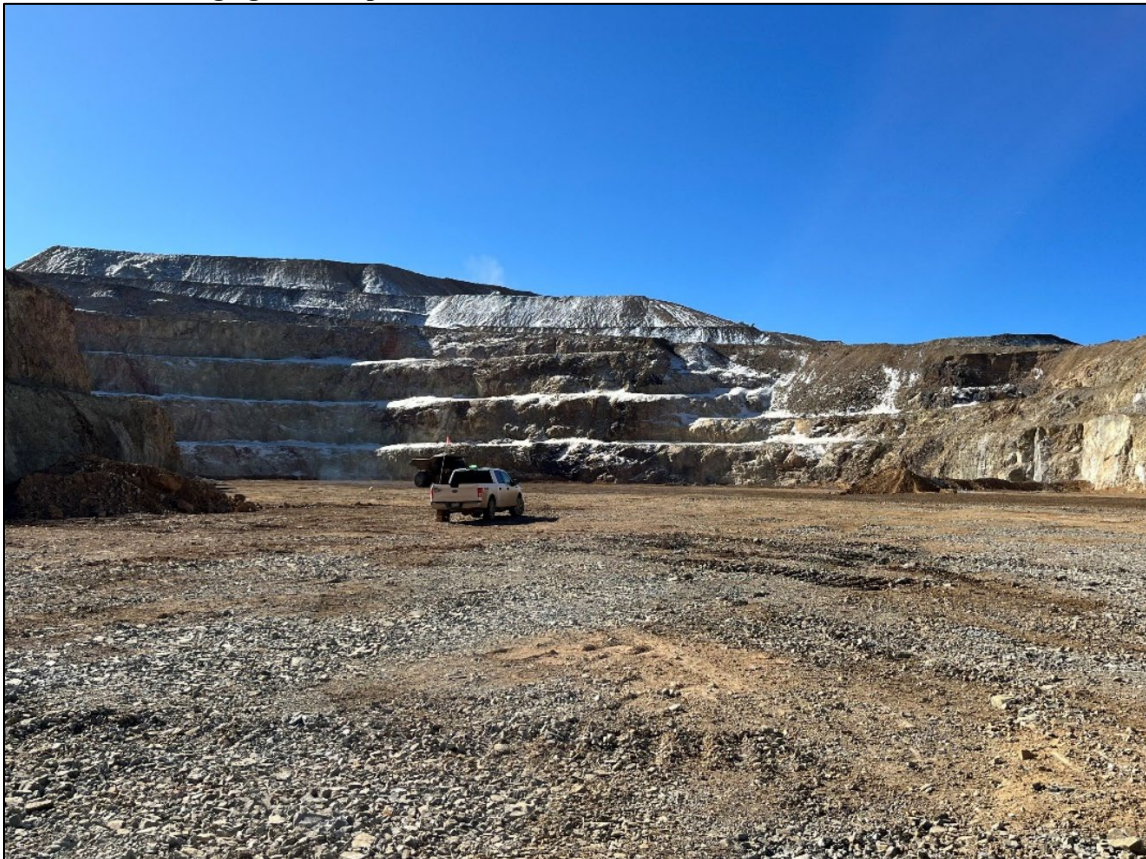
**Photo 5: View south into the Schist Island backfill low compaction area.**

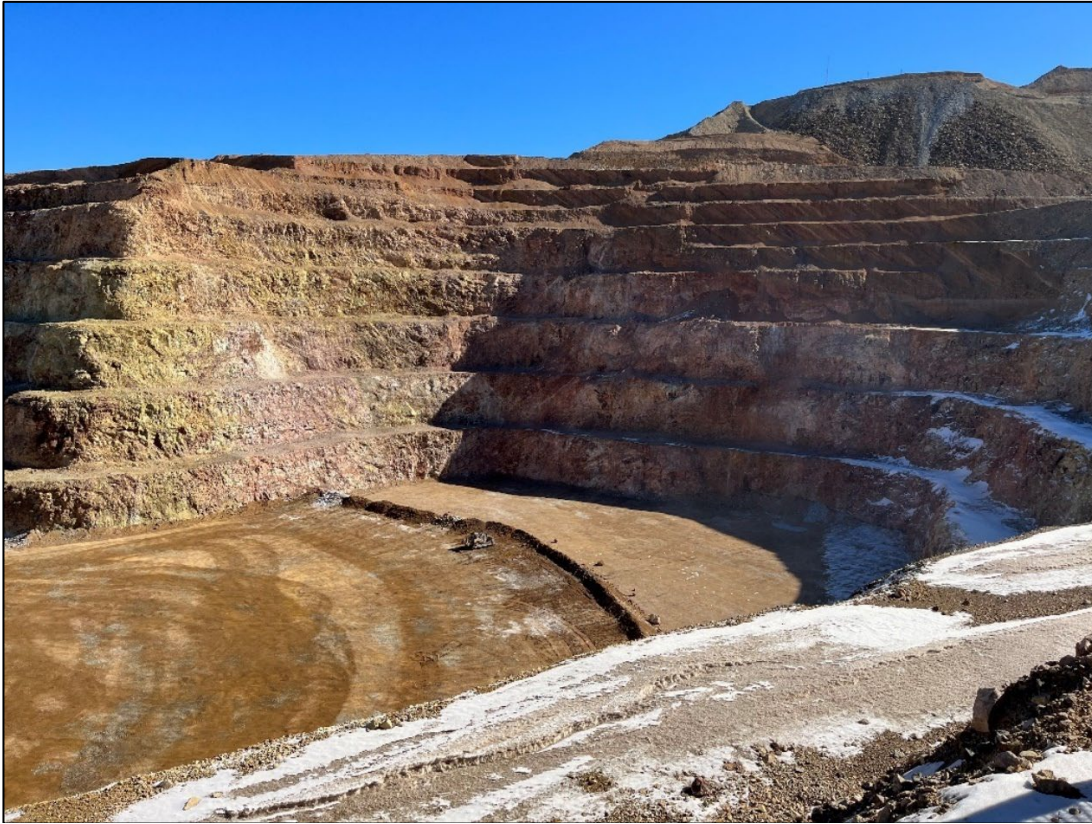
**Photo 6: View northeast from the southern Schist Island overlook, a 10 ft low compaction lift is currently active.**

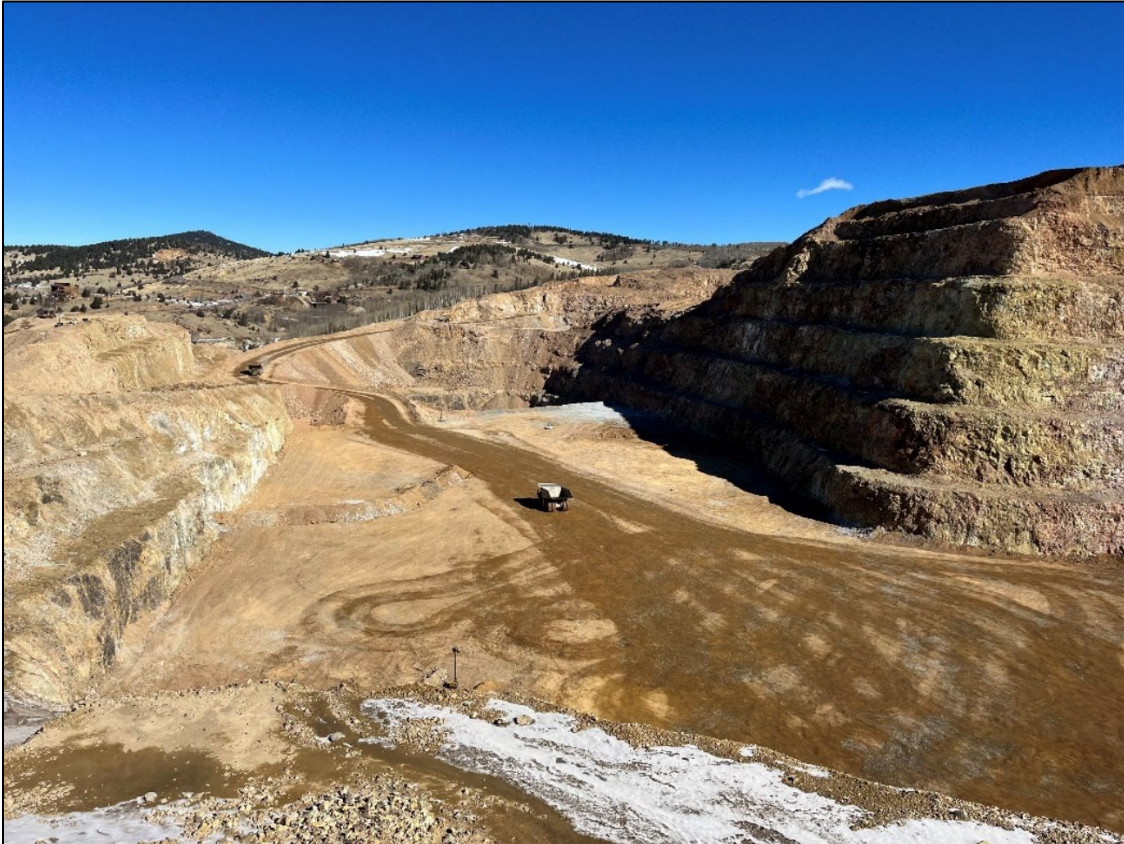
**Photo 7: View north from the southern Schist Island overlook, active hauling to the low compaction zone and delineation from the high compaction zone is visible.**

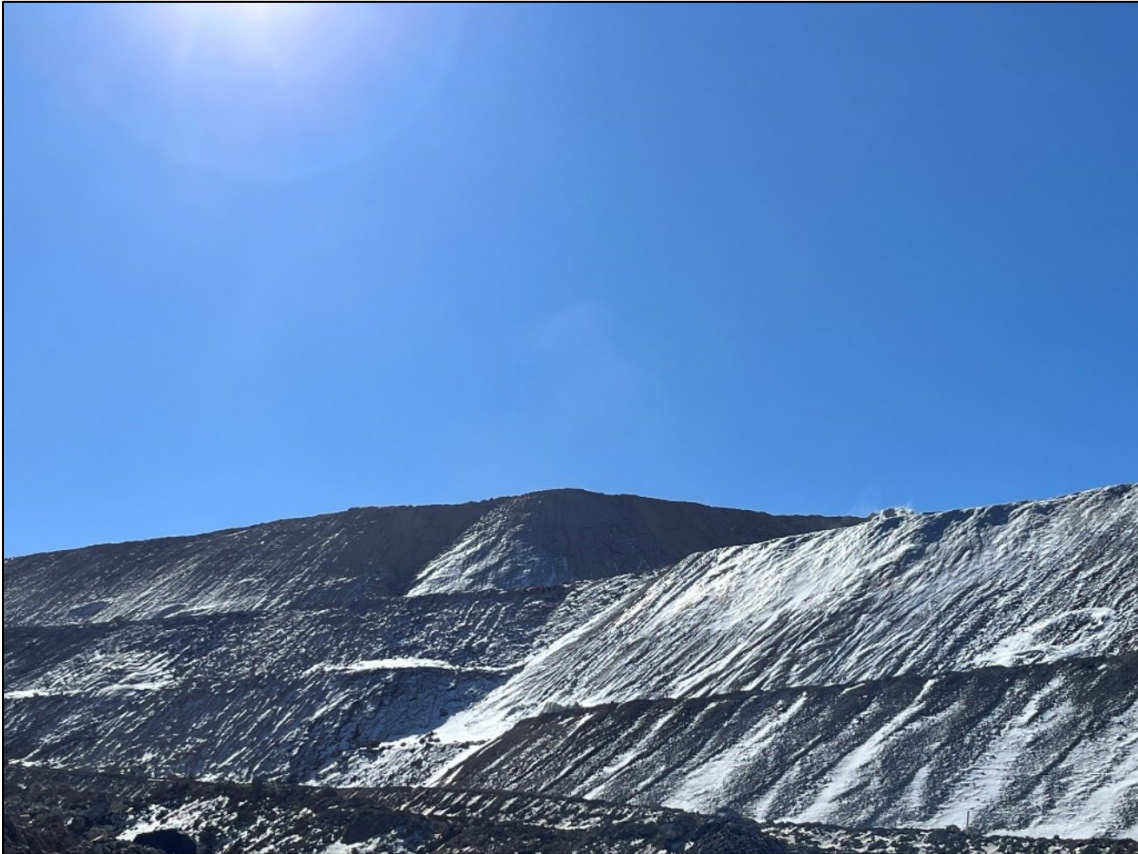
The Division received a courtesy notification from the site on February 13, 2025 regarding a washout event that occurred on February 11<sup>th</sup> at VLF2 Phase 2A at the 10,300 elevation. The email was sent as a courtesy notice and not as an official notification which would be required pursuant to Rule 8.1. However, site representatives stated that the geotechnical team had not yet completed their investigation of the event and thus, site personnel were awaiting these results before attempting to backfill and repair the feature. The material was said to have traveled to the catch bench below but had not traveled anywhere off liner. Site reps also stated that no ponded solution was visible atop the area that washed out. No active leaching is occurring in the area while the event is under investigation. The Division confirmed the presence and location of the washout during this inspection. The washout is located on the north-facing slope of VLF2, directly south of Schist Island (Photo 8). The feature appeared to be small to medium in size when compared to previous washout events on site. The feature does not appear to have progressed in size or severity since the initial notification photograph was sent to the Division (Photo 12). The Division has requested to remain updated on the outcome of geotechnical investigation, regardless of whether or not a Rule 8.1(a) notification is required.

**Photo 8: View south of the VLF2 washout area.**

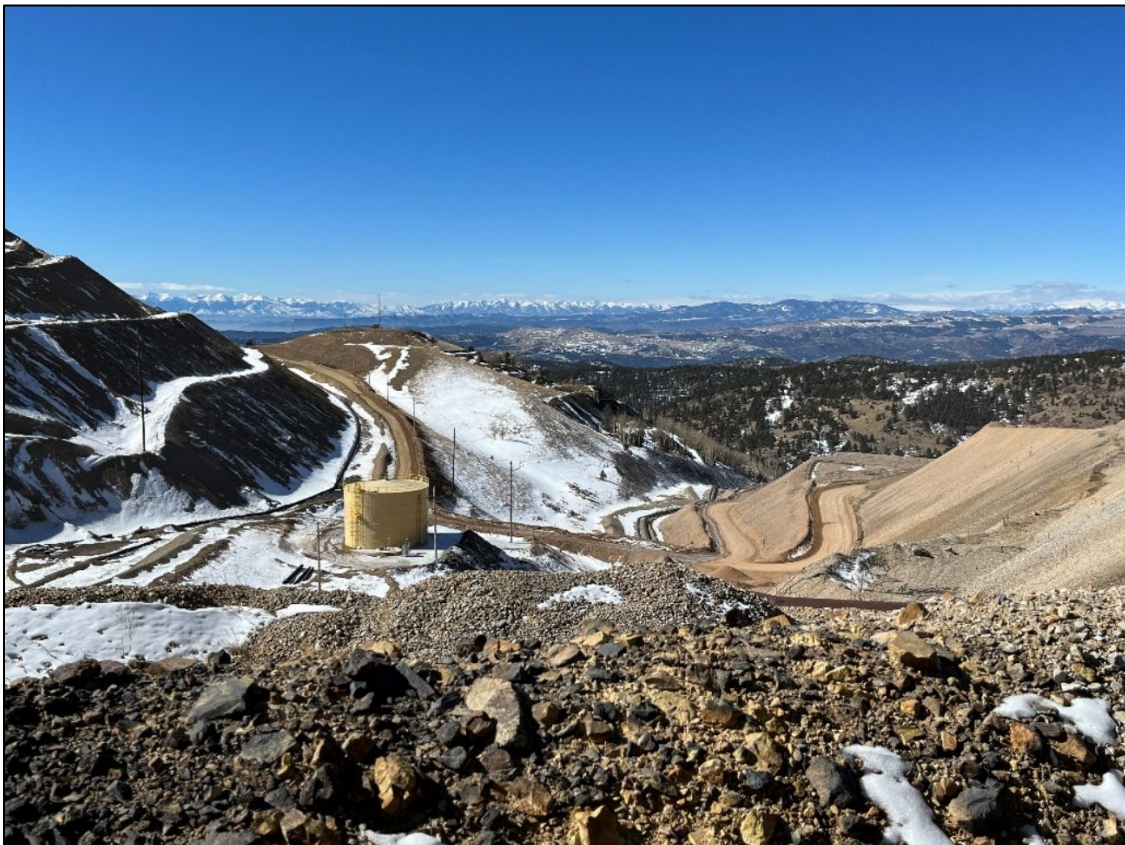
**Photo 9: View southwest of the high grade mill, a leach pad expansion is proposed for this area under Amendment 14.**

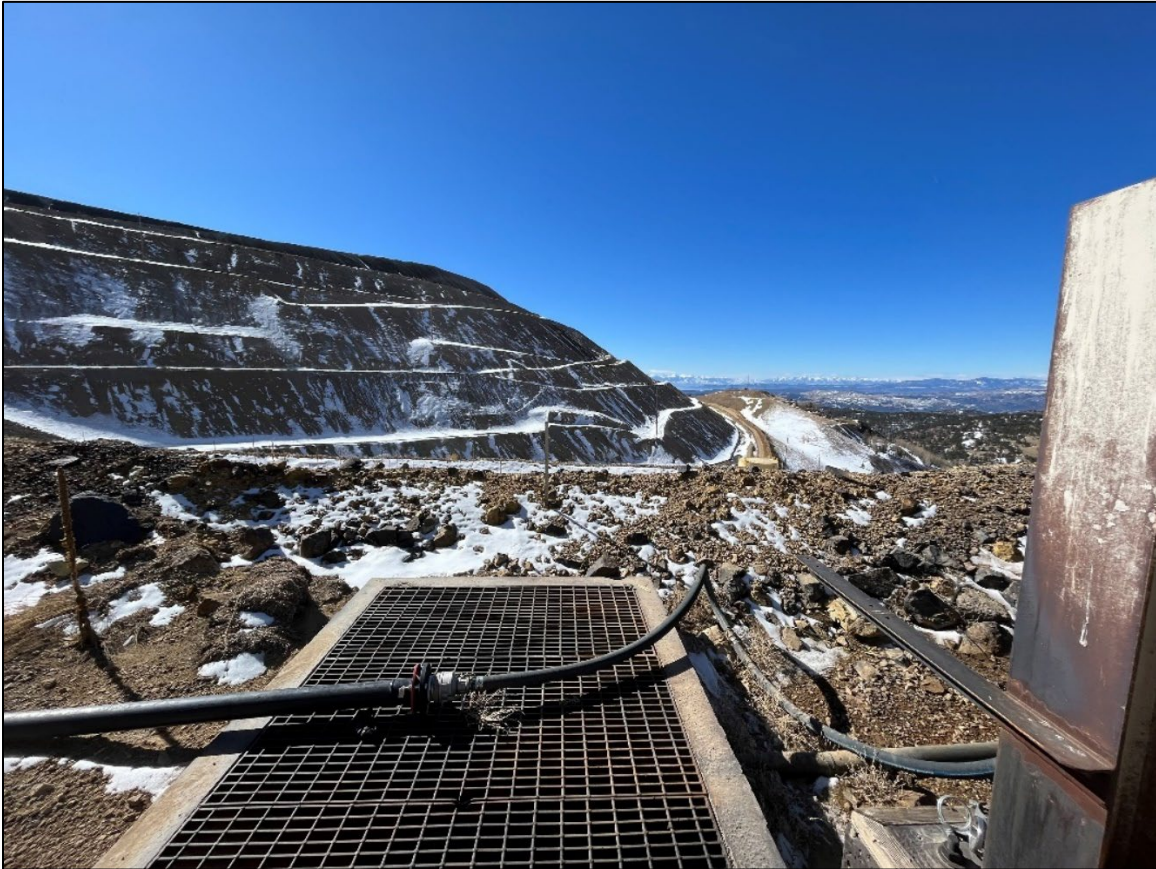
**Photo 10: Sump/pond at High Grade Mill, second sump to the east**

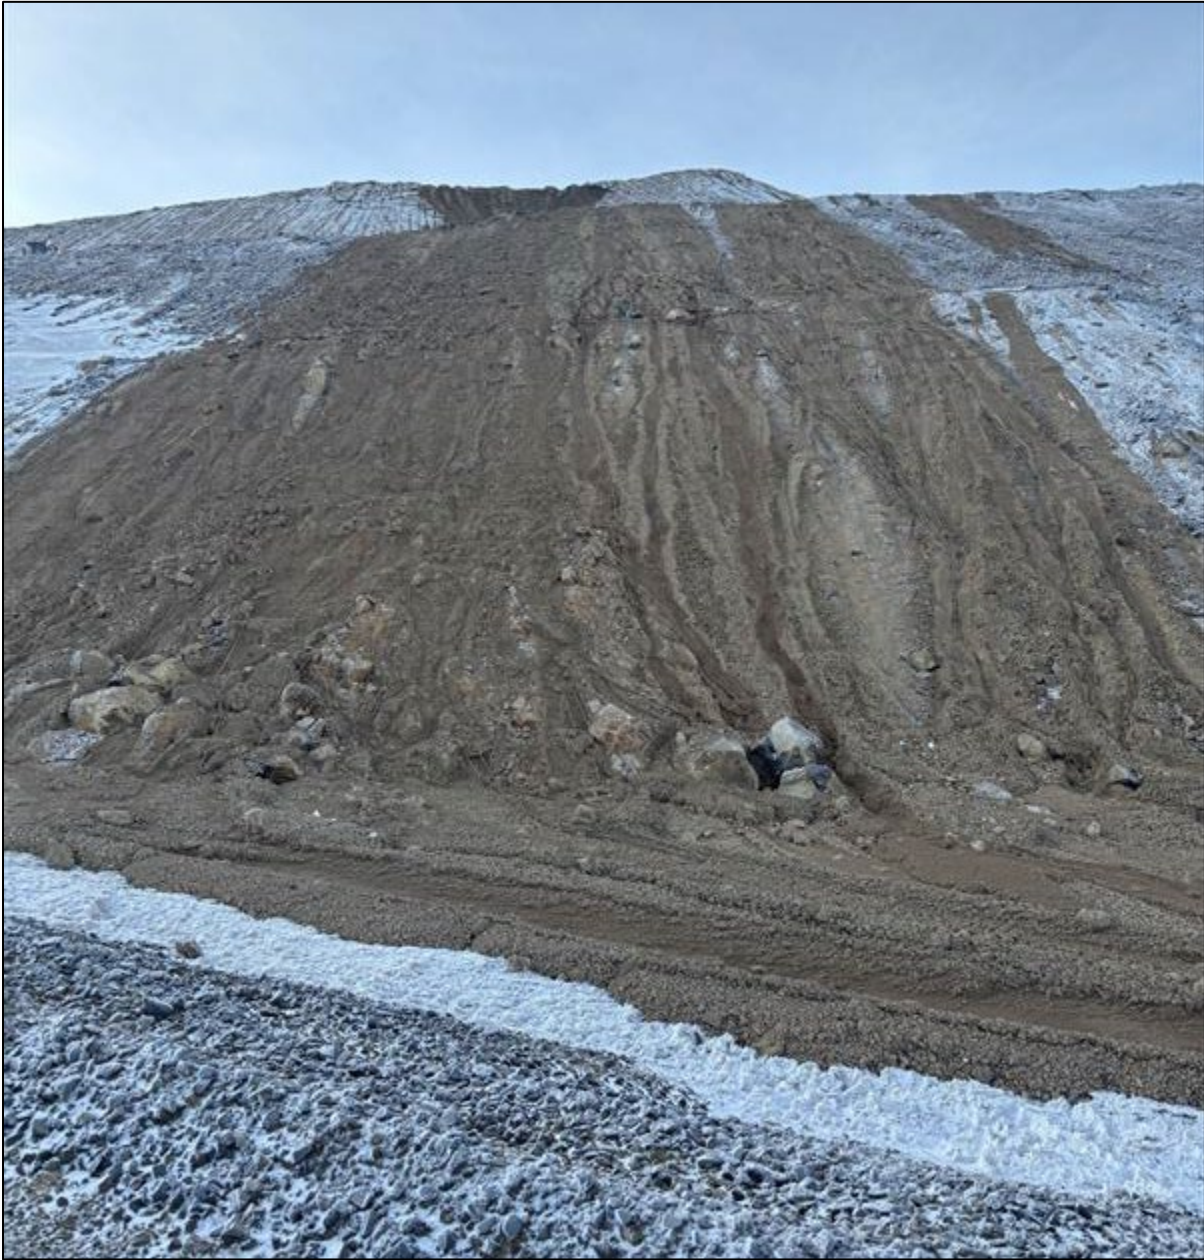
**Photo 12: Photograph sent to the Division on February 13, 2025 regarding the 2/11/25 washout event on VLF2.**

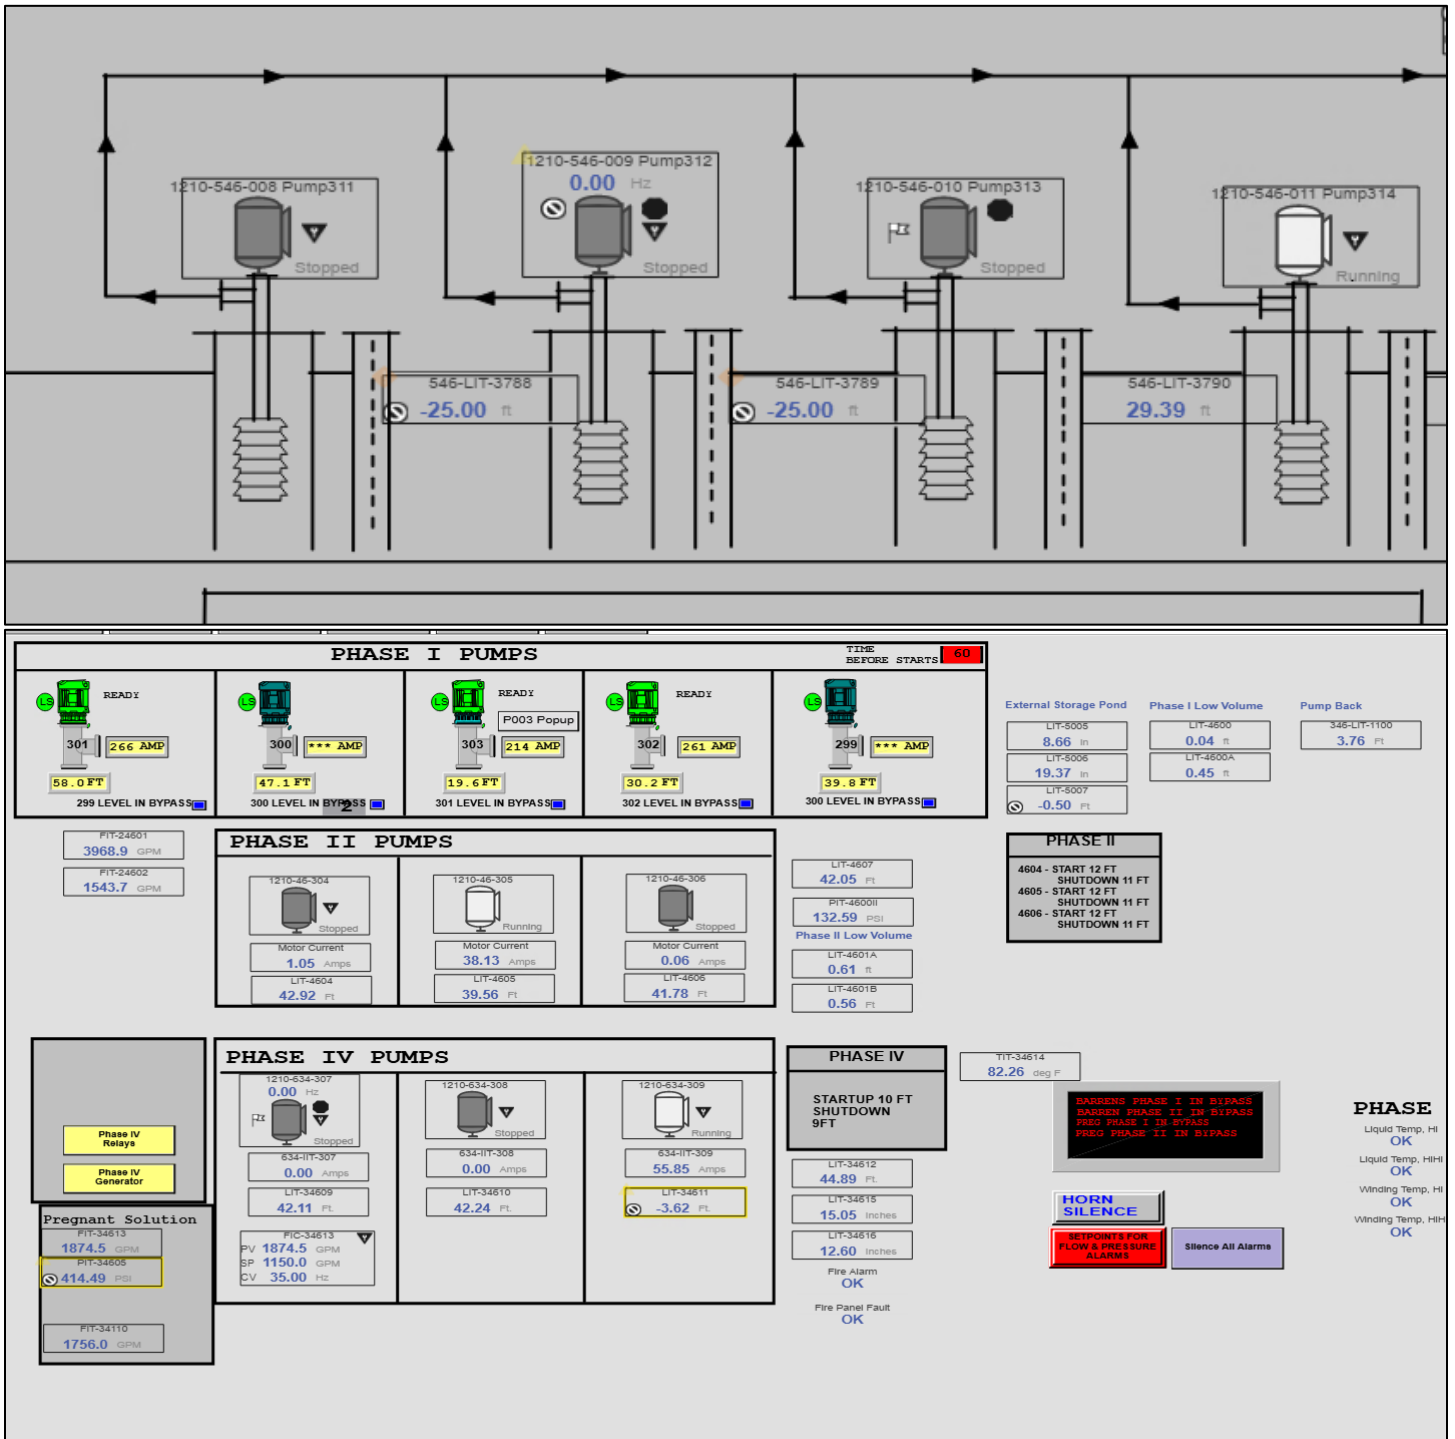
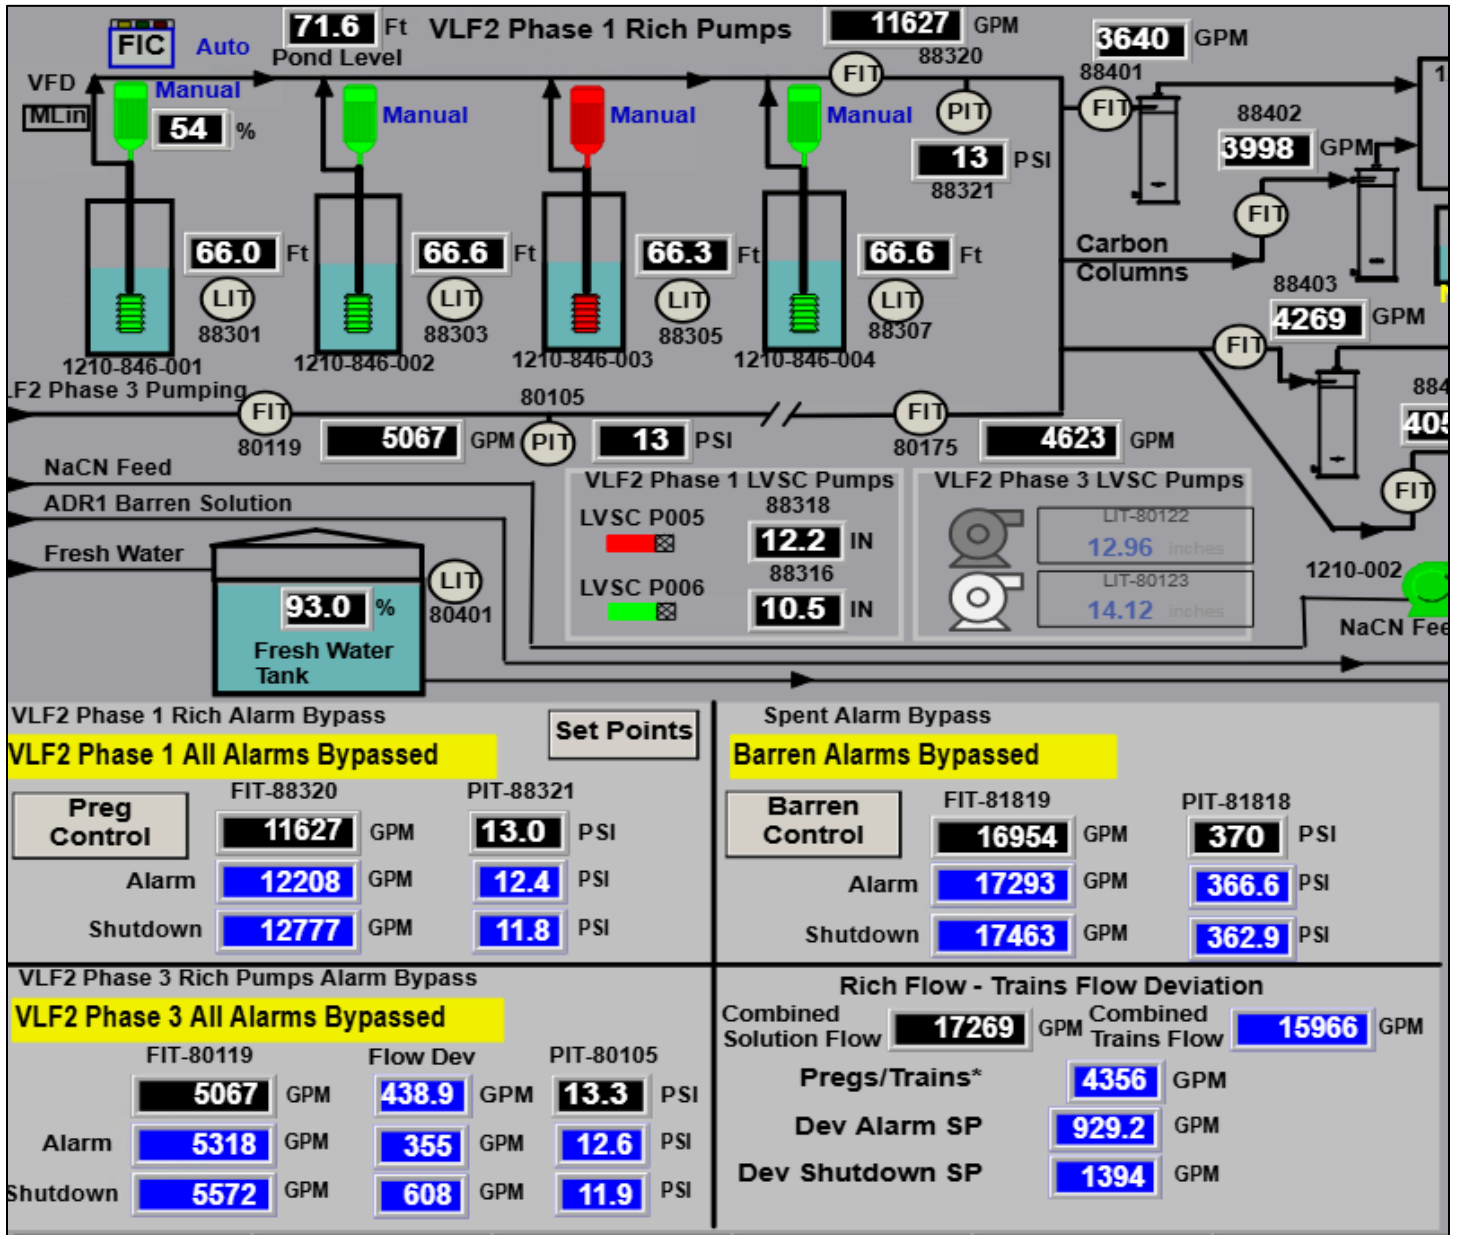
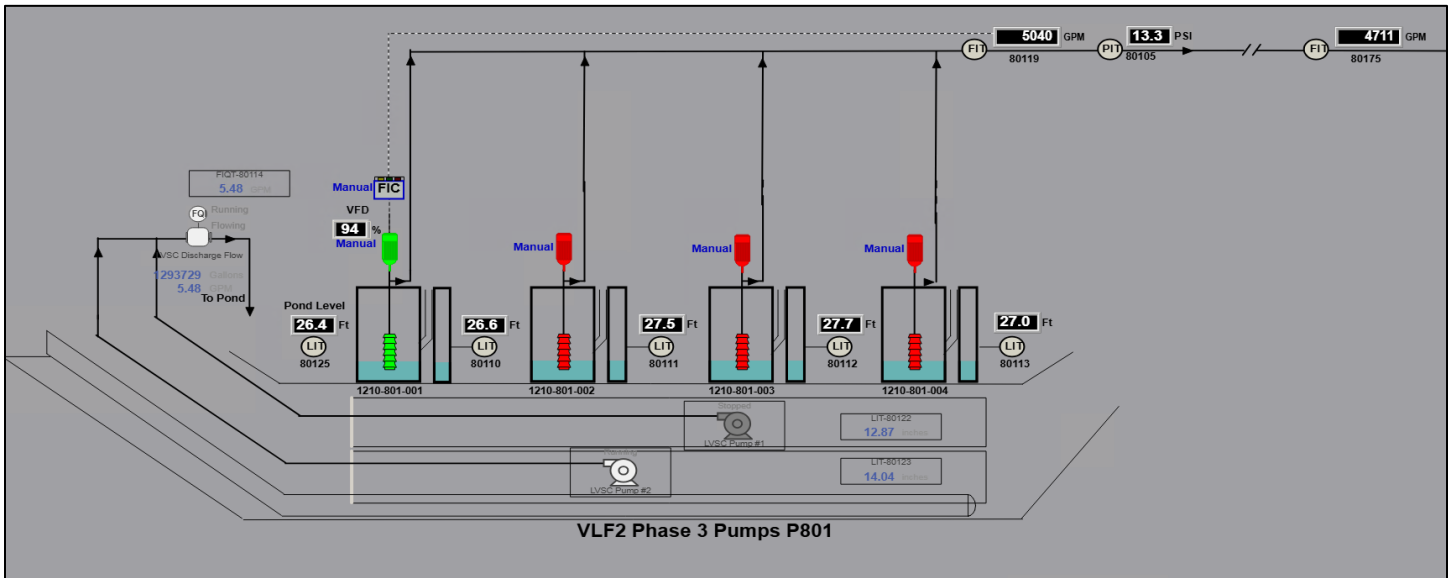
**PROBLEM/POSSIBLE VIOLATION:** Problem: The VLF2 Phase 3 PSSA piezometer outside the drawdown cone area indicated the water level outside the pump drawdown area was 0.20 ft feet lower than in the pump drawdown area, a trend opposite of what would be expected.

The ADR was inspected, and the remote monitoring system that monitors solution levels in VLF1 and 2 were observed. The Operator provided screen shots of the monitoring system taken at the time of the inspection (See below). All pump levels and flow rates appeared to be within operational norms for the site, and no problems were identified. The screen shots are included with this report. Included in the screen shots is information on the 'Report Level' which correlates with the Division's required 80% containment notification trigger. All high volume pumps, low volume pumps, and ponds presented on the screenshots were below required reporting levels. **However, the Division is noting a problem citation based on the observation that the pond level reading for the VLF2 Phase III piezometer (LIT-80125) was lower than the recorded levels in the individual High Volume Solution Collection System (HVSCS) pumps.** It is the Division's understanding that the compliance pond piezometer LIT-80125 is located outside the cone of influence of draw down from the high volume pumps. If the piezometer is outside the influence of the drawdown cone for the four HVSCS pumps, then it should have a greater depth, yet the piezometer depth reading is approximately 0.20 ft feet below that of the pump transducers. The piezometer outside the drawdown cone area is a critical check for the VLF2 PSSA to ensure the pool is below the 80 percent volume as is the limit in the currently approved permit. Please

confirm for the Division that the system's calibration is up to date and report why the piezometer reading is lower than the level recorded at the operational HVSCS pump.

**CORRECTIVE ACTIONS:** CC&V must resolve to the Division's satisfaction the apparent discrepancy in the VLF2 Phase 3 PSSA piezometer depth.
