C-1981-008 New Horizon February Partial Inspection Report

Permit Number: C-1981-008 Mine Name: New Horizon Mine Operator: Elk Ridge Mining and Reclamation, LLC Operator Address: Mr Tony Tennyson P.O. Box 628 27646 West 5th Avenue Nucla, CO 81424	County: Montrose Operation Type: Surface Permit Status: Active Ownership: Private
	Operator Representative Present: None
Operator Representative Signature: (Field Issuance Only)

Inspection Start Date: February 26, 2025 Inspection Start Time: 10:29 Inspection End Date: February 26, 2025 Inspection End Time: 11:08	Inspection Type: Coal Partial Inspection Inspection Reason: Normal I&E Program Weather: Clear
Joint Inspection Agency: None	Joint Inspection Contacts:
Post Inspection Agency: None	Post Inspection Contacts:
Inspector(s): Lucas West	Inspector's Signature:

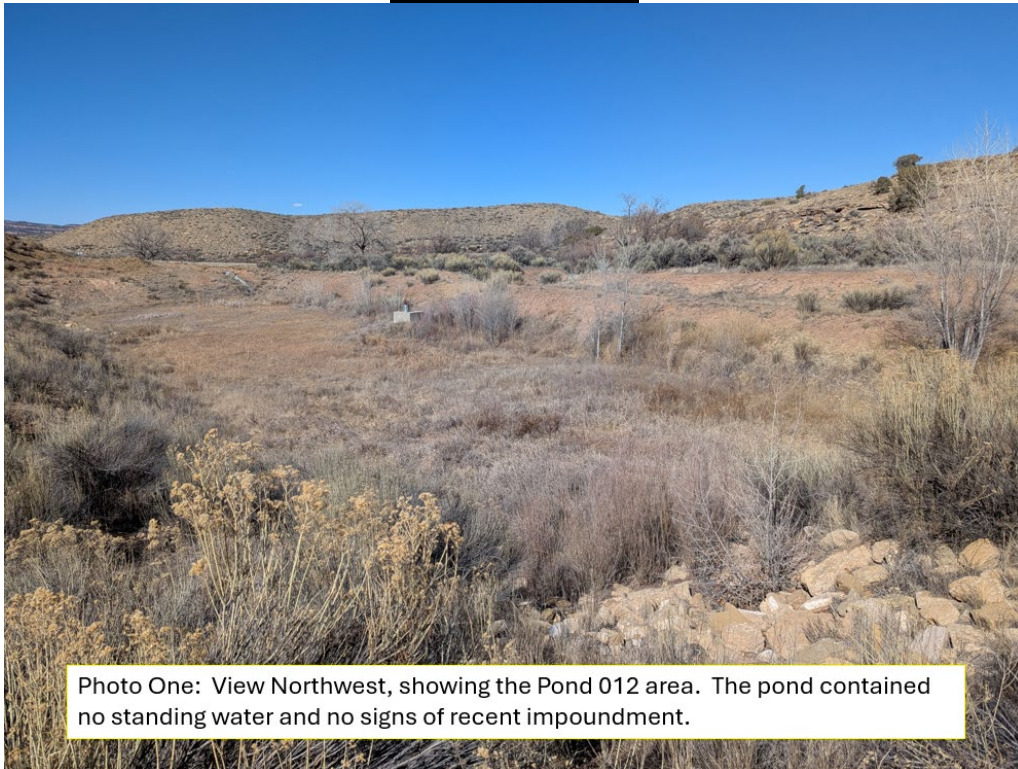
The main focus of this inspection was in the Northeastern areas of the site which included Pond 12. The pond 12 area was observed to be in excellent condition. The pond contained no standing water and no recent signs of impoundment. The pond can be seen in Photo One. The banks of the pond are well vegetated and appeared stable at the time of the inspection. A portion of the contributing ditch was observed and found to be free from obstruction and able to convey water as designed.

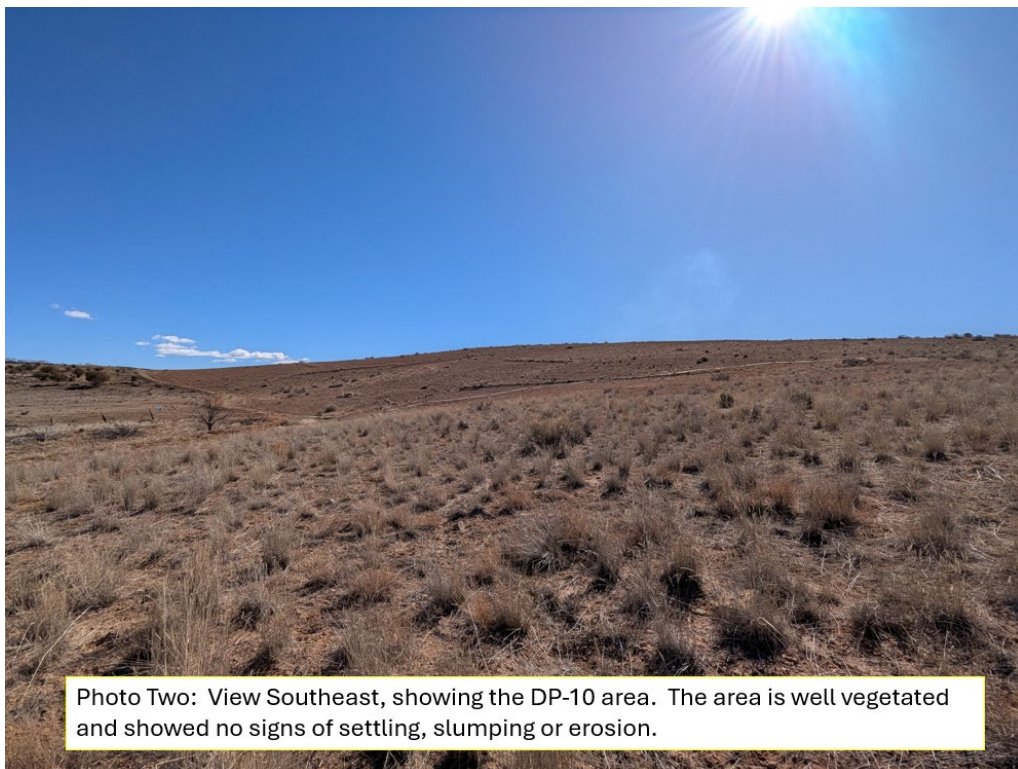
In the Northeast sections of the permit area, the DP-10 and 18 areas were observed. The areas were found to be in excellent condition with dense and diverse vegetative cover that was as good or better than adjacent undisturbed lands. No signs of settling, slumping or erosion was noted throughout the area and examples of the areas can be seen in Photos Two and Three respectively.

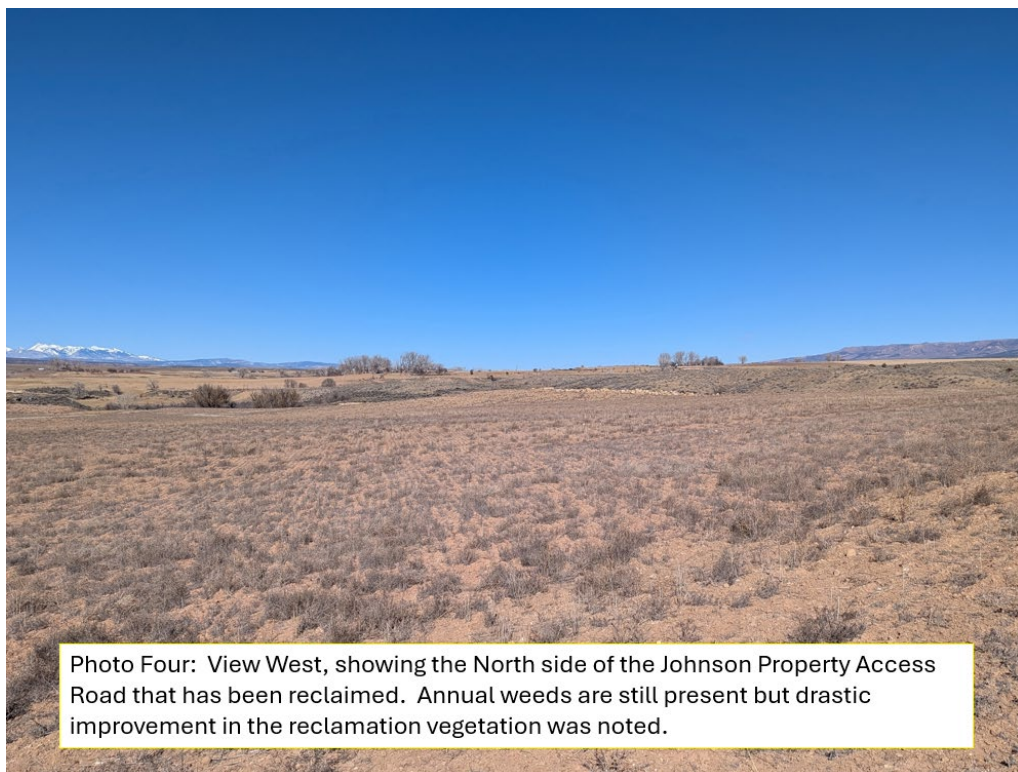
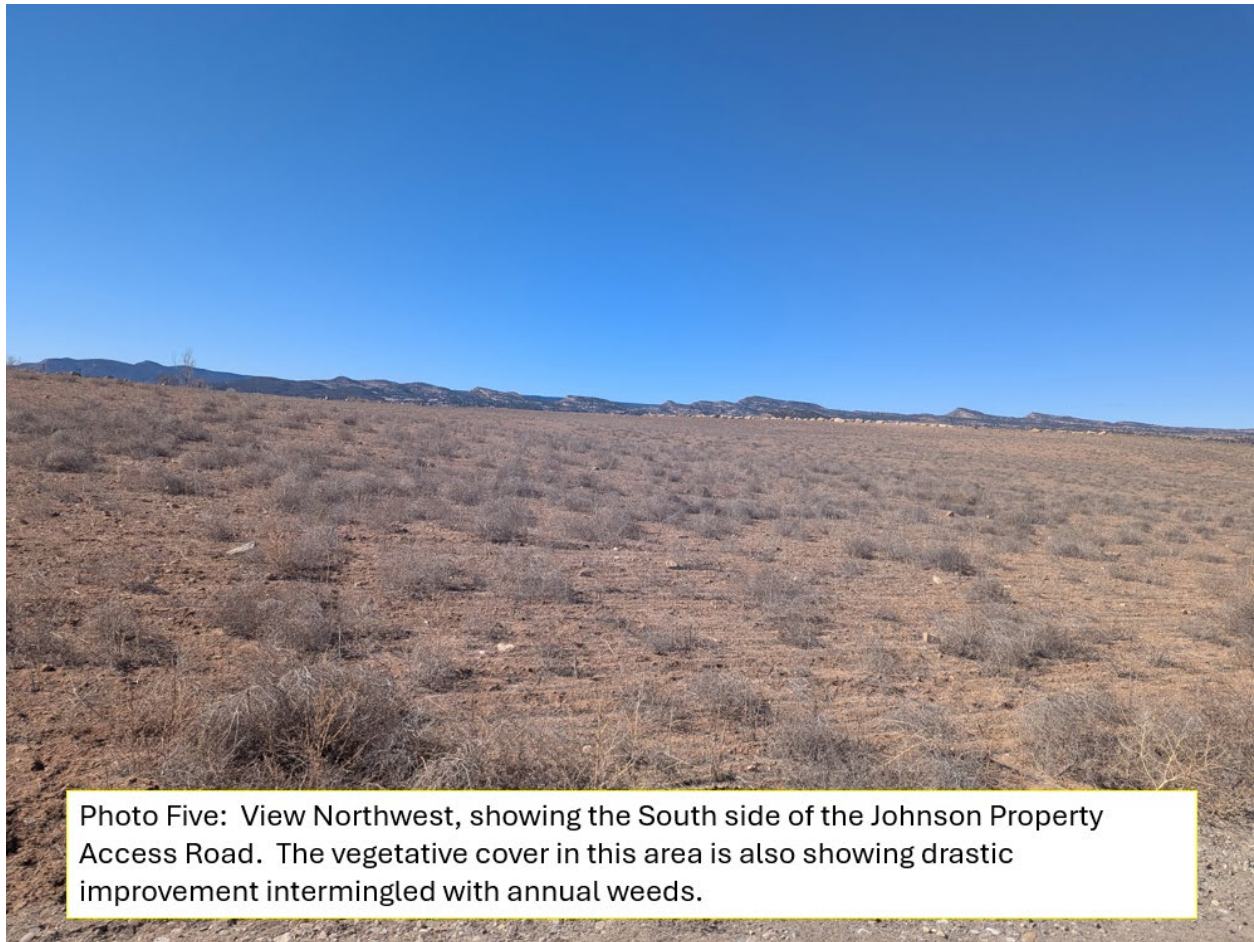
Additionally, the vegetative cover of the backfill area on both sides of the Johnson Property access road was observed. Since the revegetation was completed, the vegetative cover has been predominately dominated by annual weeds. However, as seen in Photos Four and Five, the reclamation vegetation is making significant improvements. Annual weeds are still present however more reclamation species have been identified.
