SUBJECT:	Adaptive Management and Monitoring Phase
	Vermillion Creek Restoration at Diamond Peak Ranch - 2024 Annual Report -
FROM:	Julie Ash, PE, Johannes Beeby, and Karin Emanuelson, Stillwater, Jon Dauzvardis, PWS, ECOS, Casey Cisneros, Greenback Environmental
TO:	Angelo Raftopoulos, Gene Riordan and Agency Team
DATE:	December 19, 2024

1 INTRODUCTION

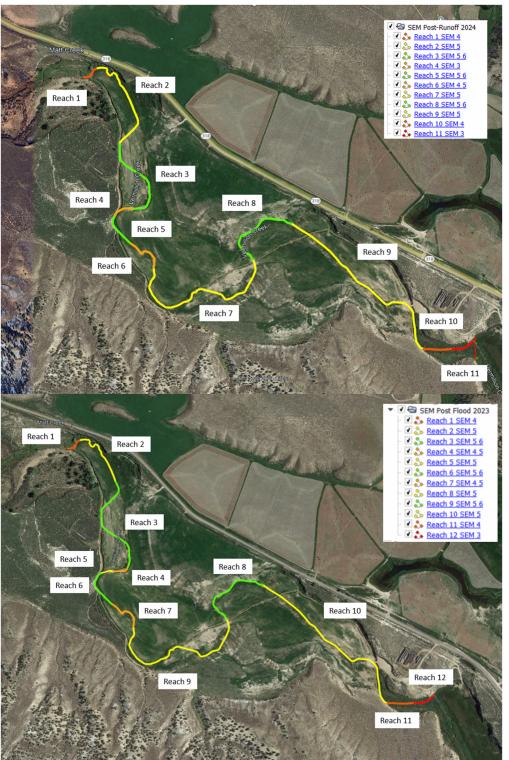
Figure 1 - Stream Evolution Model (SEM) assessment results from 2024 (top) and 2023 (bottom).

Overall, the SEM assessment showed minimal change in SEM stage from 2023 to 2024. Only one SEM reach changed trajectory in the lower half of the project area (Figure 1). Reach 5 showed slightly more channel incision since 2023 which changed its stage from SEM 5 (Aggradation and

Widening) to SEM 4/5 (Degradation and Widening/Aggradation and Widening). Consequently, Reach 5 was merged with Reach 4 since they now have the same SEM stage.

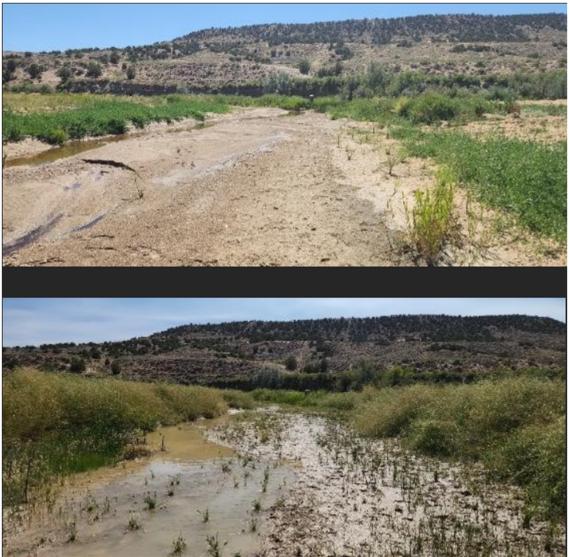
Generally, some minor channel incision (~1ft or less) did occur at the downstream end of the project area between 2023 and 2024. However, the incision was not resulting in degradation and widening, therefore, the SEM stages stayed the same. Vermillion Creek in the upper half of the project area showed no significant change. Overall, vegetation is beginning to establish along the channel bottom which will help push Vermillion Creek towards Stage 6 (Quasi-equilibrium), Stage 7 (Laterally Active), or Stage 8 (Anastomosed) (Figure 2).

Figure 2 - Vegetation is beginning to establish along the channel bottom which help push Vermillion Creek towards SEM stage 7 and/or stage 8.
