### MINERALS PROGRAM INSPECTION REPORT

<b>MINE NAME:</b> Buss Barrow Pit	<b>MINE/PROSPECTING ID#:</b> M-2019-021	<b>MINERAL:</b> Borrow material for construction	<b>COUNTY:</b> Fremont
<b>INSPECTION TYPE:</b> Monitoring	<b>WEATHER:</b> Clear	<b>INSP. DATE:</b> January 30, 2025	<b>INSP. TIME:</b> 11:00
<b>OPERATOR:</b> Fremont Paving & Redi-Mix, Inc.	<b>OPERATOR REPRESENTATIVE:</b> Ms. Jodi Schreiber	<b>TYPE OF OPERATION:</b> 111 - Construction by Government Agency

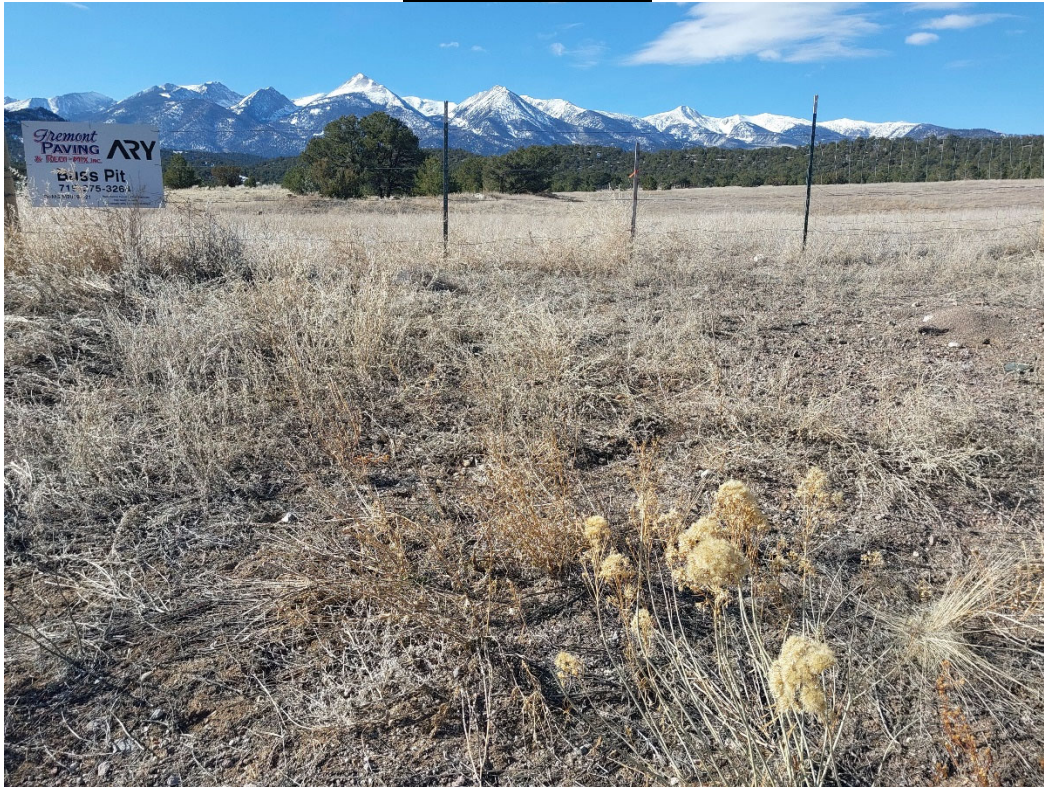
The permitted area was not accessible at the time of the inspection. The landowners have fenced the mine entrance and according to Ms. Schrieber, Fremont Paving & Redi-Mix, Inc. no longer have right of entry to the property. The inspection was conducted from the southwest shoulder of U.S. Highway 50 which is adjacent to the permitted area. The mine sign was posted on the fence where the site entrance used to be, see Photo #1. The reclaimed pit could be seen at a distance, see Photo #2.

A sign was present at what is assumed to have been the site entrance, see Photo #1. The sign does comply with the requirements outline in Rule 3.1.12(1). The sign was posted on a continuous fence and, as stated above, the site was not accessible. Permit boundary markers were not able to be verified.

Photo #1: Mine sign (left side of the image), as required by Rule 3.1.12(1), located adjacent to what was the pit entrance. The area is now fenced off and inaccessible.

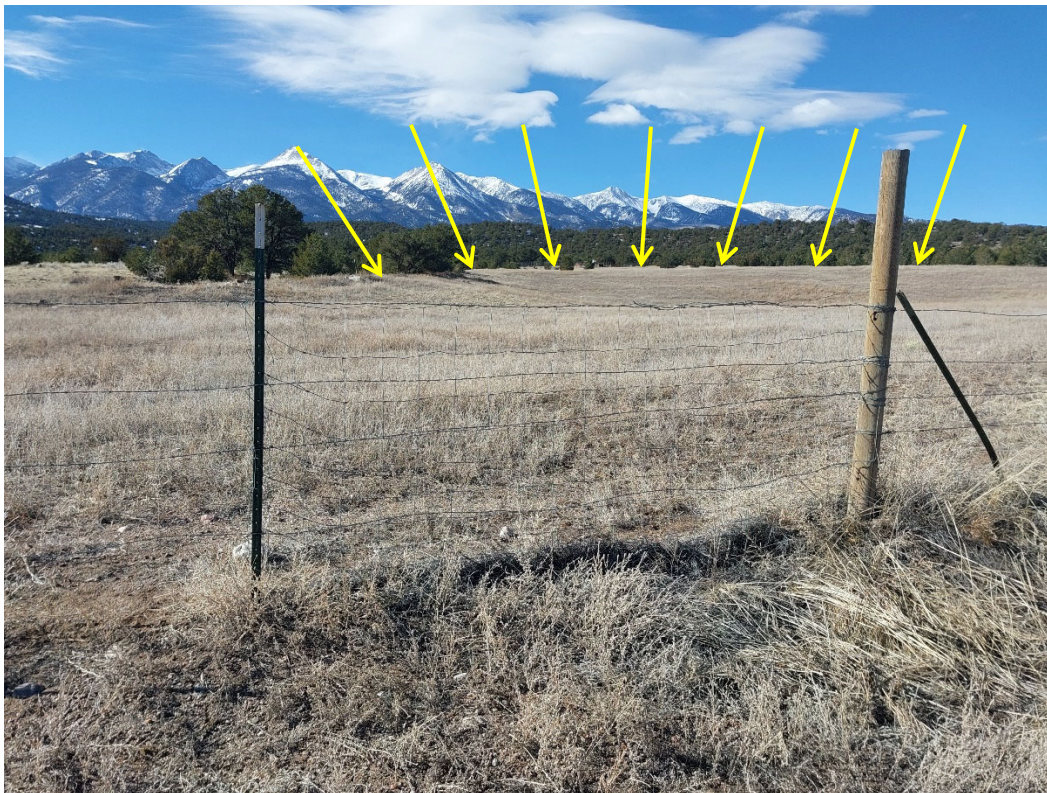
Photo #2: The depression of the ground that can be seen beyond the fence is the reclaimed pit.
