M2011007, Robert Fulton Reclamation Project, SL-1, Final Release Inspection Report

MINERALS PROGRAM INSPECTION REPORT
PHONE: (303) 866-3567

MINE NAME: Robert Fulton Reclamation	MINE/PROSPECTING ID#: M-2011-007	MINERAL: Silver and gold	COUNTY: Gilpin
INSPECTION TYPE: Surety Release Inspection	WEATHER: Clear	INSP. DATE: March 5, 2025	INSP. TIME: 11:00
OPERATOR: Venture Resources, Inc.	OPERATOR REPRESENTATIVE: None	TYPE OF OPERATION: 110d - Designated Limited Impact	
REASON FOR INSPECTION: Surety Release Requested	BOND CALCULATION TYPE: None	BOND AMOUNT: \$13,342.00	
DATE OF COMPLAINT: NA	POST INSP. CONTACTS: None	JOINT INSP. AGENCY: None	
INSPECTOR(S): Leigh Simmons	INSPECTOR'S SIGNATURE:

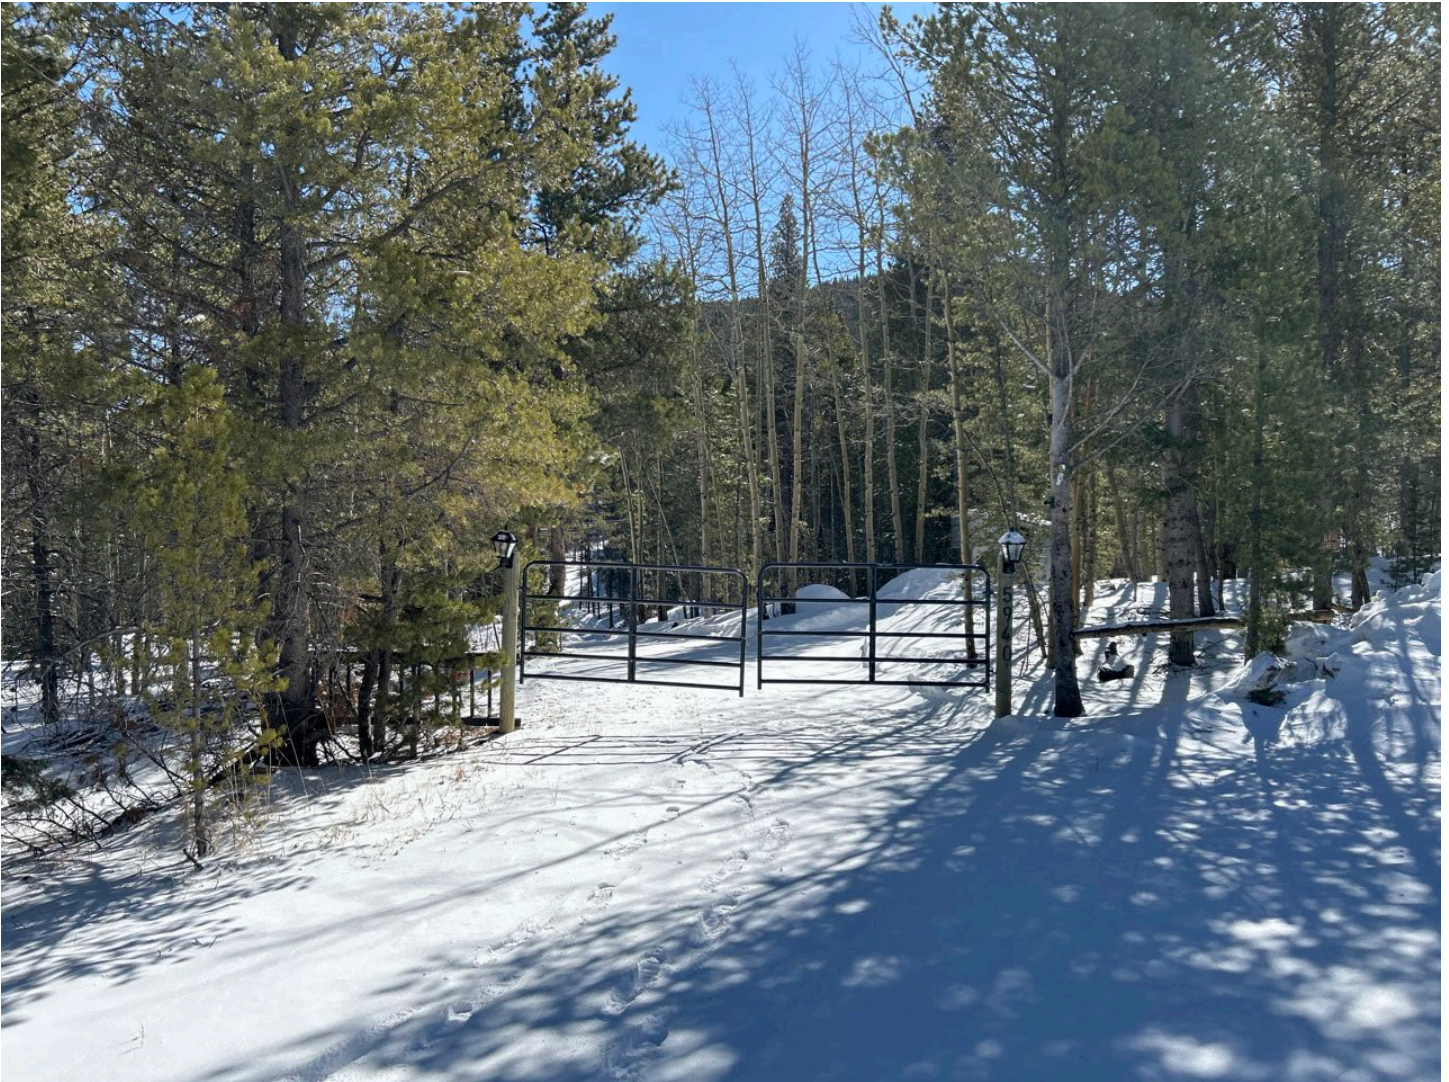
Figure 2: 469 - entrance to the site off Virginia Canyon Road

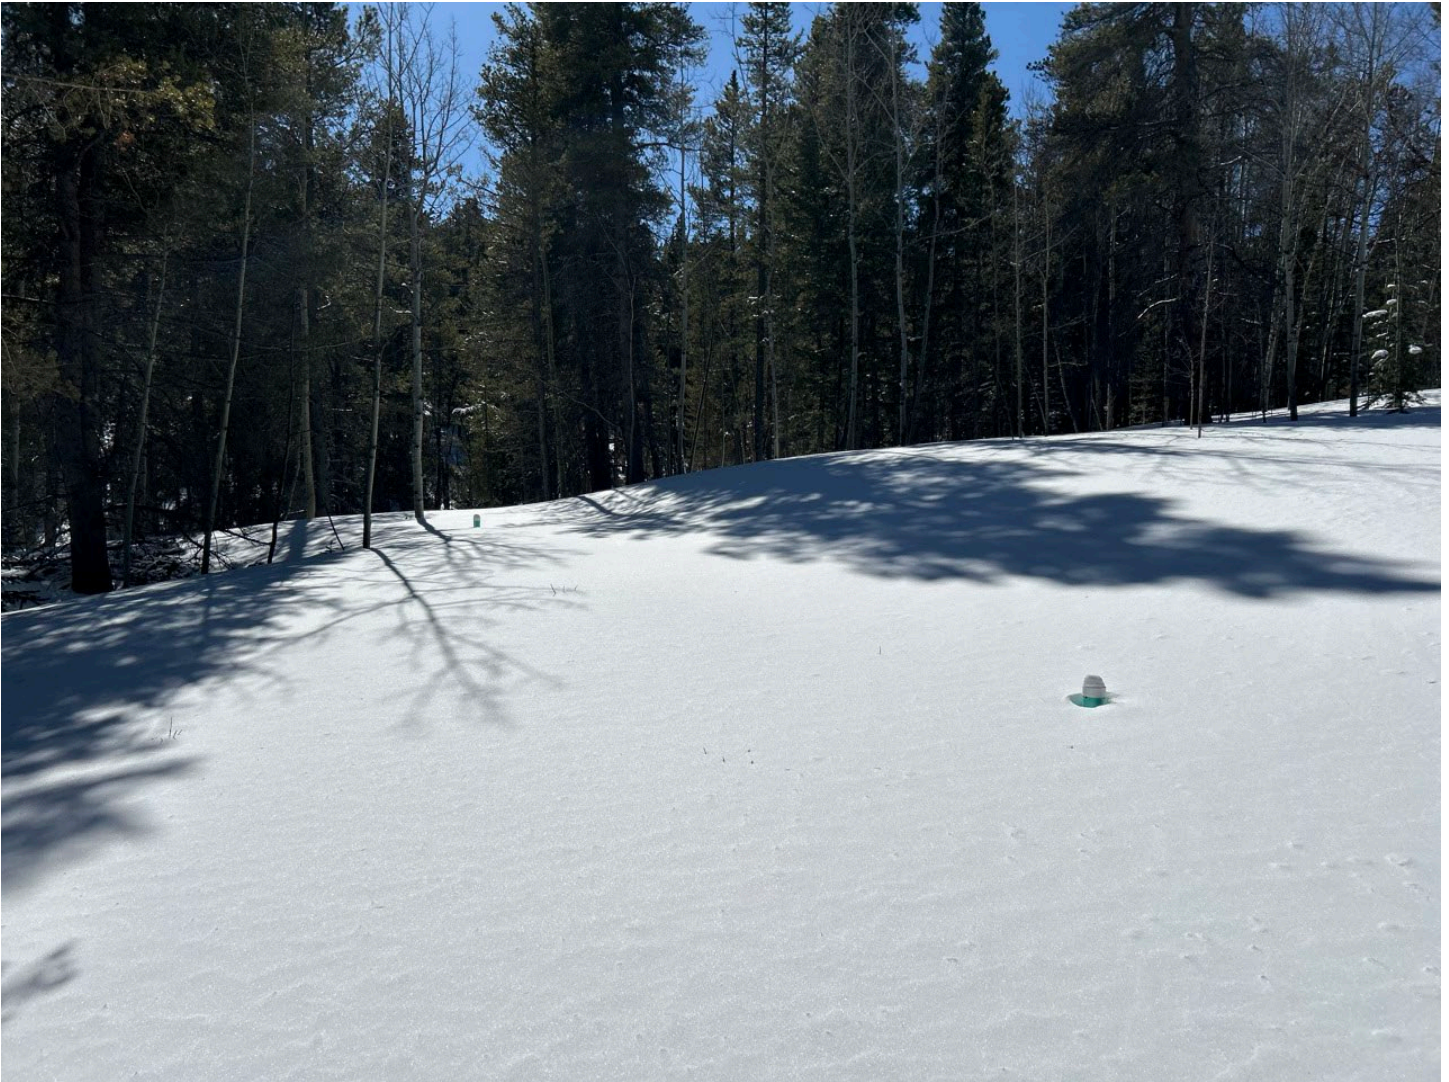
Figure 4: 472 - evidence of septic system installed by landowner

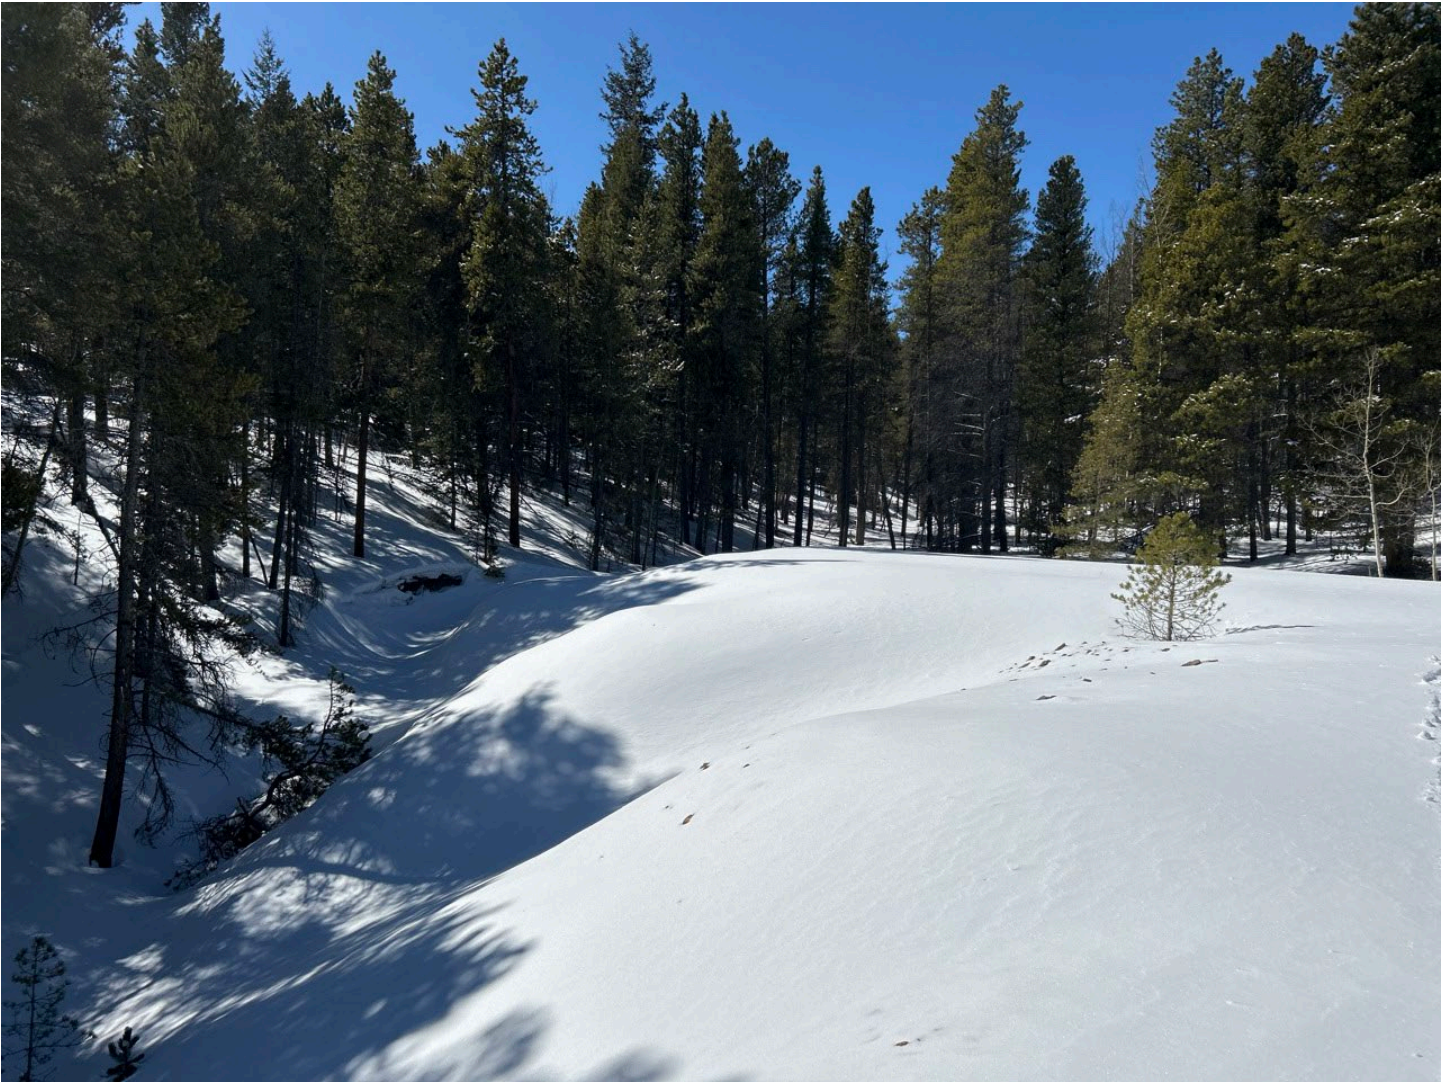
Figure 5: 473a - historic waste pile

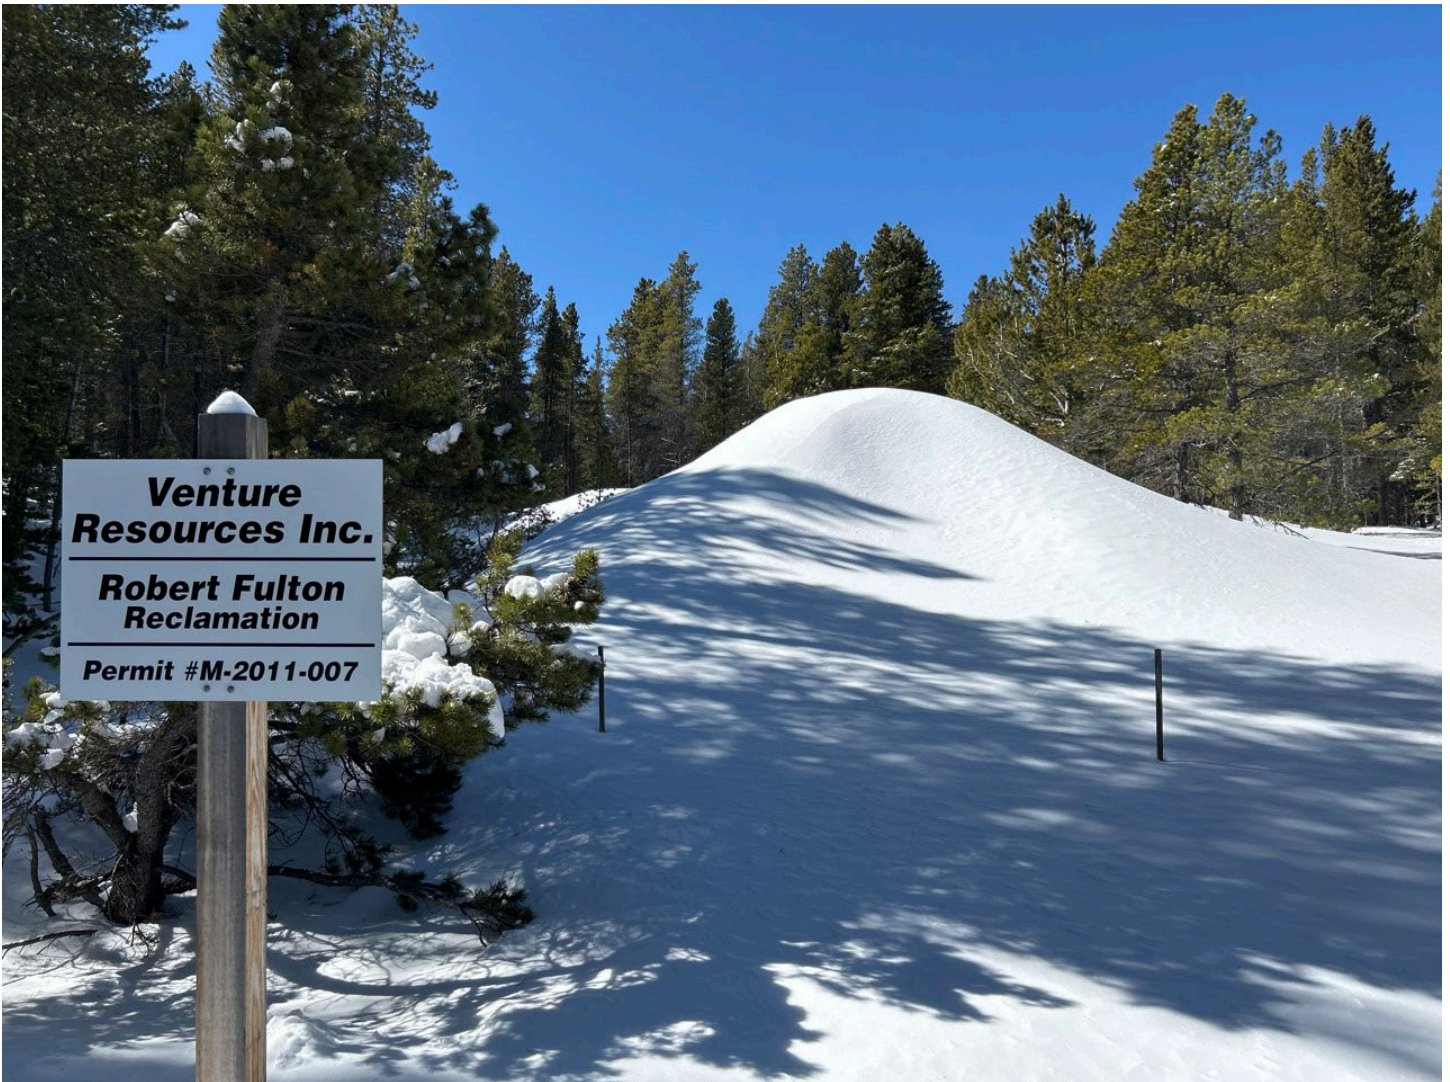
Figure 8: 474, Mine ID sign and historic waste pile from eastern boundary of permit area

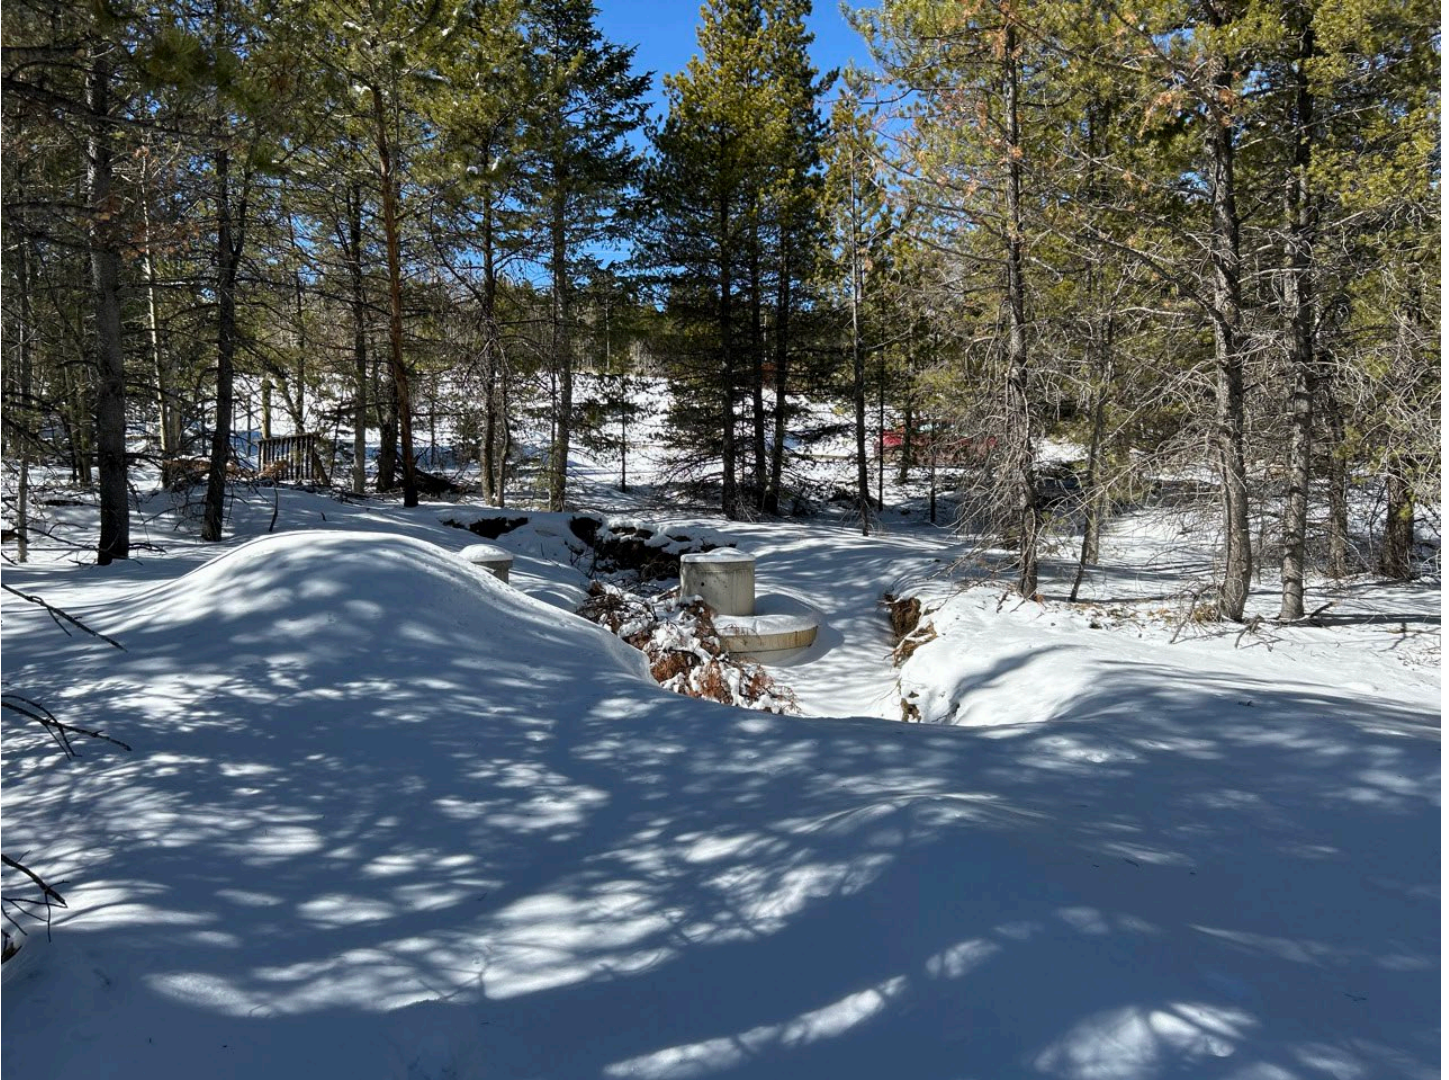
Figure 9: 475 - residential construction in progress
