MINERALS PROGRAM INSPECTION REPORT
PHONE: (303) 866-3567

MINE NAME: West Side Placer	MINE/PROSPECTING ID#: M-2016-081	MINERAL: Gold, niobium (colorado) rare earths	COUNTY: Moffat
INSPECTION TYPE: Preoperation Inspection	WEATHER: Clear	INSP. DATE: February 24, 2025	INSP. TIME: 11:30
OPERATOR: AuPt Industries LLC	OPERATOR REPRESENTATIVE: Peter Freedman	TYPE OF OPERATION: 110(2) - Hard Rock Limited Impact	
REASON FOR INSPECTION: Preoperation Inspection	BOND CALCULATION TYPE: Partial Bond	BOND AMOUNT: \$48,833.00	
DATE OF COMPLAINT: NA	POST INSP. CONTACTS: None	JOINT INSP. AGENCY: None	
INSPECTOR(S): Hunter Ridley	INSPECTOR'S SIGNATURE:

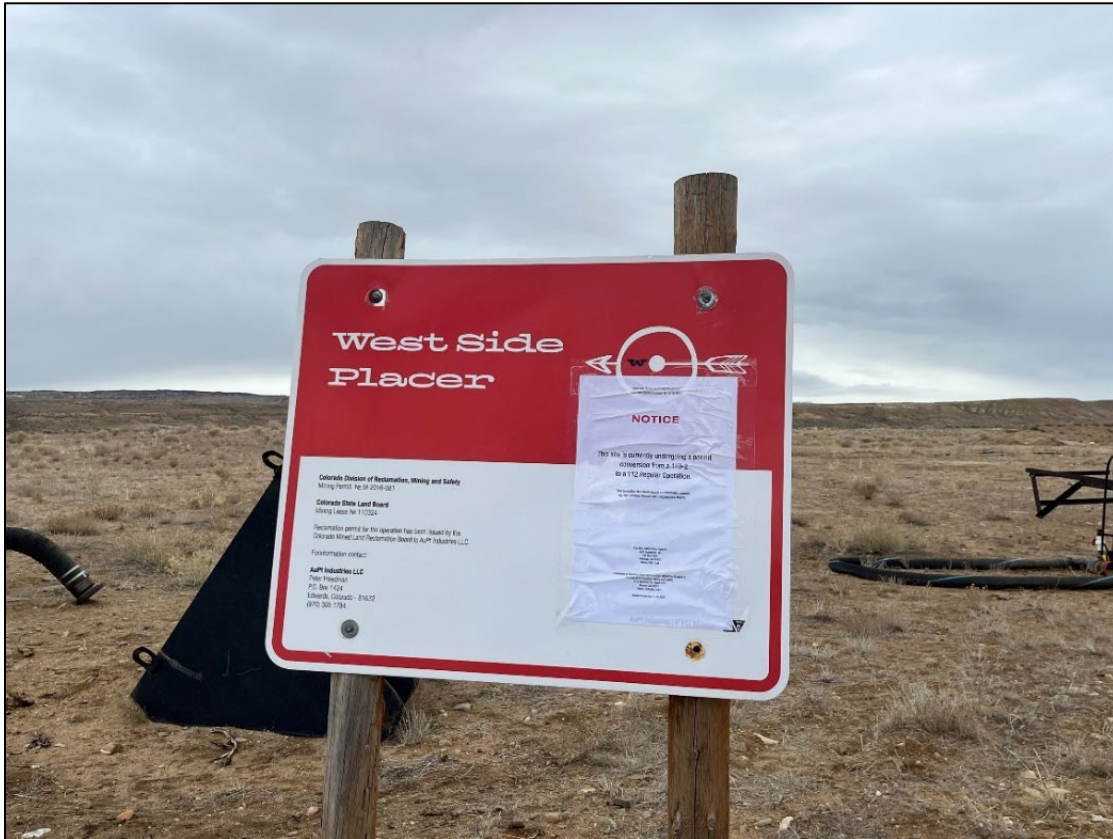
Signs and Markers: The mine identification sign remains in place in compliance with Rule 3.1.12 and is located at the northern part of the permit boundary along County Road 88 (Photo 1). The Conversion Application Notice sign was posted in accordance with Rule 1.6.2(1)(b). New proposed permit area boundary markers in the form of metal t-posts with neon flags were observed throughout the site, e.g. Photo 2. These boundaries were cross referenced with a permit boundary map to ensure accurate boundary post marking. T-post markers were found to be accurate and sufficient to delineate the proposed permit boundary.

Photo 1: Mine sign and Notice sign posted on the entrance gate in compliance with Rule 1.6.2(1)(b).

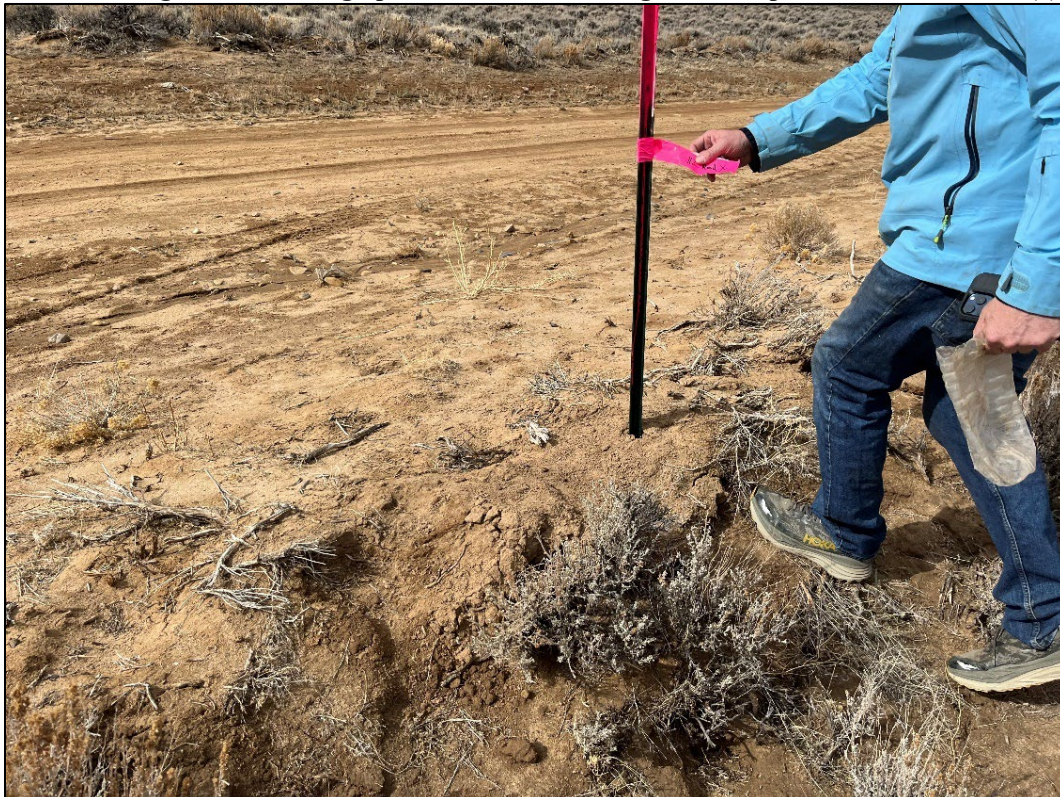
Photo 2: Example of a permit boundary marker for the new 112c acreage.

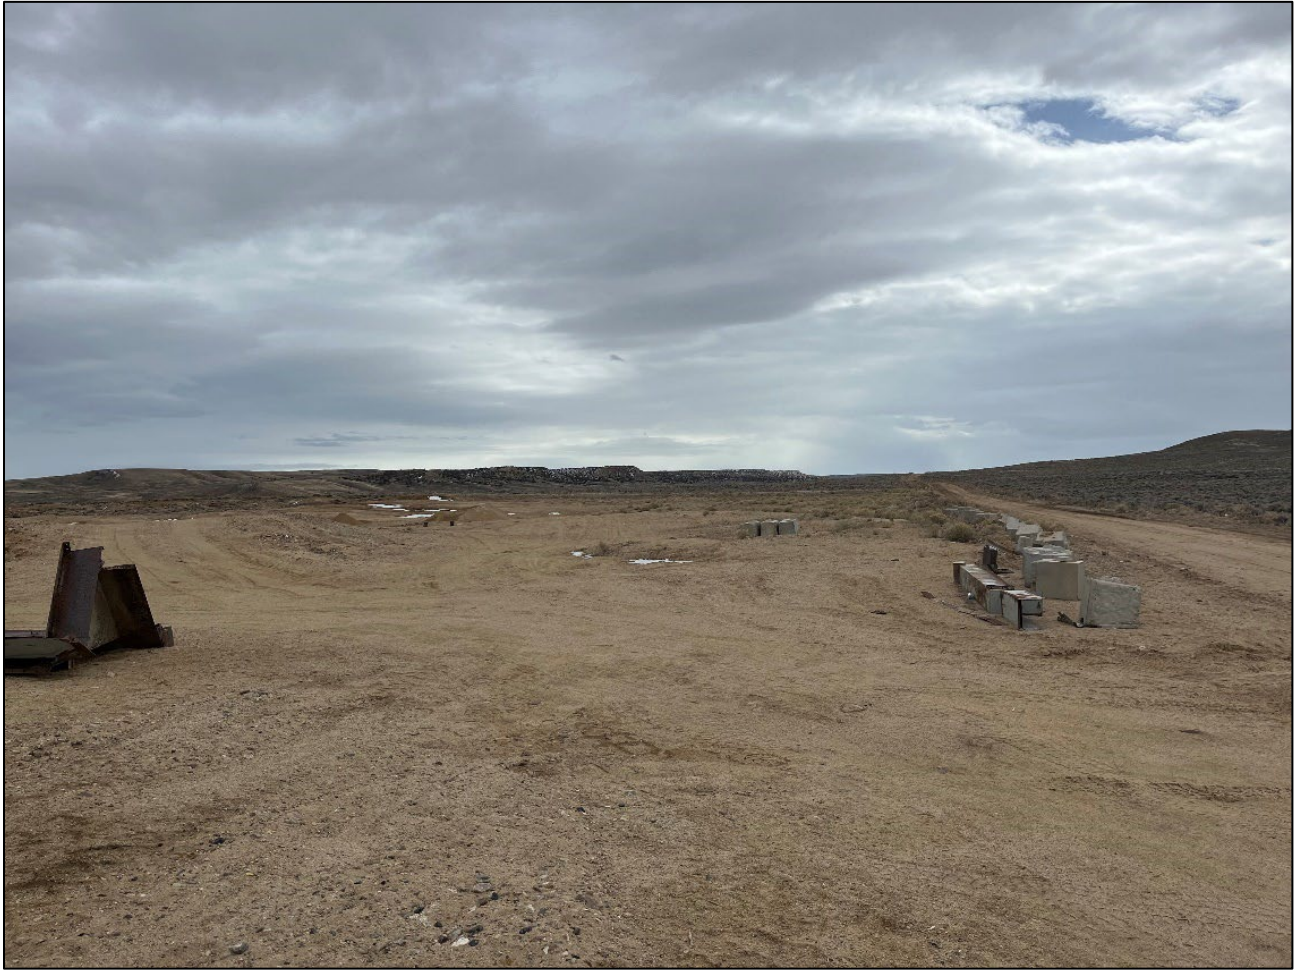
On site Support Facilities: Plant facilities were removed from the middle portion of the permit in 2023. The Operator stated that new plant facilities are part of the proposed conversion application and mine expansion (Photo 3). These facilities will utilize a closed loop processing system. Therefore, the site will not need to utilize any settling ponds related to the processing cycle. The processing plant will occupy and ~6-acre area. It's location in relation to the newly proposed permit boundary is shown on **Figure 1**.

Photo 3: Current disturbed area related to the pre-existing 110c permit. This area is the site of the proposed processing plant.

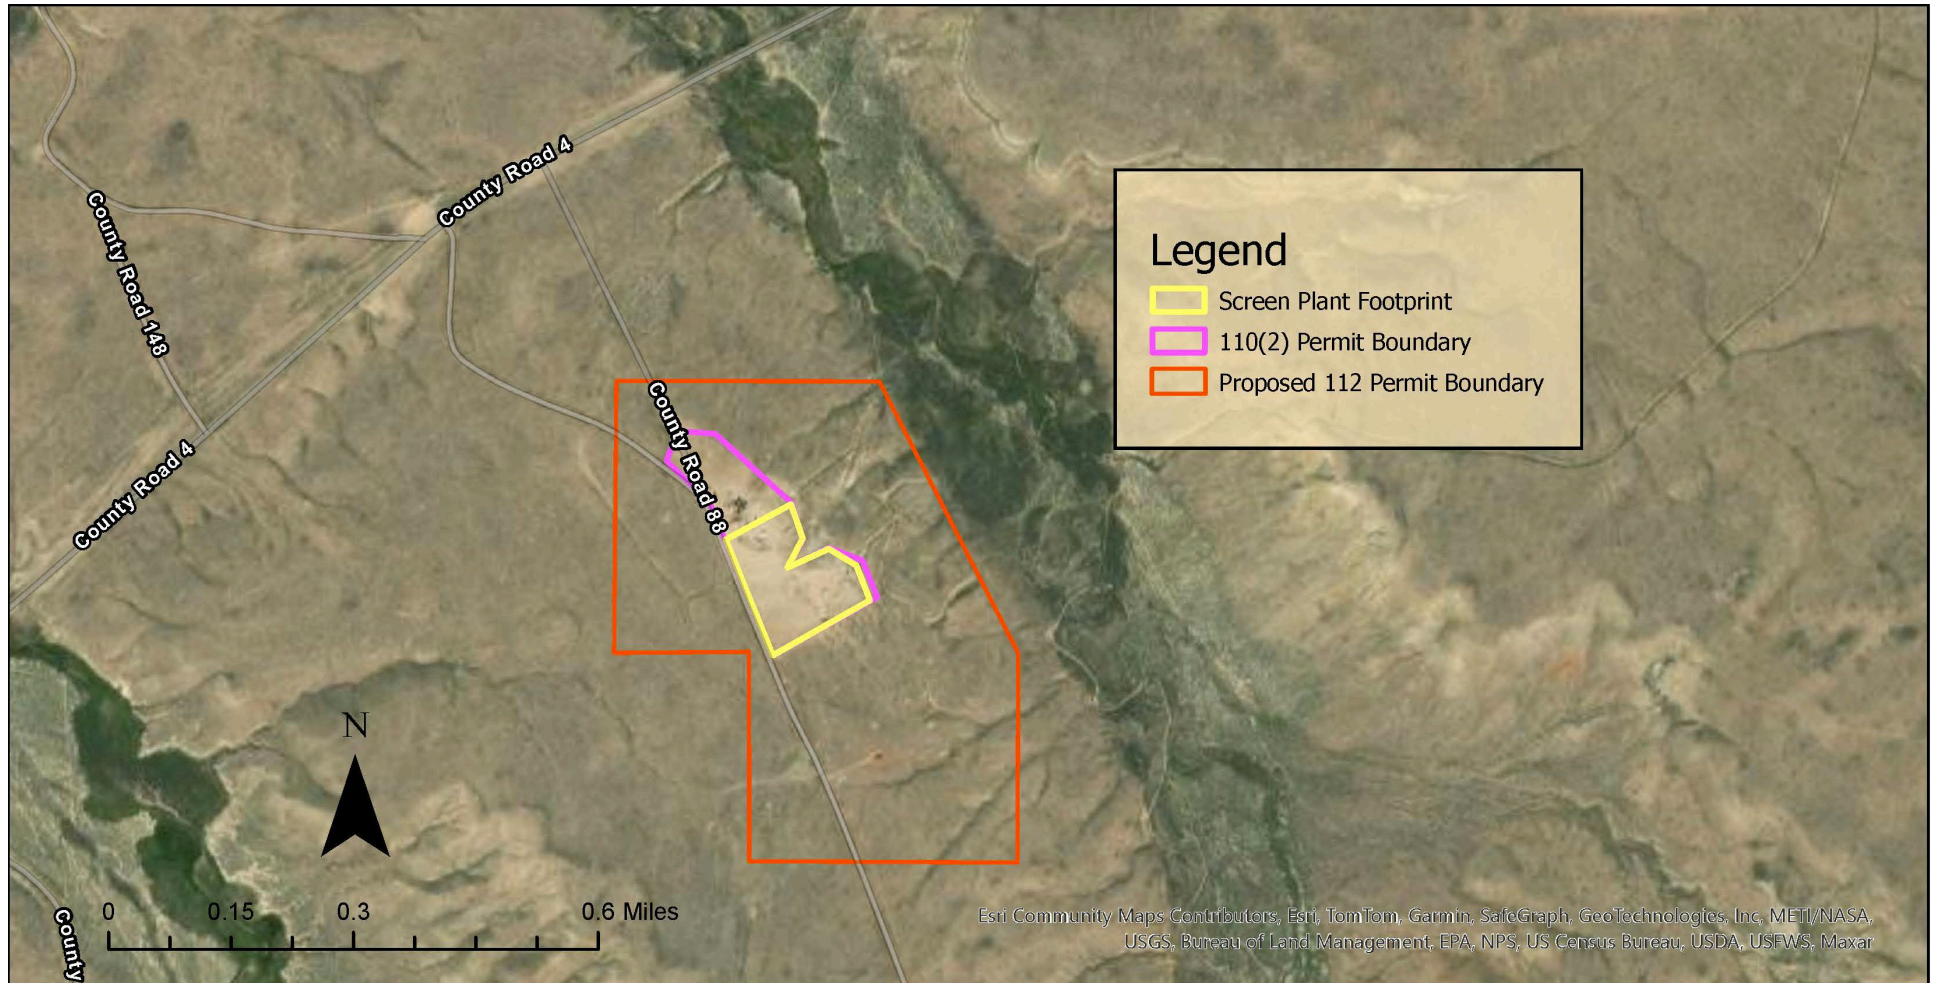
Figure 1: Inspection Map created with .kmz files submitted with the CN2 application materials.
