MINERALS PROGRAM INSPECTION REPORT
PHONE: (303) 866-3567

MINE NAME: Dowe Flats Mine	MINE/PROSPECTING ID#: M-1993-041	MINERAL: Limestone (general)	COUNTY: Boulder
INSPECTION TYPE: Monitoring	WEATHER: Clear	INSP. DATE: March 5, 2025	INSP. TIME: 09:45
OPERATOR: CEMEX, Inc.	OPERATOR REPRESENTATIVE: Robin Simons	TYPE OF OPERATION: 112c - Construction Regular Operation	
REASON FOR INSPECTION: Normal I&E Program	BOND CALCULATION TYPE: Partial Bond	BOND AMOUNT: \$12,683,299.00	
DATE OF COMPLAINT: NA	POST INSP. CONTACTS: None	JOINT INSP. AGENCY: None	
INSPECTOR(S): Patrick Lennberg	INSPECTOR'S SIGNATURE:

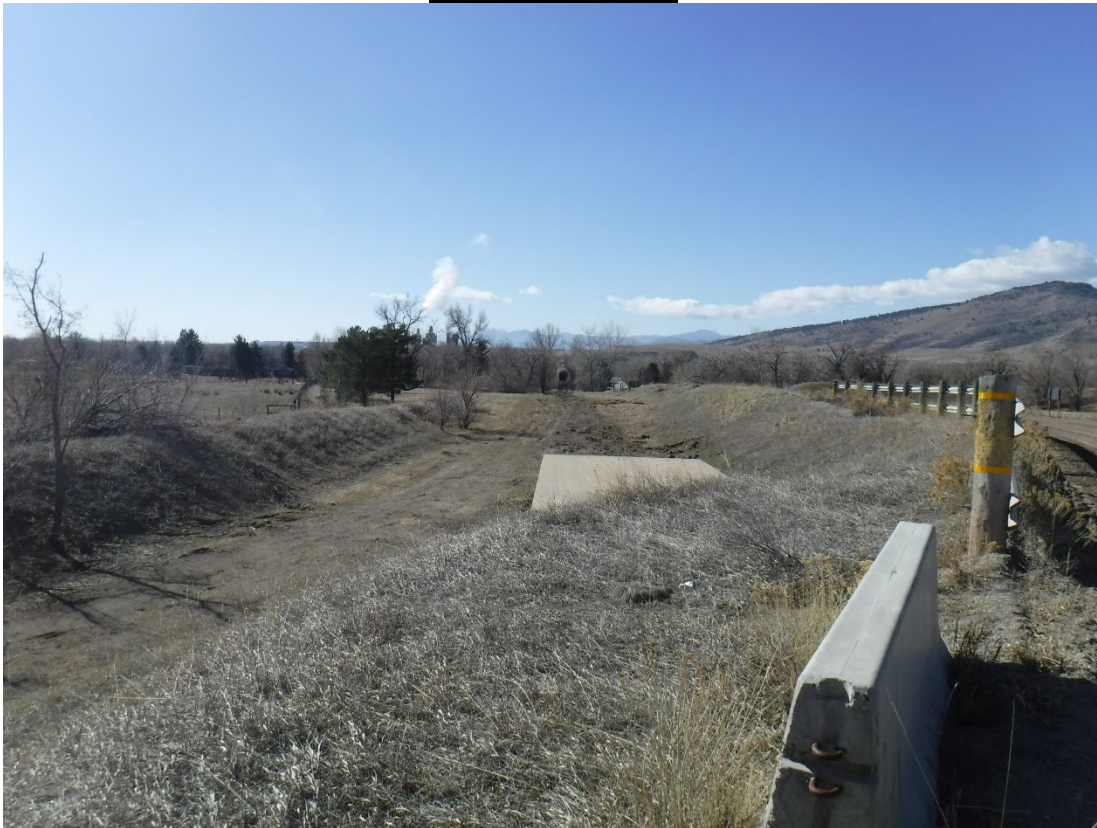
Photo 1: A view looking south along the conveyor belt corridor, the tunnel over highway is center of picture.

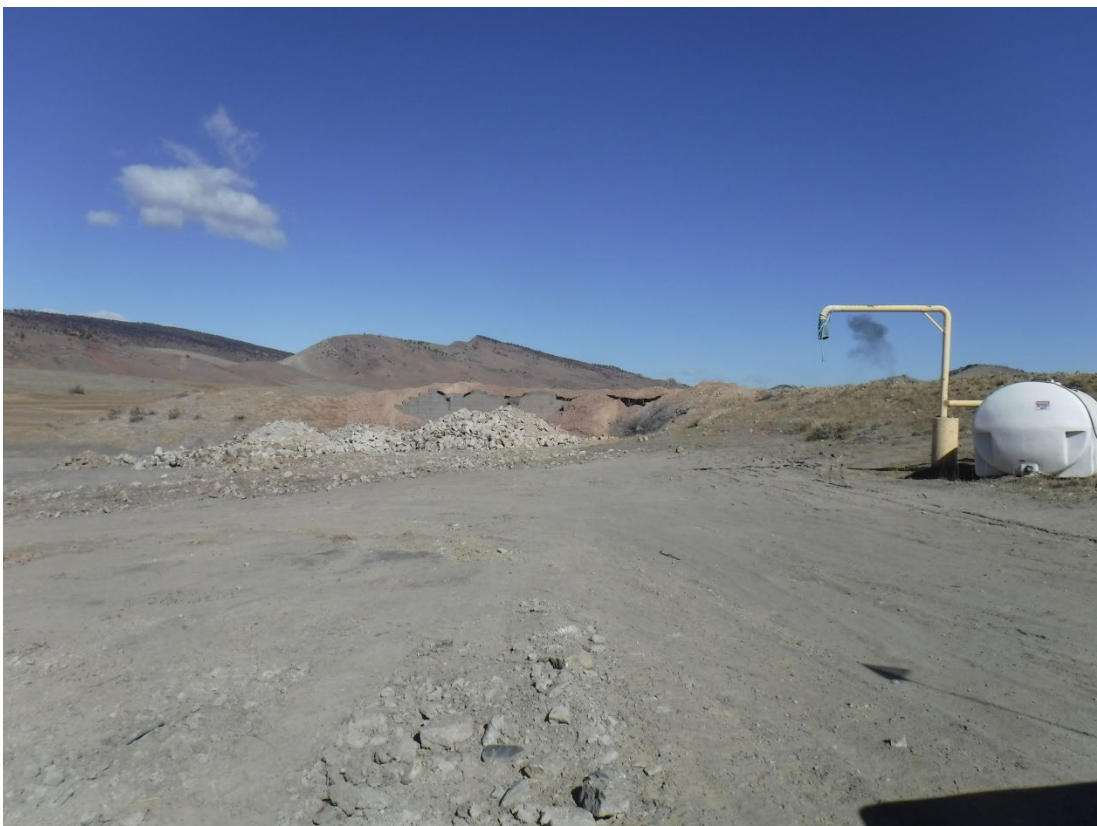
Photo 2: Former crusher location

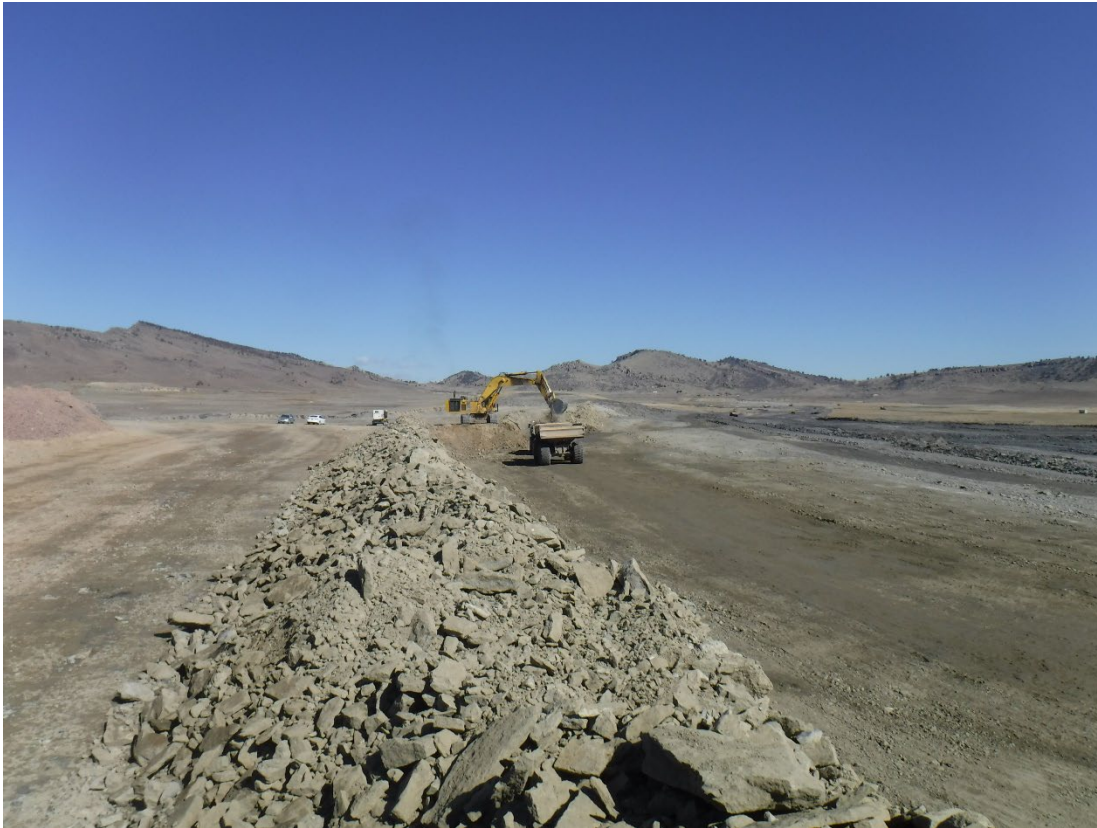
Photo 3: Excavating fill material for pit backfill, looking north

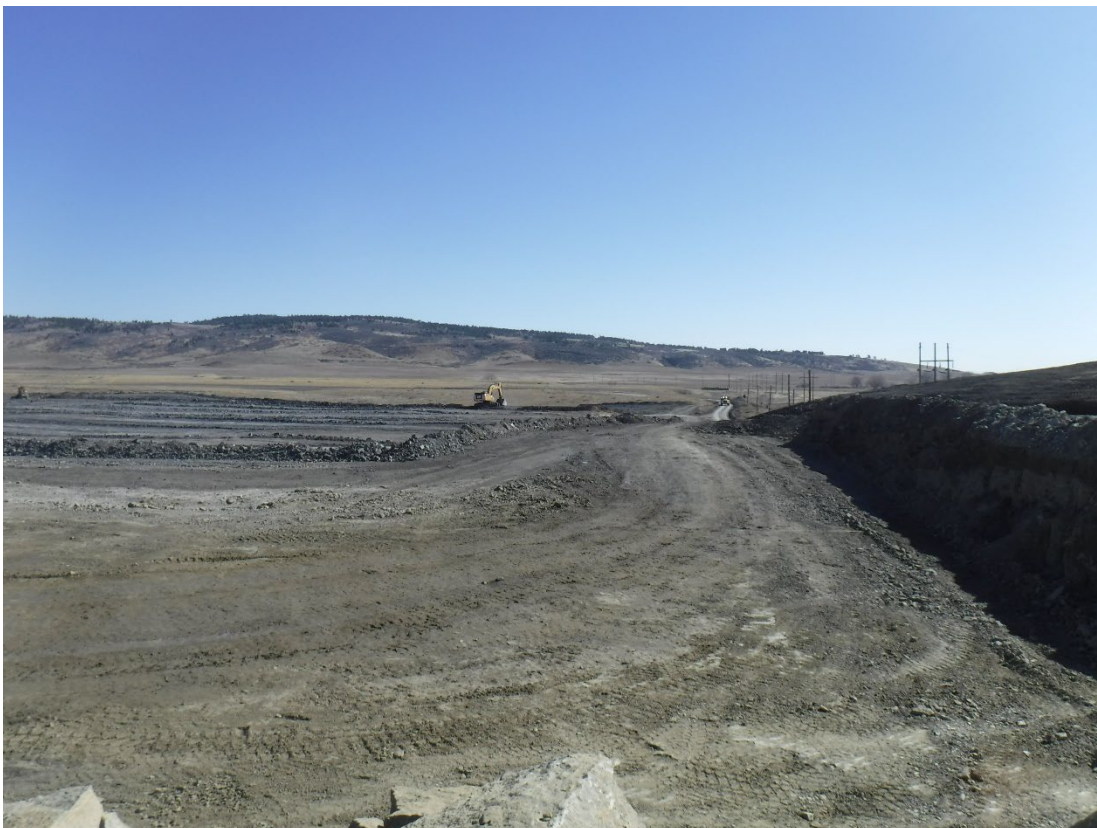
Photo 4: Excavating fill material for pit backfill, looking east

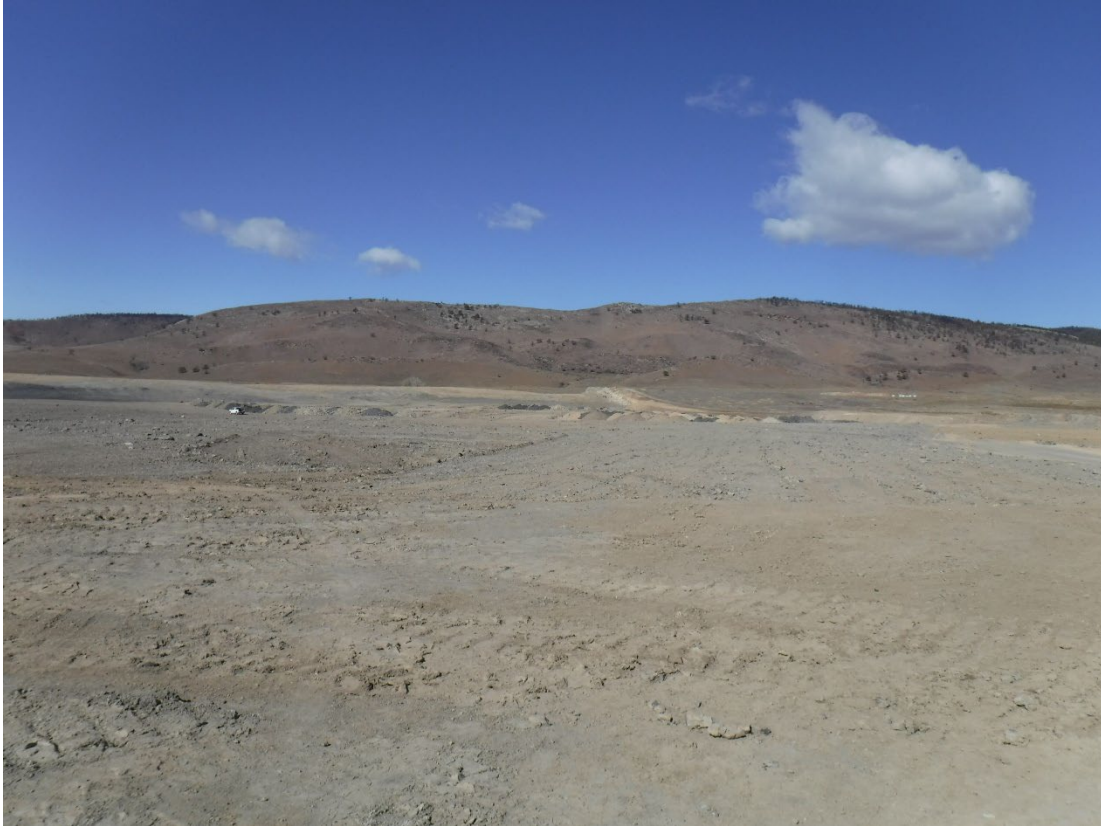
Photo 5: Area to the north of the open pit that has been rough graded, looking west

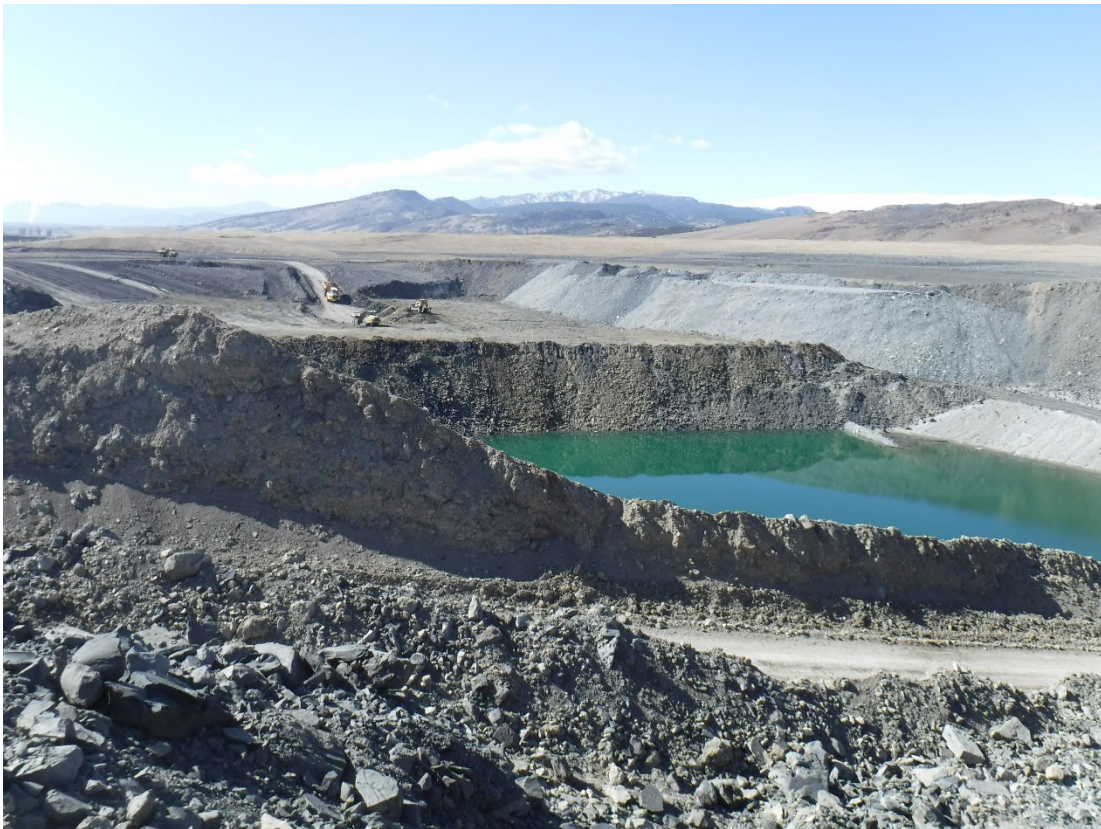
Photo 6: Pit area being backfilled, looking southwest

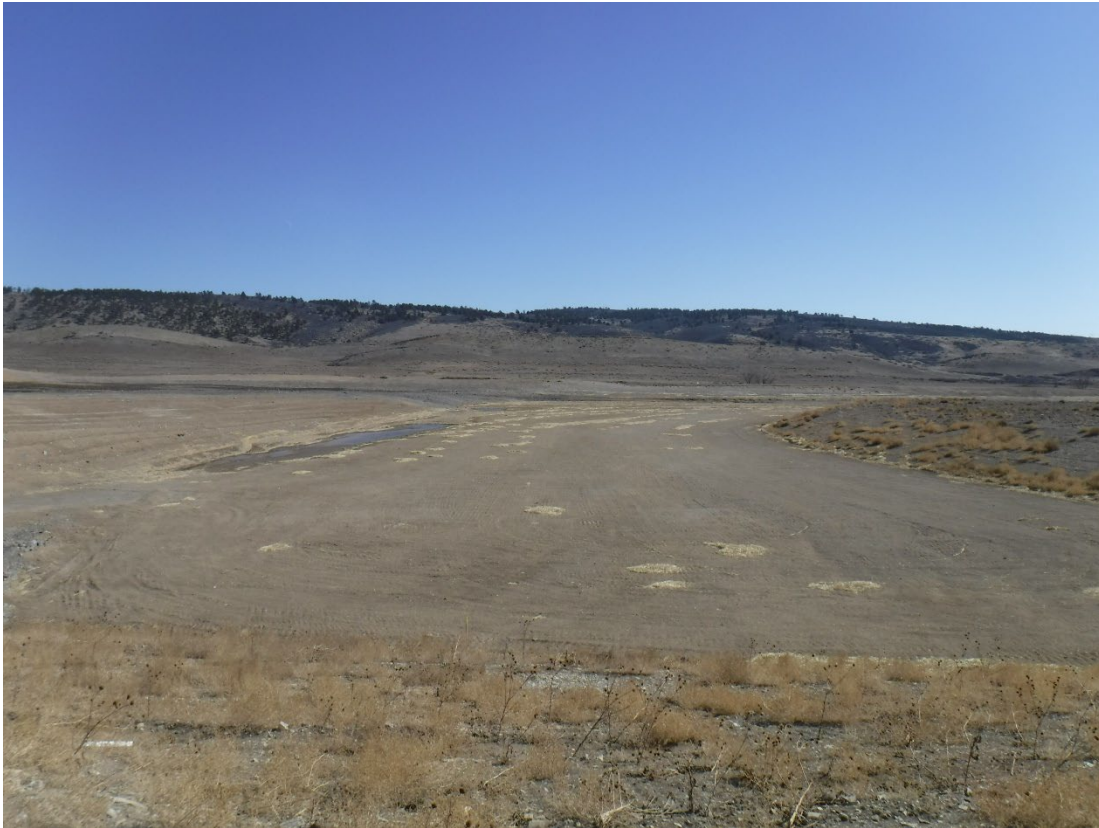
Photo 7: Former pit area that has been backfilled and brought to final grade and seeded, looking east

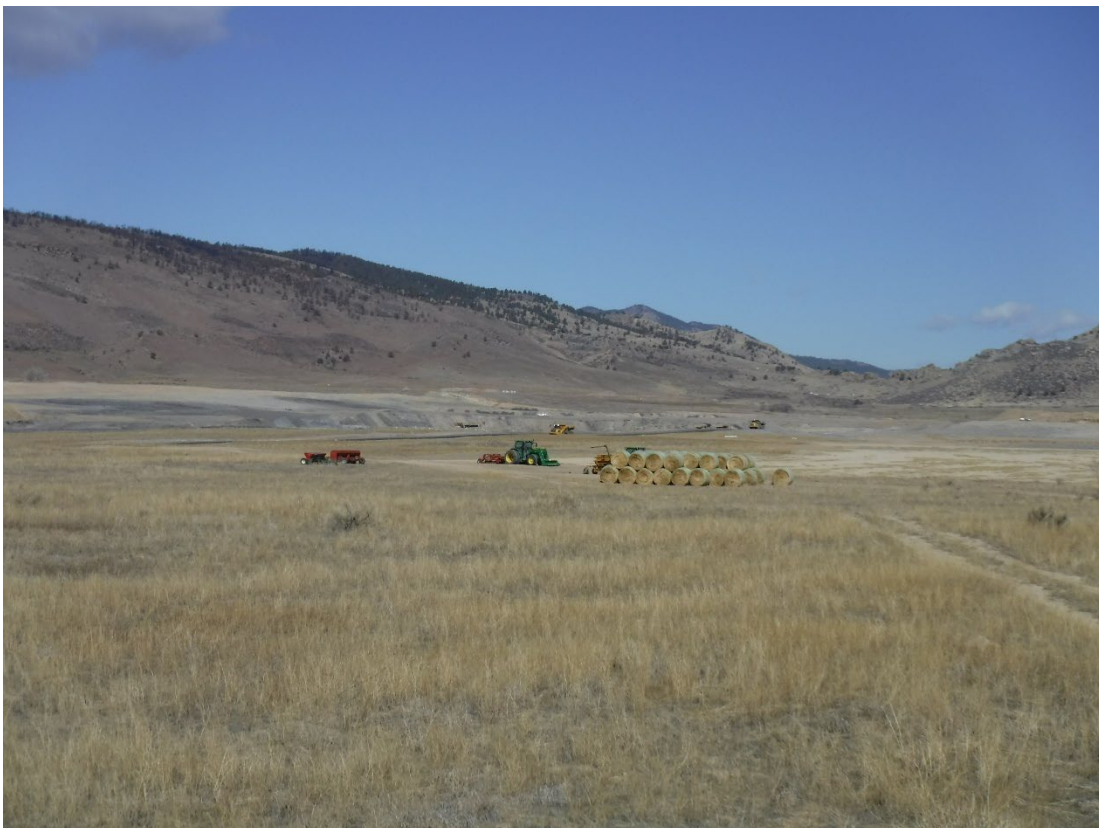
Photo 8: Areas to the right of the picture have been backfilled and final graded to the left are areas that are being backfilled
