MINERALS PROGRAM INSPECTION REPORT PHONE: (303) 866-3567

MINE NAME:	MINE/PROSPECTING ID#:	MINERAL:	COUNTY:
Lyons Quarry	M-1977-141	Quartz	Boulder
		(quartzite/quartzose ss)	
INSPECTION TYPE:	WEATHER: Clear	INSP. DATE:	INSP. TIME:
Monitoring		March 12, 2025	12:00
OPERATOR:	OPERATOR REPRESENTATIVE:	TYPE OF OPERATION:	
Holcim - WCR, Inc.	Wyatt Webster	112c - Construction Regular Operation	
REASON FOR INSPECTION:	BOND CALCULATION TYPE:	BOND AMOUNT:	
Normal I&E Program	Partial Bond	\$9,887,461.00	
DATE OF COMPLAINT:	POST INSP. CONTACTS:	JOINT INSP. AGENCY:	
NA	None	None	
INSPECTOR(S):	INSPECTOR'S SIGNATURE:	SIGNATURE DATE:	
Patrick Lennberg	Patrick IS	March 13, 2025

PERMIT #: M-1977-141 INSPECTOR'S INITIALS: JPL INSPECTION DATE: March 12, 2025

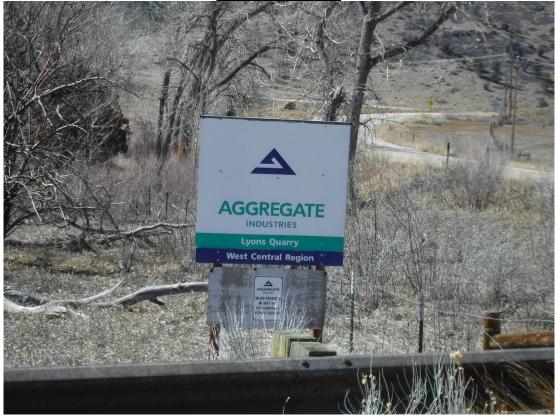
The Lyons Quarry is in Boulder County approximately 2.25 miles southwest of Lyons, Colorado and is situated south of the South Saint Vrain Creek and Hwy 7. The site is accessed from the east via Old St. Vrain Rd. The affected lands are owned by Boulder County. The approved post-mining land use is rangeland. A mine sign was observed at the entrance to the mine as required by Rule 3.1.12. It should be noted the mine sign should be updated to reflect Holcim – WCR, Inc as the permittee not Aggregate Industries.

Photo 1: Mine sign at the primary mine entrance

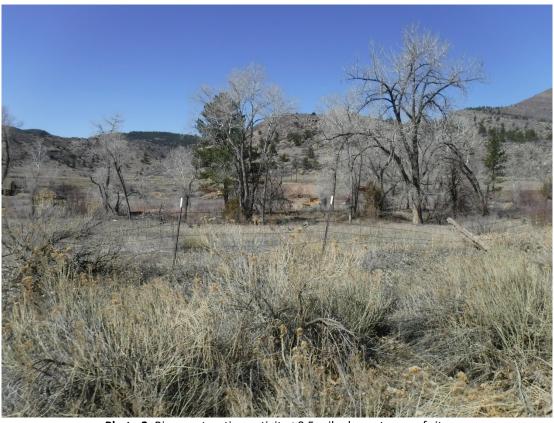
The site, as mentioned above, is located on land owned by Boulder County. Boulder County is in the process of planning and implementing various stream restoration projects along South St Vrain Creek. At the time of inspection there was a construction crew was working on a project 100 feet upstream of the bridge across the creek used to access the site. On January 30th the County submitted to the Division a completed "Is It Mining" form regarding excess material generated from these restoration projects. The County would like to stockpile ~7,000 cubic yards of material within the Lyons Quarry permit boundary, at the staging area, for use in future restoration projects. The Division made the determinization that no permit was needed for the proposed activities. The operator will be submitting a forthcoming Technical Revision to allow for the stockpiling of material in the permit area.

Photo 2: River restoration activity ~0.5 mile downstream of site

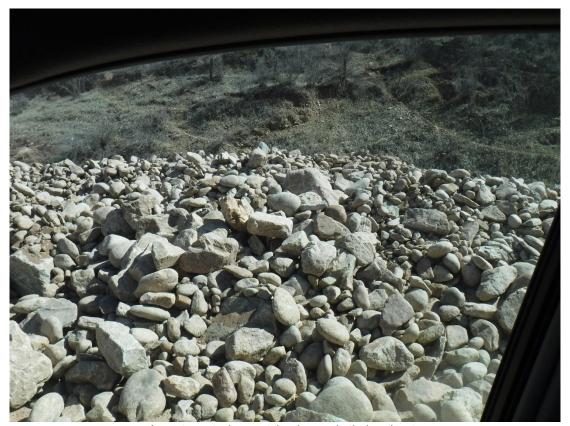
Photo 3: Typical material to be stockpiled at the site

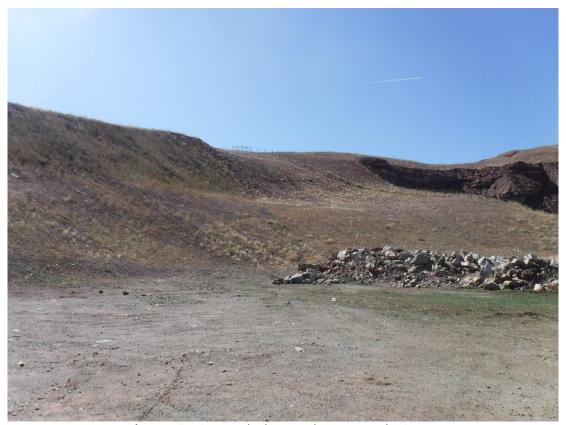
Photo 4: Staging area looking southwest towards pit area

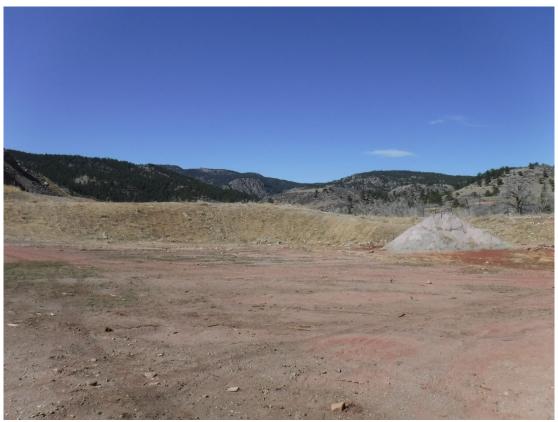
Photo 5: Staging area looking northwest towards creek

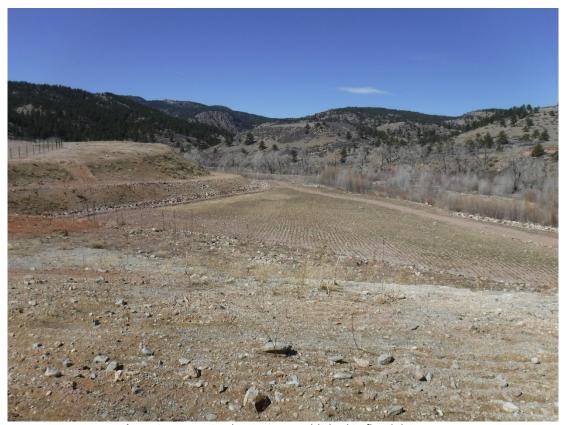
The area within the floodplain of the site has vegetation becoming well established. The operator is hoping to be able to release this area, from the armored berm north across the creek, later this year to allow the County the option of beginning another restoration project in that area.

Photo 6: Vegetation becoming established in floodplain area

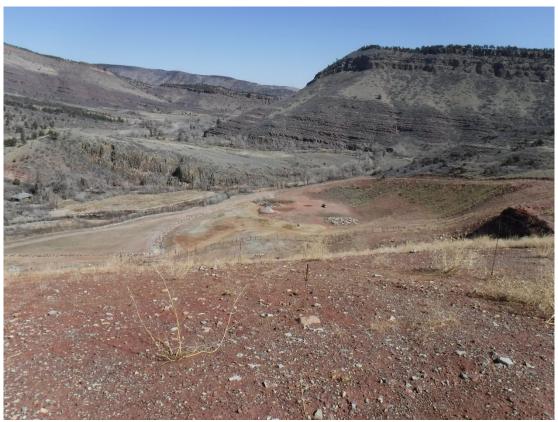
Photo 7: Overview of staging area looking northeast

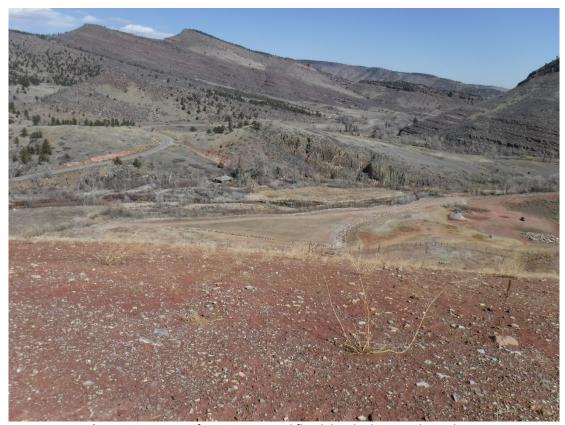
Photo 8: Overview of staging area and floodplain looking north-northeast

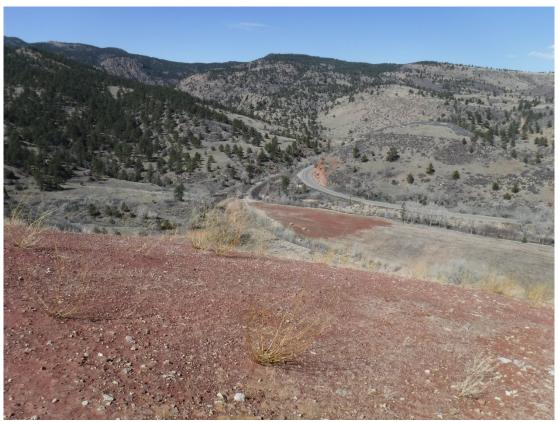
Photo 9: Overview of floodplain looking northwest

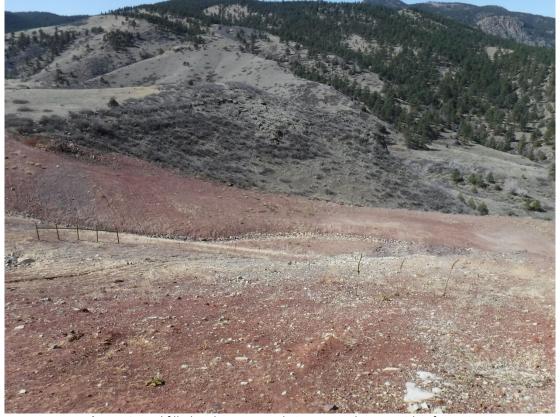
This is a 112c operation permitted for 71 acres to mine quartz monzonite for construction material use. Pre-law disturbances were present in the area, the majority of which were included within the permit area. The approved mining plan includes six mining areas and a non-mining disturbance area for material processing, stockpiling, and equipment storage located adjacent to the creek. The last mining activity at the site was in 2009. The Division estimates total disturbance to the site consists of 54.2 acres split between two reclamation areas. Reclamation Area 1 is 17 acres in area and Reclamation Area 2 is approximately 37.2 acres in size. The site is in final reclamation with vegetation becoming established and all major earthwork has been completed.

Photo 10: Backfilled and revegetated pit area on the west side of permit
