March Inspections Williams Fork, Seneca IIW and Yoast

11 March 2025

Permit Number: C-1981-044
Mine Name: Williams Fork Mines
Operator: Moffat County Mining, LLC
Operator Address:
Ms. Miranda Kawcak
29515 Routt County Road #27
Oak Creek, CO 80467

Inspection Start Date: 11 March 2025 Inspection Start Time: 12:00 a.m. Inspection End Date: 12 March 2025 Inspection End Time: 11:00 a.m.	Inspection Type: Complete Inspection Inspection Reason: Normal I&E Program Weather: Cloudy
Joint Inspection Agency:	Joint Inspection Contacts:
None	No
Post Inspection Agency:	Post Inspection Contacts:
None	No
Inspector(s):	Inspector's Signature: Signature Date:
Robin Reilley, M.S. GISP	Bobin Leiller 12 March 2025

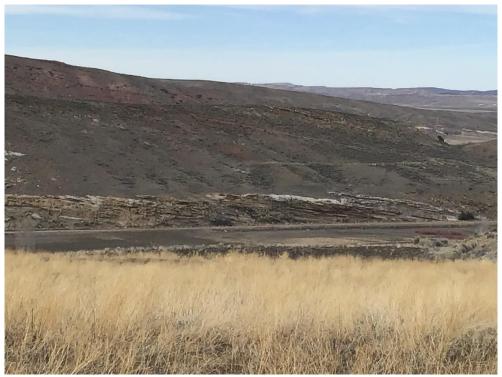
Photo 1: Williams Fork bottom lands looking west from above.

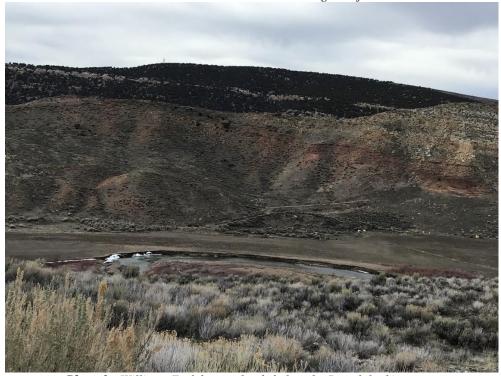
Photo 2: Williams Fork bottom lands below the Portal, looking west.

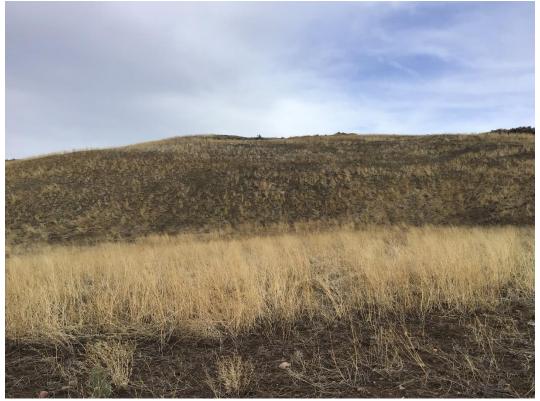
- o Revegetated areas of reclamation appeared stable and dormant the time of inspection.
- 5A Portal area exhibits predominantly dormant vegetation with some small chamisa and sage shrubs and grasses beginning to green.
- Vegetation throughout the site appeared dormant at the time of inspection.
- o Croplands exhibited dormant stubble.
- o No significant weeds were noted at the time of inspection.

Photo 3: Williams Fork portal area, typical dormant weedy vegetation on recently reclaimed slopes.
