March Inspections Williams Fork, Seneca IIW and Yoast

COLORADO
Division of Reclamation,
Mining and Safety
Department of Natural Resources

Permit Number: C-1994-082 Mine Name: Yeast Mine Operator Address: Seneca Property LLC Ms. Miranda Kawcak 29515 Routt County Road No. 27 Oak Creek, CO 80467	County: Routt Operation Type: Surface Permit Status: Permanent Cessation Ownership: Private Operator Representative Present: Miranda Kawcak
Operator Representative Signature: (Field Issuance Only) This report was issued electronically from the Divisions' Denver Office.

Inspection Start Date: 12 March 2025 Inspection Start Time: 9:30 a.m. Inspection End Date: 12 March 2025 Inspection End Time: 10:00 a.m.	Inspection Type: Coal Partial Inspection Inspection Reason: Normal I&E Program Weather: Clear
Joint Inspection Agency: None	Joint Inspection Contacts:
Post Inspection Agency: None	Post Inspection Contacts:
Inspector(s): Robin Reilley, M.S. GISP	Inspector's Signature:

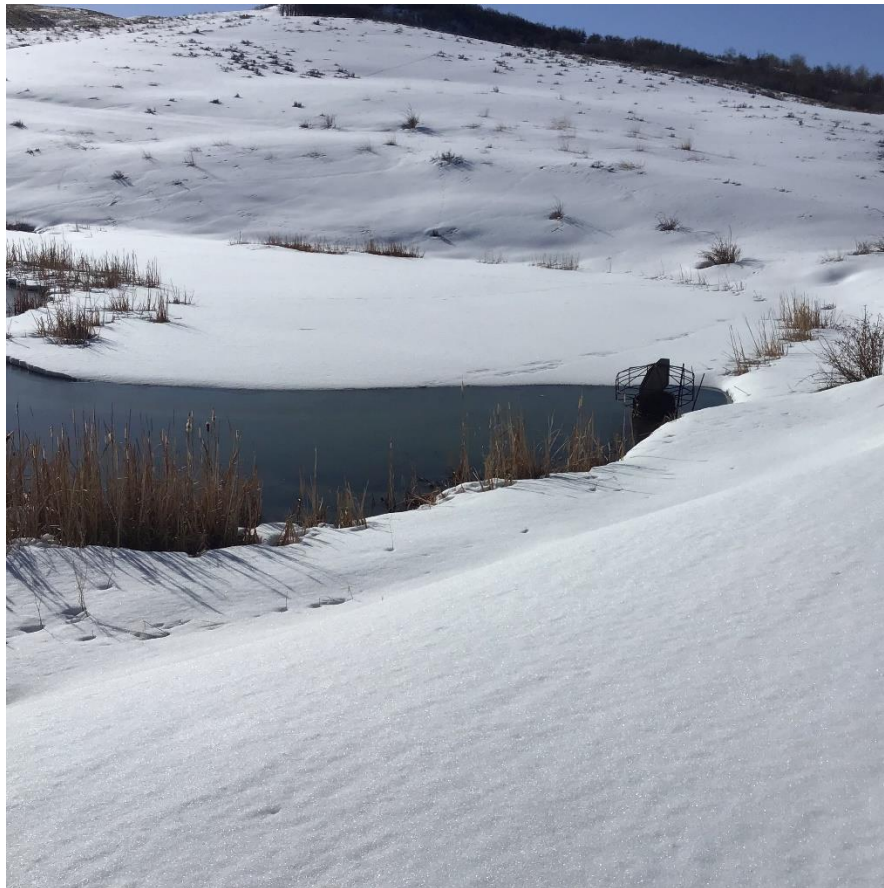
- Pond banks and dams appeared stable, and snow covered with no signs of seepage.
- Ponds 13 and 14 were ice covered.
- Pond 12 was discharging at the time of inspection.

Photo 1: Pond 12, discharging and ice coming off.

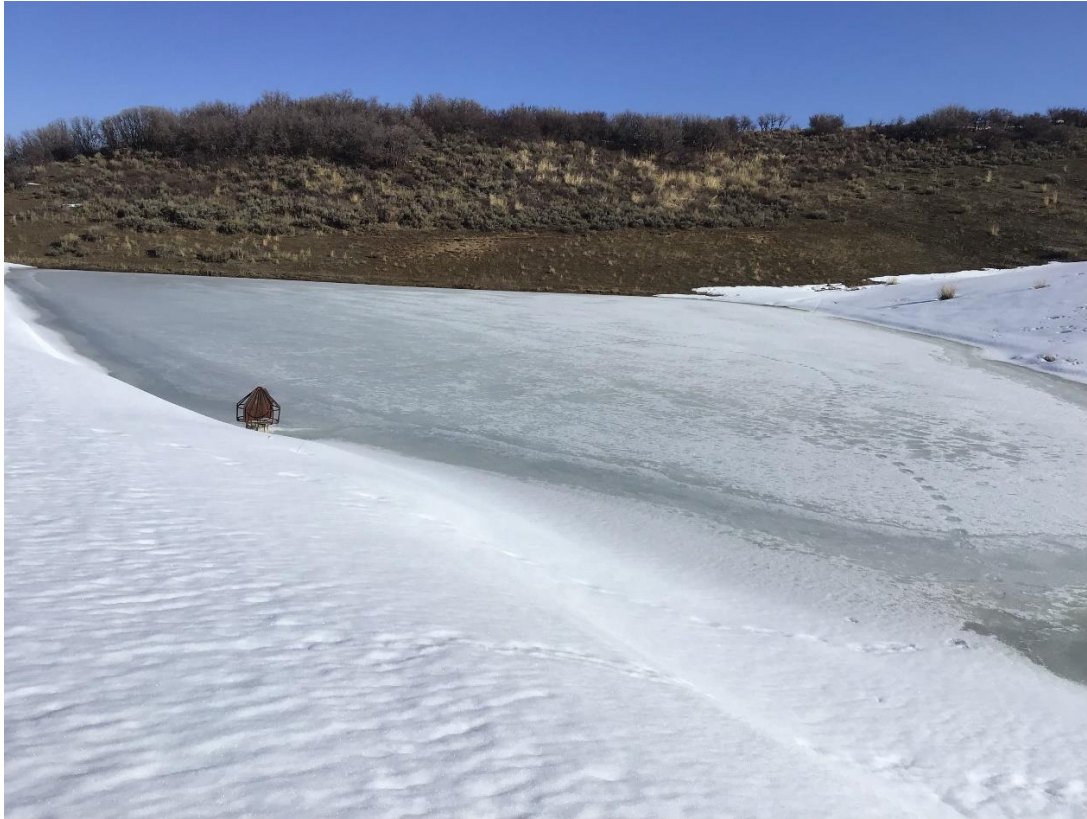
Photo 2: Yoast Pond 13, ice covered and not discharging.

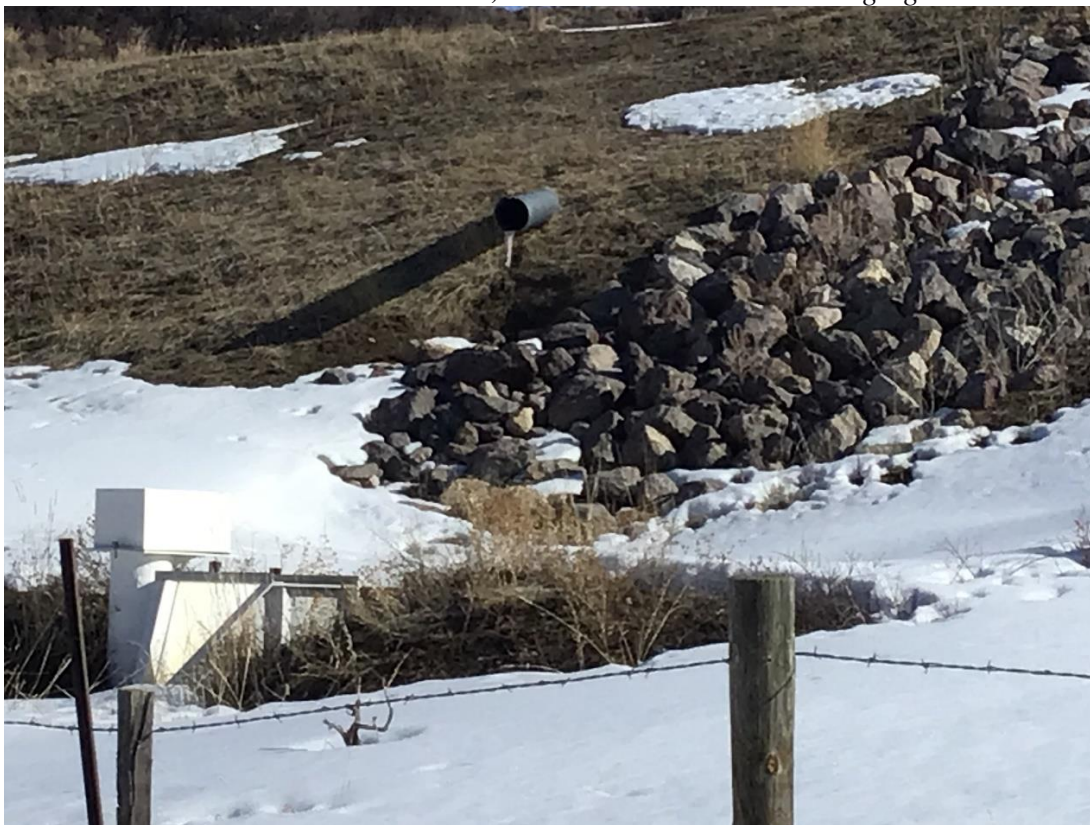
Photo 3: Pond 13 discharge culvert.

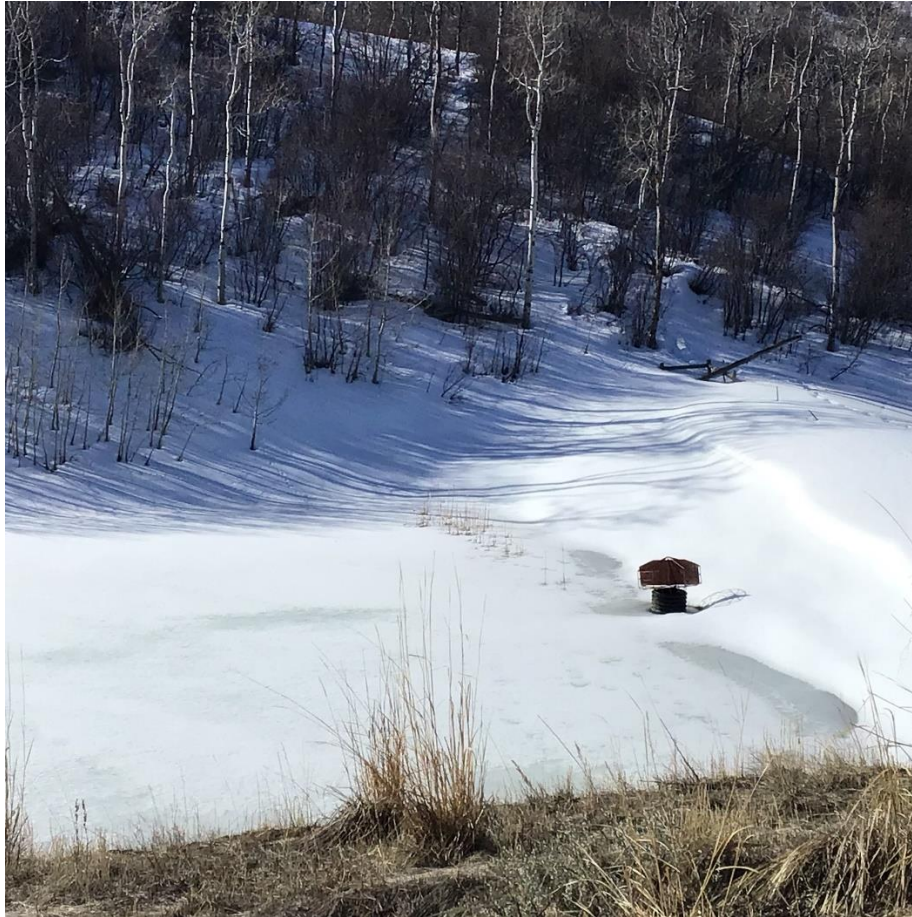
Photo 4: Pond 14, ice covered.
