7458 WCR 42, M2025007- Inspection Report

MINERALS PROGRAM INSPECTION REPORT
PHONE: (303) 866-3567

MINE NAME: 7458 WCR 42 Site	MINE/PROSPECTING ID#: M-2025-007	MINERAL: NA	COUNTY: Weld
INSPECTION TYPE: Possible Illegal(Unpermitted Operation)	WEATHER: Clear	INSP. DATE: February 19, 2025	INSP. TIME: 09:00am
OPERATOR: Ewing Outdoor Supply	OPERATOR REPRESENTATIVE: Christian Silco	TYPE OF OPERATION: Distribution Yard	
REASON FOR INSPECTION: Citizen Complaint	BOND CALCULATION TYPE: None	BOND AMOUNT: NA	
DATE OF COMPLAINT: NA	POST INSP. CONTACTS: None	JOINT INSP. AGENCY: None	
INSPECTOR(S): Chris Girardi	INSPECTOR'S SIGNATURE:

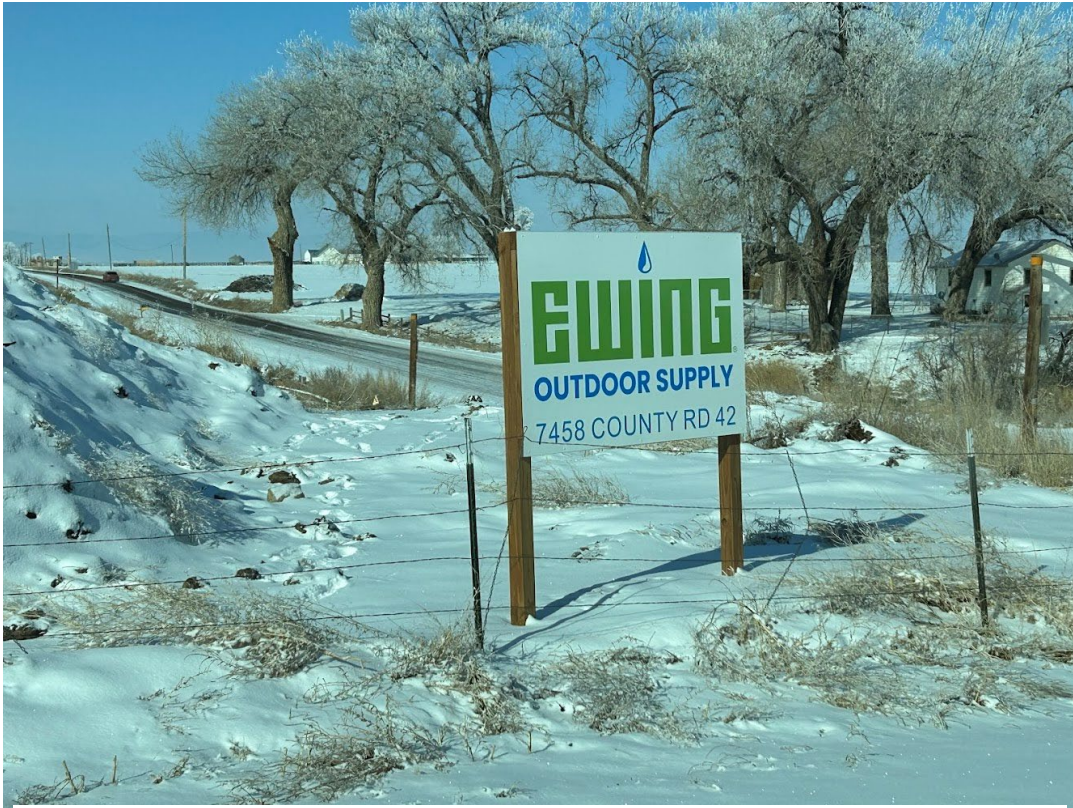
Photo 1: View of company sign upon entering property from the north, facing west.

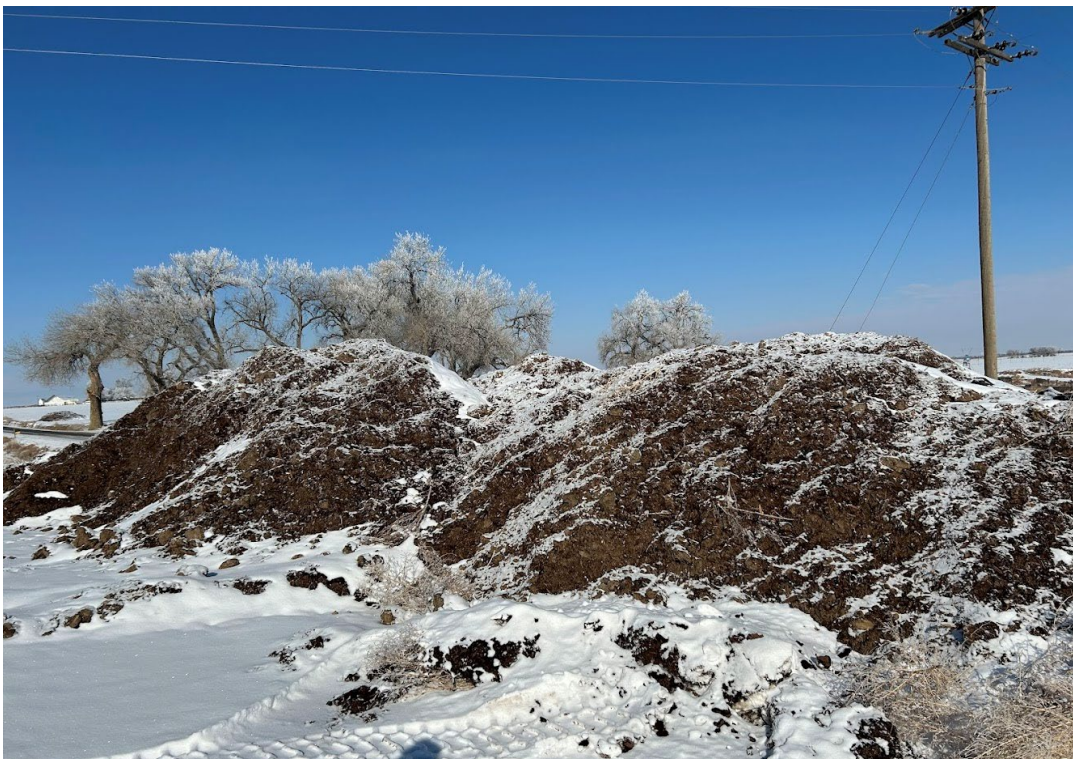
The property is located adjacent to the east of Great Western Railway of Colorado railroad tracks. The property is a distribution center for landscape materials, primarily mulch. Due to a recent snowstorm, several inches of snow blanketed the property. The property contained several large stockpiles of mulch (see Photo 5), and small stockpiles of gravel acquired from the Walstrum Quarry. According to the Operator, they had recently used a skid steer to scrape a layer of material along the railroad tracks due to safety concerns. Years of unloading wood-based materials, predominantly mulch, had caused a buildup of soft material along the railroad tracks. Heavy machinery would often dip into the ground along the tracks. After removing this soft material, the Operator encountered base material from the previous property owner adjacent to the rail line. This material was a soft, spongy material unsuitable to remain as the base along the tracks. The Operator replaced the removed base material and mulch by importing approximately fifty (50) to seventy (70) tons of 1.5-inch granite ballast to create a stable base. Some of the excavated material was then backfilled into concrete bins (see Photo 6). Some of the excavated material, consisting of primarily mulch, was placed in a small stockpile located on the north end of the parcel (see Photos 2-3).

Based on the Division's field observations, a reclamation permit will not need to be obtained by Ewing Outdoor Supply for the subject property at this time. It appears the grading work done at the site was for maintenance of their landscape material distribution operation. It does not appear the material excavated was construction material obtained from its natural occurrence on the property and therefore this activity does not meet the definition of a mining operation in accordance with Rule 1.1(30). If Ewing Outdoor Supply intends to excavate native construction material from the site to sell and/or transport off-site, then a reclamation permit would need to be obtained.

Photo 2: Excess excavated material, facing northwest.

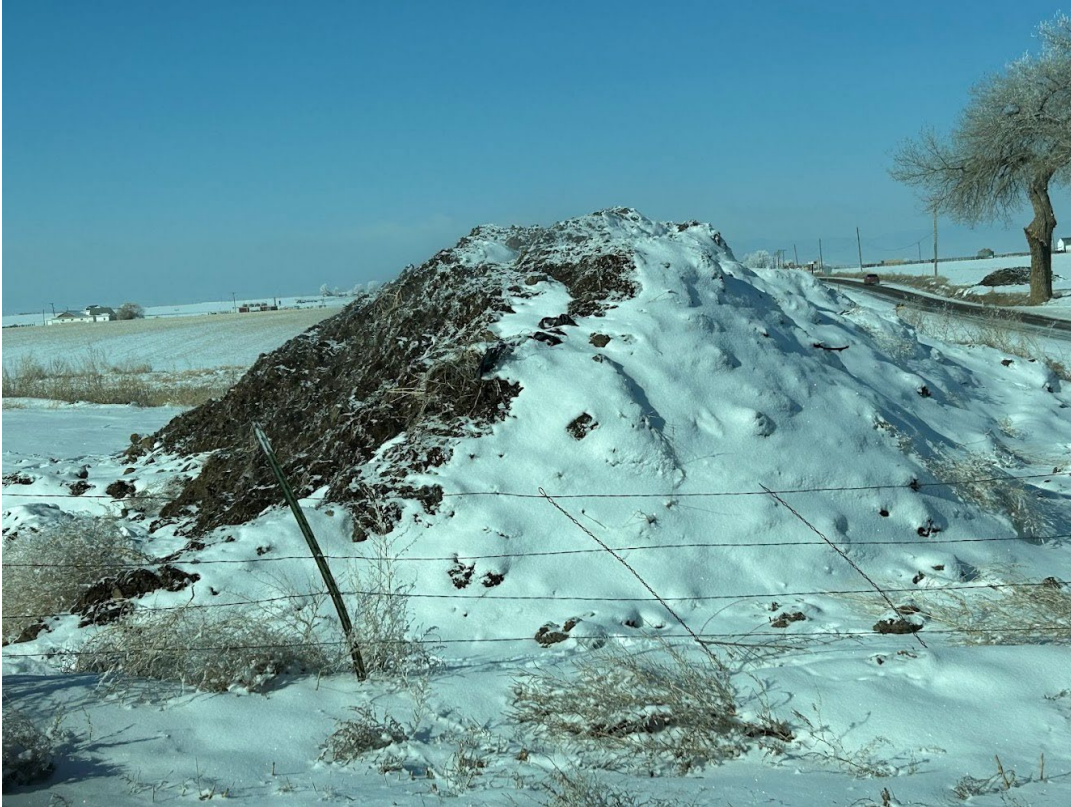
Photo 3: View excess excavated material, facing west.

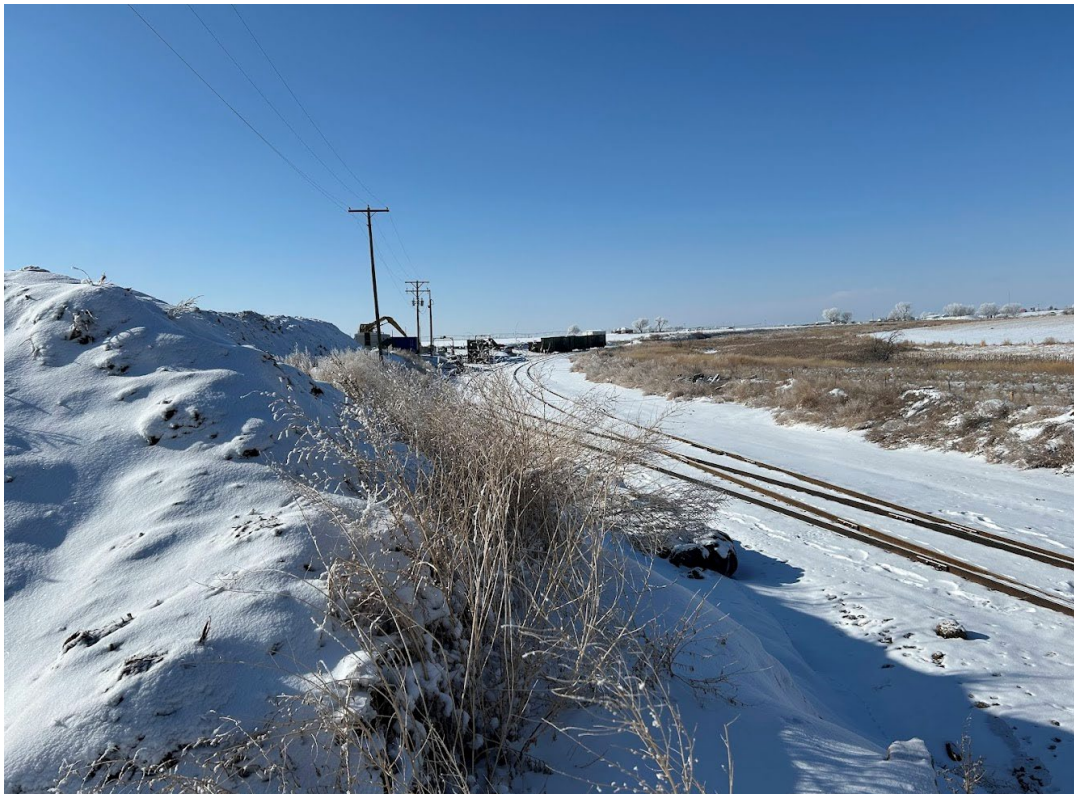
Photo 4: View of railroad from the perspective of the excess excavated material, facing southwest.

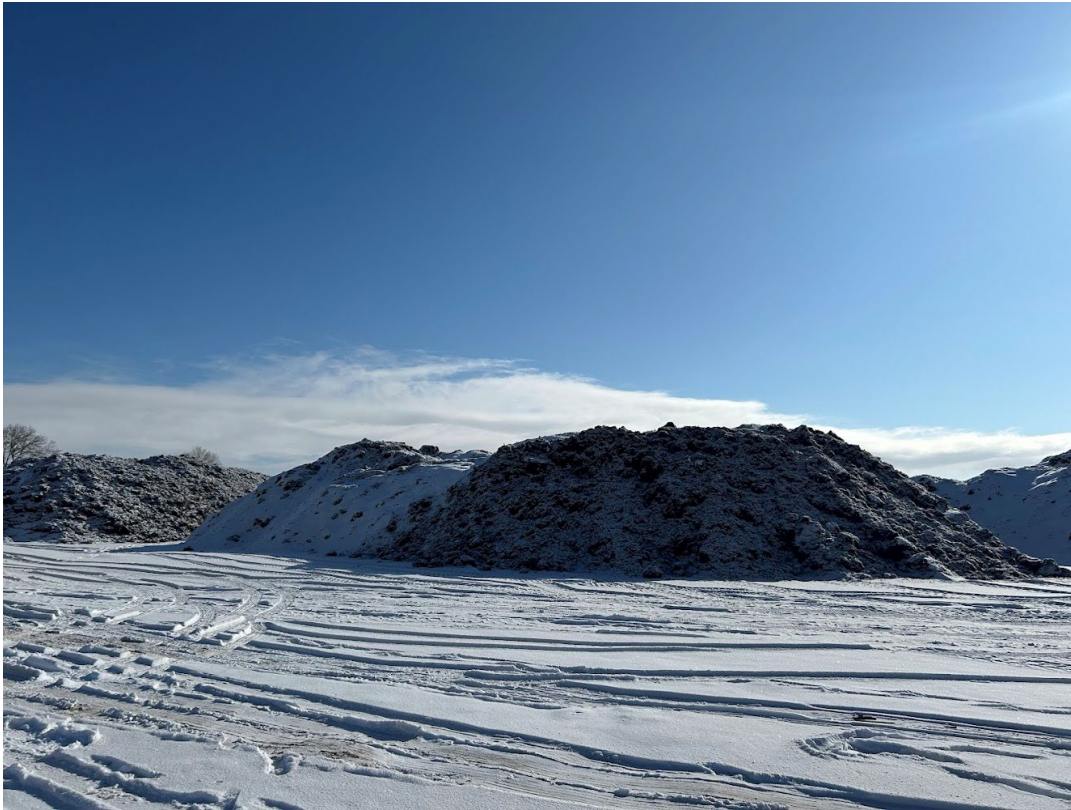
Photo 5: View of snow-covered mulch stockpiles, facing north.

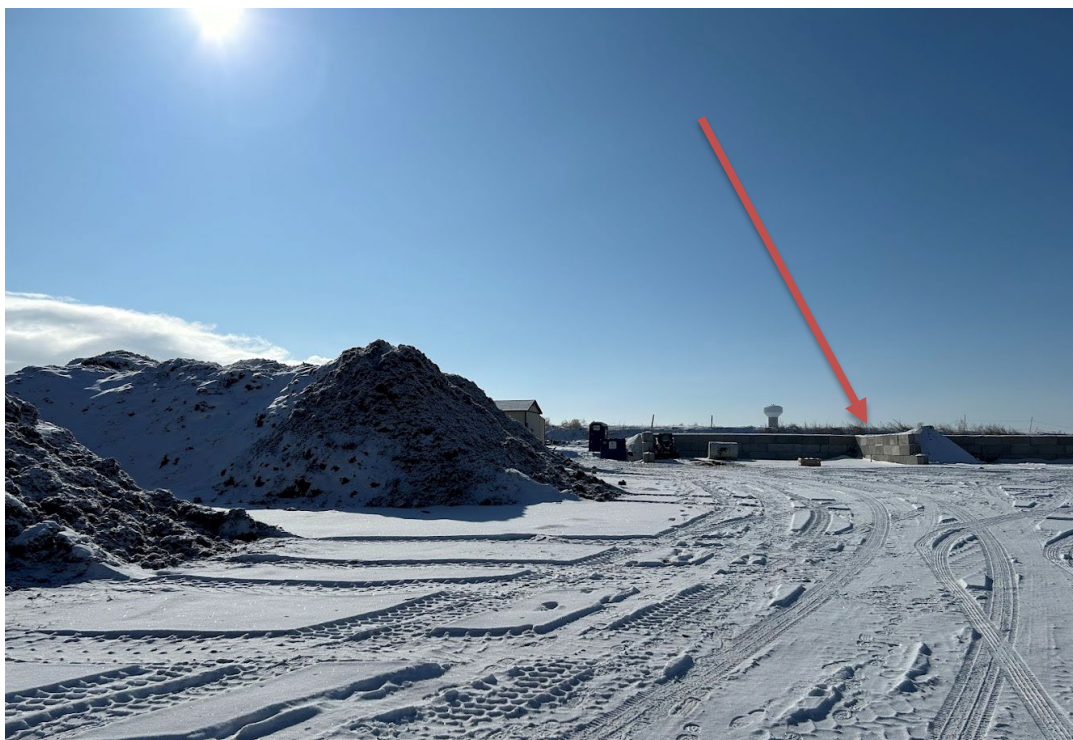
Photo 6: View of snow-covered mulch stockpiles and the concrete bins (see arrow) containing the majority of the material excavated along the railroad tracks, facing south.
