MINERALS PROGRAM INSPECTION REPORT
PHONE: (303) 866-3567

MINE NAME: Fremont Gravel Pit	MINE/PROSPECTING ID#: M-1984-117	MINERAL: Sand and gravel	COUNTY: Fremont
INSPECTION TYPE: Monitoring	WEATHER: Clear	INSP. DATE: January 30, 2025	INSP. TIME: 12:20
OPERATOR: Fremont County	OPERATOR REPRESENTATIVE: Mr. Scott Hileman	TYPE OF OPERATION: 110c - Construction Limited Impact

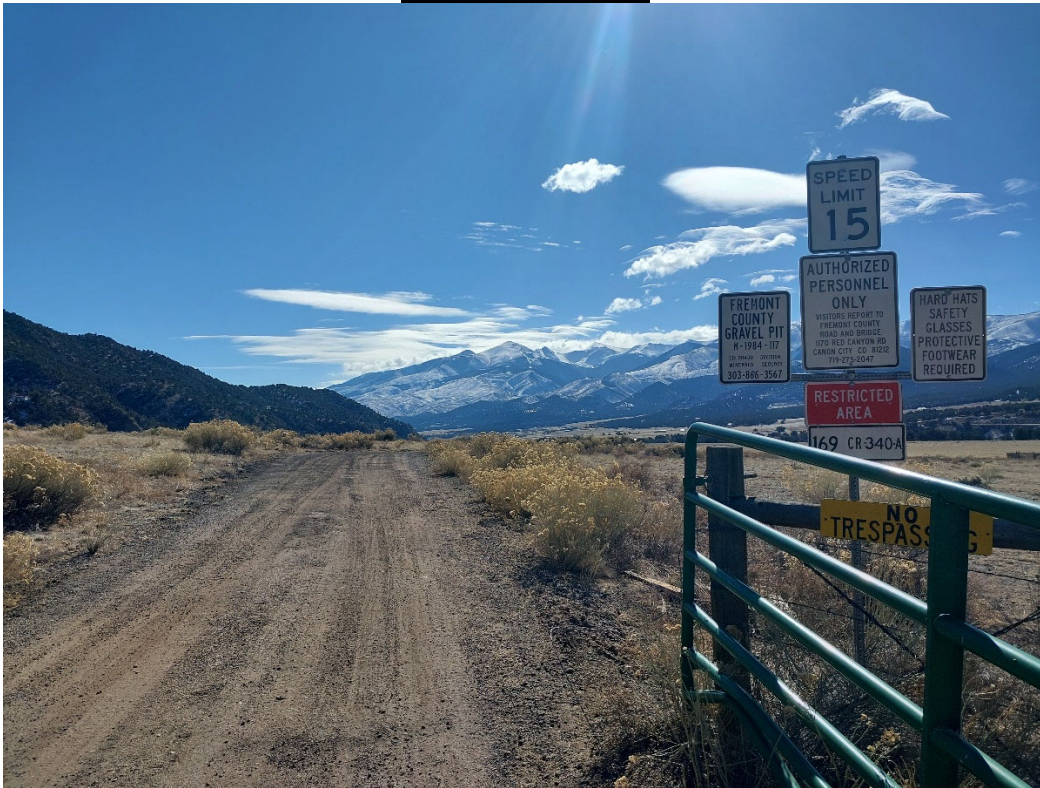
There is a mine sign posted at the entrance of the permitted area, meeting the requirements outlined in Rule 3.1.12(1), see Photo #1. Permit boundary markers were also observed to be in place and in good condition, see Photos #2 - #6.

The access road for the site was in good condition, see Photo #1.

Photo #1: Mine sign, in accordance with Rule 3.1.12(1) along the access road; looking south.

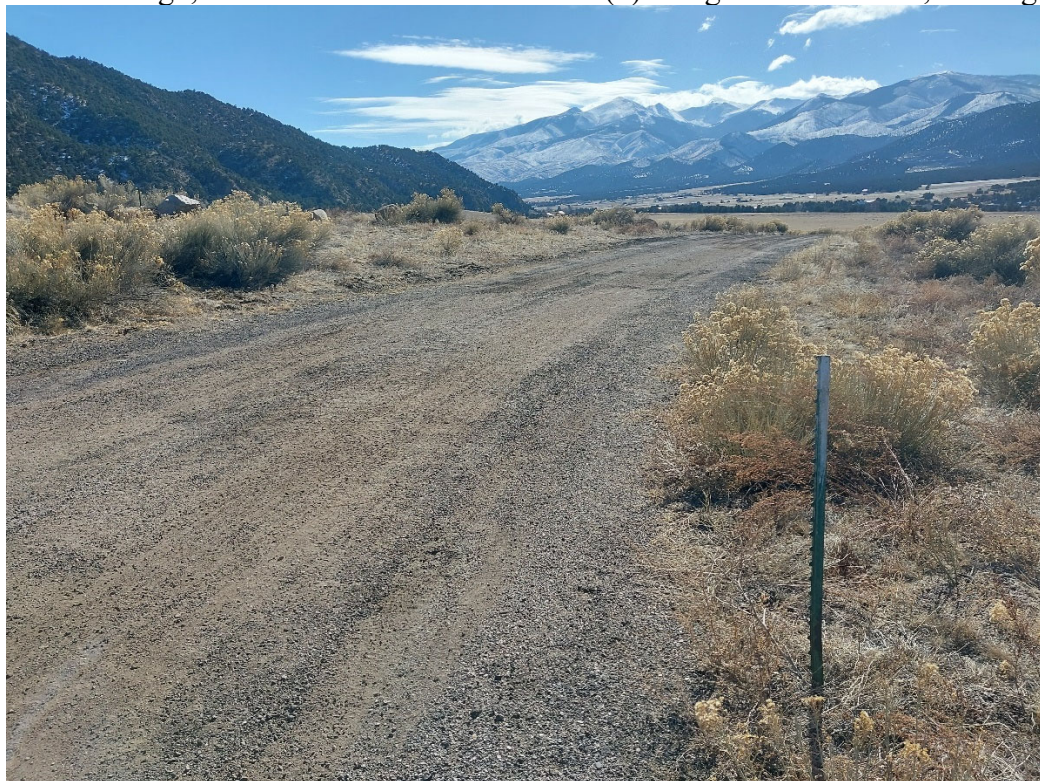
Photo #2: T-post marking the NW corner of the permit boundary; looking south.

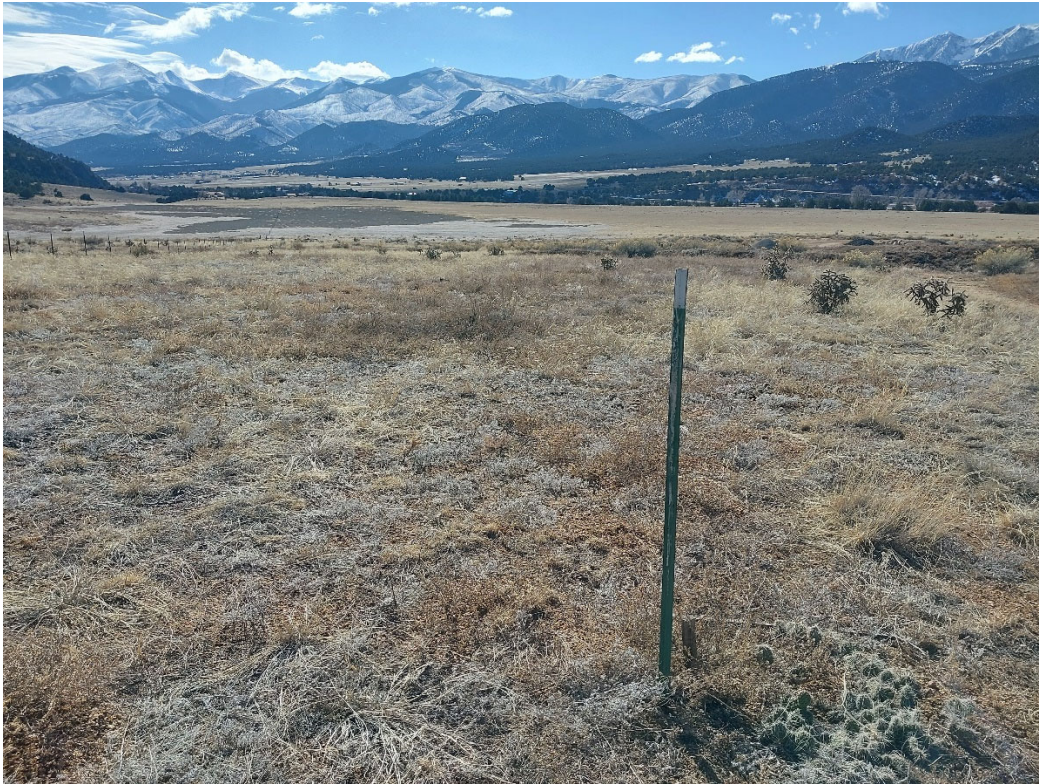
Photo #3: T-post marking the NE corner of the permit boundary, looking southwest.

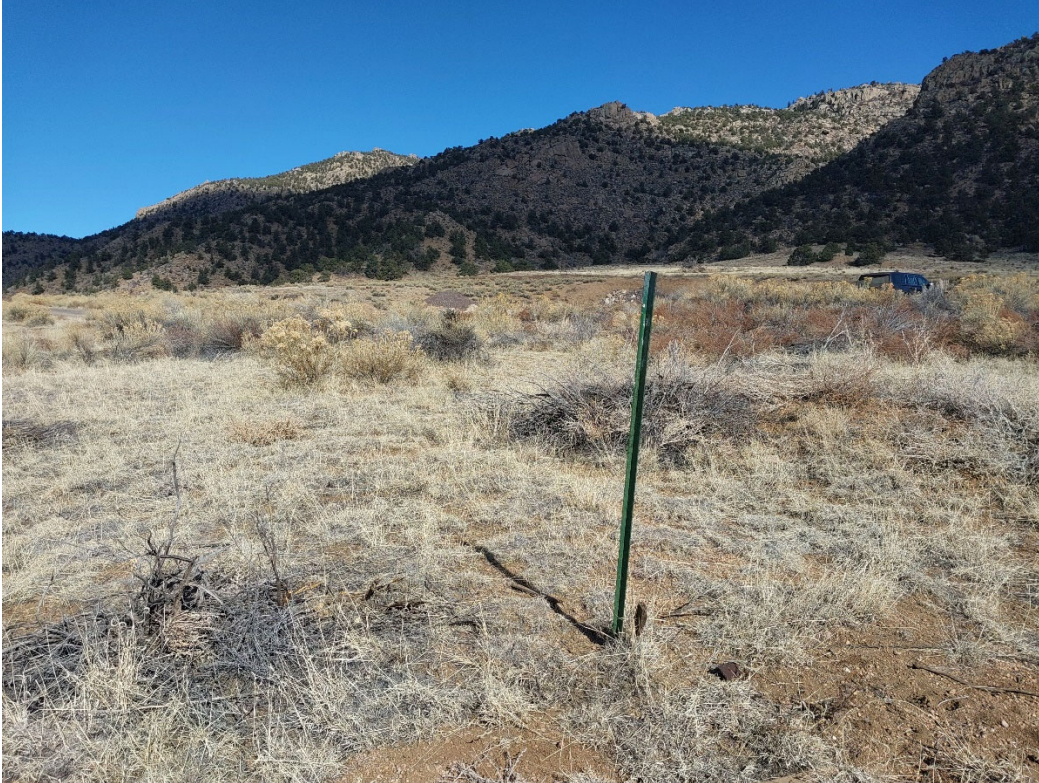
Photo #4: T-post marking the SW corner of the permit boundary; looking to the northeast.

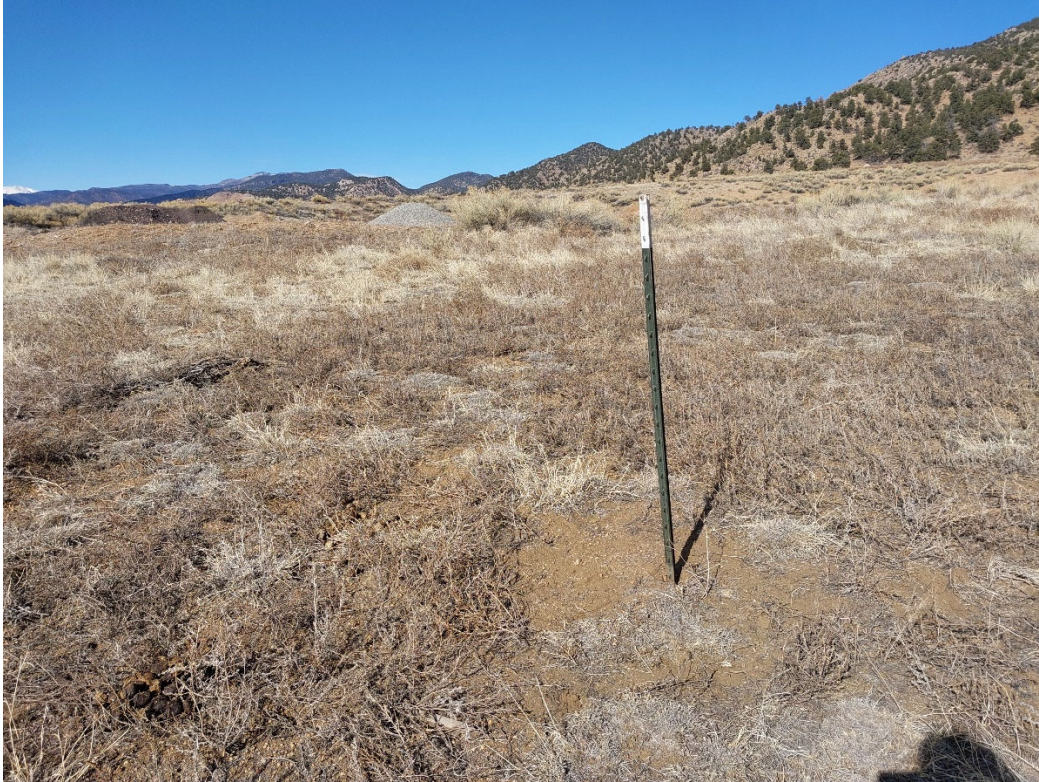
Photo #5: T-post marking the south-central permit boundary; looking north.

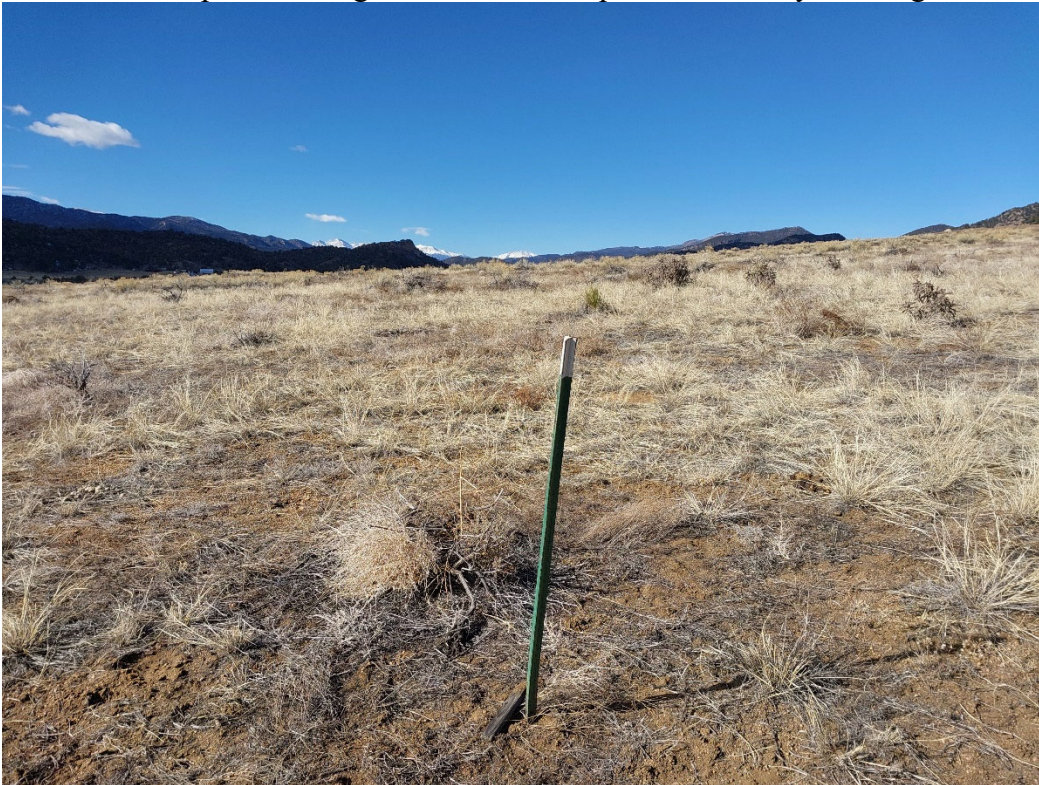
Photo #6: T-post marking the SE corner of the permit boundary; looking to the northwest.

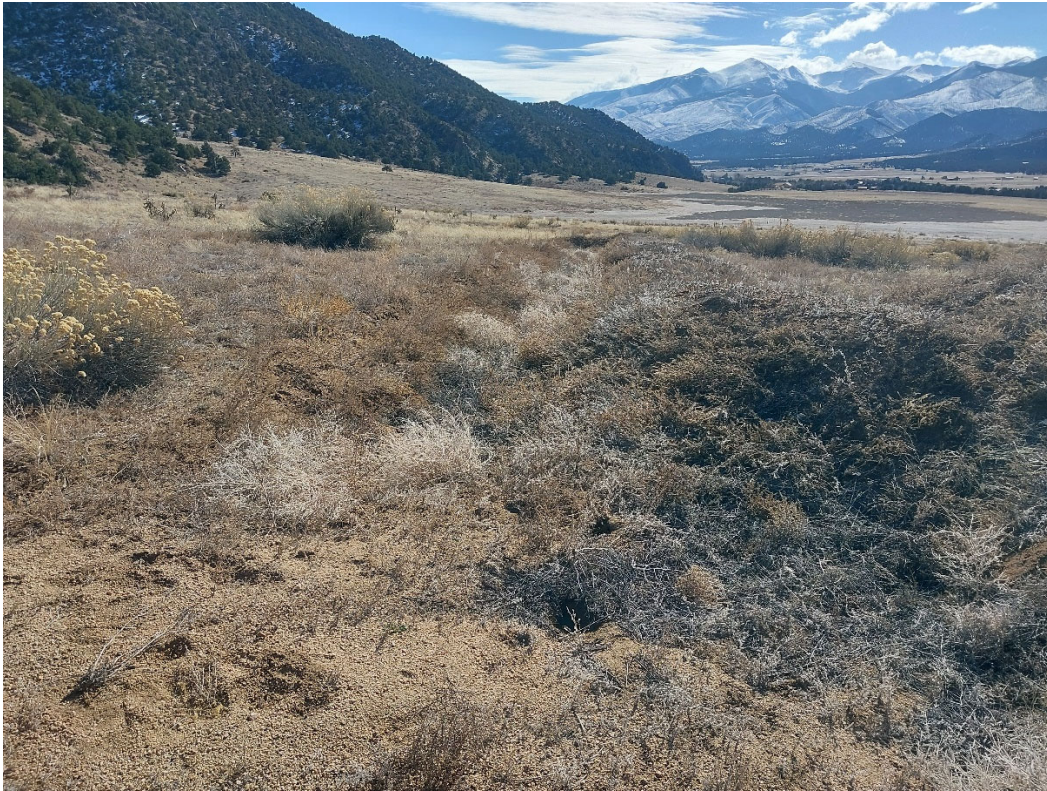
There is a ditch that runs along the north and east side of the affected area for runoff. There was a buildup of tumbleweeds in the ditch, but they were well formed, see Photo #8.

Photo #7: View of the stormwater ditch running along the east side of the pit area; looking to the south.

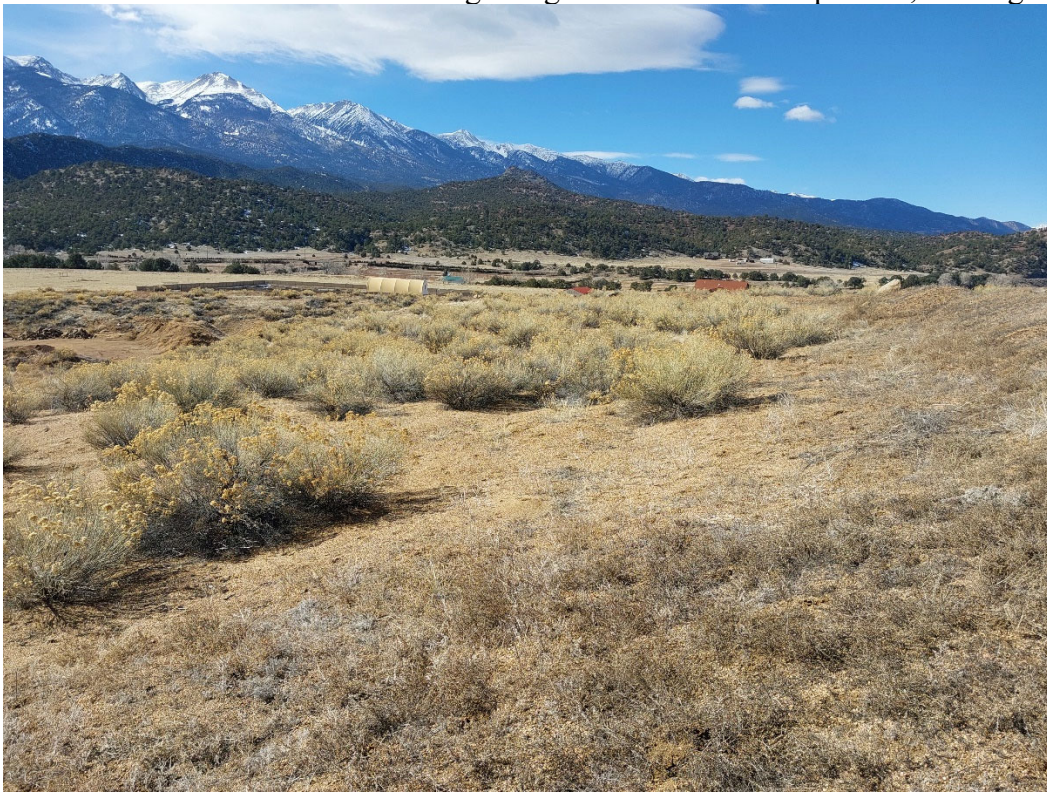
The north side of the affected area has been backfilled and graded. The slopes appear to be 4H:1V or less and are establishing vegetation, see Photo #7.

Photo #8: View of the backfilled and graded area on the north side of the affected area; looking to the west.

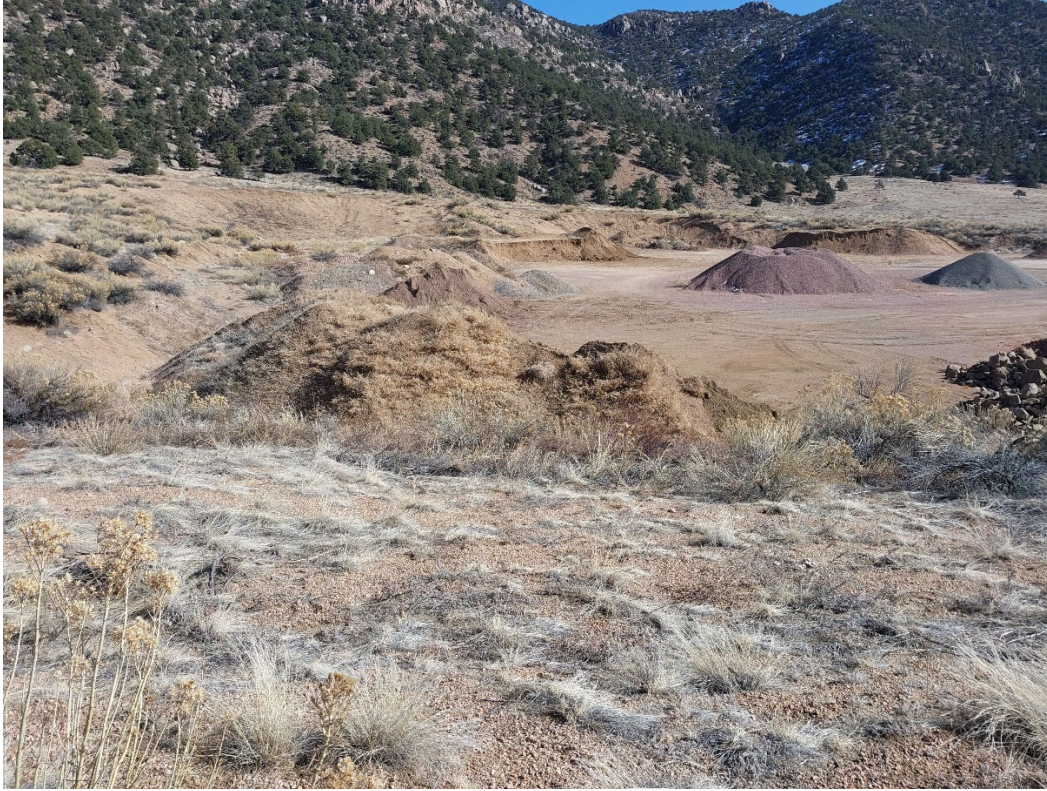
PROBLEM: The current mine plan needs to be updated and clarified pursuant to C.R.S. 34-32.5-112 (1)(c)(VI). The operator must provide sufficient information to describe or identify how the operator intends to conduct the operation. During the inspection, it was observed that numerous stockpiles and imported materials were stored on the permitted area. These activities are not included in the current approved mining plan.

A problem is being cited in this report for the mining plan compliance. The currently approved mining plan does not call for stockpiling material or importing material. During this site visit, multiple stockpiles of material were observed, including imported material from other operations, asphalt, and concrete barriers from road projects. Photos #9 through Photos #12 and Figure #1 show the various types of materials stockpiled and approximate locations. See the problem citation above regarding the corrective action required to resolve this issue.

Photo #9: View of the north side of the pit floor; looking east. The stockpiles of material that have been imported can be seen in the central of the right side of the photo (red and grey), along with stockpiles of what appears to be material sourced from the permit area in the background and the foreground.

Option #1: The operator shall submit a Technical Revision, with the required \$216 revision fee, to update and clarify the current approved mine plan to reflect existing and proposed activities by the corrective action date.

Option #2: The operator shall remove the stockpiled imported material from the permitted area and provide photos evidence to the Division by the corrective action date.

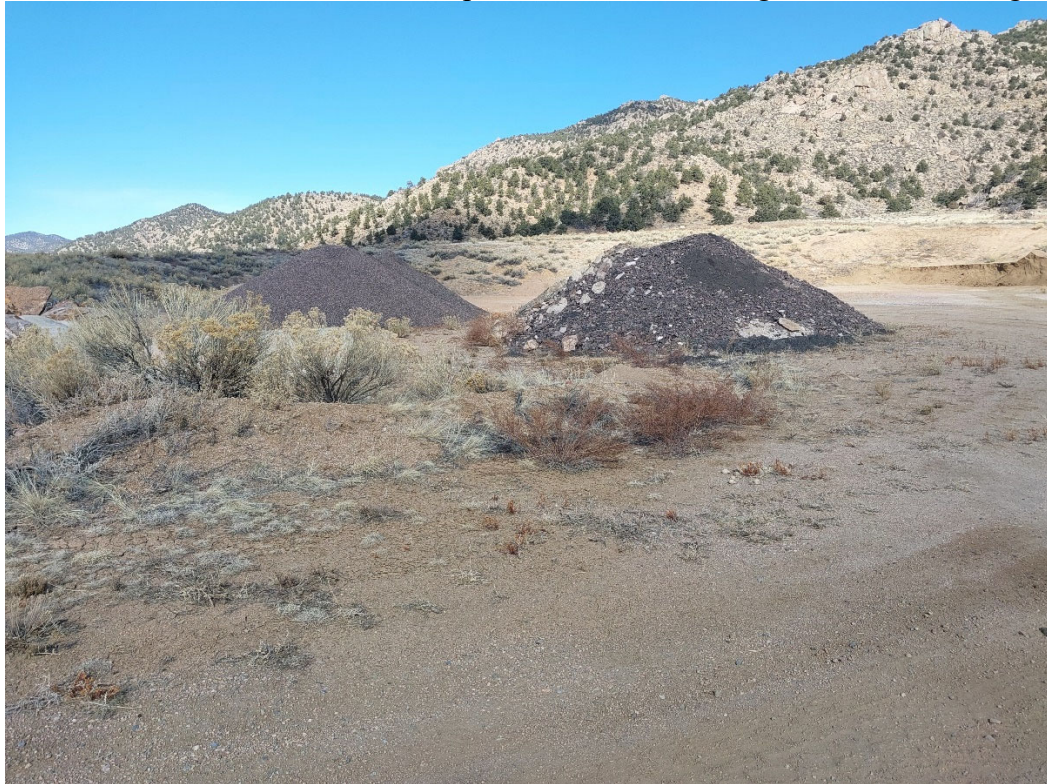
Photo #10: View of the stockpiled recycled asphalt situated on the southern portion of the pit floor; looking to the northeast.

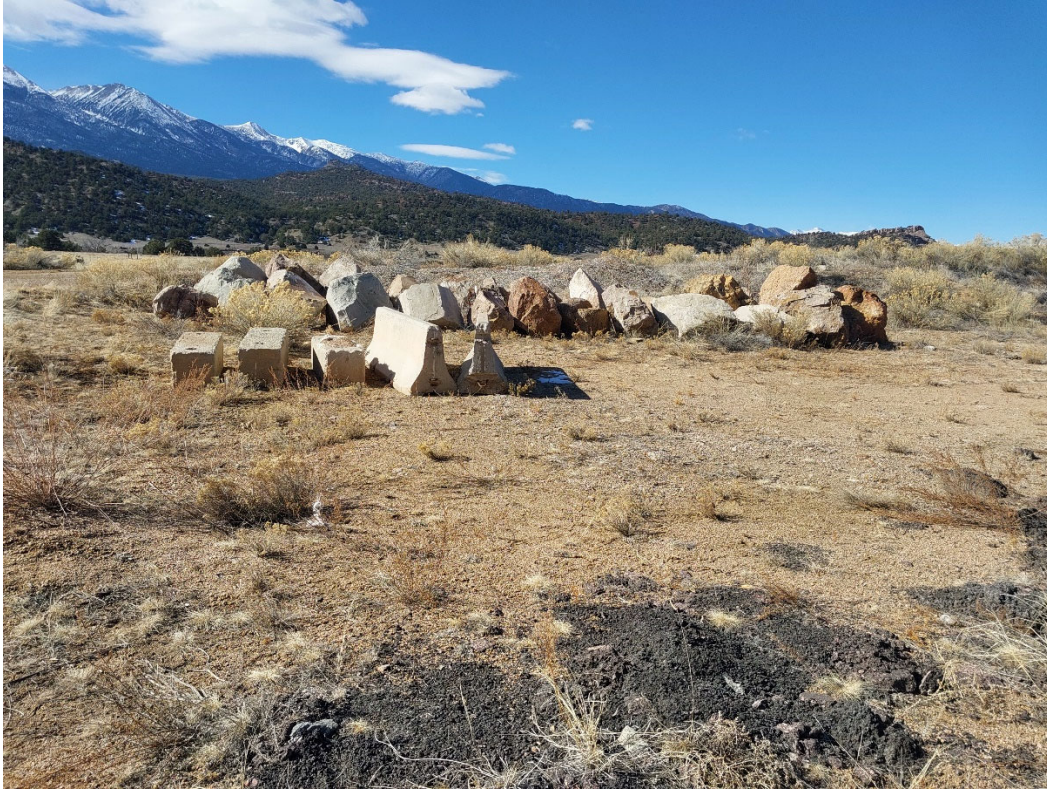
Photo #11: View of the concrete and large boulders used for county road projects, situated along the southwestern portion of the pit area; looking to the northwest.

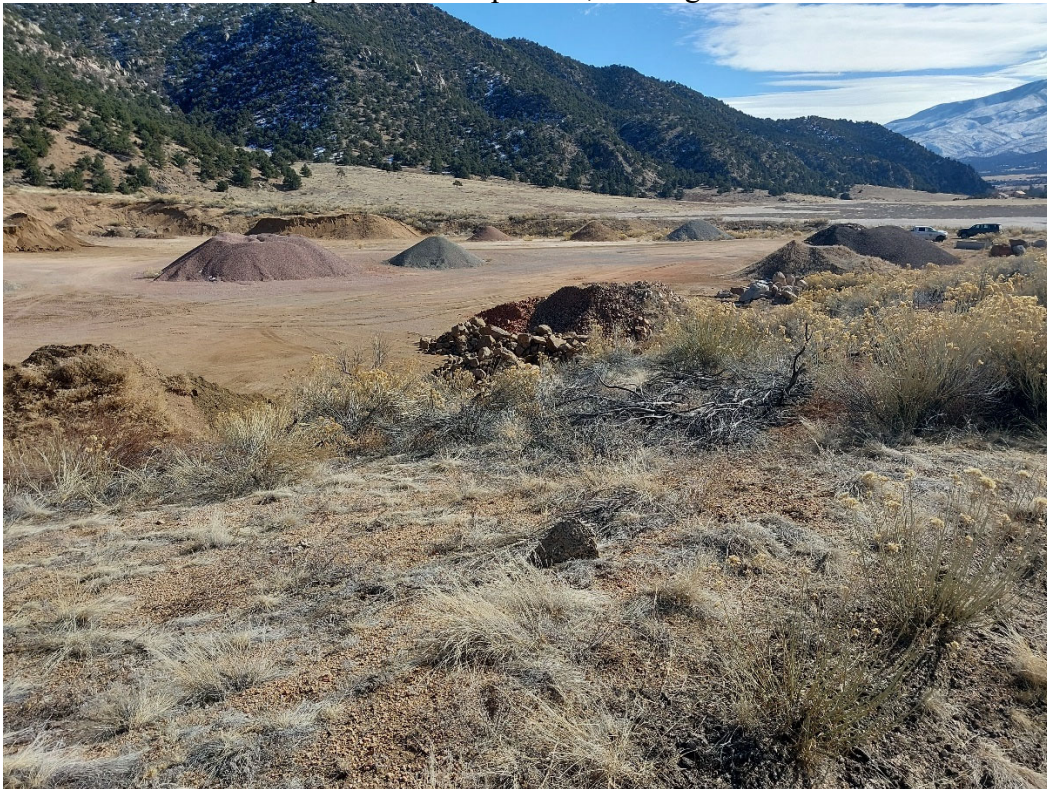
Photo #12: View of the stockpiled material observed on the pit floor; looking to the south-southeast. Much of the material viewed are imported materials.

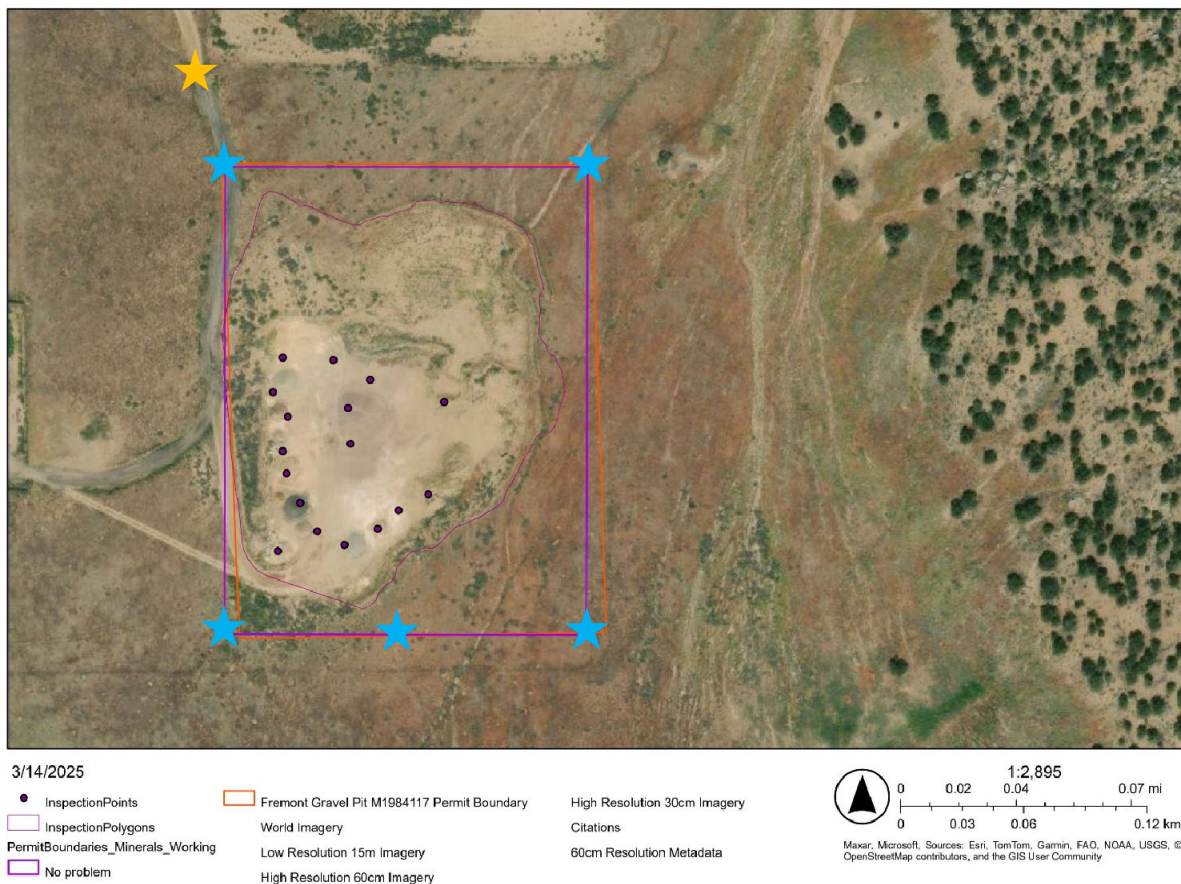
Figure #1: Map created from observations made during the inspection. The thicker purple line and the orange line represent the approximate permit boundary, the thinner light purple inspection polygon represents the extent of the affected area, the yellow star represents where the posted mine sign was located, the blue stars represent the locations of the five permit boundary markers, and the purple inspection points represent the locations of the various stockpiles of materials observed.
