Hardship Lode Quarry, M1987027- Inspection Report

MINERALS PROGRAM INSPECTION REPORT
PHONE: (303) 866-3567

MINE NAME: Hardship Lode Quarry	MINE/PROSPECTING ID#: M-1987-027	MINERAL: Stone	COUNTY: Custer
INSPECTION TYPE: Monitoring	WEATHER: Windy	INSP. DATE: February 7, 2025	INSP. TIME: 12:00
OPERATOR: Colorado Quarries Inc	OPERATOR REPRESENTATIVE: Aaron Tezak	TYPE OF OPERATION: 112c - Construction Regular Operation	
REASON FOR INSPECTION: Normal I&E Program	BOND CALCULATION TYPE: Complete Bond	BOND AMOUNT: \$97,325	
DATE OF COMPLAINT: NA	POST INSP. CONTACTS: None	JOINT INSP. AGENCY: None	
INSPECTOR(S): Chris Girardi	INSPECTOR'S SIGNATURE:

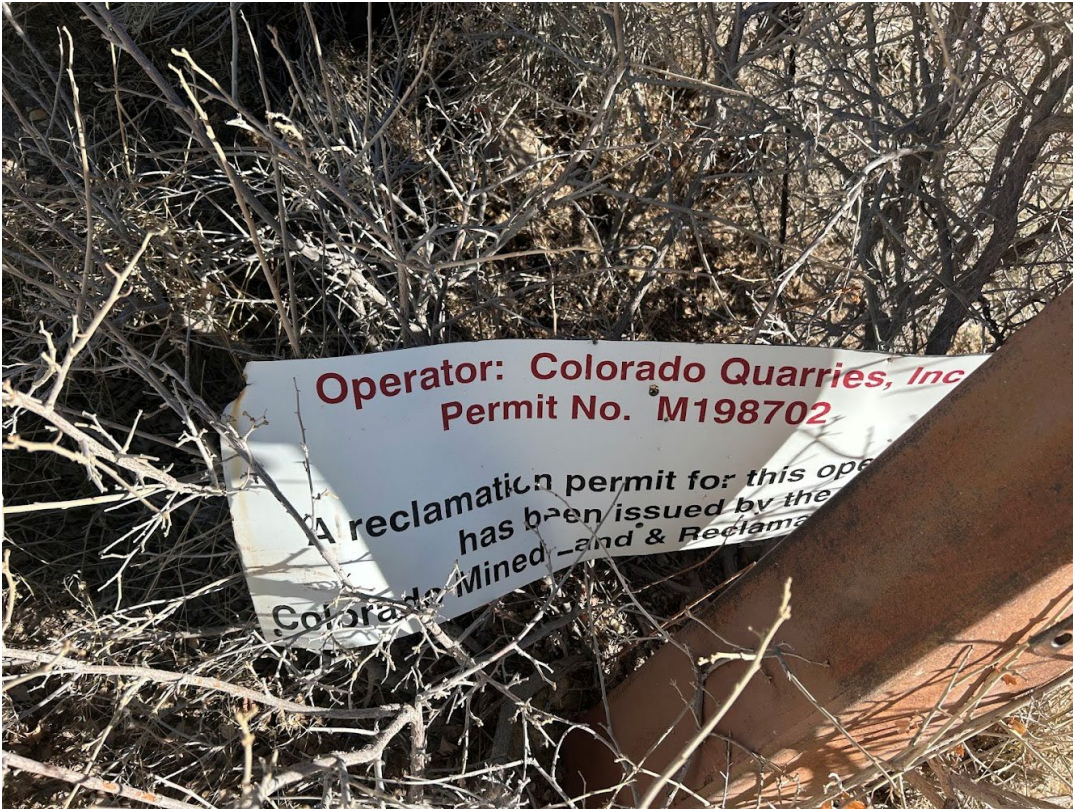
PROBLEM: The mine identification sign observed does not meet the requirements of Rule 3.1.12. The Operator shall, at the entrance of the mine site post a sign, which shall be clearly visible from the access road, with a minimum size equaling one hundred and eighty-seven (187) square inches, such as eleven (11) inches in height and seventeen (17) inches in width, with appropriate font size, with the following: the name of the Operator, a statement that a reclamation permit for the operation has been issued by the Colorado Mined Land

Reclamation Board; and the permit number. The permit number displayed on the observed sign was incorrect.
CORRECTIVE ACTIONS: Please revise the mine identification sign to indicate the correct permit number of M-1987-027.

The site is accessed from a locked gate at the entrance. A mine identification sign (see Photo 1) was observed next to the entrance gate. However, the sign displayed a permit number of "M198702". This has been cited as a problem. In accordance with Rule 3.1.12(1), please correct the mine entrance sign to display "M1987027". The permit boundary is enclosed with a fence. The affected area is delineated with T-posts (see Photo 4).

Photo 1: Permit identification sign at entrance gate.

CORRECTIVE ACTION DUE DATE: 4/17/25

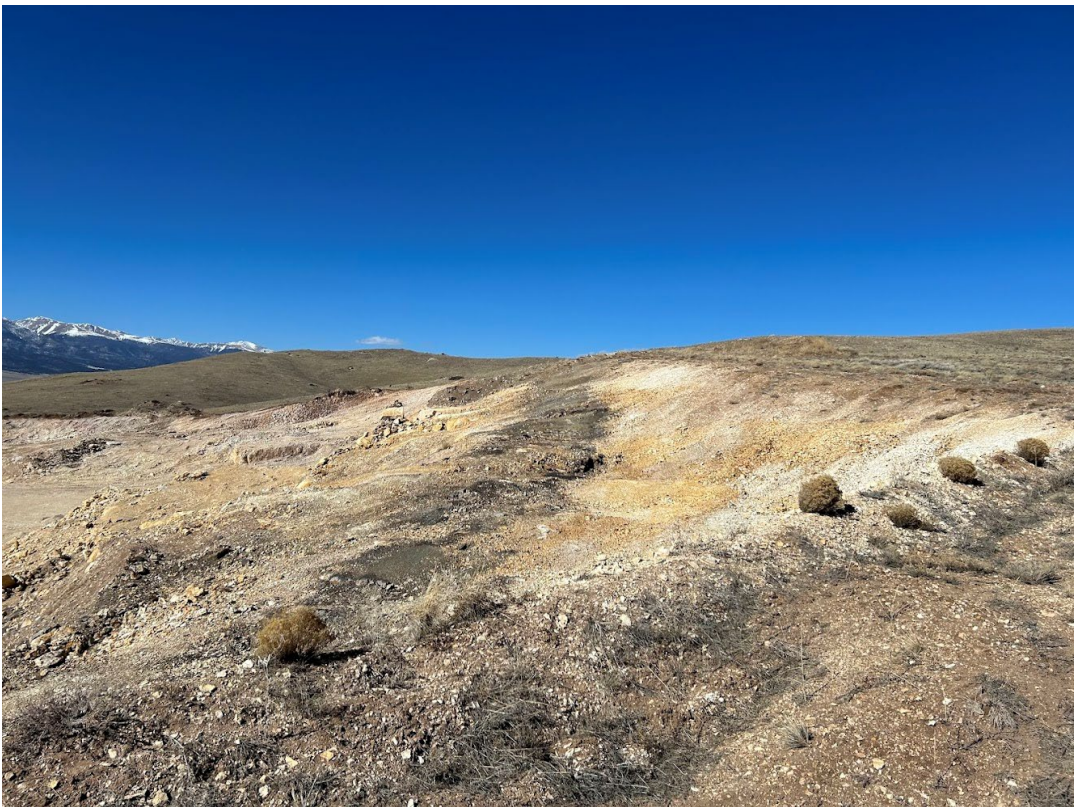
Photo 2: Overview of the northern portion of the affected area, facing west.

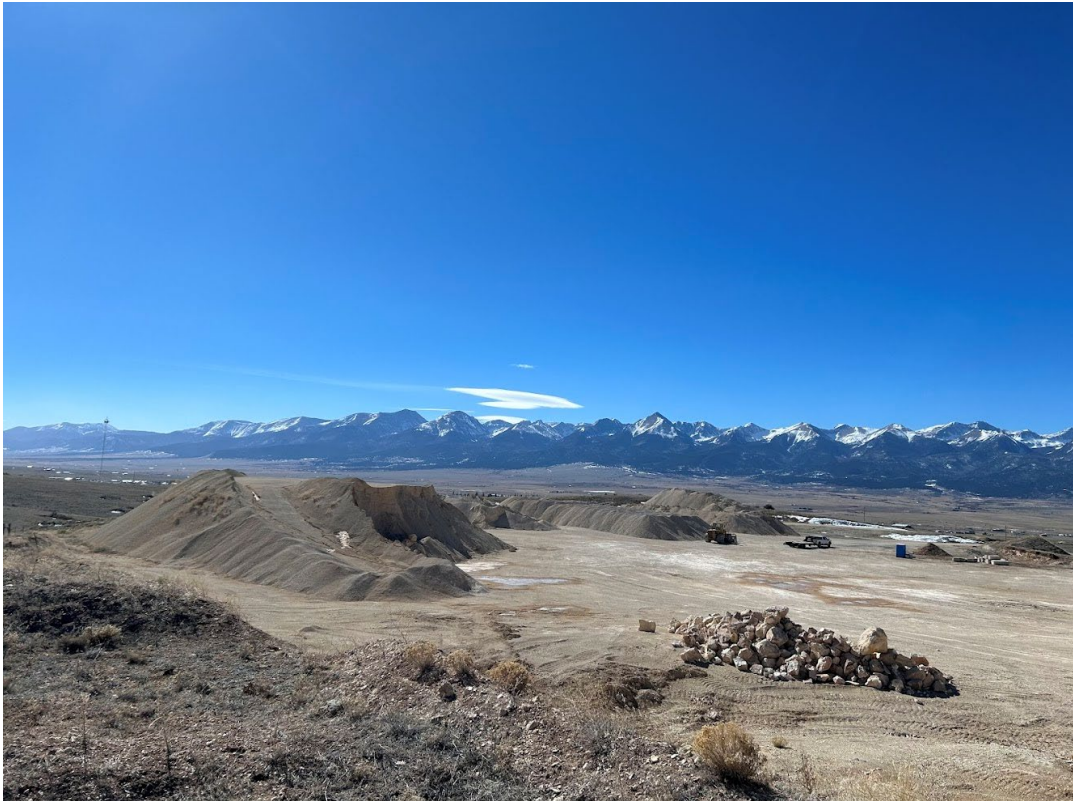
Photo 3: Overview of the southern portion of the affected area, including pit floor and material stockpiles. Facing southwest.

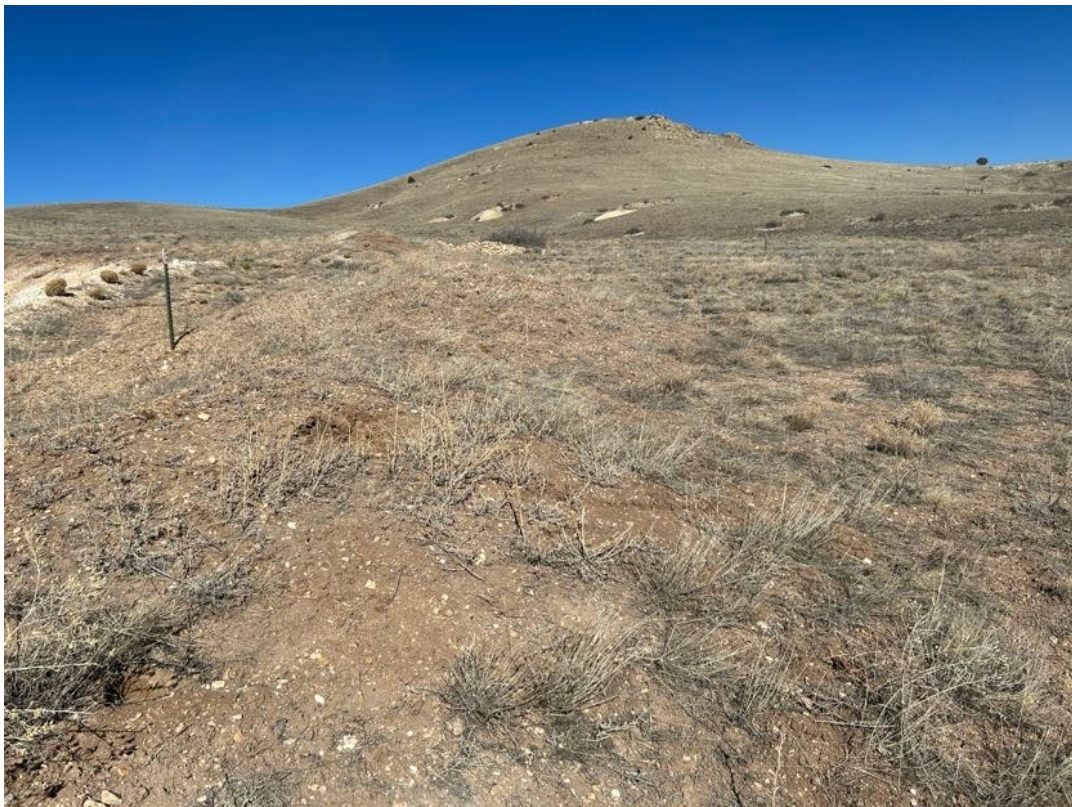
Photo 4: T-post marking the affected area to the southeast, facing north.

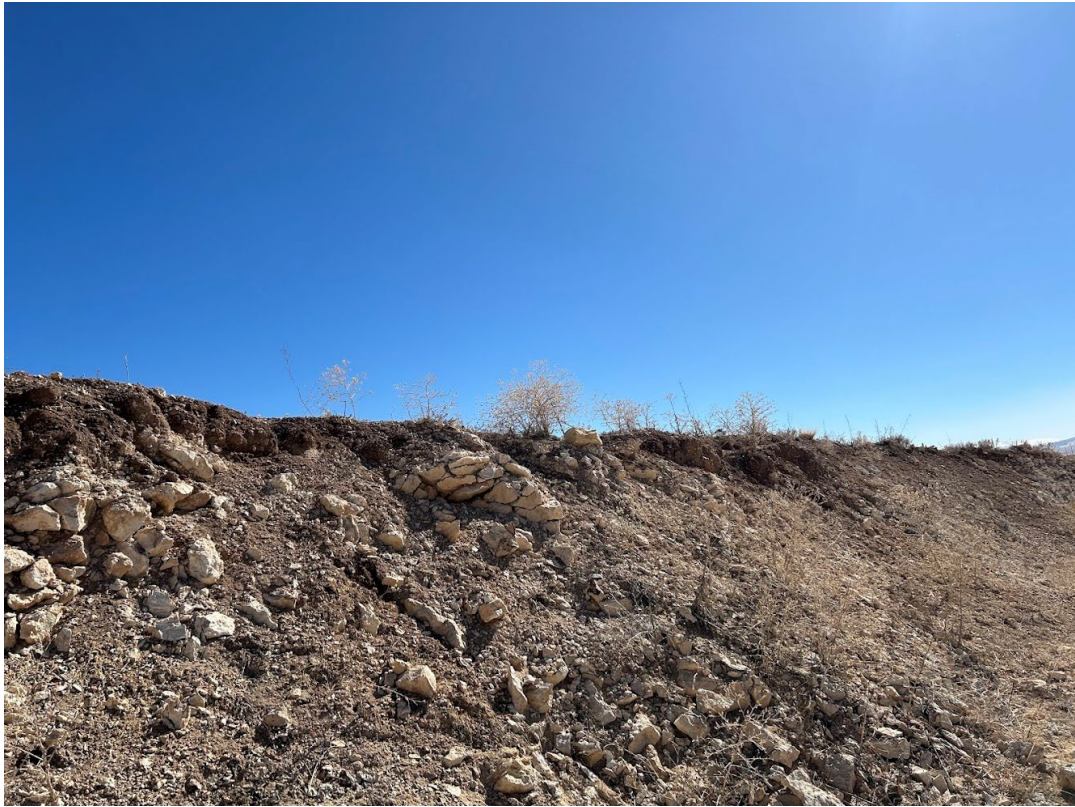
PROBLEM: There are state-listed noxious weeds present on site. This is a problem for failure to employ weed control methods for state listed noxious weed species within the permitted area, and to reduce the spread of weeds to nearby areas as required by Section 3.1.10 (6) of the rule.

Noxious weeds observed included a significant amount of Knapweed and a minor amount of Mullein within the unaffected portion of the permit area and minor amounts of Knapweed along the eastern portion of the highwall (see Photos 5-7). This has been cited as a problem. The Division conducted an inspection of the permit area on February 12, 2020, and the subsequent Inspection Report cited a problem for noxious weeds and requested a weed control plan be submitted in the form of a Technical Revision in order to address the noxious weed problem. Correspondence between the Operator and Fremont County Weed Management

Photo 5: East highwall and knapweed, facing east.

CORRECTIVE ACTIONS: Implement approved weed control plan and provide proof to the Division that this has been done. If a weed control plan is not already in place, the operator shall develop a weed control and management plan in accordance with Section 3.1.10 (6) of the Rule. This plan should be developed in consultation with the county extension agency, or weed control district office and should include specific control measures to be applied, a schedule for when control measures will be applied and a post-treatment monitoring plan. This weed control plan shall be submitted to the Division as a Technical Revision to the approved plan with the appropriate Technical Revision fee of \$216.00 by the corrective action date.

CORRECTIVE ACTION DUE DATE: 5/17/25

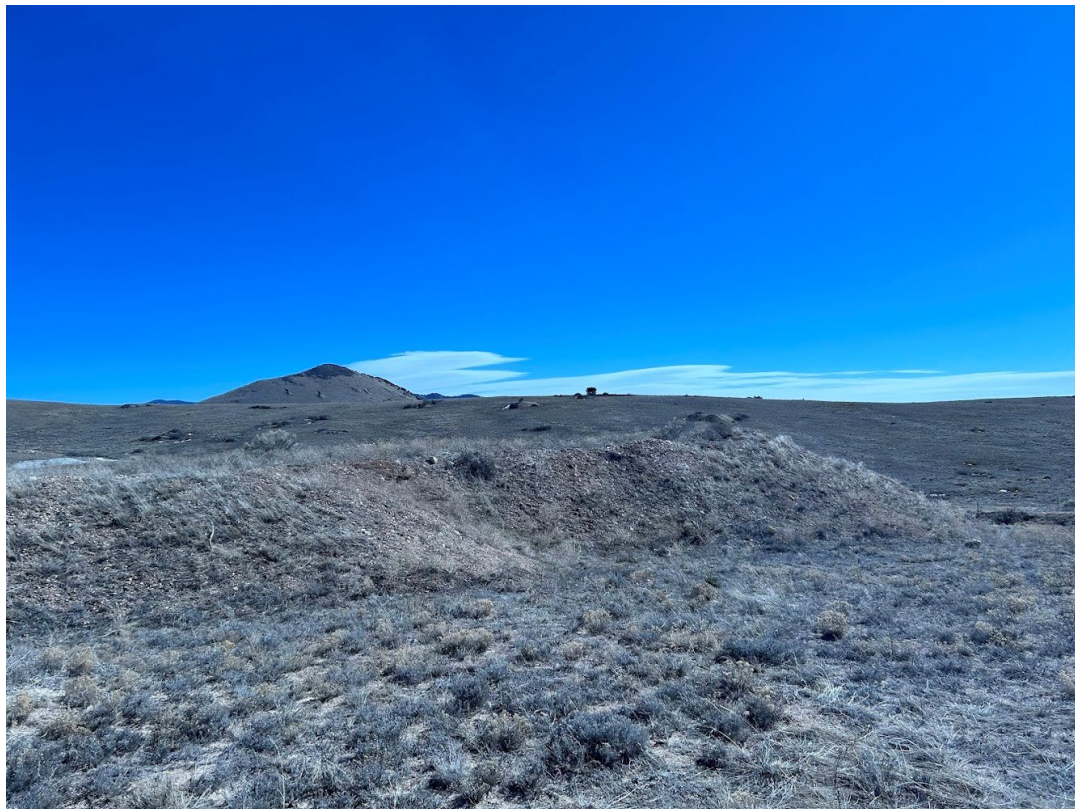
Topsoil was observed in a vegetated stockpile to the east the pit and the unaffected portion of the permit area (see Photo 6). The topsoil stockpiled was vegetated with native grasses and minor amounts of Knapweed. The pit floor contained several stockpiles of material, including sand, gravel, and boulders at various locations in the pit floor (see Photos 3 and 10). A wheel dozer (see Photo 3) was observed in the pit floor near a gravel stockpile. The laydown area contained portable conveyers, grizzly screeners, a pile of lumber wood, concrete blocks, and storage tanks on trailers (see Photos 8-10). No problems were observed regarding the laydown area.

Photo 6: Vegetated topsoil stockpile located in the unaffected area to the east of the pit, facing east.

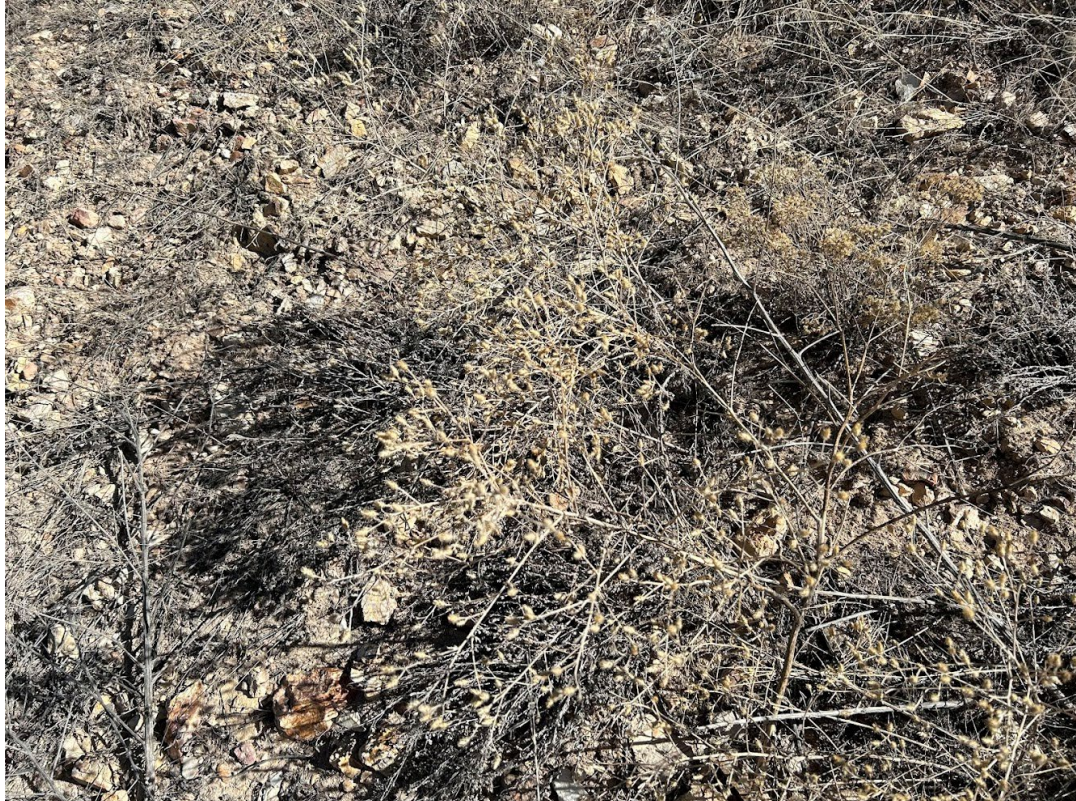
Photo 7: Knapweed located amongst the topsoil stockpile.

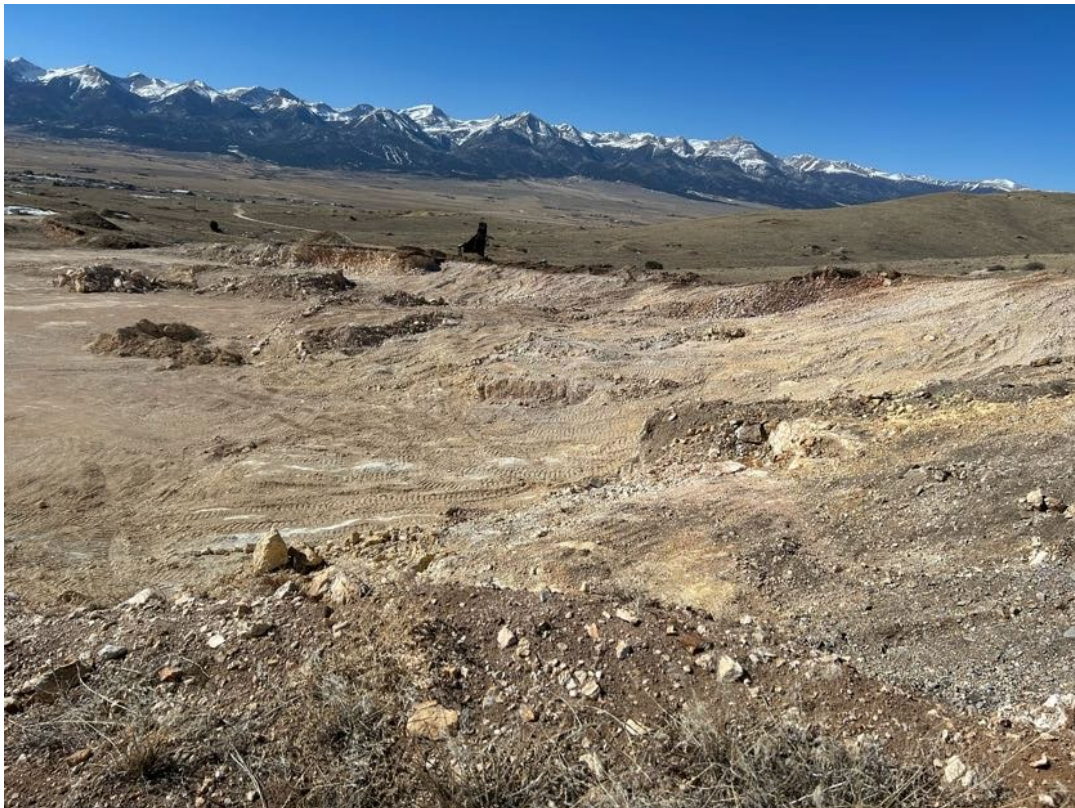
Photo 8: Northern portion of the pit highwall, facing west.

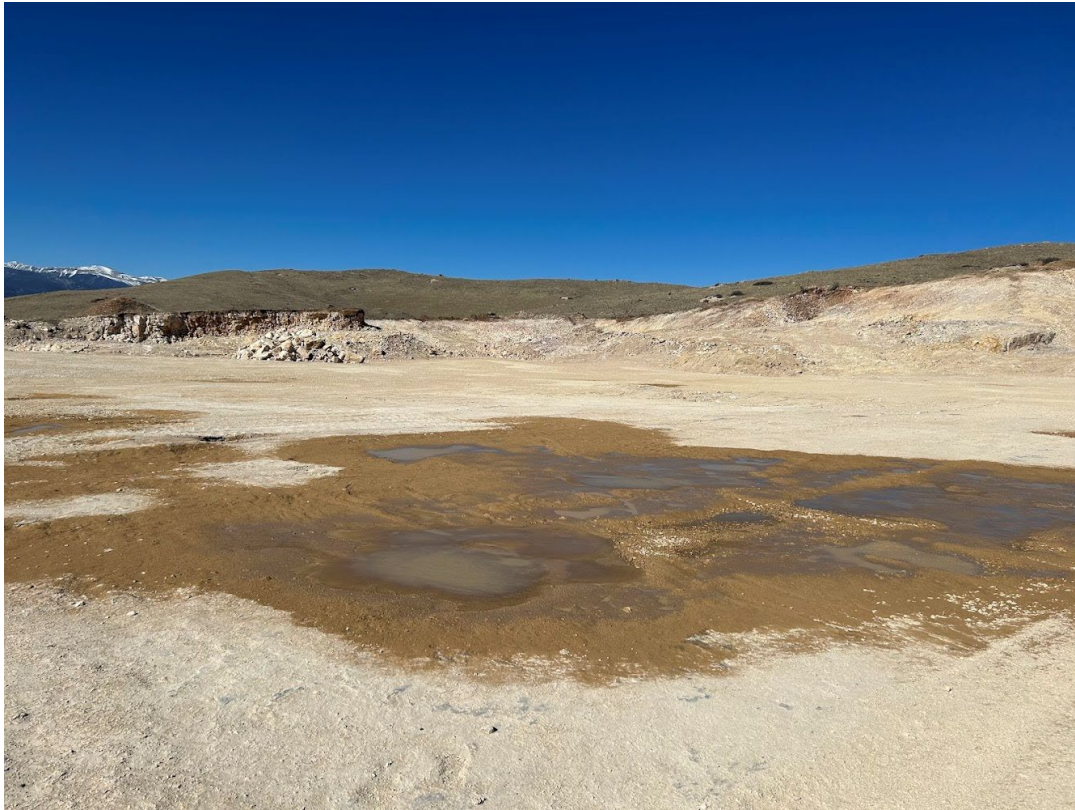
The site consists of rolling hills and grassy vegetation, including Rubber rabbitbrush, Yucca, wheatgrasses, and Knapweed. The site overalls slopes to the south. At the time of the inspection, no mining was being conducted. The site consists of a large, sloped pit from the extraction of a rhyolite outcrop, as well as stockpiles of mined material, a topsoil stockpile, and equipment. The pit is approximately 13-acres in size and ranges from eighteen (18) to approximately fifty (50) feet in depth. According to the mining plan, the operation is still mining the Pit Number One Area, while the Pit Number Two area to the south remains unaffected. The pit is progressing to the north via a highwall close to 50 feet in depth with a slope ranging between 3:1 and 4:1 (horizontal to vertical ratio) (see Photos 2 and 8). The pit highwall along the eastern portion is approximately 18 feet in depth with a slope at close to 3:1 with some portions exhibiting a steeper slope (see Photos 5 and 13). No erosional features were observed along the pit slopes. The pit floor contains several stockpiles of processed fine-grained material, sand, gravel, and a small pile of boulders. A small amount of water was present on the pit floor (see Photo 9). However, the Operator stated the ponding was due to recent snow melt.

Photo 9: Minor amount of ponding on the pit floor, facing west.

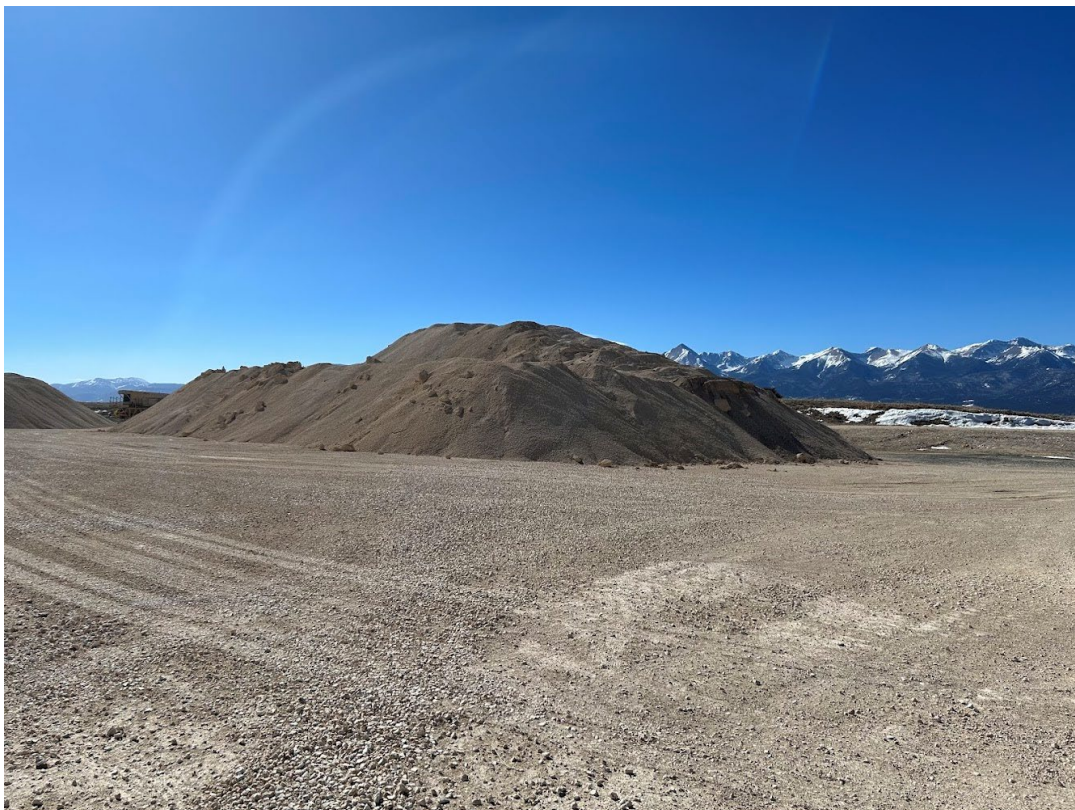
Photo 10: Fine-grained material stockpile after processing within the pit floor, facing southwest.

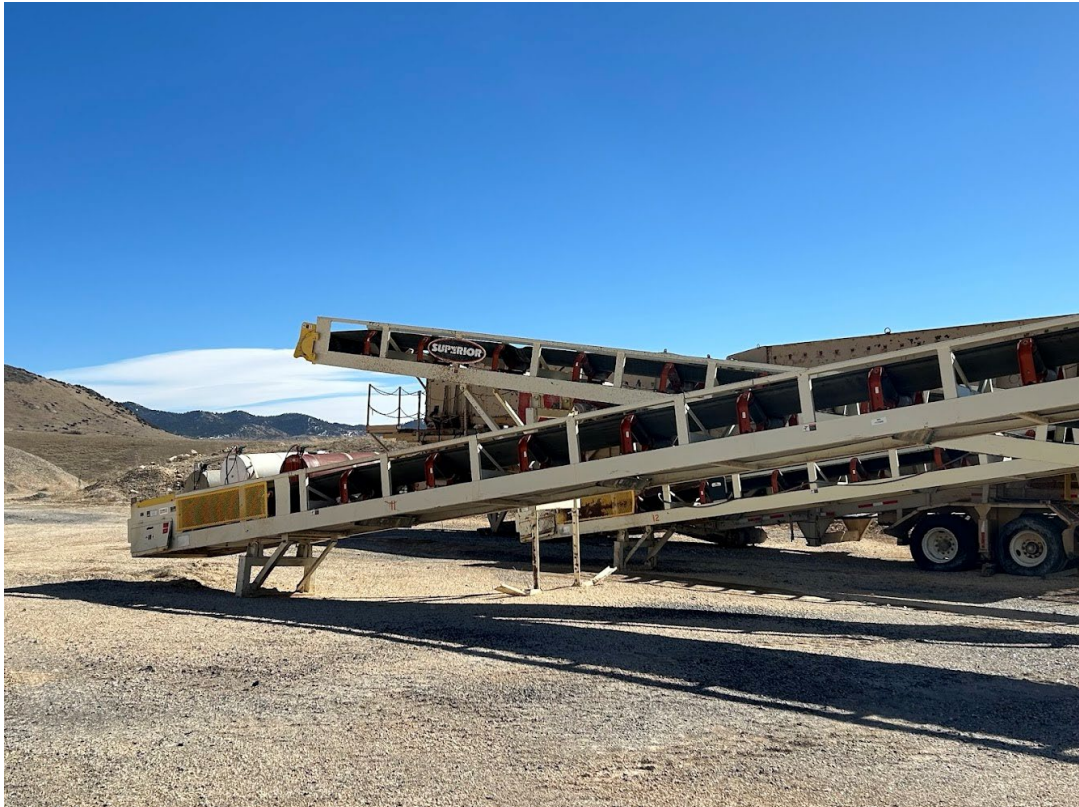
Photo 11: Conveyers in the laydown area, facing east.

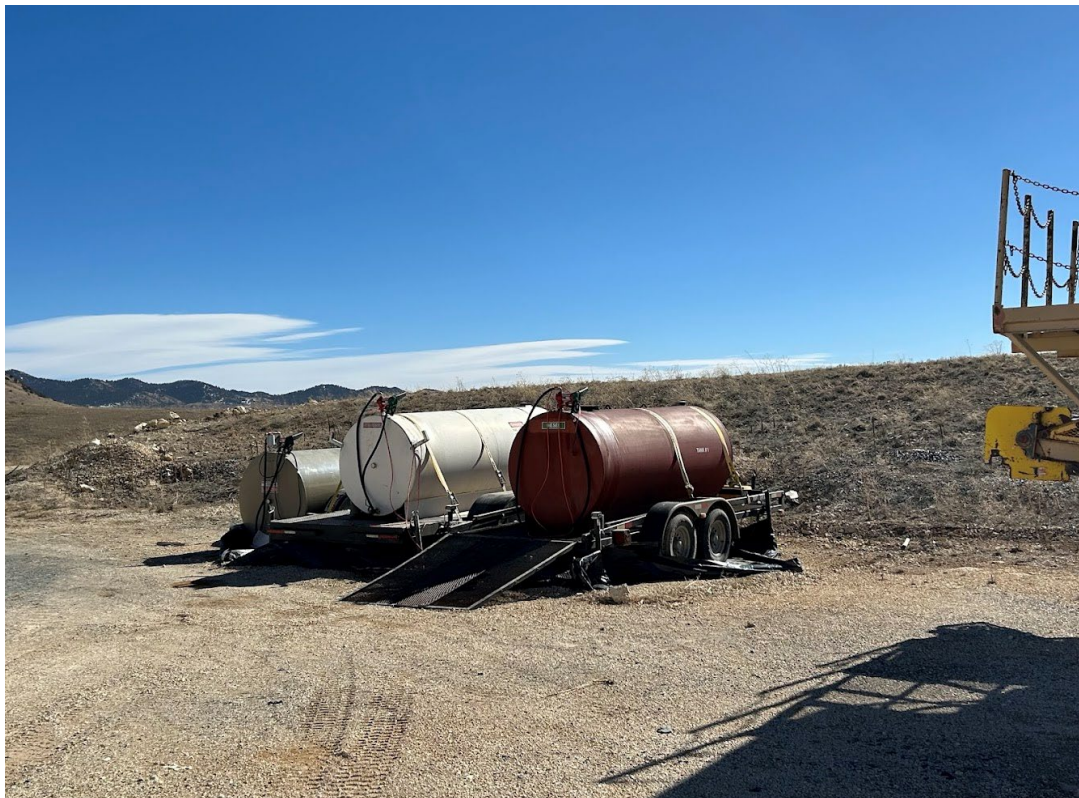
Photo 12: Small storage tanks strapped to trailers in the laydown area, facing east.

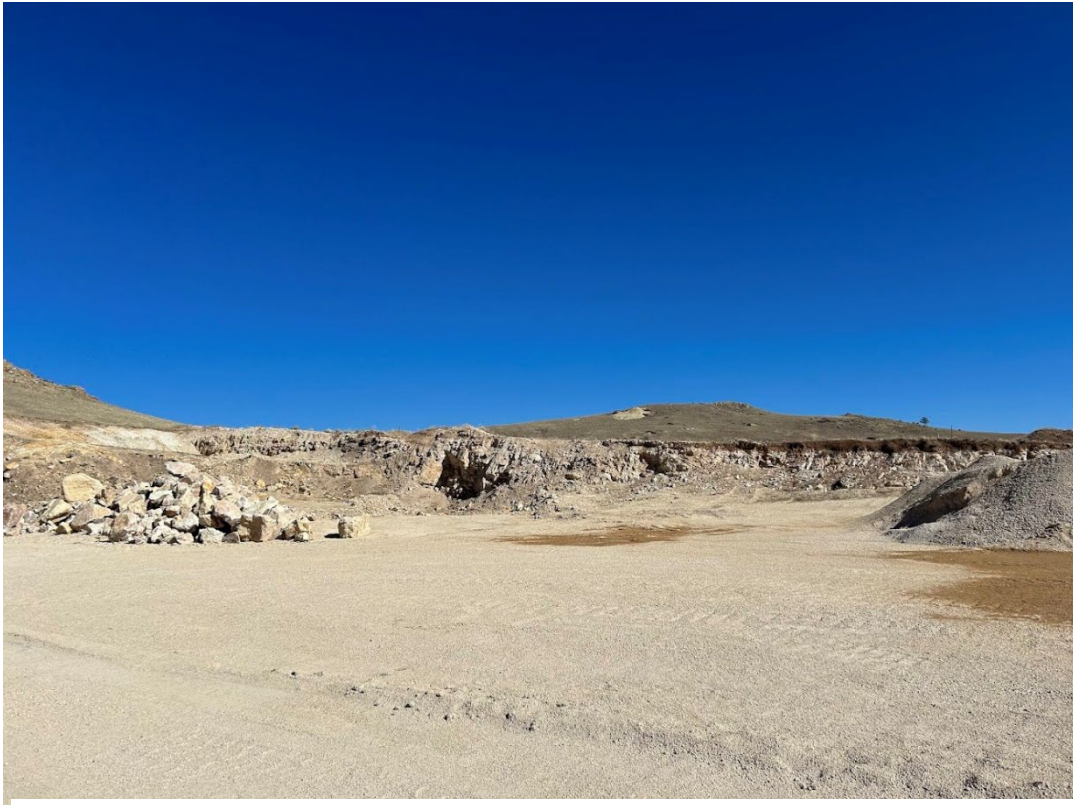
Photo 13: View of the pit highwall along the eastern portion, facing east.
