MINERALS PROGRAM INSPECTION REPORT
PHONE: (303) 866-3567

MINE NAME: Irwin/Thomas Mine	MINE/PROSPECTING ID#: M-2016-054	MINERAL: Sand and gravel	COUNTY: Boulder
INSPECTION TYPE: Monitoring	WEATHER: Clear	INSP. DATE: March 12, 2025	INSP. TIME: 10:00
OPERATOR: Holcim - WCR, Inc.	OPERATOR REPRESENTATIVE: Wyatt Webster, Chris Zadel, Dominick Sobotka	TYPE OF OPERATION: 112c - Construction Regular Operation	
REASON FOR INSPECTION: Normal I&E Program	BOND CALCULATION TYPE: Partial Bond	BOND AMOUNT: \$8,260,499.00	
DATE OF COMPLAINT: NA	POST INSP. CONTACTS: None	JOINT INSP. AGENCY: None	
INSPECTOR(S): Patrick Lennberg	INSPECTOR'S SIGNATURE:

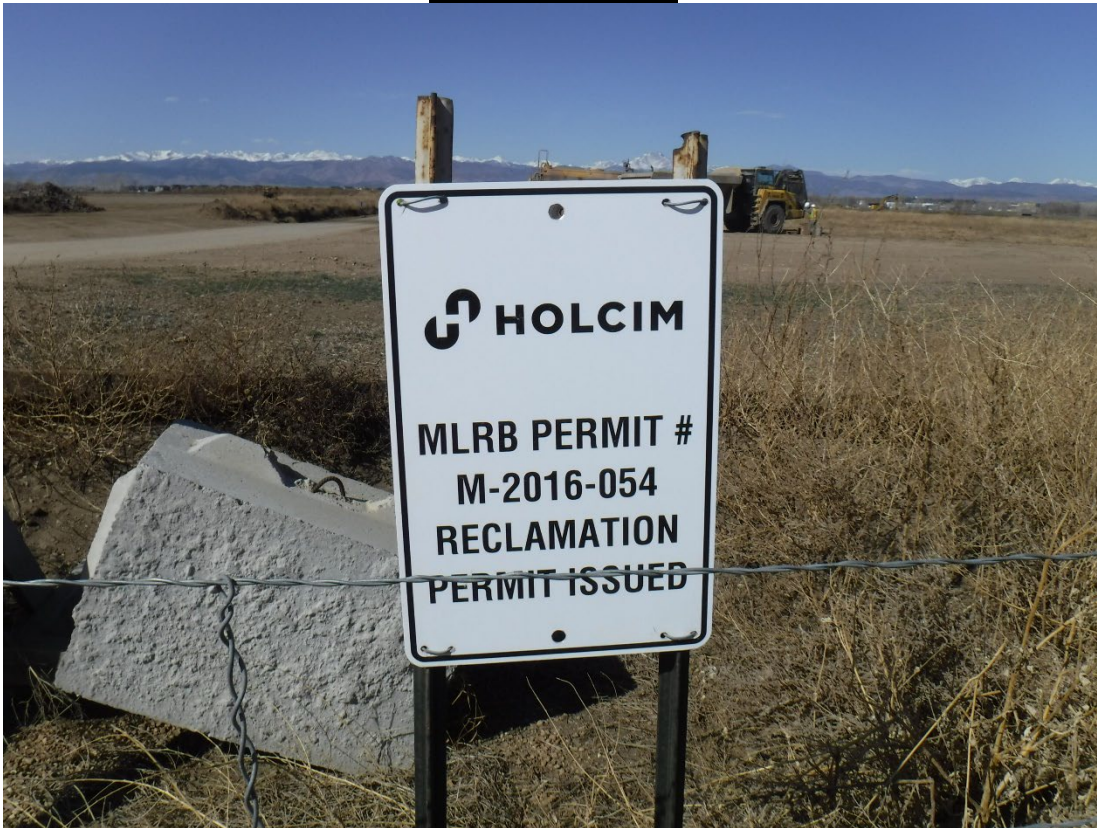
The Irwin/Thomas Mine is located in Boulder County at the southeastern edge of Longmont, Colorado and is accessed from the northeast off N 119th Street. The site is situated near the confluence of Left Hand Creek and St. Vrain Creek. The approved post-mining land use is agriculture. A mine sign was posted at the primary mine entrance pursuant to Rule 3.1.12.

Photo 1: Mine sign at primary mine entrance, 1 of 2

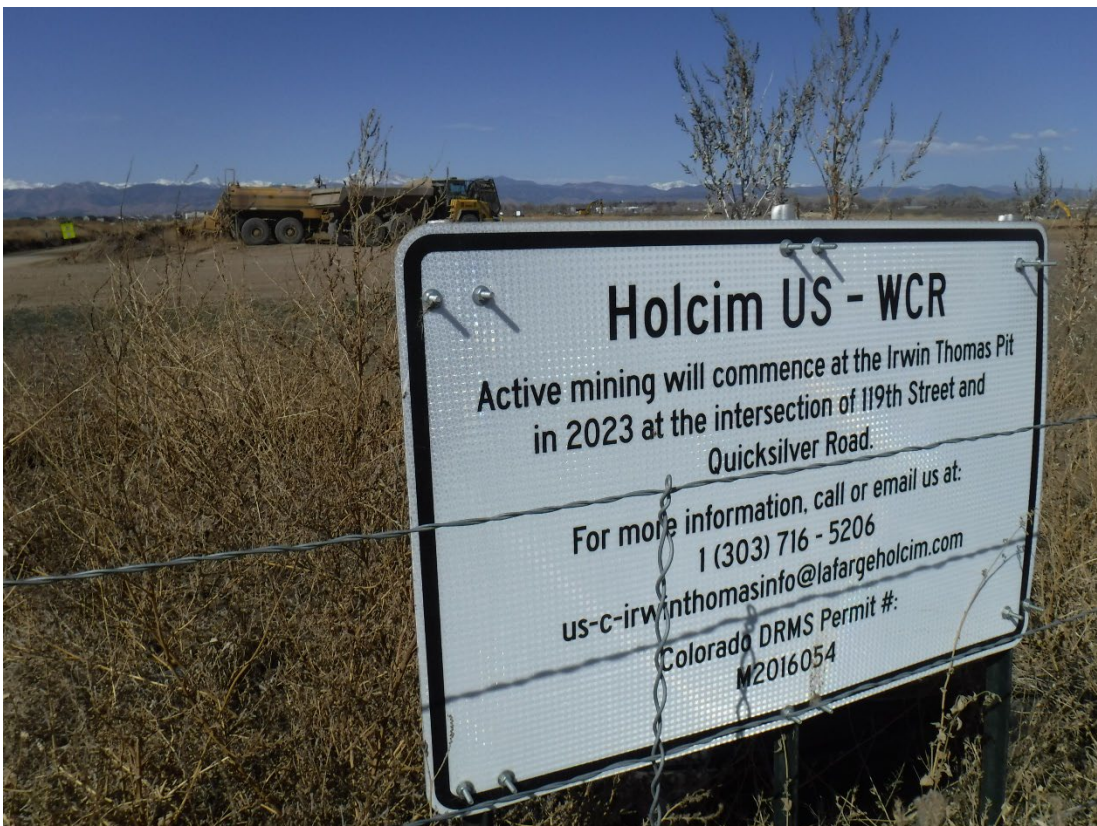
Photo 2: Mine sign at primary mine entrance, 2 of 2

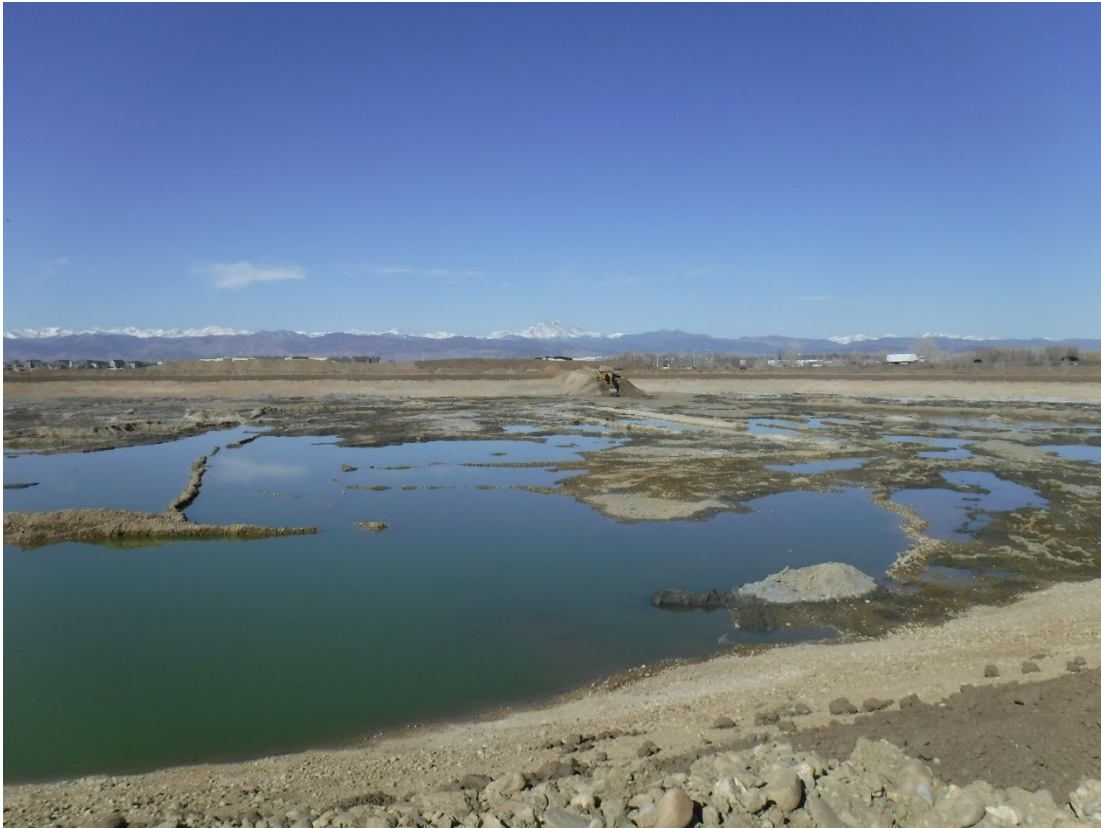
Photo 3: Removing the access ramp to Cell 2, the minimal amount of water is due to slurry wall

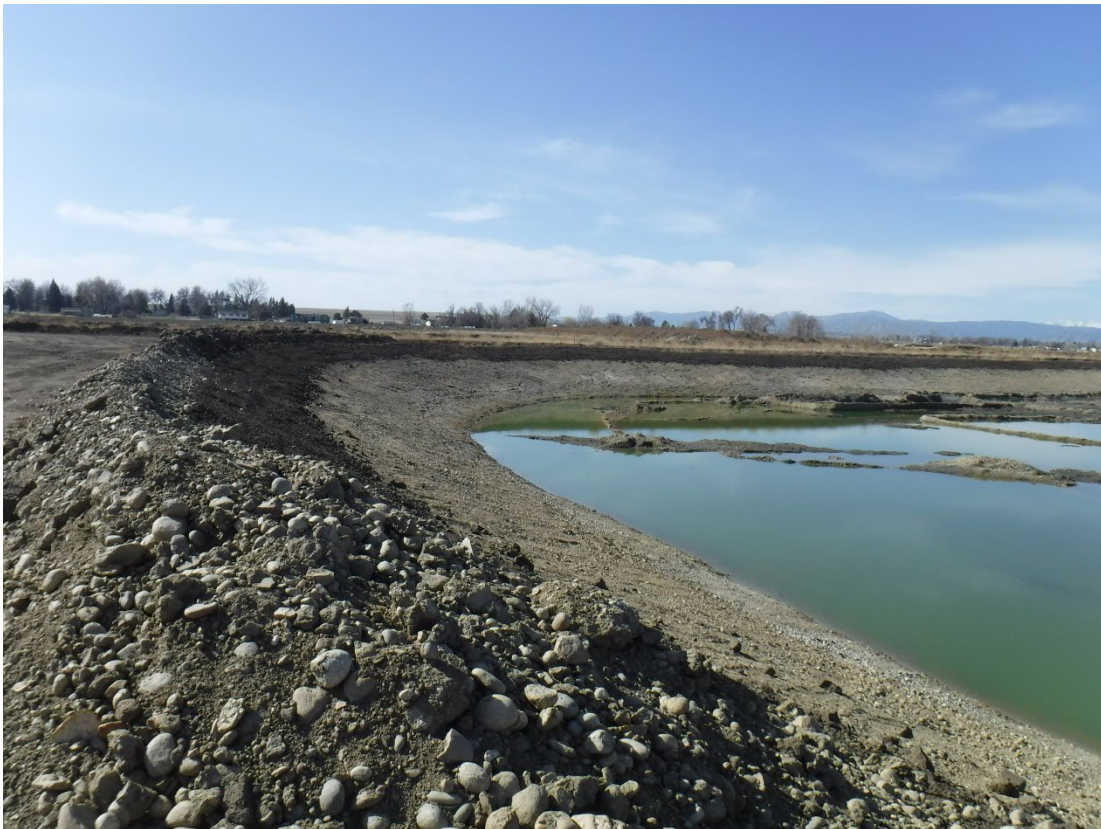
Photo 4: Graded side slopes of Cell 2

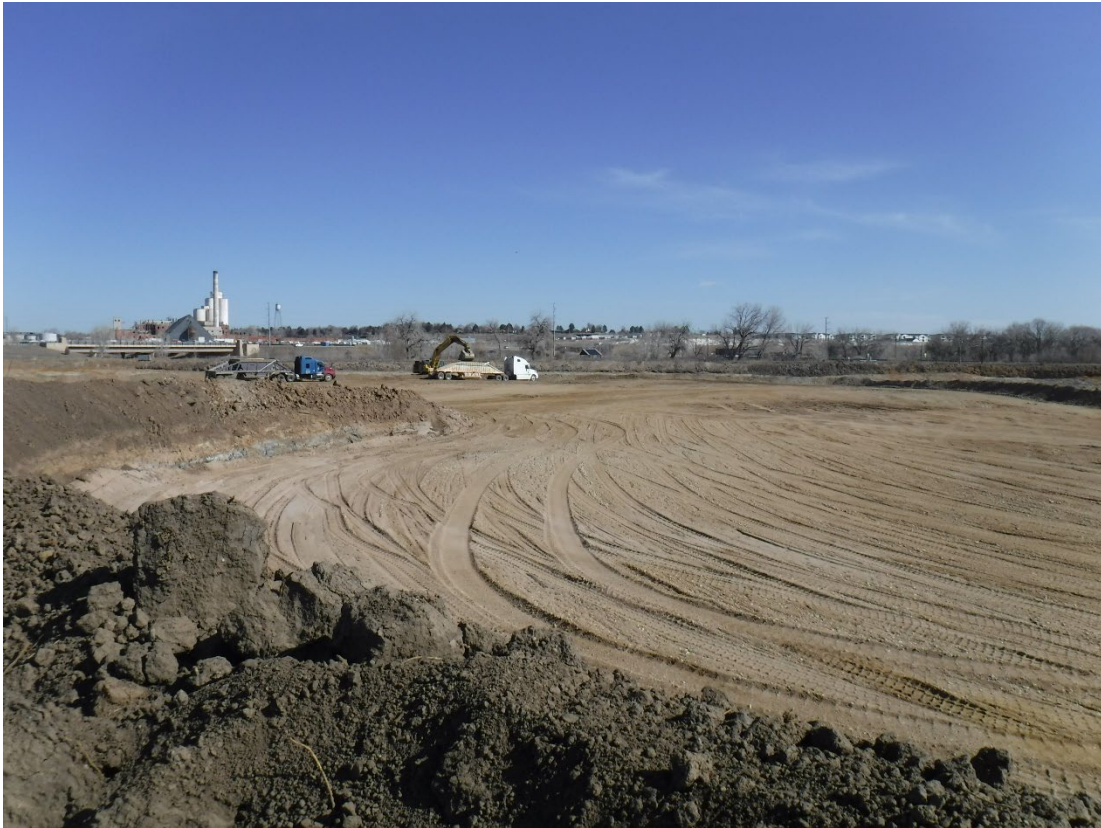
Photo 5: Active mining in Cell 3

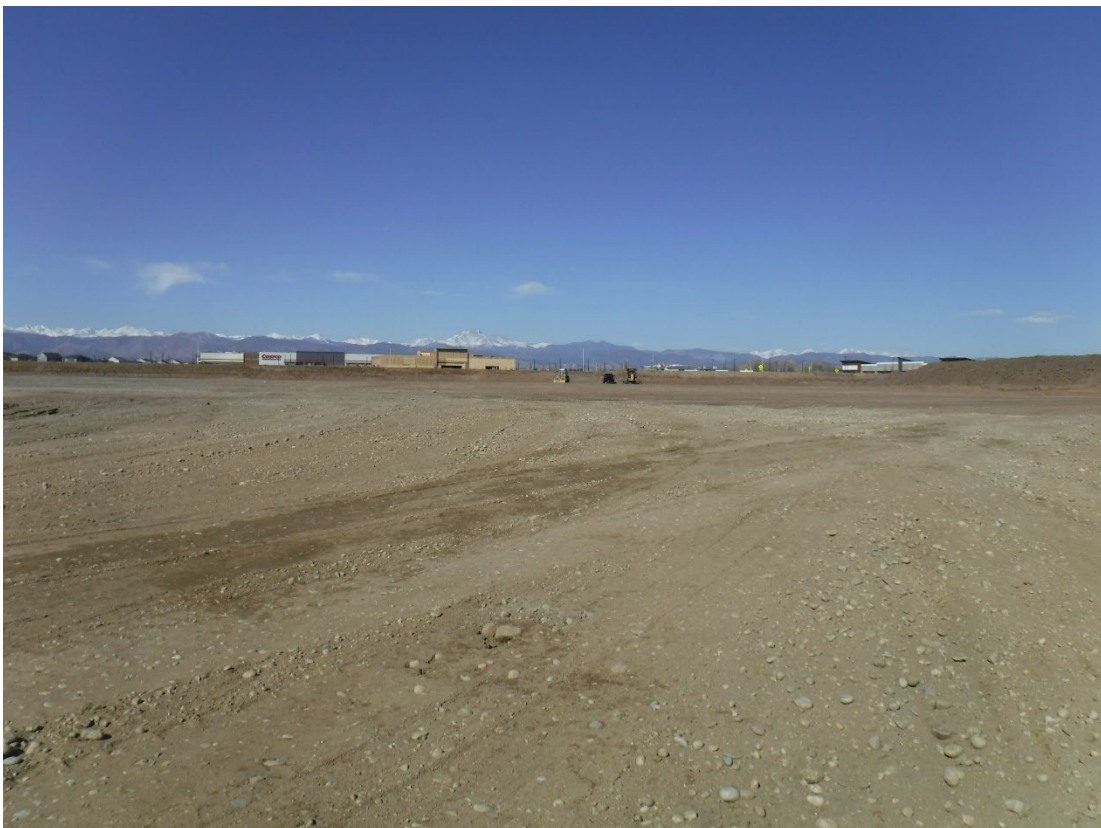
Photo 6: Backfilled portions of Cell 1, looking west

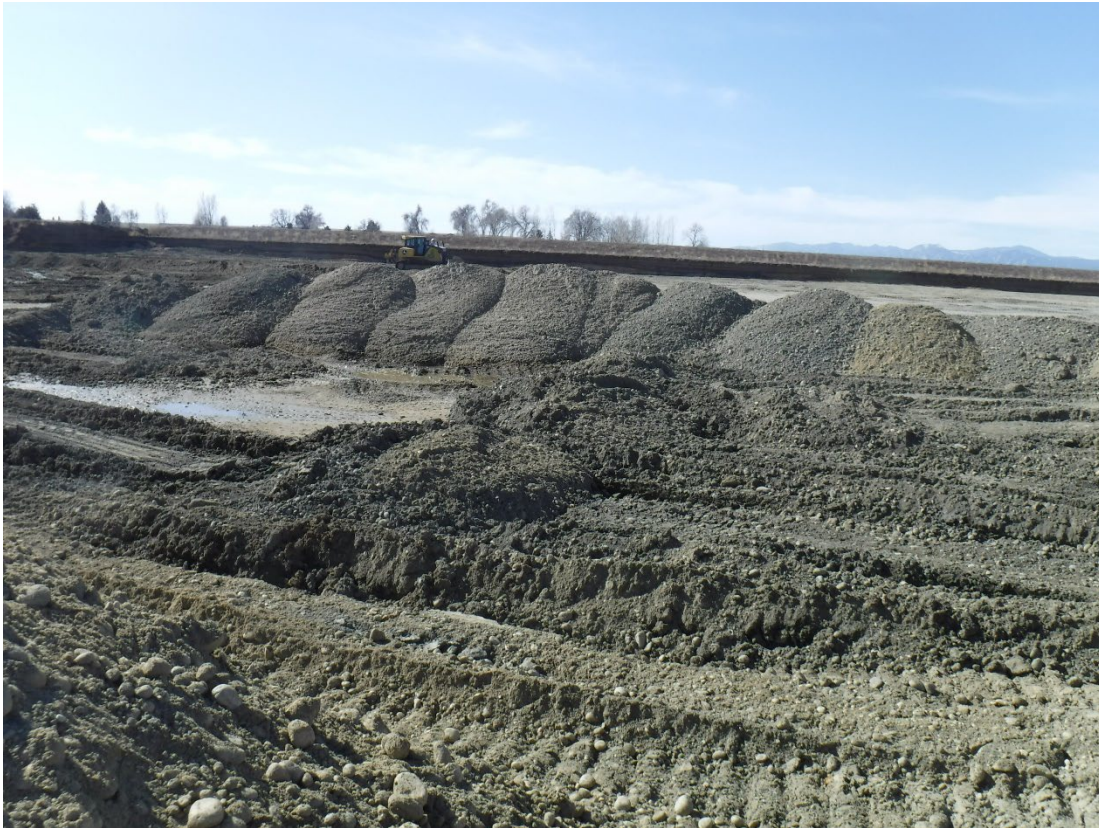
Photo 7: Backfilling southern portion of Cell 1, looking south

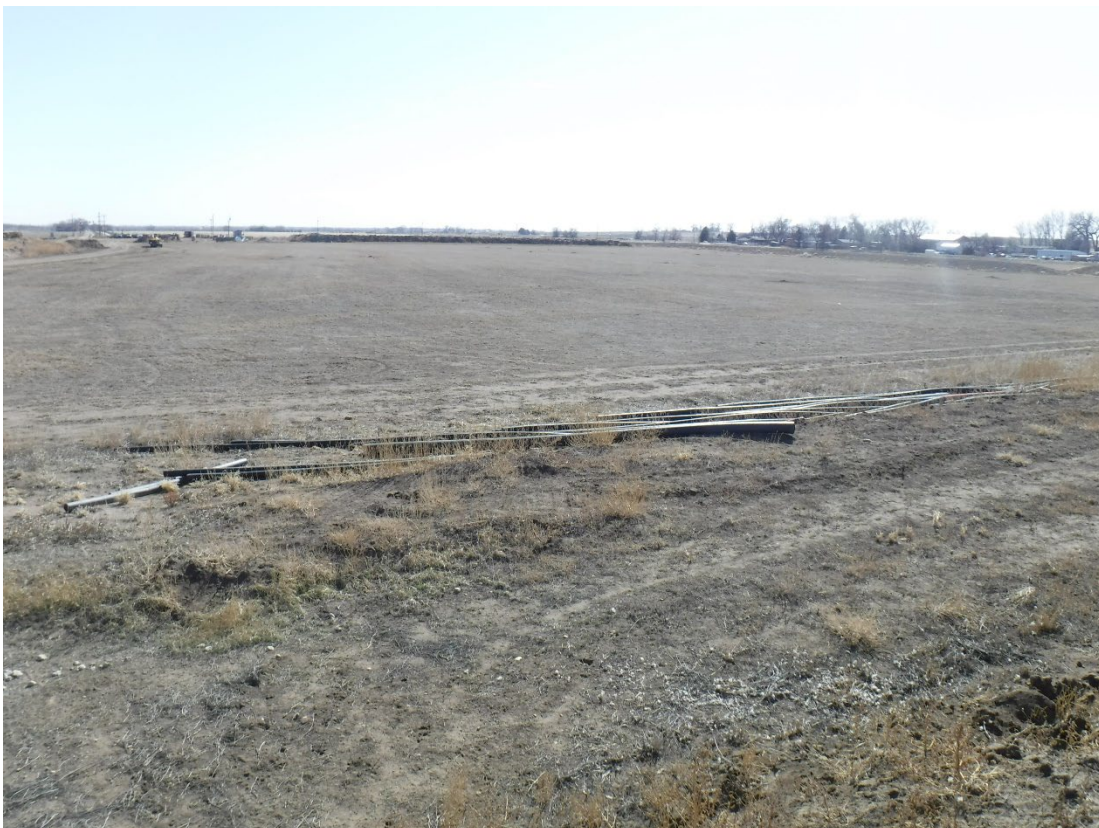
Cells 4 and 5 are in the process of being prepared for mining. During the inspection the Operator noted that they will be submitting a Technical Revision to mine the material that separates the Cells. It was discussed that there may be additional bonding implications with additional material needed to backfill the area between those Cells that was not considered during TR1.

Photo 8: Looking east across Cells 4 and 5

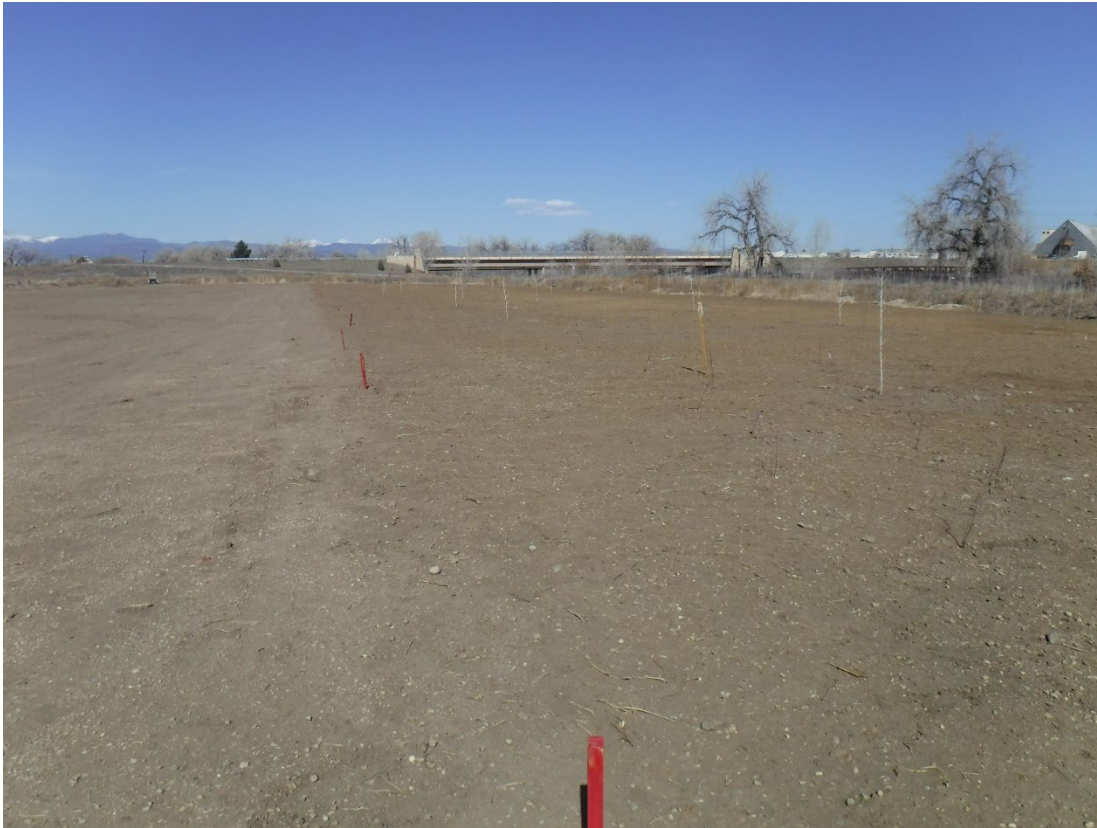
Photo 9: Reclaimed and reseeded Cell 1A, seeded and planted with enhanced riparian vegetation

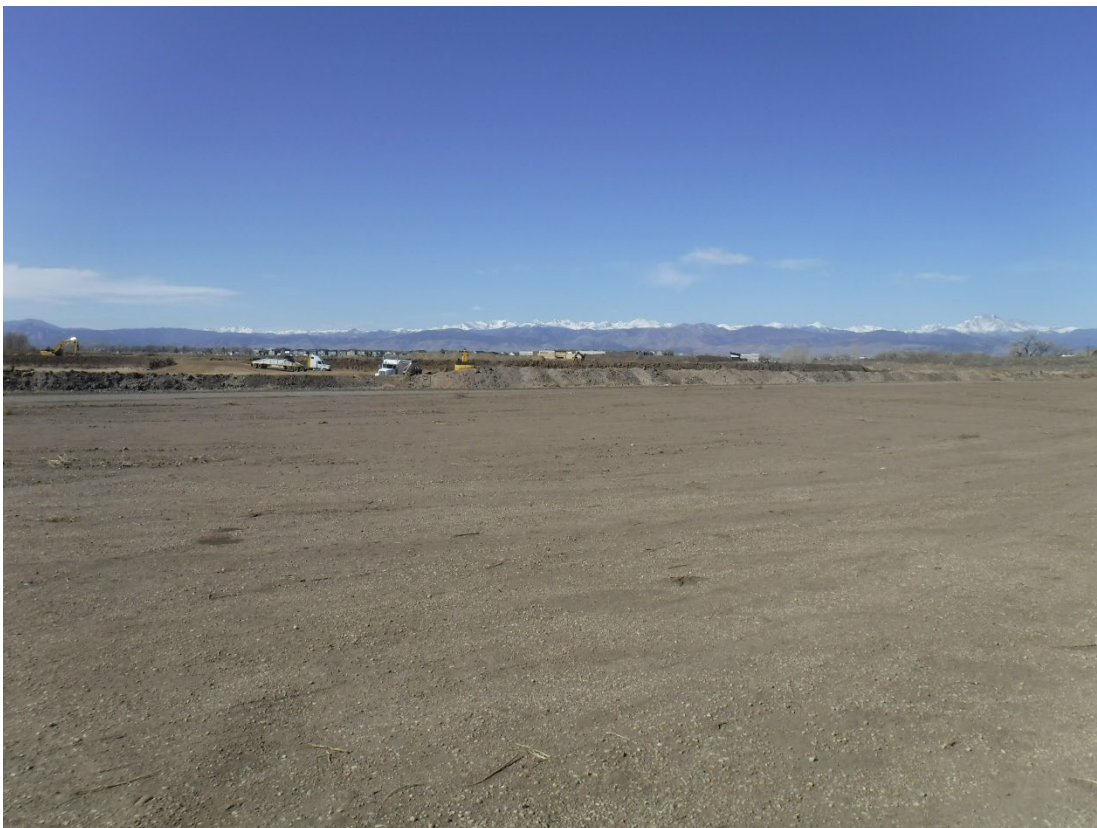
Photo 10: Reclaimed Cell 1A, looking west towards Cell 3

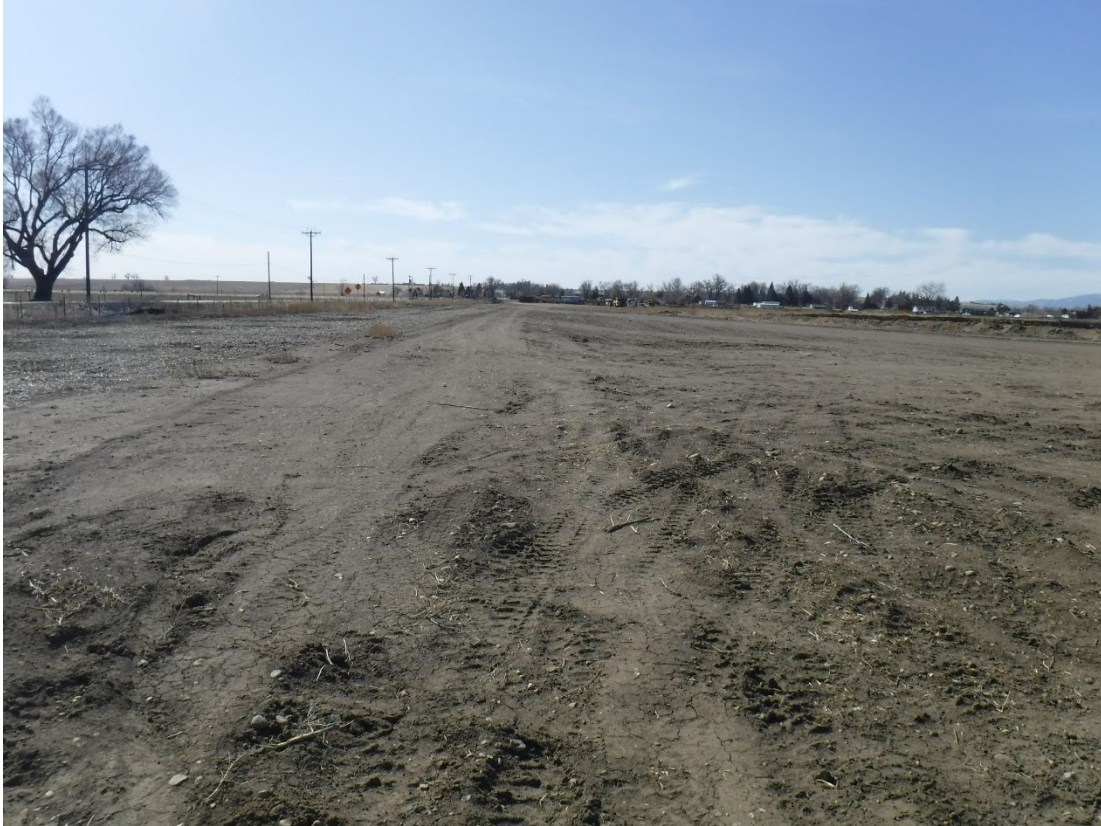
Photo 11: Looking south along the axis of the underdrain and portion of Cell 5

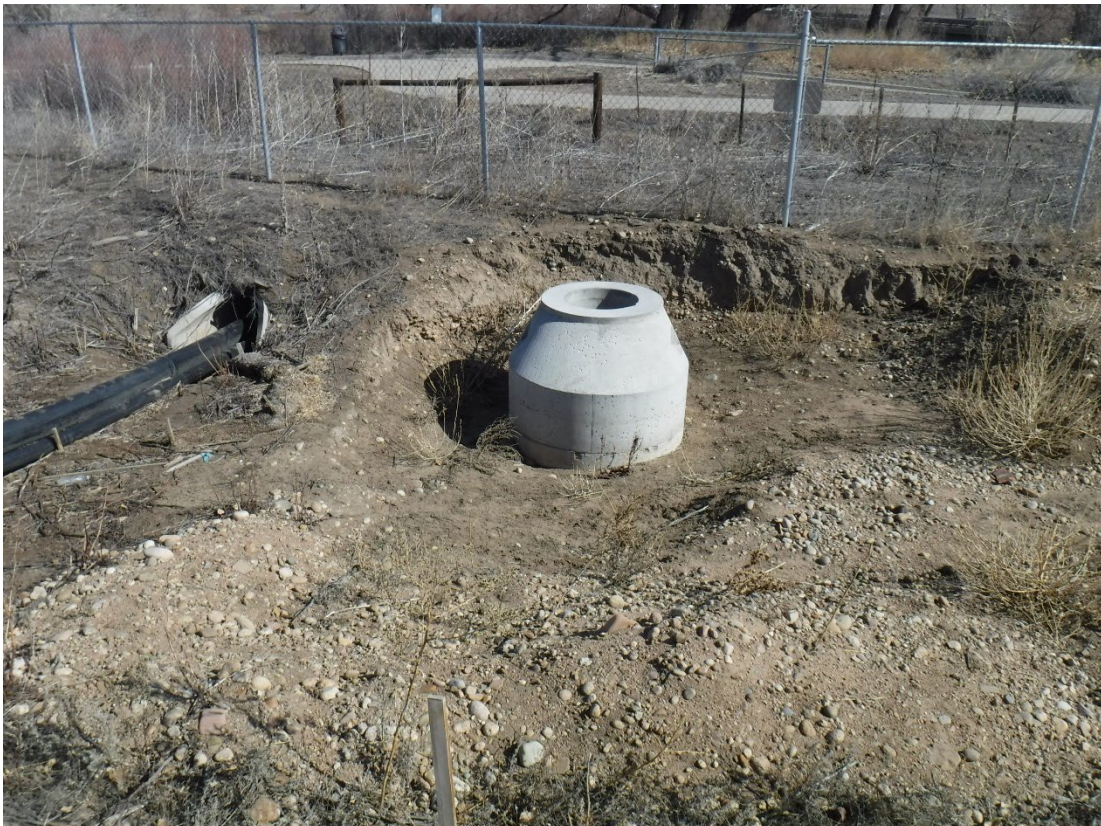
The outfall of the underdrain was observed just northeast of Cell 1A. At the time of inspection the underdrain had a plug in it to prevent discharge. The plug was in place because a concrete riser was needed to add to the manhole to promote gravity flow to an adjacent culvert that conveys water to St Vrain Creek. The Division stated that with runoff occurring soon that getting that manhole riser installed should be a priority to ensure groundwater does not mound unnecessarily.

Photo 12: Underdrain outfall location adjacent to the culvert that drains under bikepath to creek
