MINERALS PROGRAM INSPECTION REPORT
PHONE: (303) 866-3567

MINE NAME: Nahcolite Project	MINE/PROSPECTING ID#: M-1983-194	MINERAL: Carbonates	COUNTY: Rio Blanco
INSPECTION TYPE: Monitoring	WEATHER: Clear	INSP. DATE: March 11, 2025	INSP. TIME: 09:30
OPERATOR: Natural Soda LLC	OPERATOR REPRESENTATIVE: Roy McClung	TYPE OF OPERATION: 112d-3 - Designated Mining Operation	
REASON FOR INSPECTION: Normal I&E Program	BOND CALCULATION TYPE: None	BOND AMOUNT: \$4,466,425	
DATE OF COMPLAINT: NA	POST INSP. CONTACTS: None	JOINT INSP. AGENCY: None	
INSPECTOR(S): Amy Yeldell	INSPECTOR'S SIGNATURE:

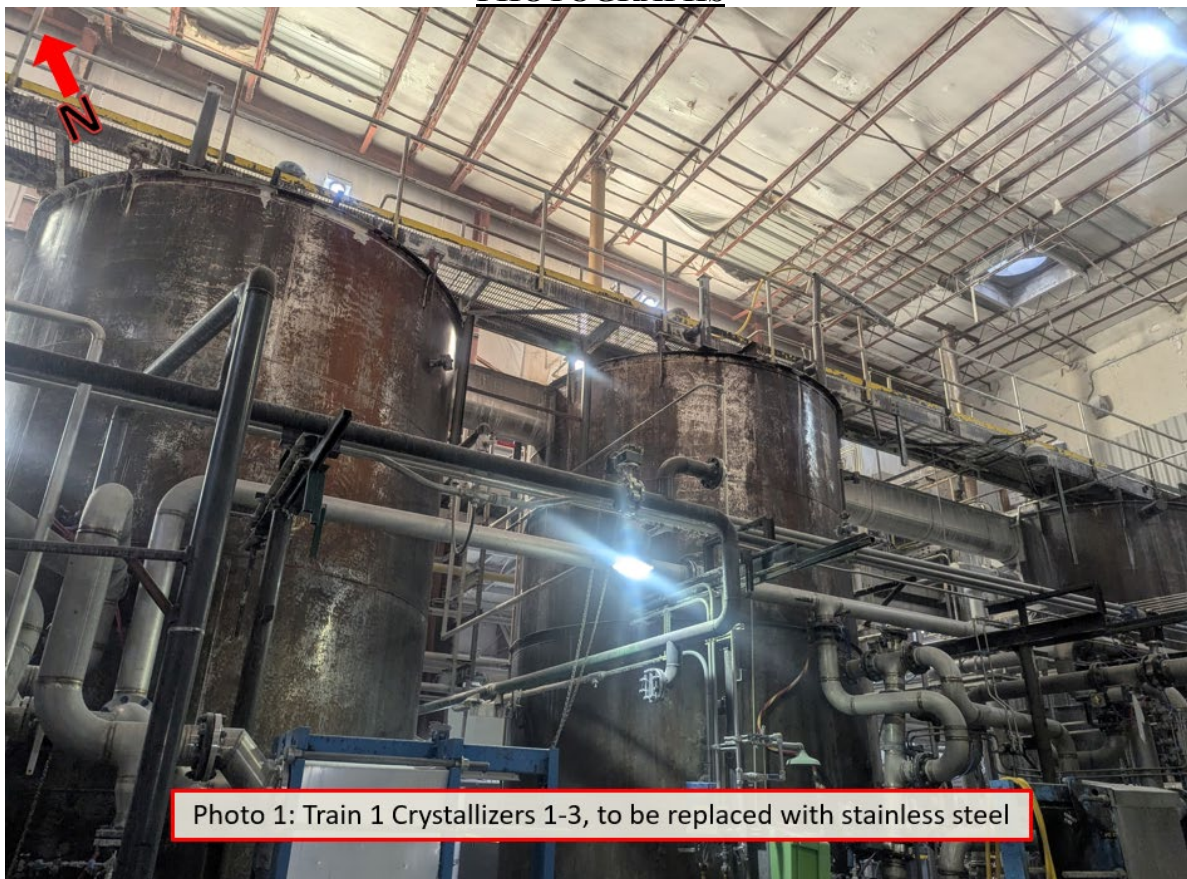
A couple of years ago the original #4 crystallizer in Train #1 was replaced with a new stainless-steel tank. The other three crystallizers in Train #1 are scheduled to be replaced with stainless steel tanks as well later this year (Photo One). Also, during this upgrading, the ceiling insulation over Train #1 will be replaced with an encapsulated panel so that it does not get damaged by moisture and deteriorate.

Photo 1: Train 1 Crystallizers 1-3, to be replaced with stainless steel

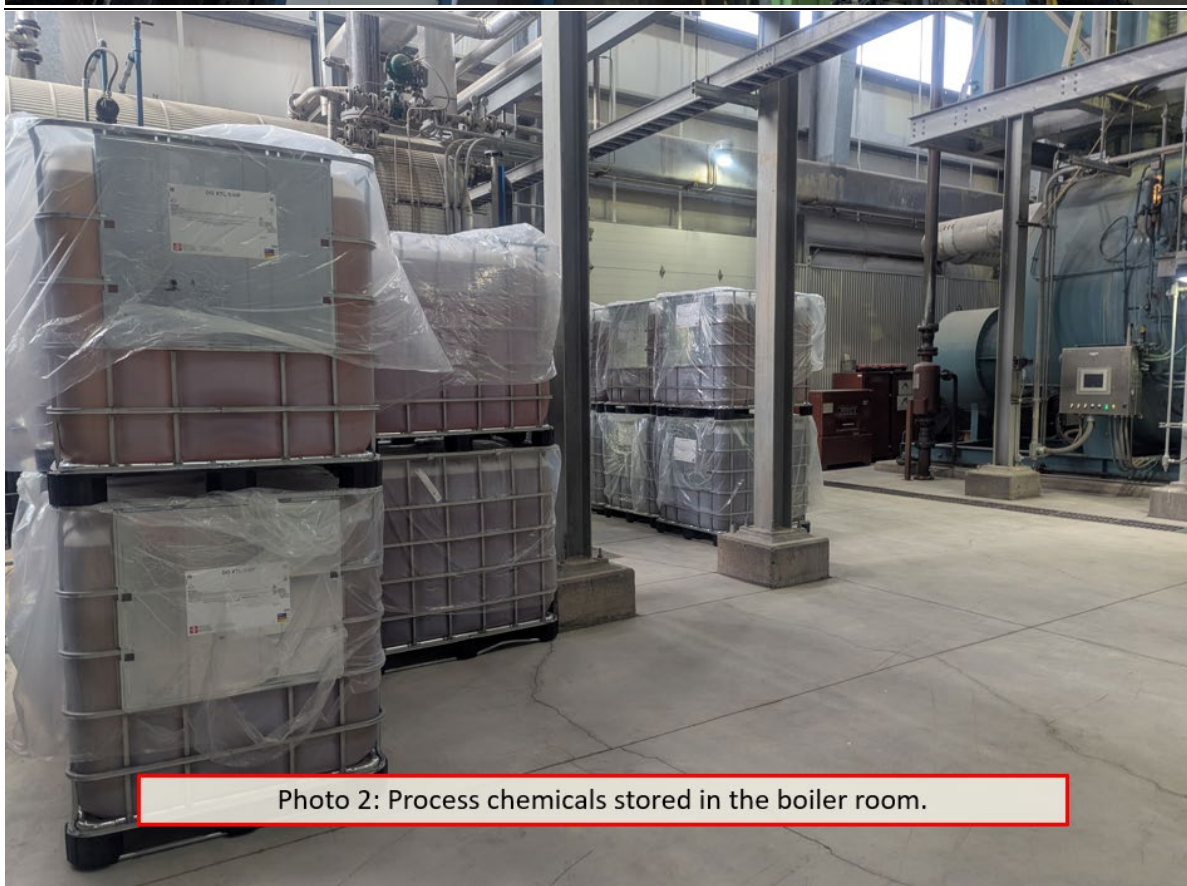
A food grade additive, crystal habit modifier (seed crystal), is stored within the boiler room (Photo Two). This product is added in low concentrations (less than 20 ppm) to help keep particles flat and maintain shape throughout processing. The additive also helps give the sodium bicarbonates something to initially bind to rather than scaling up the process equipment. The Train #1 hydroclones which is scheduled for replacement was also being stored in the boiler area (Photo Three).

Photo 2: Process chemicals stored in the boiler room.

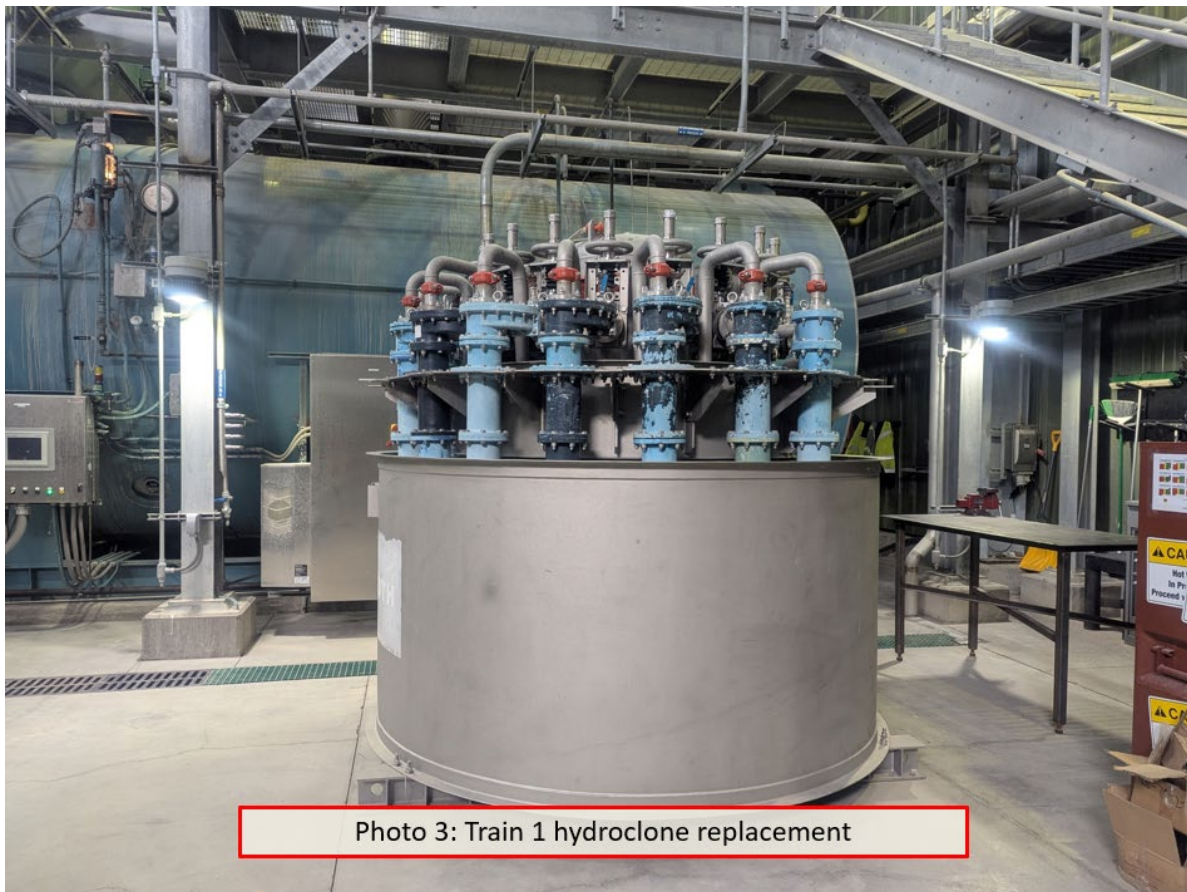
Photo 3: Train 1 hydroclone replacement

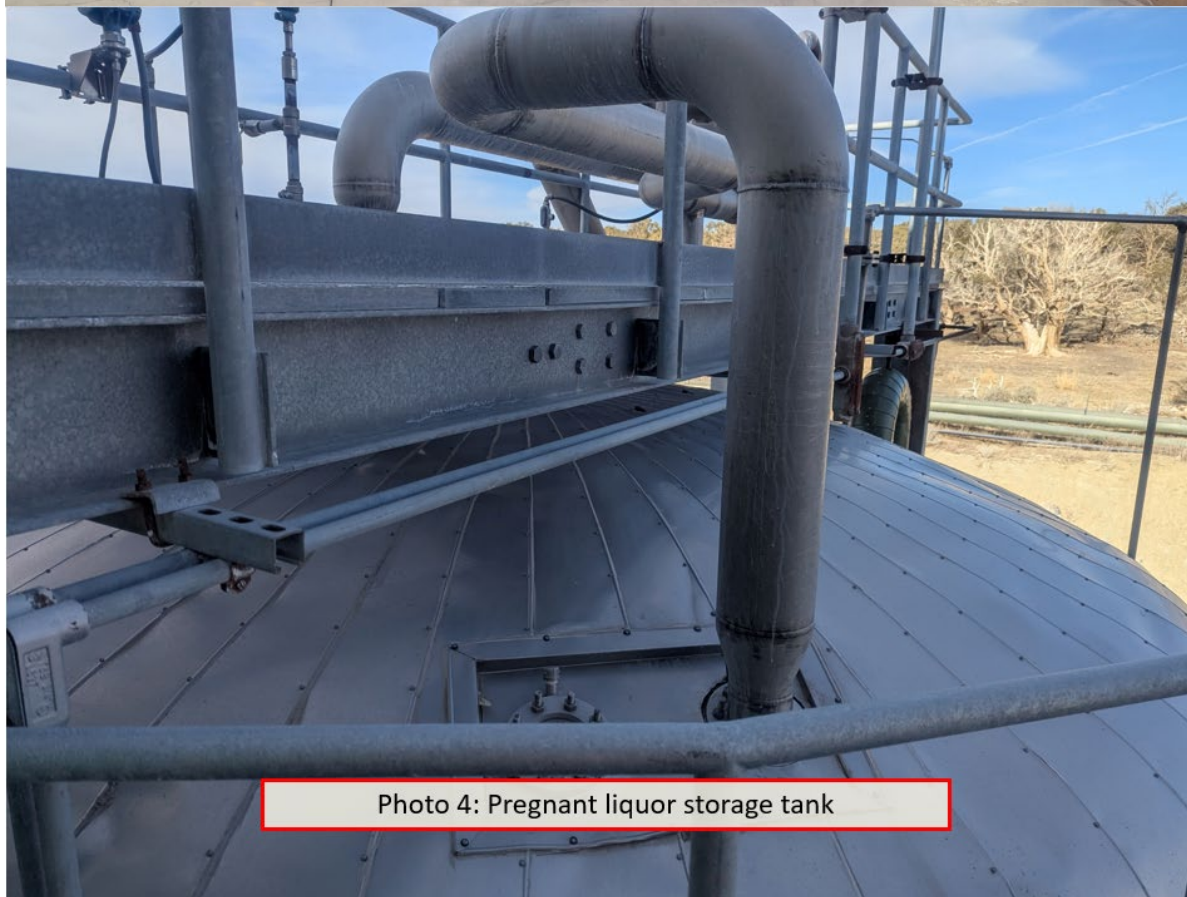
The pregnant liquor storage tank was observed (Photo Four). It is a large, insulated tank on the north side of the plant. It's designed to help regulate flows from the well field before entering the plant and mitigate pressure issues resulting from temperature fluctuations.

Photo 4: Pregnant liquor storage tank

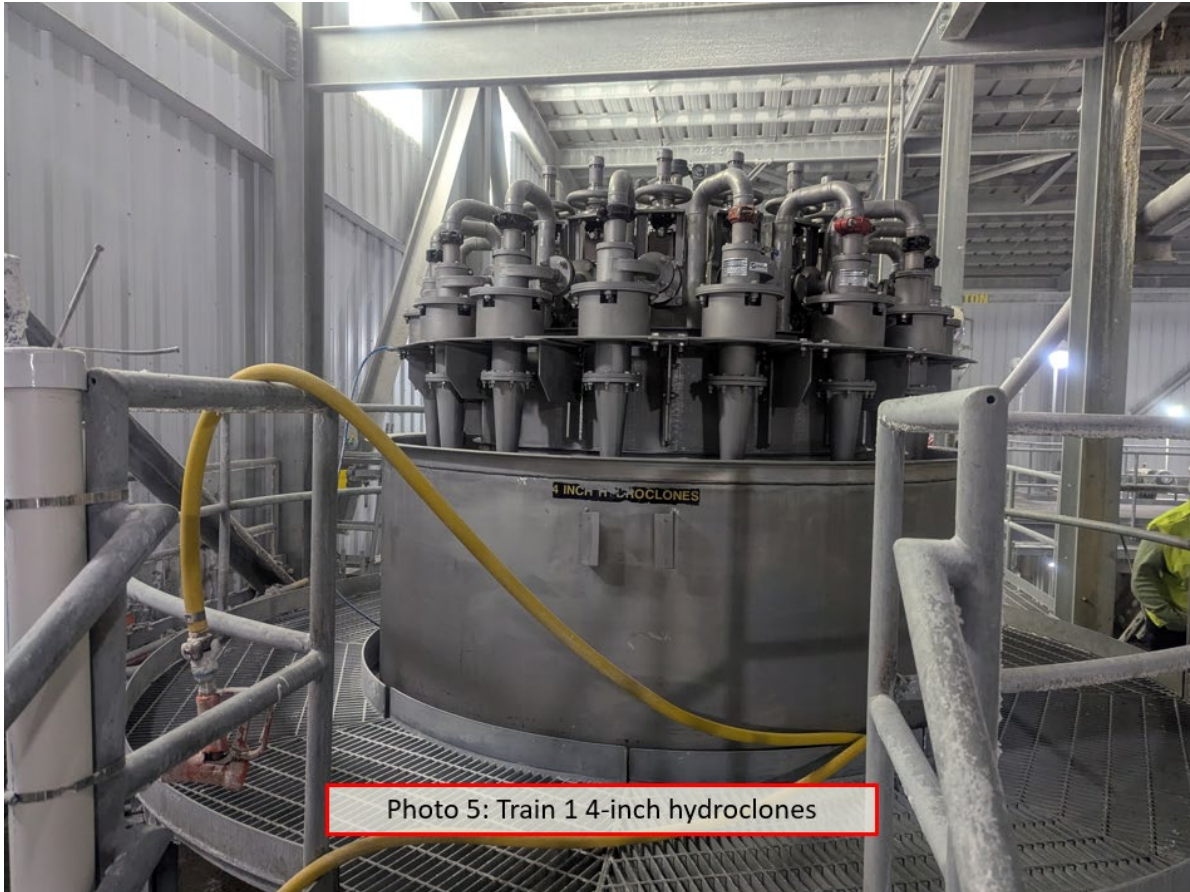
The inspection then proceeded to the dewatering stage. The concentrated bicarb solution leaves the crystallizers as a slurry and goes to the hydroclones for thickening. The flow leaving from the hydroclones is 50% moisture and is fed to the centrifuge. The hydroclones within Train #1 are scheduled to be replaced since they do not contain a valves for maintenance like Train #2, (Photo Five and Sixe). Right now any repairs to an individual

Photo 5: Train 1 4-inch hydroclones

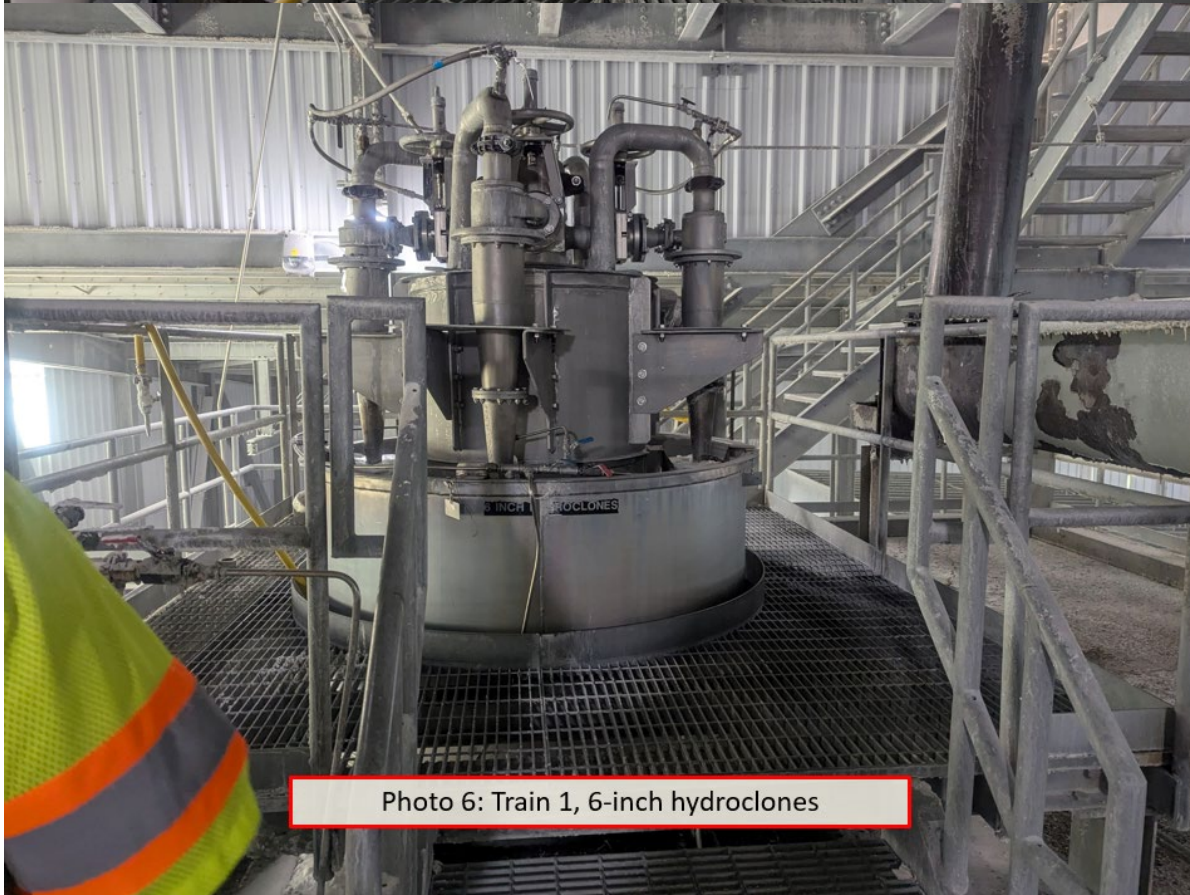
Photo 6: Train 1, 6-inch hydroclones

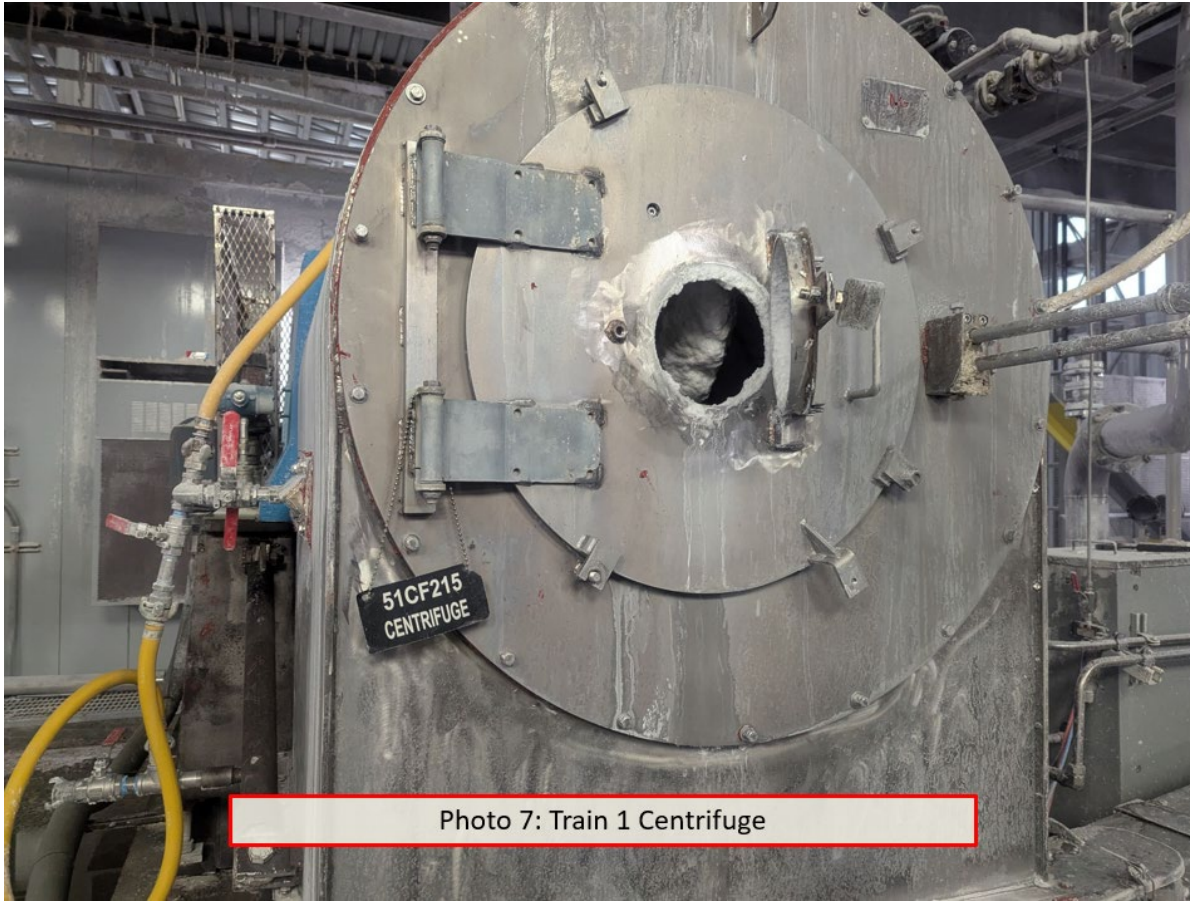
hydroclone requires shutting down all of Train #1. Within the centrifuge the slurry is spun for further dewatering (Photo Seven). The Train #1 centrifuge is also anticipated to be replaced this summer with a similar but more modern unit. Material exiting the centrifuge has approximately 4% moisture remaining and is referred to as "wet cake". All liquid from the dewatering stage is returned to the crystallizer area where it is now in the barren stream, which is used to cool the crystallizer feed streams. All seed crystal removed in the centrifuge is recirculated within the barren stream and re-used.

Photo 7: Train 1 Centrifuge

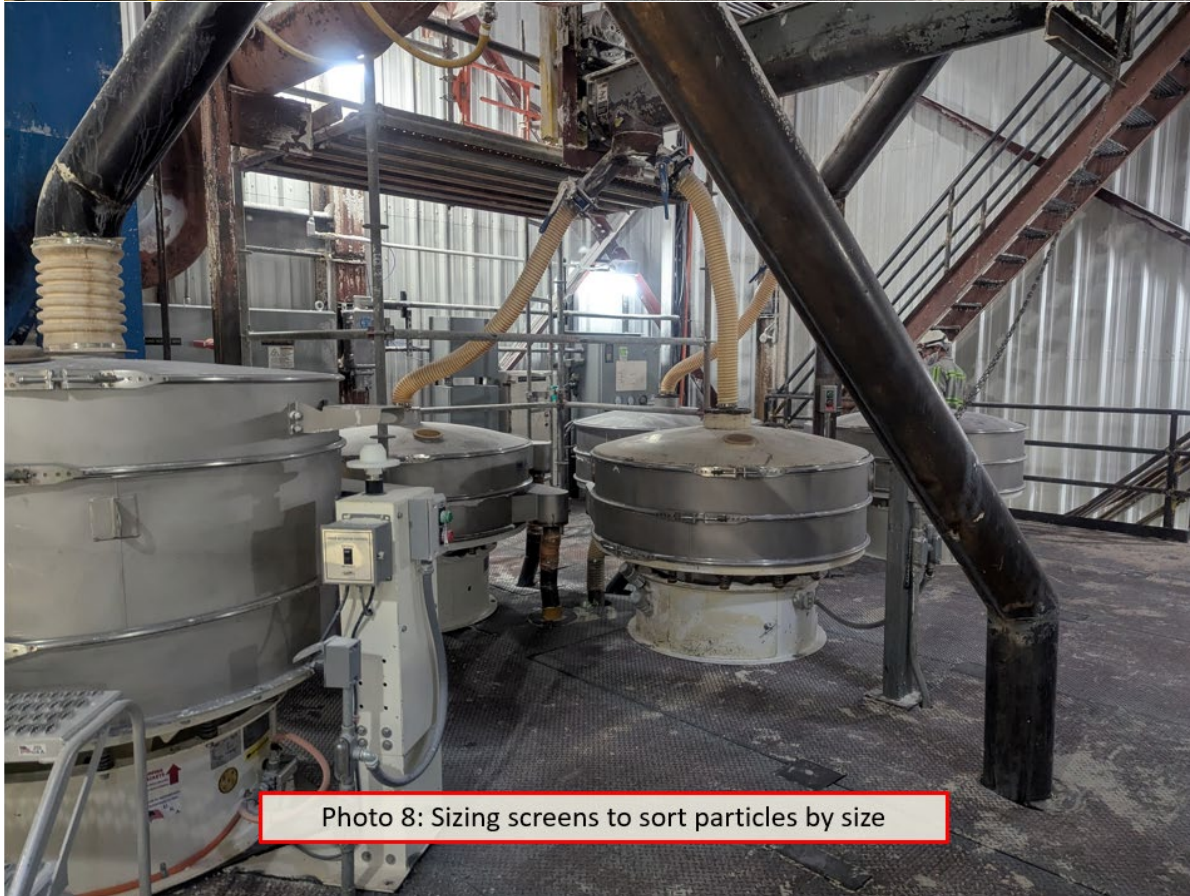
From the centrifuge, the wet cake screw transports, the wet cake into the mixer where it is combined with recycled dry product to enhance drying and handling. The mixture then goes through thermal drying. The flash dry blows super-heated air vertically. As the dry cake is introduced into the hot air it dries and becomes lighter and is blown upward into the dry cyclone. Modifications to the cyclone observed in the last inspection are complete. The cyclone helps to filter out the air and size particles before going to the bag house (Photo Eight). At the end of the drying system materials contain approximately 3% moisture. Particles are then sorted based on crystal size and packaged accordingly.

Photo 8: Sizing screens to sort particles by size

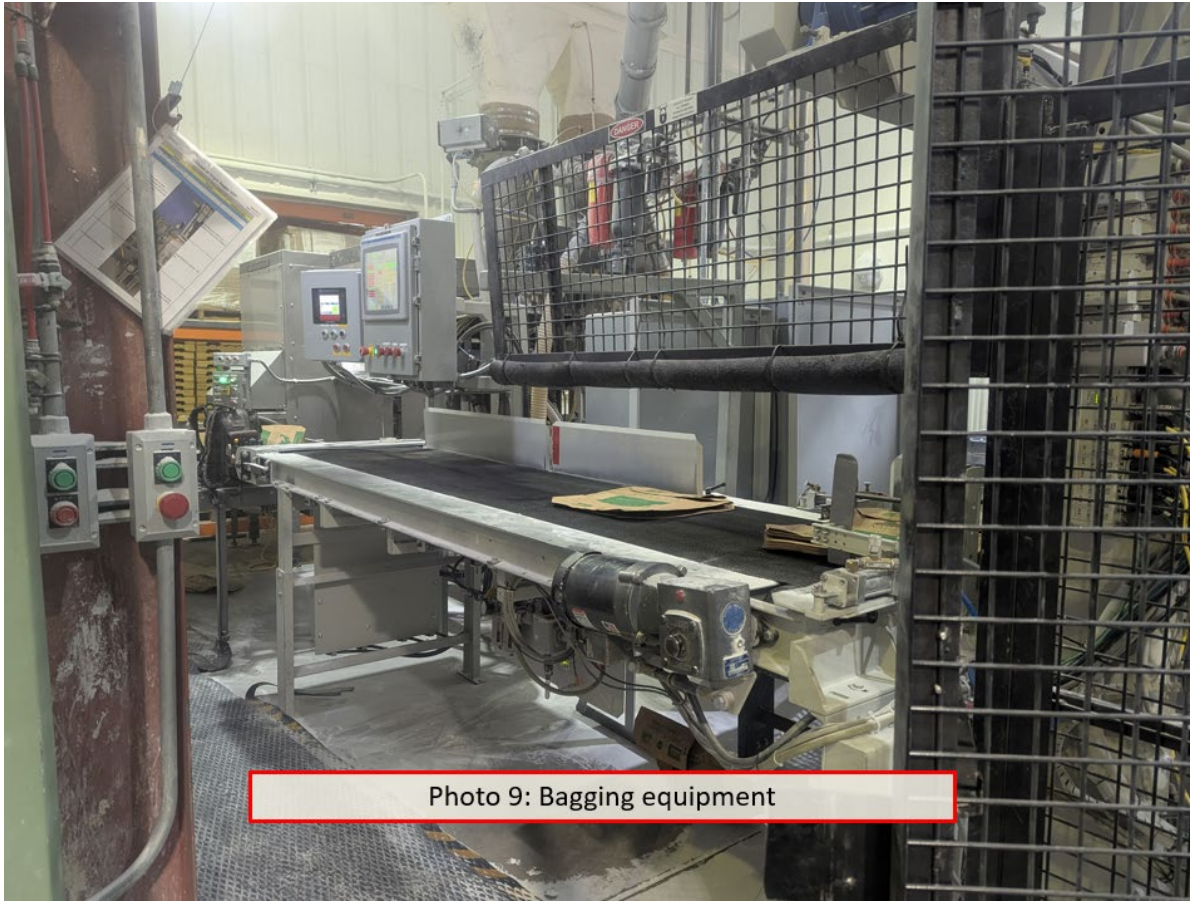
Lastly the bagging facility was observed. Maintenance was being conducted so this process was not directly observed (Photo Nine). All packaging is automated. Product is metered out and place into a bag or sack. Once sealed the completed bags are then QC weighted, stamped with an ID, x-rayed and if passable are loaded onto pallets. The QC process for the super sacks have a similar process upon filling them. Acceptable bags are then stacked on a pallet, wrapped and ready for off-site transport.

Photo 9: Bagging equipment
