STATE OF
COLORADO

March Inspection Report

Permit Number: C-1981-018 Mine Name: Deserado Mine Operator: Blue Mountain Energy, Inc Operator Address: Mr Kurtis Blunt 3607 County Road 65 Rangely, CO, 81648	County: Moffat, Rio Blanco Operation Type: Underground Permit Status: Active Ownership: Private
	Operator Representative Present: Kurtis Blunt
Operator Representative Signature: (Field Issuance Only)

Inspection Start Date: March 11, 2025 Inspection Start Time: 09:30 Inspection End Date: March 11, 2025 Inspection End Time: 13:00		Inspection Type: Coal Complete Inspection Inspection Reason: Normal I&E Program Weather: Cloudy	
Joint Inspection Agency: None		Joint Inspection Contacts: NA	
Post Inspection Agency: None		Post Inspection Contacts: NA	
Inspector(s): Todd Jesse	Inspector's Signature:

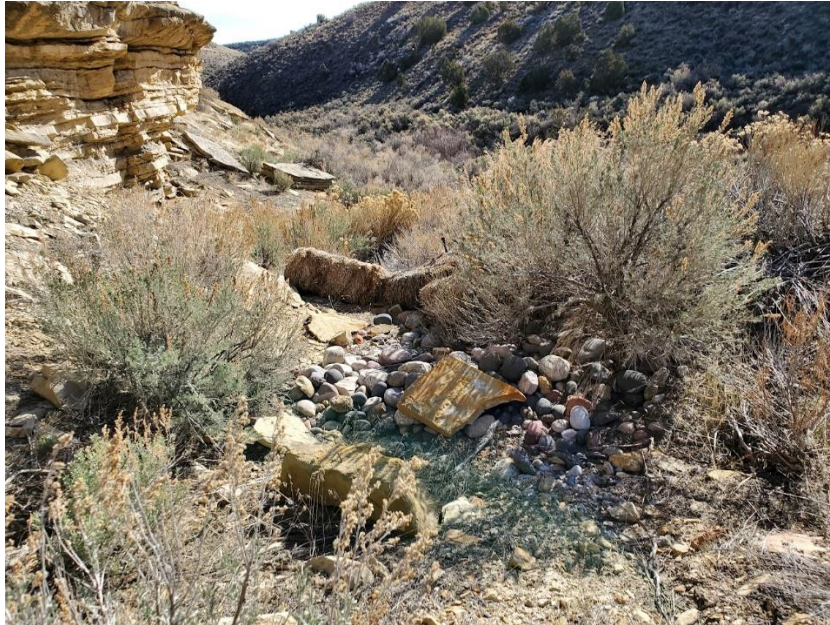
The explosives storage area for the Deserado Mine is located at the southern end of the main facilities area. The storage consists of a pad with a storage bunker for the explosives. The cut and fill slope of the pad was stable with no erosional features. Runoff from the pad is directed to an outlet at the southern end of the pad and passes down a channel through straw bales. The bales appear to be in good condition and functioning as designed

Photo 1 – View to the east of straw bales in drainage of explosives pad.

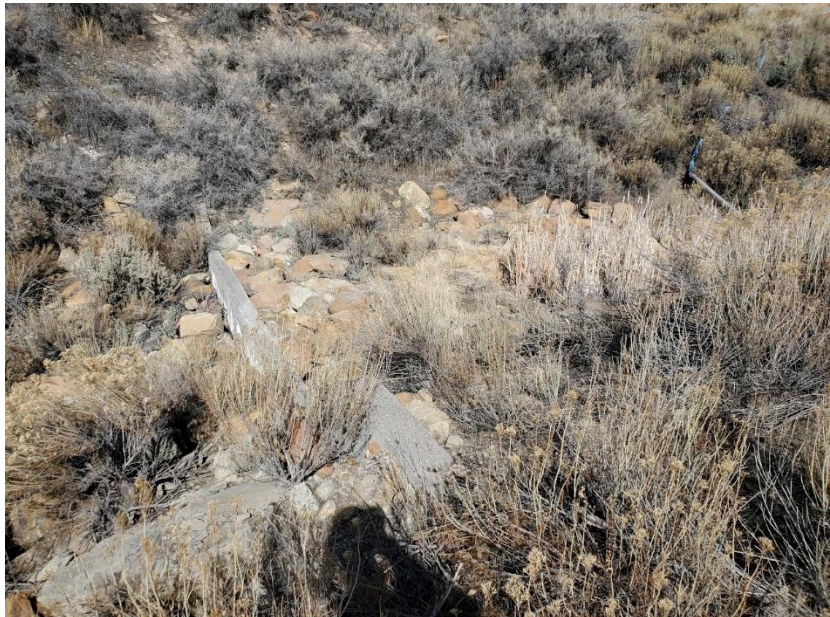
Photo 2 – View to the west of Pond DP-1 spillway.

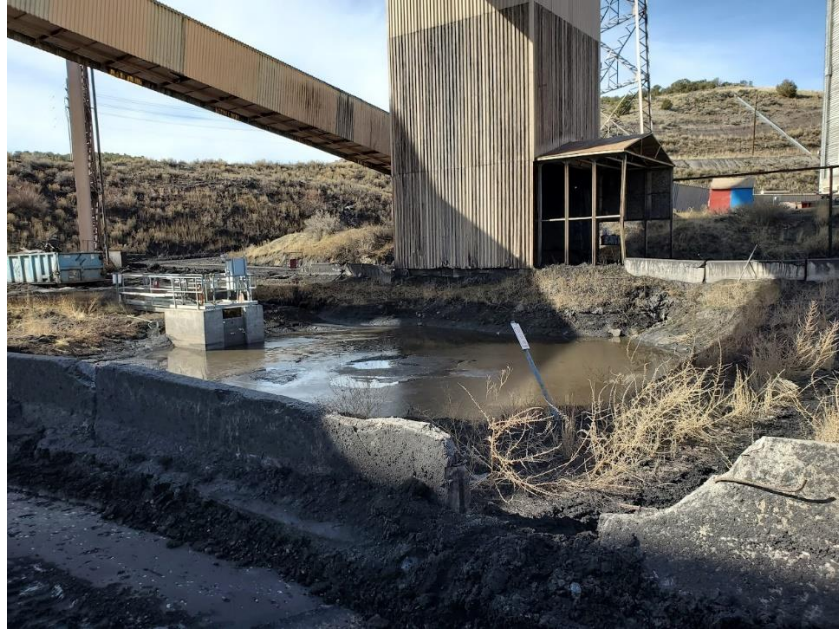
Photo 3 – View to the west of PP-1 Pond.

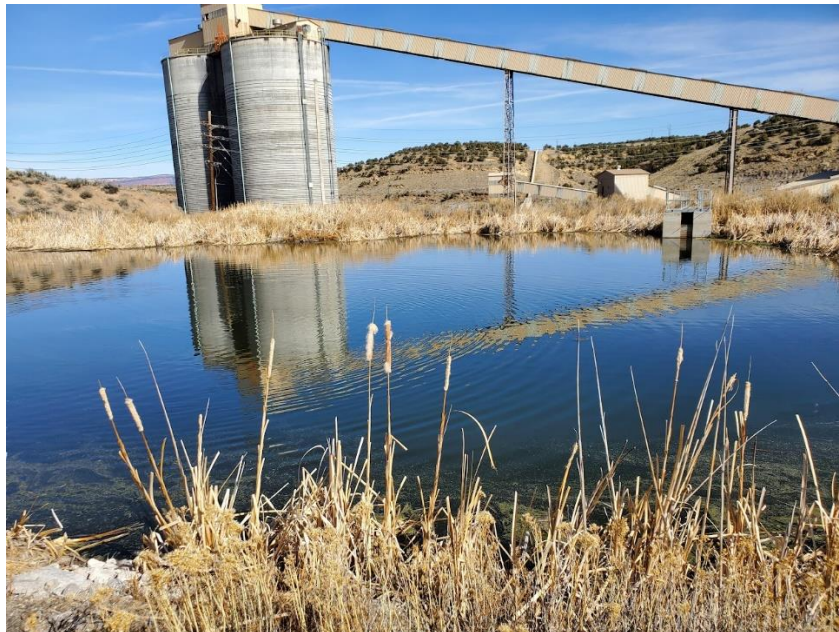
There are three ponds located in the main facilities area: the DP-1 Pond, the PP-1 Pond and the PP-2 Pond. The DP-1 Pond is located on the southern part of the lower facilities bench. DP-1 collects all runoff from the from the three facilities benches. The outlet structure was clear of debris and the pond was discharging at the time of inspection. The embankments appear stable with well-established vegetative cover. The emergency spillway has minor amounts of vegetation but still appears to be able to convey water and is well armored (Photo 2). There were no erosional concerns identified. The PP-1 Pond is located on the middle bench of the facilities area near the prep plant. The pond held minor amounts of water and was well below the discharge level (Photo 3). There were no erosion or stability issues identified in the PP-1 Pond. The PP-2 Pond is located on the upper facilities bench. The outlet structure was in good condition with no vegetation obscuring the outlet (Photo 4). Water diversion ditches throughout the main facilities area were unobstructed and stable.

Photo 4 – View to the north of PP-2 Pond and outlet.

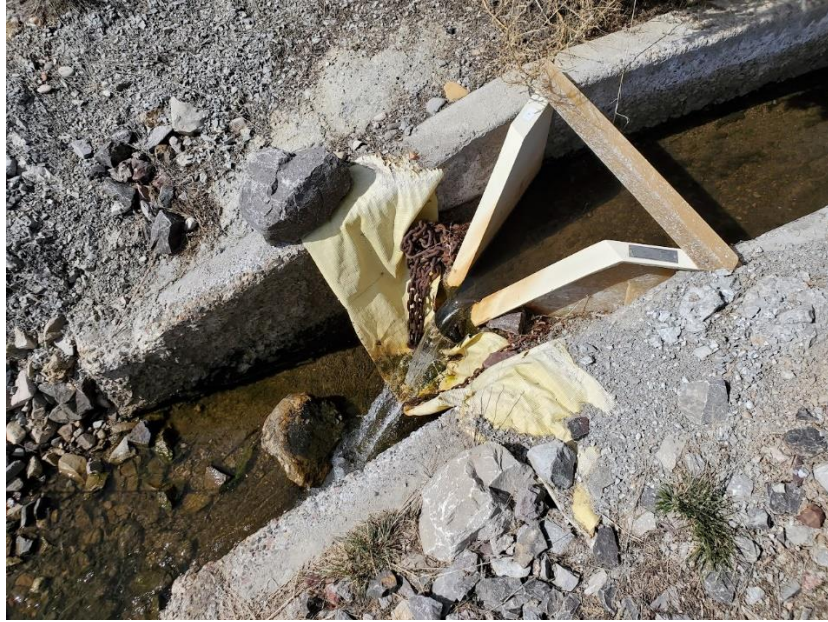
The B Seam Dewatering System No. 1 was active during the inspection. Cells were impounding water. There was well established vegetation on the embankments of the cells. The cells were stable with no erosional or other stability features noted. The Last Chance Pond was discharging approximately 15-20gpm at the time of the inspection (Photo 5).

Photo 5 – View to south of discharge at Last Chance Pond

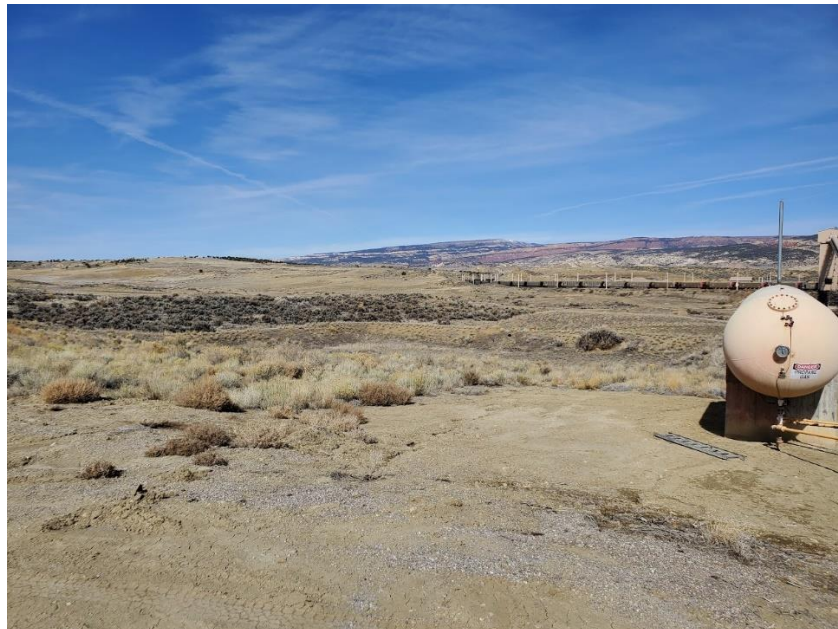
The SS-2 Pond is located at the northwestern base of the Slot Storage Facility. The pond was dry at the time of the inspection. The embankments of the pond were well vegetated and stable with no indications of erosion (Photo 6).

Photo 6 – View to the north of SS-2 Pond.

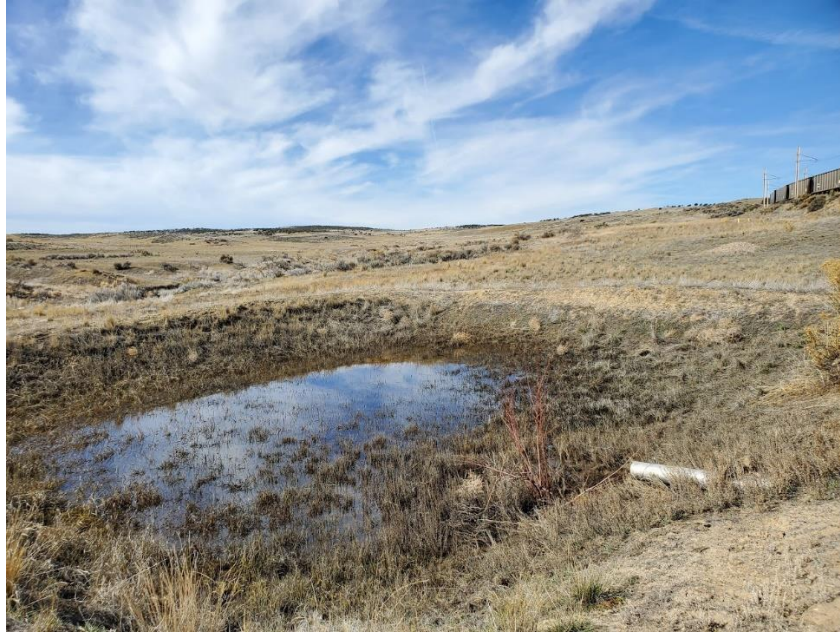
The RS-1 Sump and the RR-1 Pond are located at the south side of the Rail Loadout. The RS-1 Sump was still holding minor amounts of water, but water levels are down significantly since the last inspection (Photo 7). There were no indications of erosion. The RR-1 Pond was dry. The embankments of the pond seem stable. The erosion feature on the northern embankment that has been noted in previous inspection reports does not appear to have grown in size (Photo 8). The Rail Loadout Storage South Ditch has minor amounts of vegetative debris but does not appear obstructed and is able to convey water (Photo 9).

Photo 7 – View to the west of RS-1 Sump.

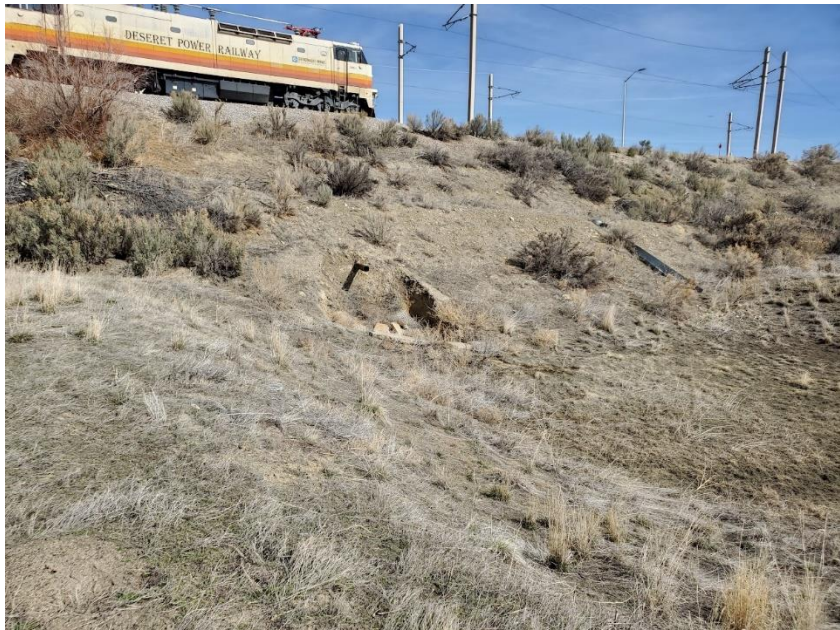
Photo 8 – View to the north of RR-1 Pond erosion scar.

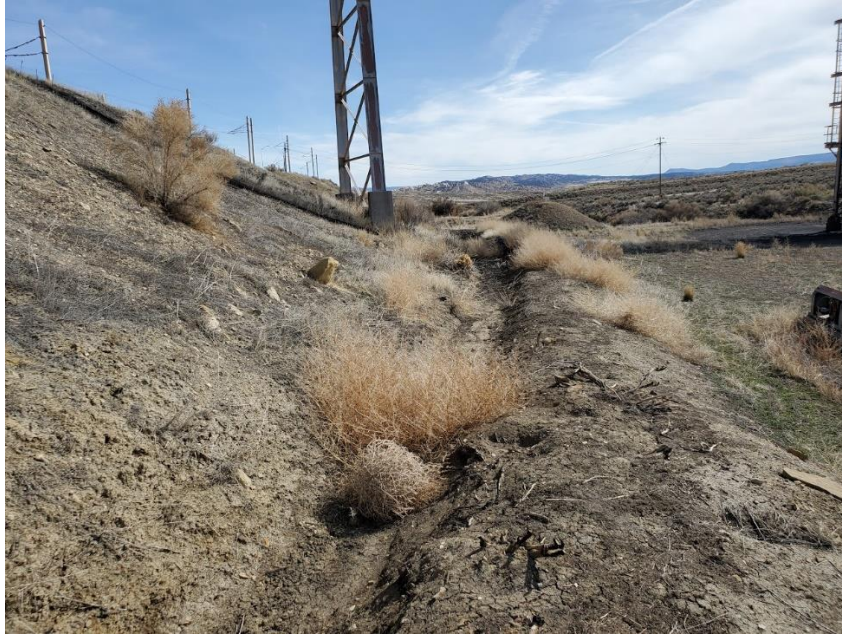
Photo 9 – View to the east of railroad diversion ditch.

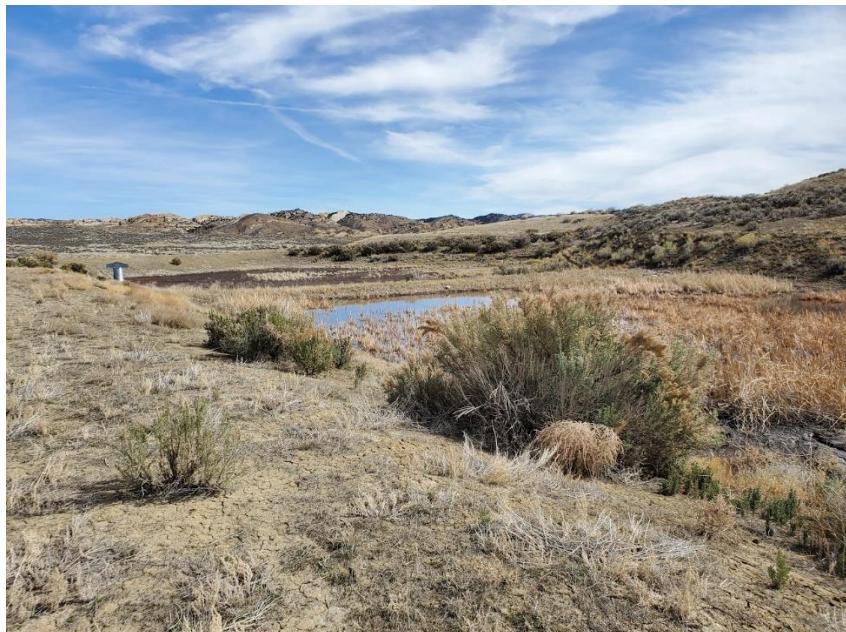
Two ponds are located at the northern base of Refuse Pile RP-2/3/4. The RP -2/3 Pond is located on the pile's northeast corner. The Pond consists of three cells – the upper cells were holding water at the time of the inspection

(Photo 10). The channels above the ponds appear clear of debris. No erosional features were noted on the embankments of the conveyance ditches. The trash rack was clear of debris. The RP-4 Pond is located at the northwest base of the pile. The pond was dry during the inspection. The outlet for the RP-4 Pond is capped with a trash rack. The outlet was clear of debris.

Photo 10 – View to the northeast of RP-2/3 Pond.

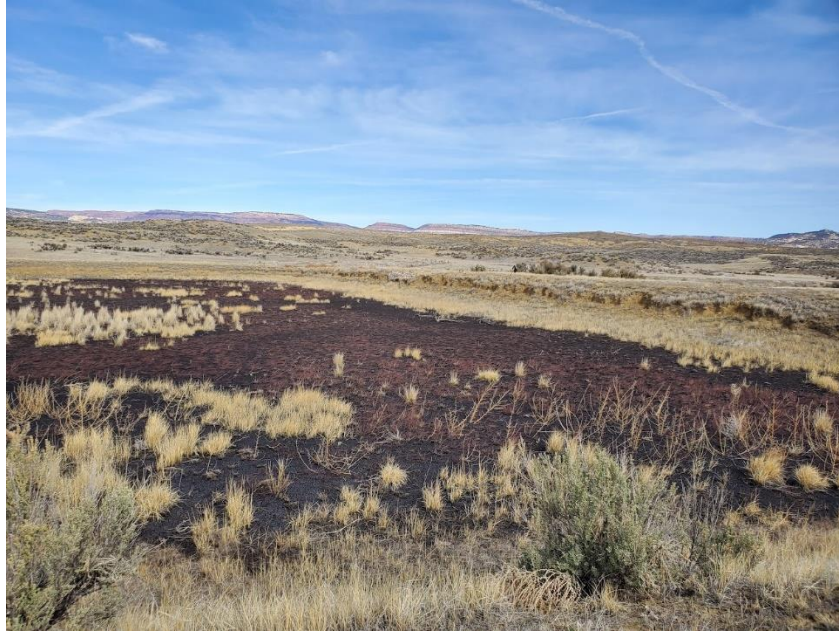
Pond RP-5 is located at the northern base of the RP-5a Refuse Pile. The pond was dry at the time of the inspection. The embankments of the ponds were vegetated and seemed stable (Photo 11). No indications of erosion were observed. The outlet was clear of obstructions.

Photo 11 – View to the northeast of RP-5 Pond embankment.

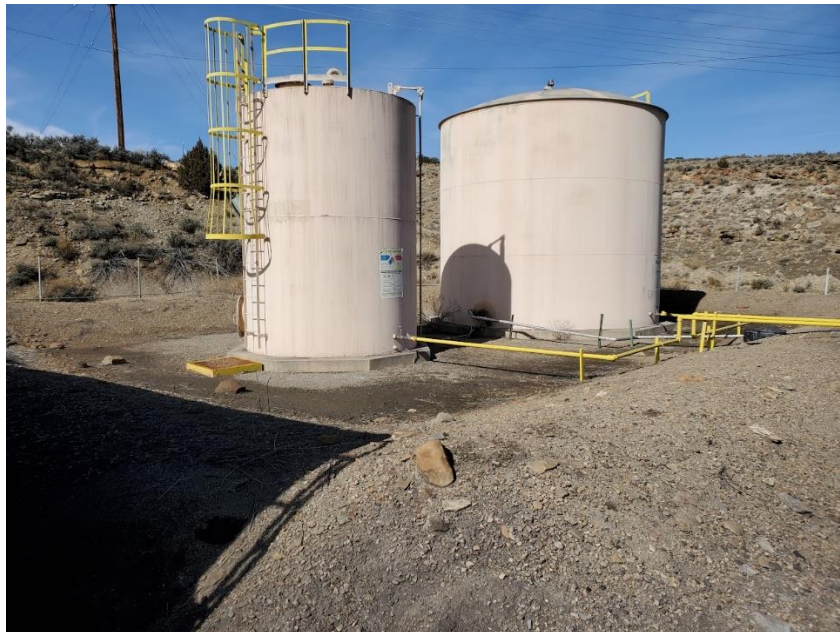
Hydrocarbons are being stored in accordance with best practices. Fuel is stored in double walled tanks near the haul road leaving the facilities area. In addition to double walled tanks there is also a earthen berm in place for containment (Photo 13).

Photo 12 – View to the east of fuel containment.

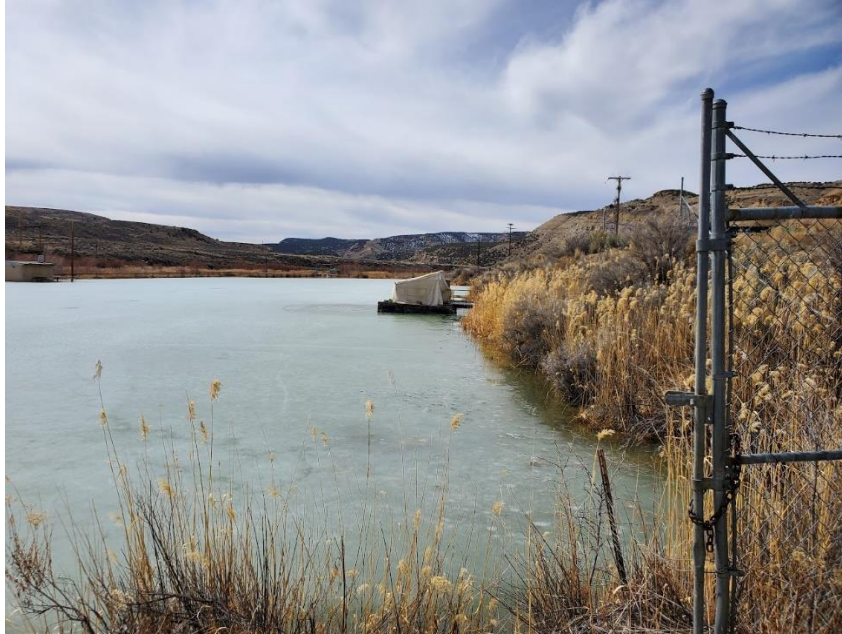
Photo 13 – View to the south of process water pond.

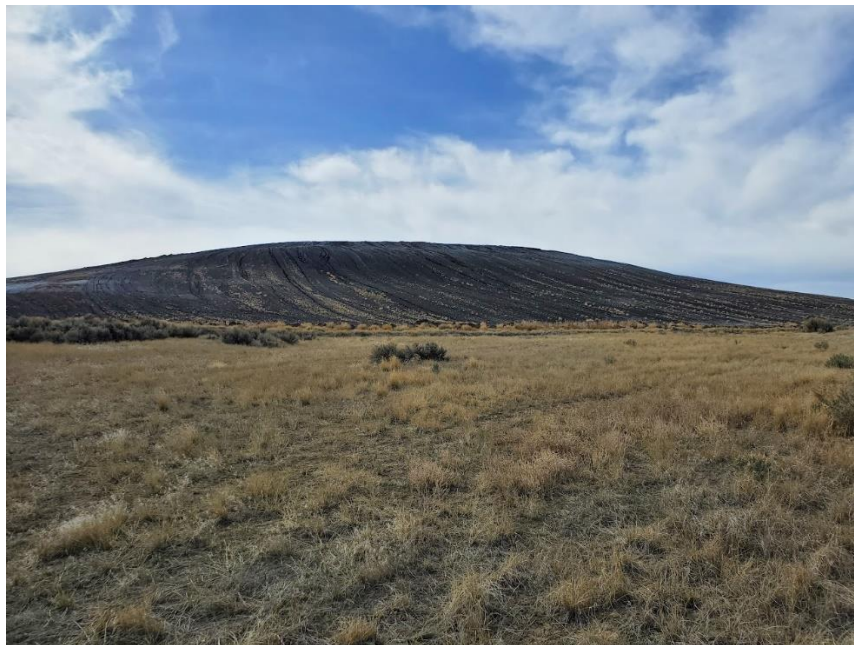
The RP-5a Pile appeared stable during the inspection. Erosion on the slopes of the pile has been noted in previous Division reports. Similar to the RP-2/3/4 Refuse Pile, these rills have not enlarged since the previous inspection. There were no signs of displacement or slumping on the refuse pile (Photo 14). A minor amount of vegetation is present on the slopes of the stack.

Photo 14 – View to the south of RP-5a refuse pile.

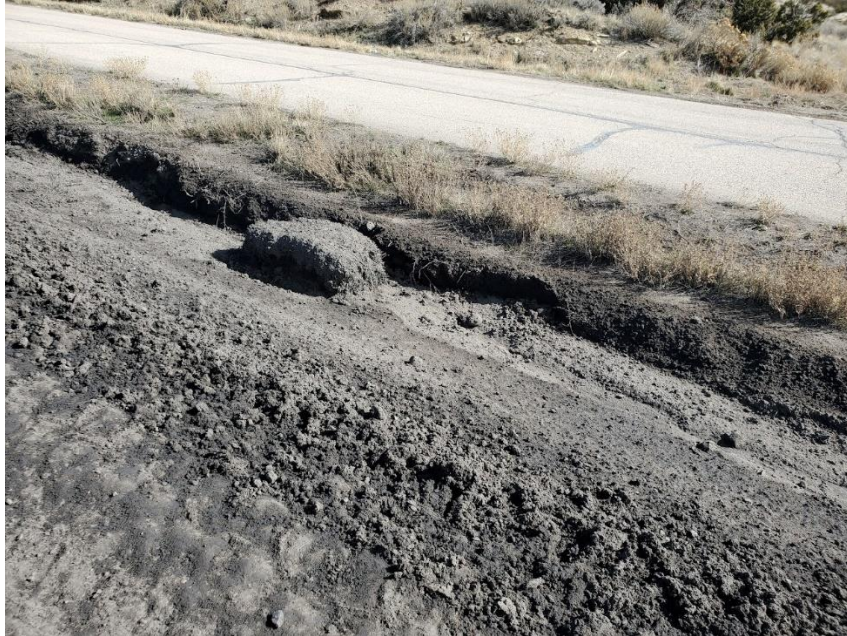
The Haul Road was clear and well maintained. There we no sections with ruts or other road damage. The road surface was treated for dust, and no noticeable amount of dust was generated by haul trucks. **The ditches that parallel the roads have excessive sediment and haybales used to control sediment are not functioning as designed. Bales are clogged with sediment stormwater is able to bypass bales (Photo 15). Please clean sediment from the drainage ditches that parallel the road and replace straw bales as needed.**

Photo 15 – View to the north of haul road drainage ditch with hay bale.

Please see the attached report from the complete inspection last week. As we discussed, I noted two maintenance items.
1) Updating the APEN page in the binder & 2) mucking out the haul road drainage ditch and replacing hay bales. Let me know if you have any questions. Hope you have a good weekend.

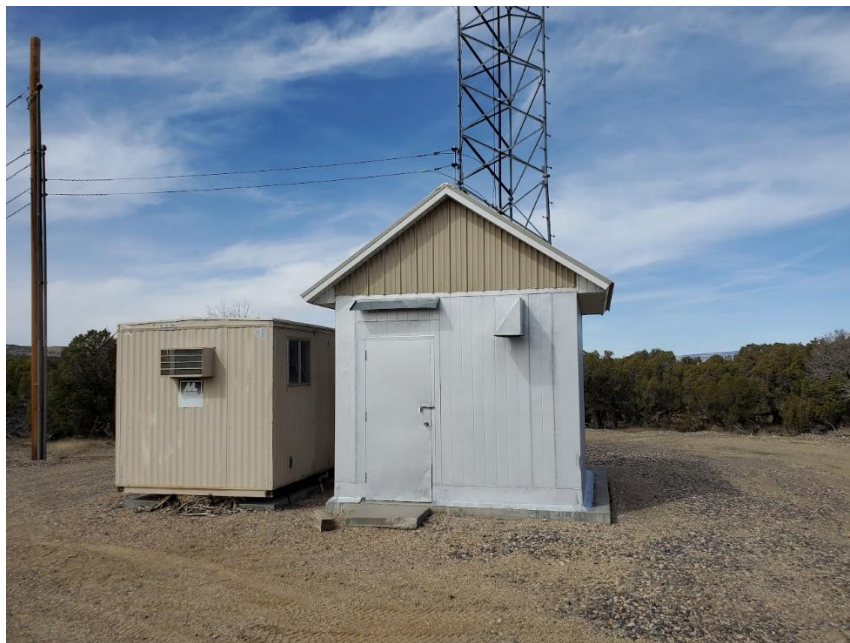
The pad for radio tower is located to the north of the Main facilities. The pad for the tower was stable with no indications of erosion (Photo 16).

Photo 16 – View to the east of radio tower pad.
