**MINERALS PROGRAM INSPECTION REPORT**  
**PHONE: (303) 866-3567**

<b>MINE NAME:</b> Lyons Quarry	<b>MINE/PROSPECTING ID#:</b> M-1977-208	<b>MINERAL:</b> Limestone (general)	<b>COUNTY:</b> Boulder
<b>INSPECTION TYPE:</b> Monitoring	<b>WEATHER:</b> Clear	<b>INSP. DATE:</b> March 5, 2025	<b>INSP. TIME:</b> 10:50
<b>OPERATOR:</b> CEMEX, Inc.	<b>OPERATOR REPRESENTATIVE:</b> Robin Simons	<b>TYPE OF OPERATION:</b> 112c - Construction Regular Operation	
<b>REASON FOR INSPECTION:</b> Normal I&E Program	<b>BOND CALCULATION TYPE:</b> Complete Bond	<b>BOND AMOUNT:</b> \$21,288,785.00	
<b>DATE OF COMPLAINT:</b> NA	<b>POST INSP. CONTACTS:</b> None	<b>JOINT INSP. AGENCY:</b> None	
<b>INSPECTOR(S):</b> Patrick Lennberg	<b>INSPECTOR'S SIGNATURE:</b>

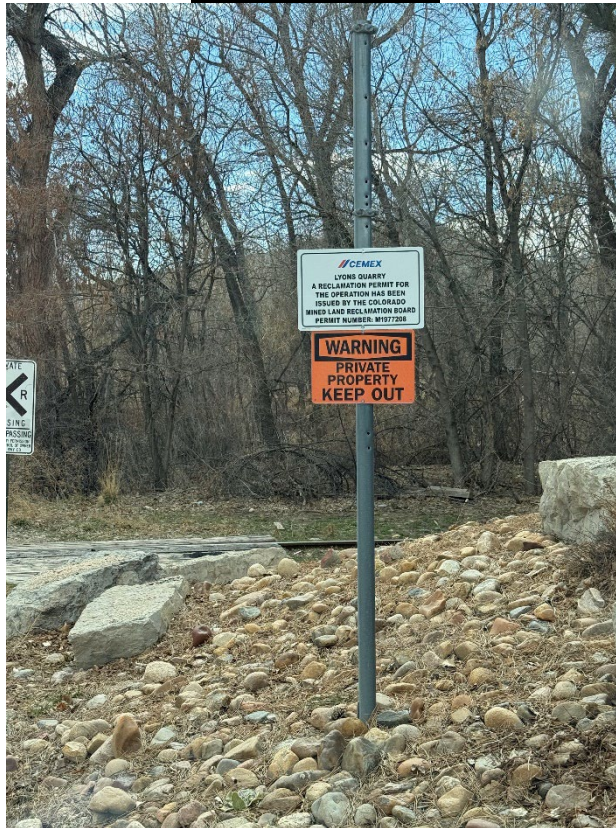
The site is 112c Construction Materials permit for 979.54 acres. The permit area is in Boulder County, approximately 2 miles southeast of Lyons, CO. The site is accessed from the north off Hwy 66. The post-mining land use for this site is pastureland. The affected lands are owned by the Operator. Mine signs were posted along the primary mine entrance as required by Rule 3.1.12.

Photo 1: Mine sign at the primary mine entrance

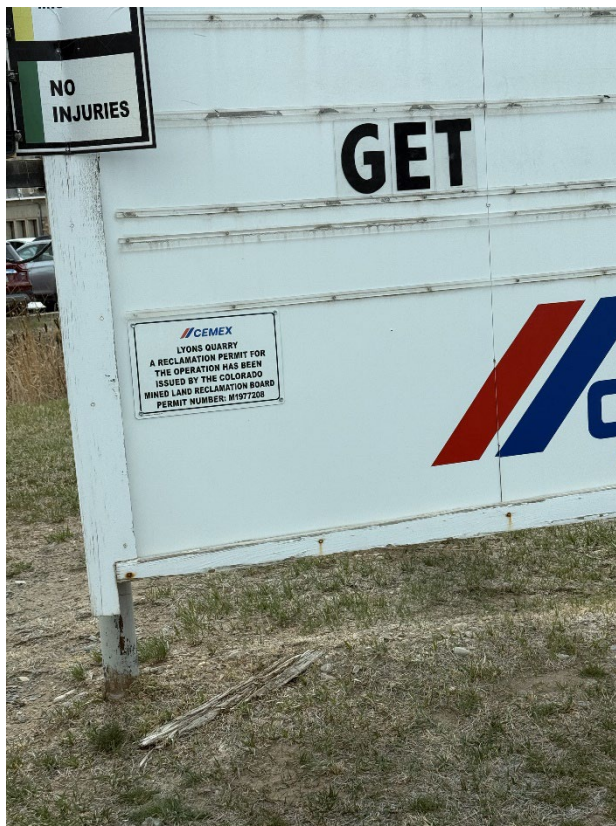
Photo 2: Mine sign at the entrance to plant area

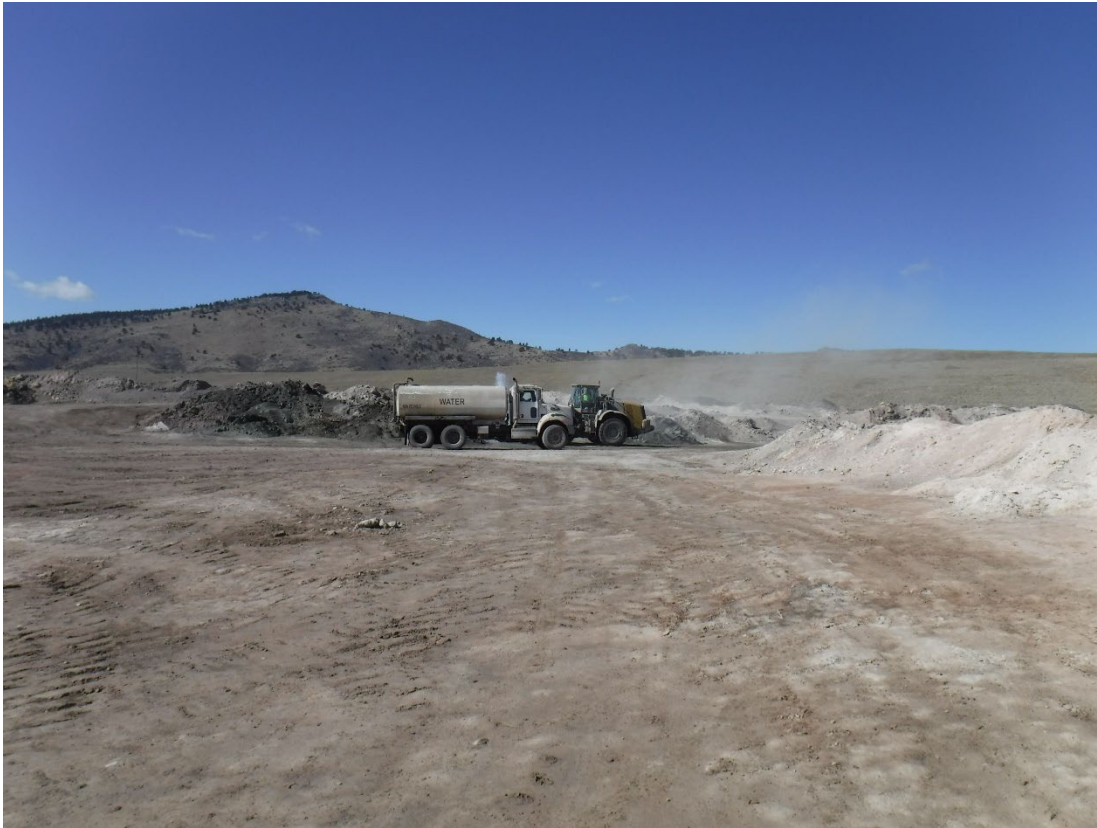
During the inspection the Division observed disposal of CKD material at the C-Pit area. The material was transported from the plant area to the C-Pit area where a water truck was used to spray the material as it was being placed on the ground. The Division did observe minimal dust originating from this activity. The Division continued its walk around C-Pit and noted that most area of exposed CKD had a crust on the surface and the other areas were damp and moist from the water truck. The Division observed that piping was in place to resume the use of sprinklers in the exposed CKD area of C-Pit. In discussing the C-Pit area the operator commented that they were using chemical dust suppressants approximately quarterly. The Division estimated the exposed CKD in the area to be less than 7 acres, per TR17, including the side slopes leading to the C-Pit Pond.

**Photo 3:** Water truck spraying bucket of loader

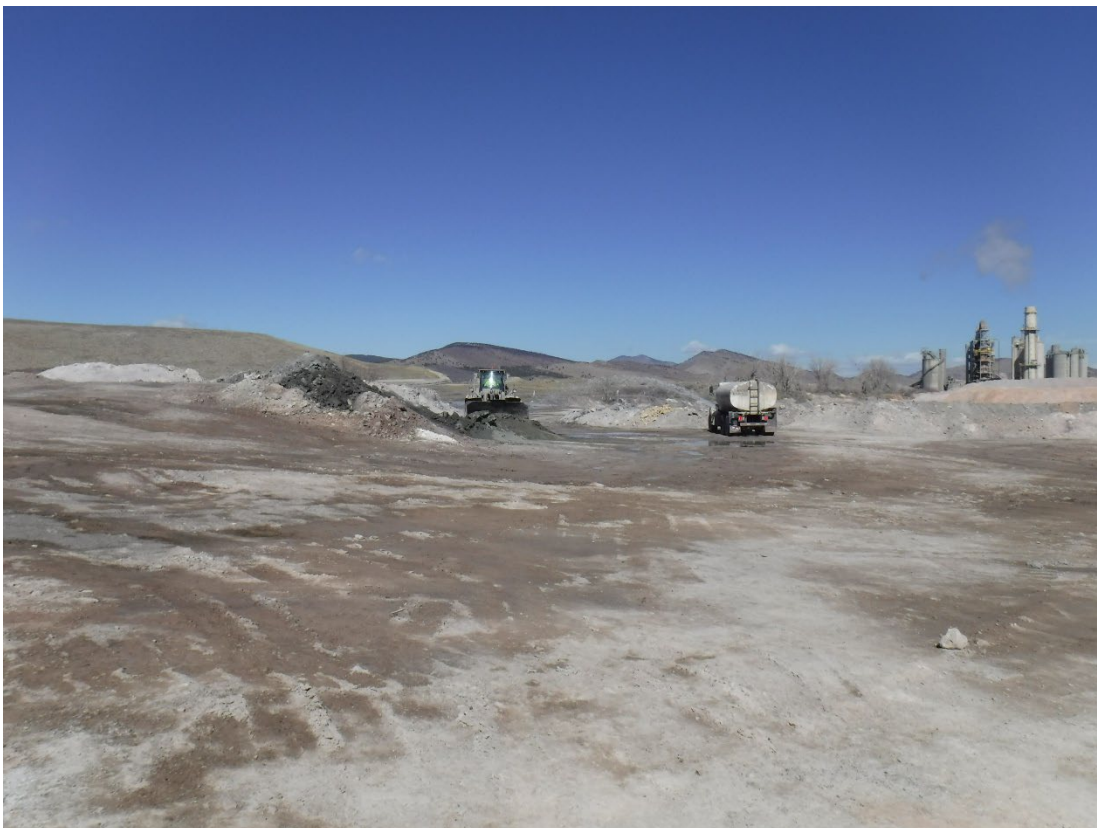
**Photo 4:** Loader and water truck after spraying bucket

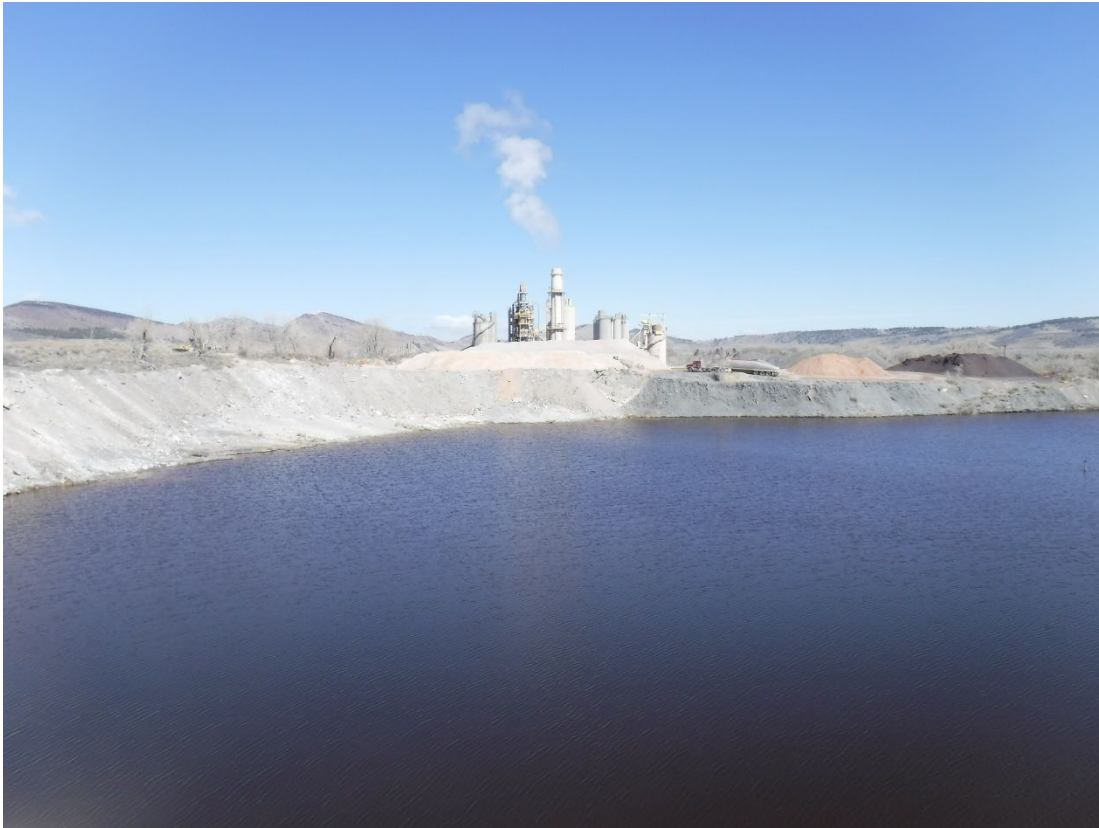
The site imports materials from various sources. Shale material is being sourced from the Arcosa mine in Jefferson County, sandstone, limestone, and gypsum are being sourced from their sandstone quarry and other quarries in Larimer County. Iron material is from the mid-west. During the inspection the Division did not observe any dust coming from the various stockpiles of material.

**Photo 5:** Looking from CKD disposal area across C-Pond at plant, stockpiles of materials center of photo

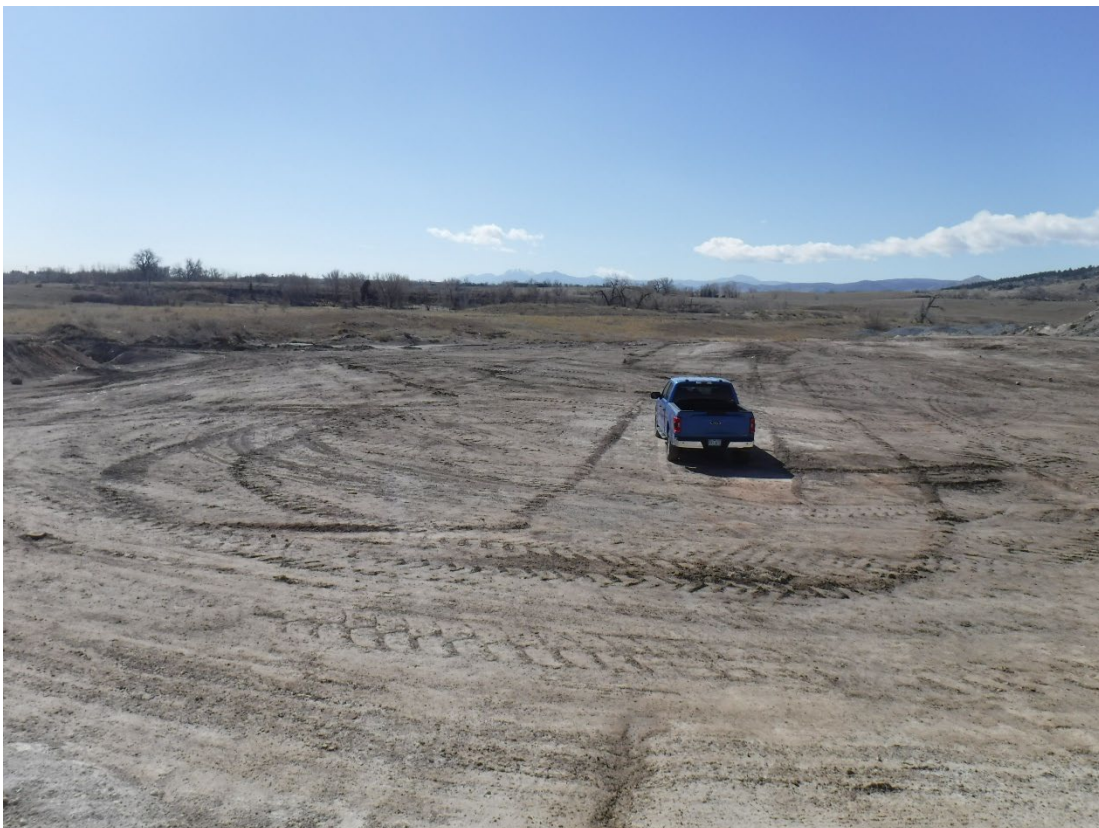
**Photo 6:** Looking south across CKD disposal area

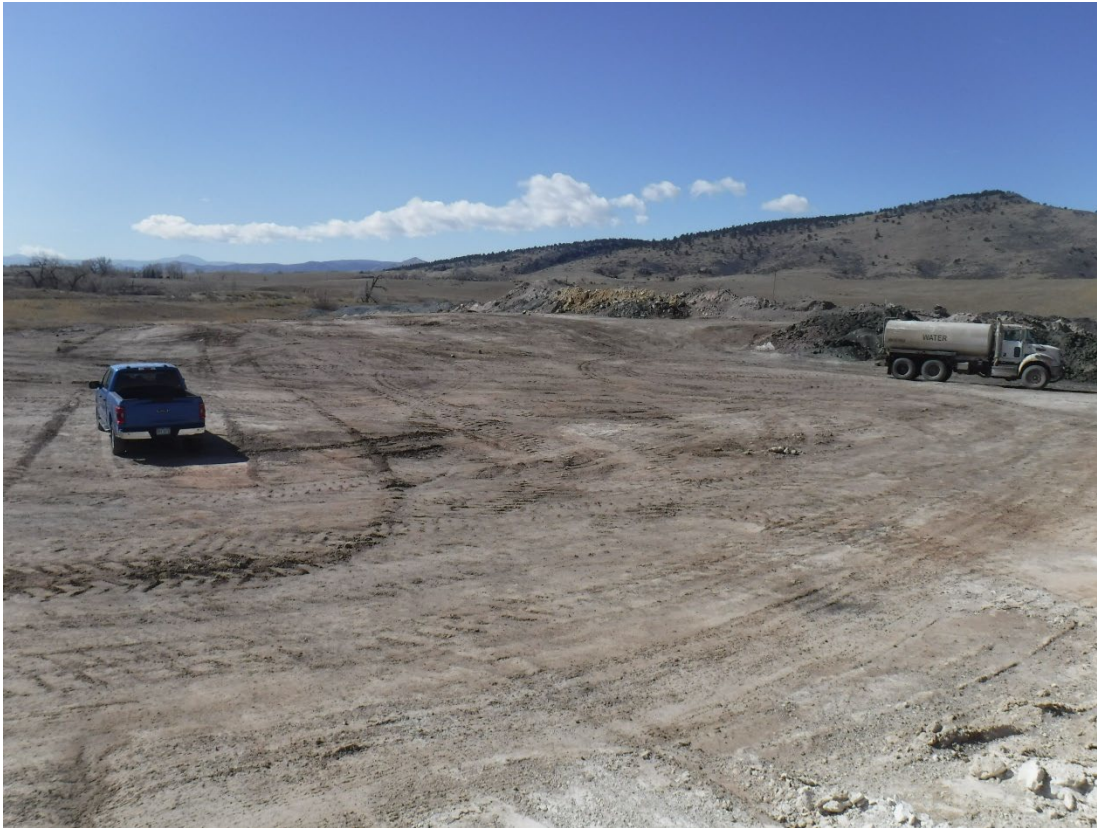
**Photo 7:** Looking southwest across CKD disposal area

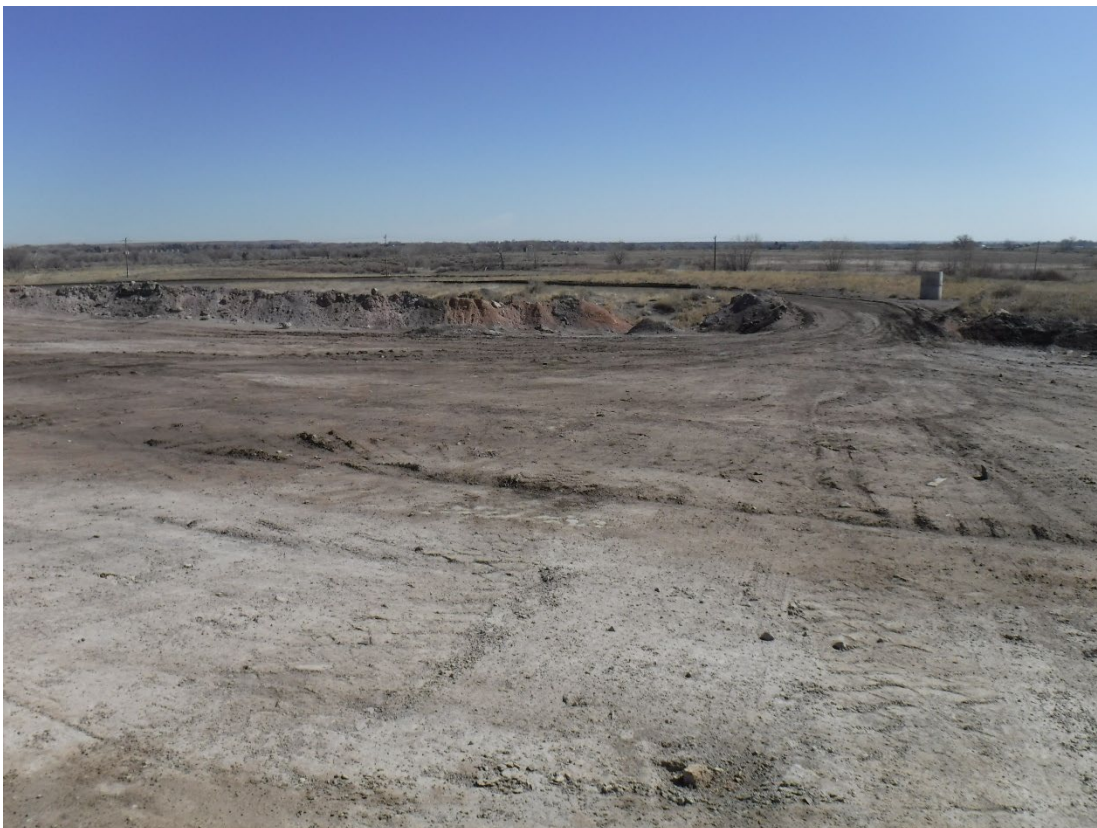
**Photo 8:** Looking east across CKD disposal area

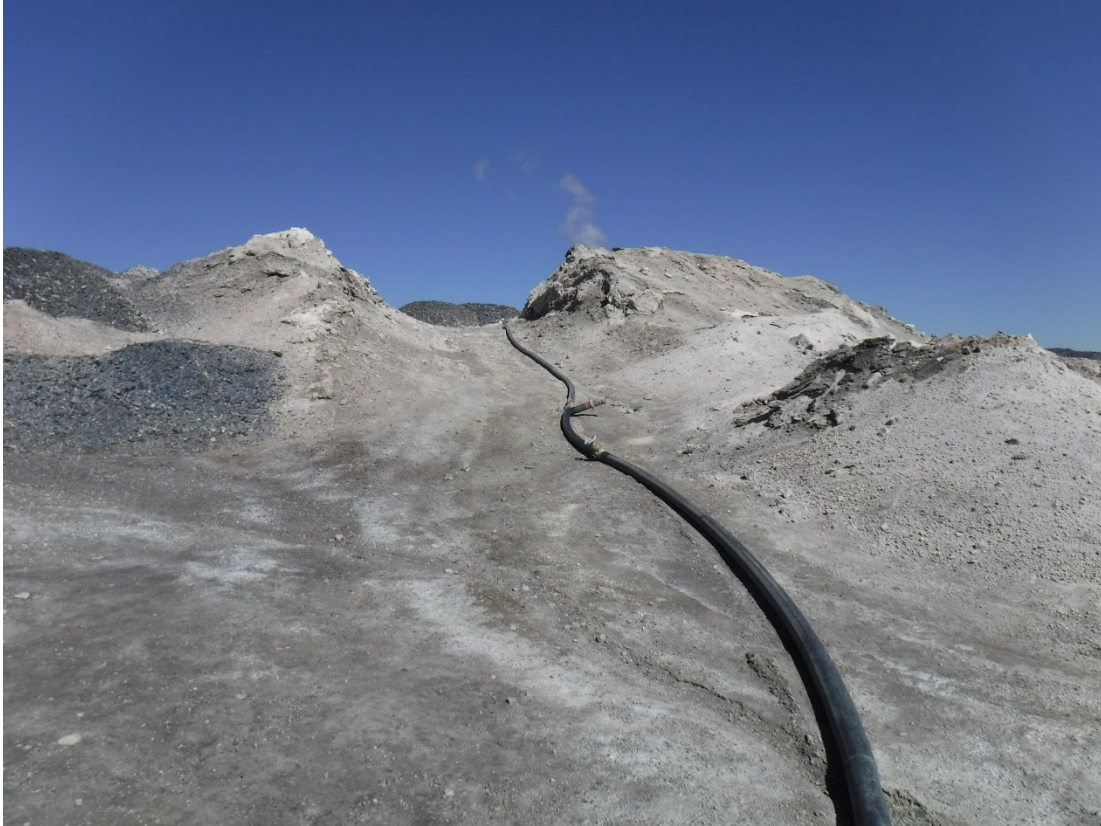
**Photo 9:** Sprinkler pipeline across CKD area looking north

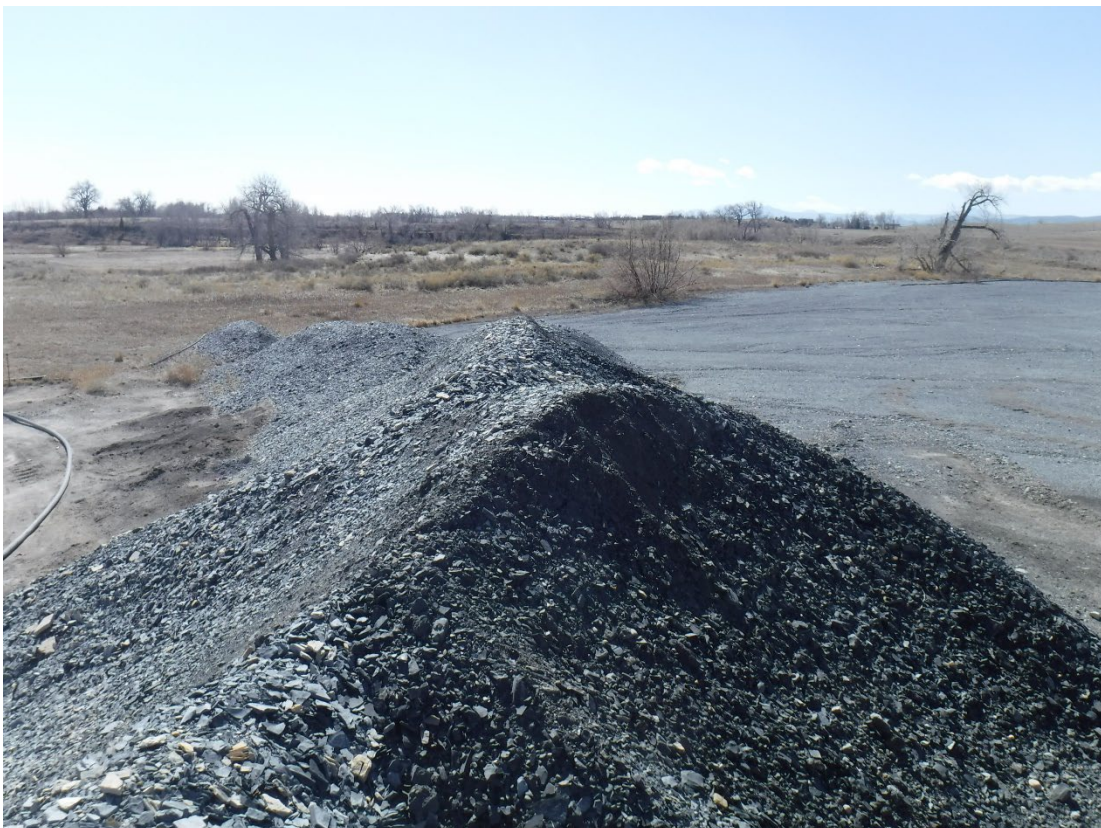
**Photo 10:** Shale cover material along edge of exposed CKD

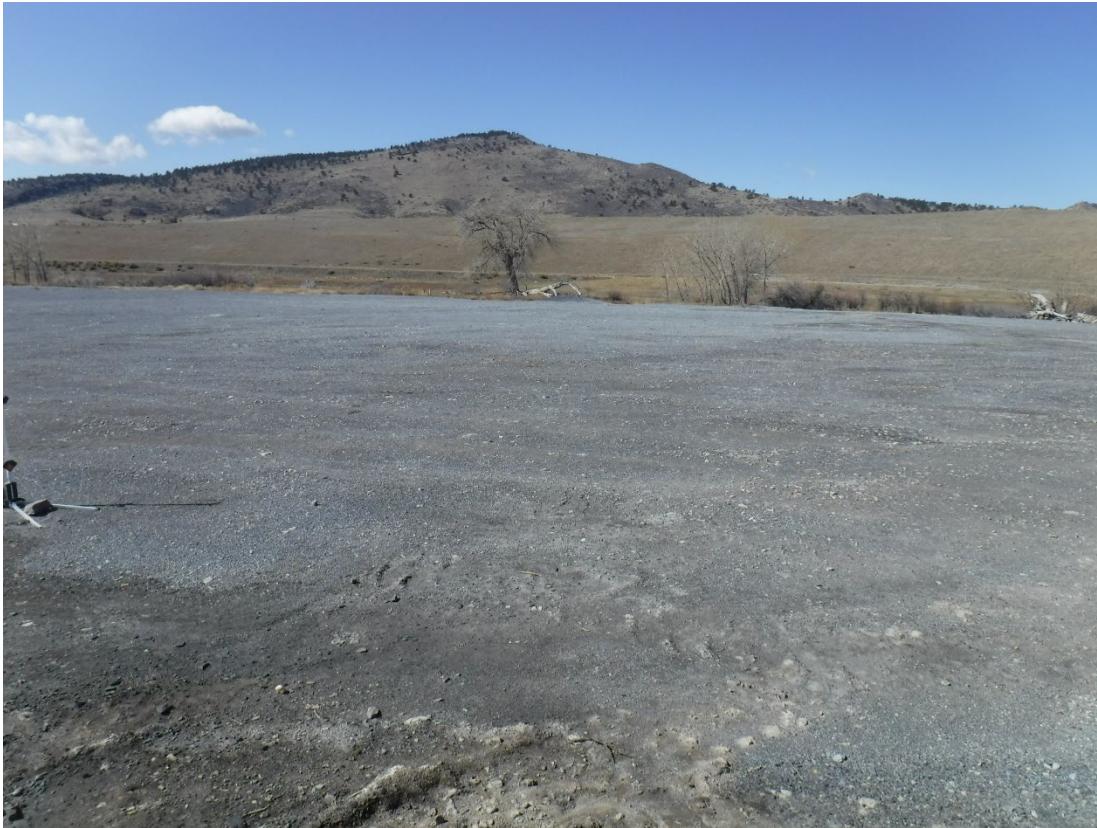
**Photo 11:** Shale cover material spread over CKD material, looking west

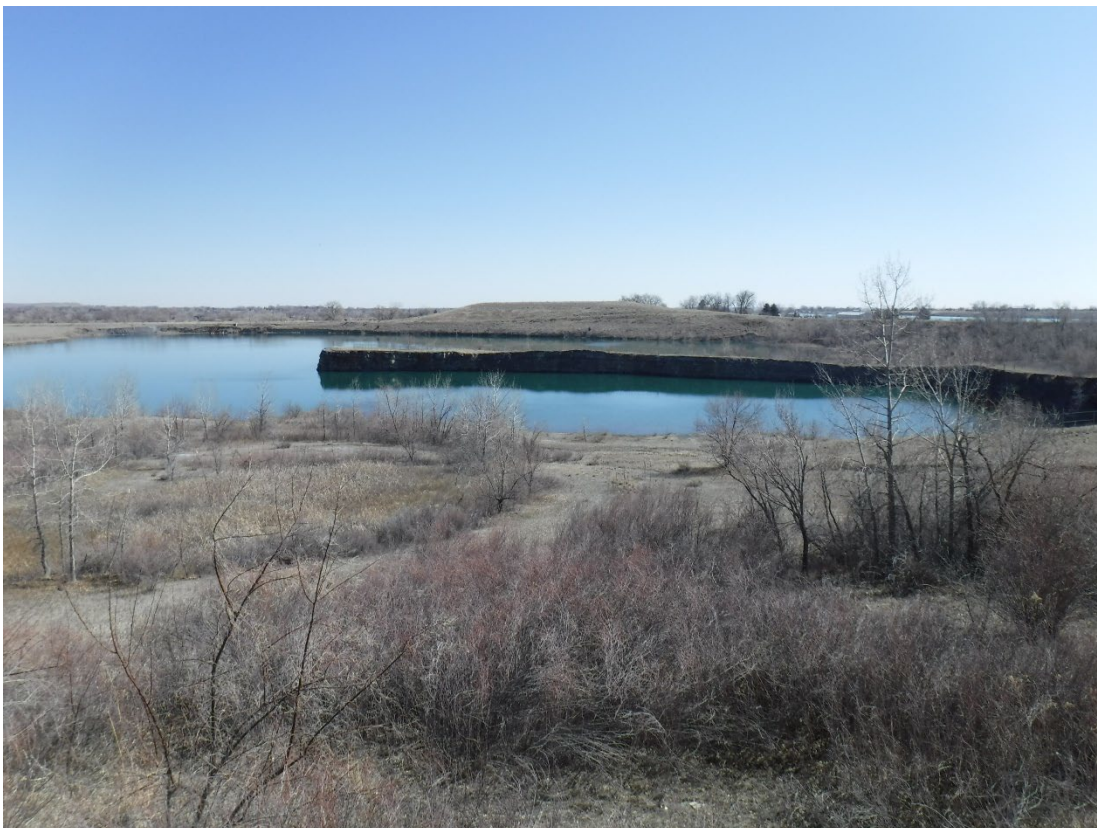
The Division observed the A-Pit area from a distance and did not note anything. The Division did observe that the operator had recently cut down a few Russian Olive Trees, a List B Noxious Weed in Colorado.

**Photo 12:** A-Pit area, looking east
