TRAPPER MINING INC.
CRAIG, COLORADO

HORSE GULCH FILL
QUARTERLY FILL CERTIFICATION

Horse Gulch Fill Quarterly Inspection Report

First Quarter 2025

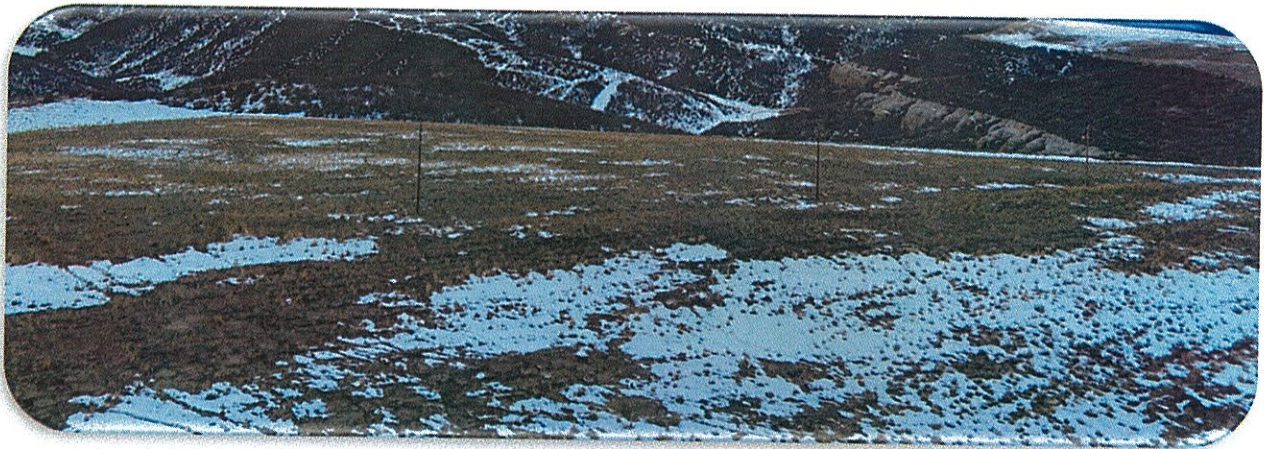
No appearances of instability, structural weakness, or other hazardous conditions were observed. Both the southeast side of the fill and the northeast side of the fill were inspected this quarter (Photographs 1 and 2). The area where cracks were detected on the top south portion of the dump during the first quarter of 2013 inspection was checked. There was no additional cracking found.

Photograph 1: North-east Side Looking South-west (3/13/2025)

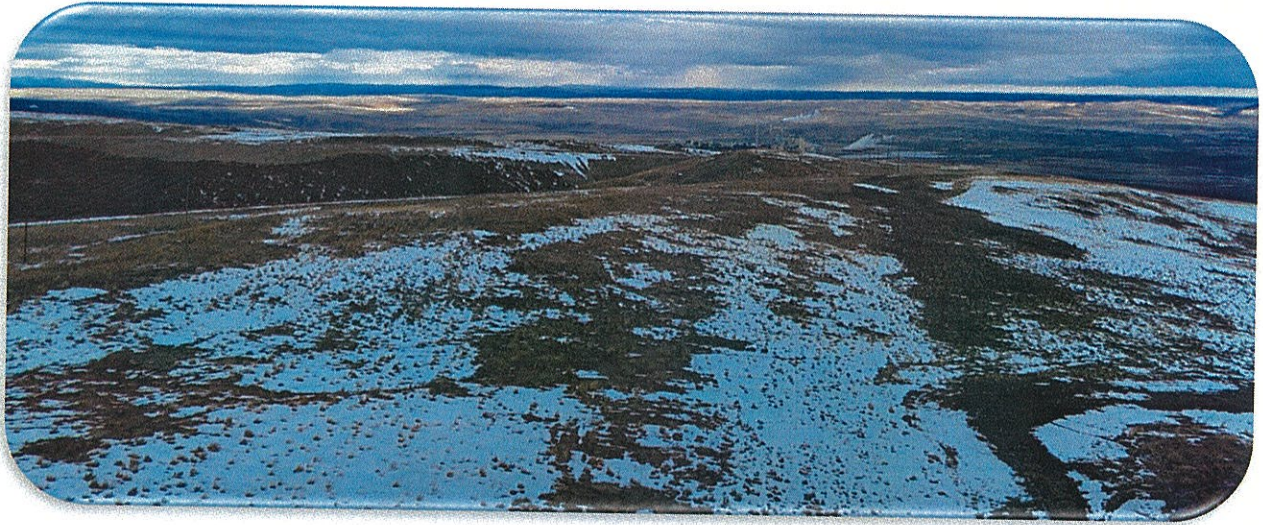
Photograph 2: South Side Looking North (3/13/2025)

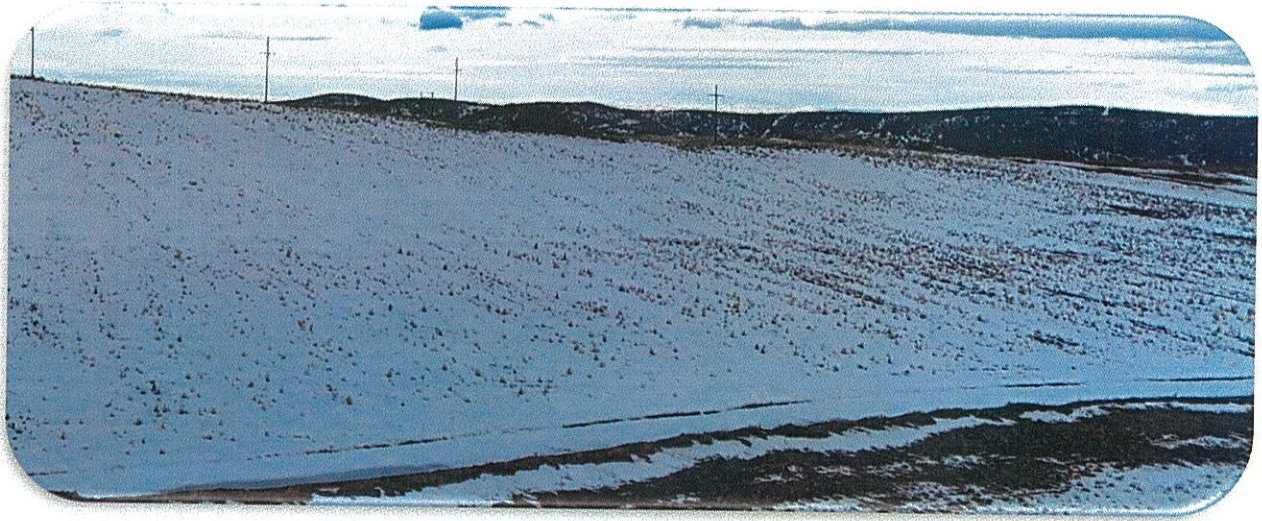
There was no placement of material or contour work done on the fill this quarter. All the required material for the fill has been placed and compacted. It is anticipated there will be no more additional fill material placed on the fill.

Photograph 3 depicts the east facing slope of the fill.

Photograph 3: East Side of the Fill Looking North-west (3/13/2025)
