Fremont Gravel Pit M1984117

M-1984-117 Fremont Gravel Pit Post Inspection Map

FREMONT COUNTY PIT
M-1984-117
9.85 ACRES

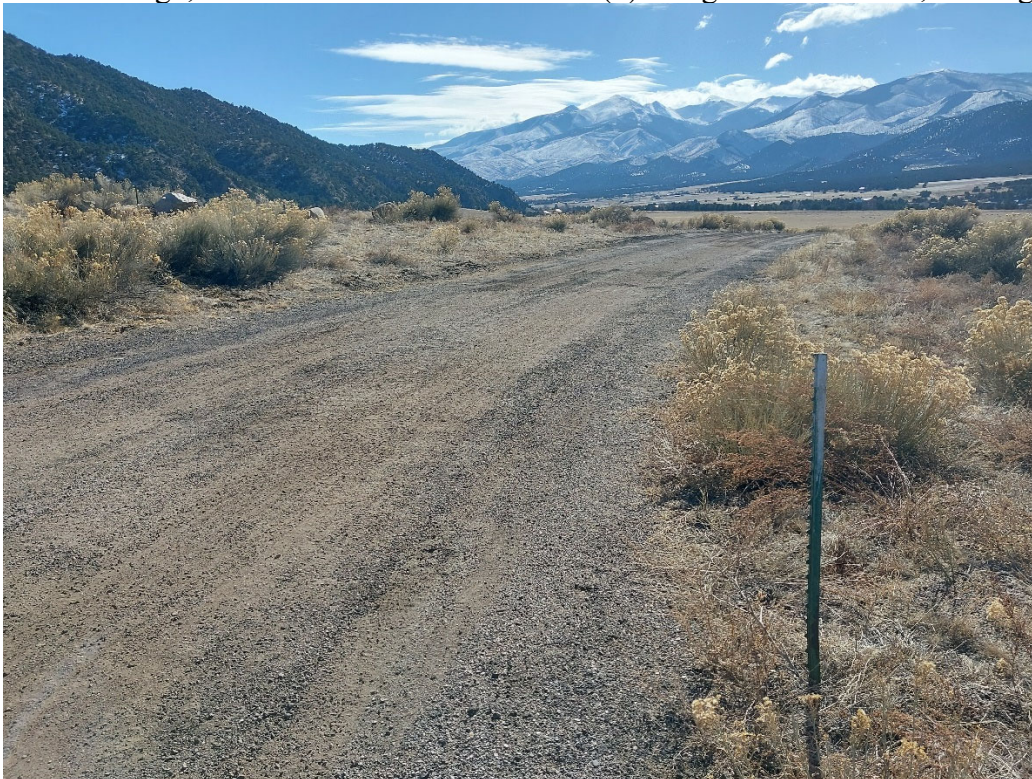
Photo #2: T-post marking the NW corner of the permit boundary; looking south.

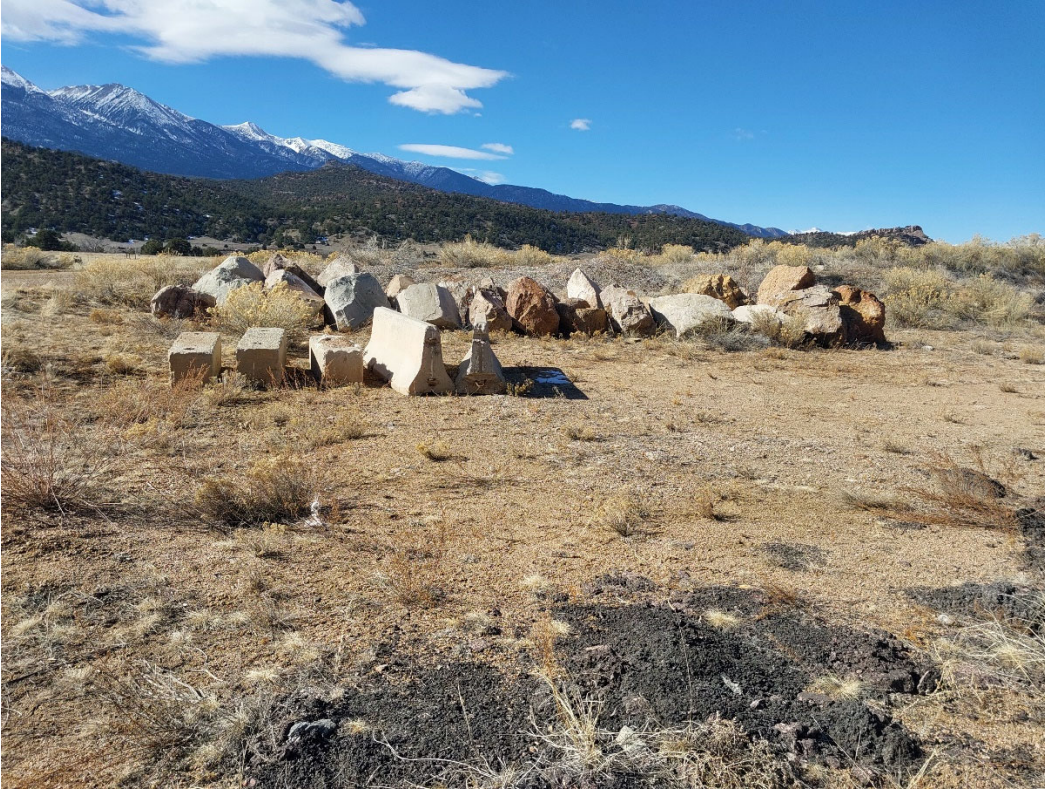
Photo #11: View of the concrete and large boulders used for county road projects, situated along the southwestern portion of the pit area; looking to the northwest.

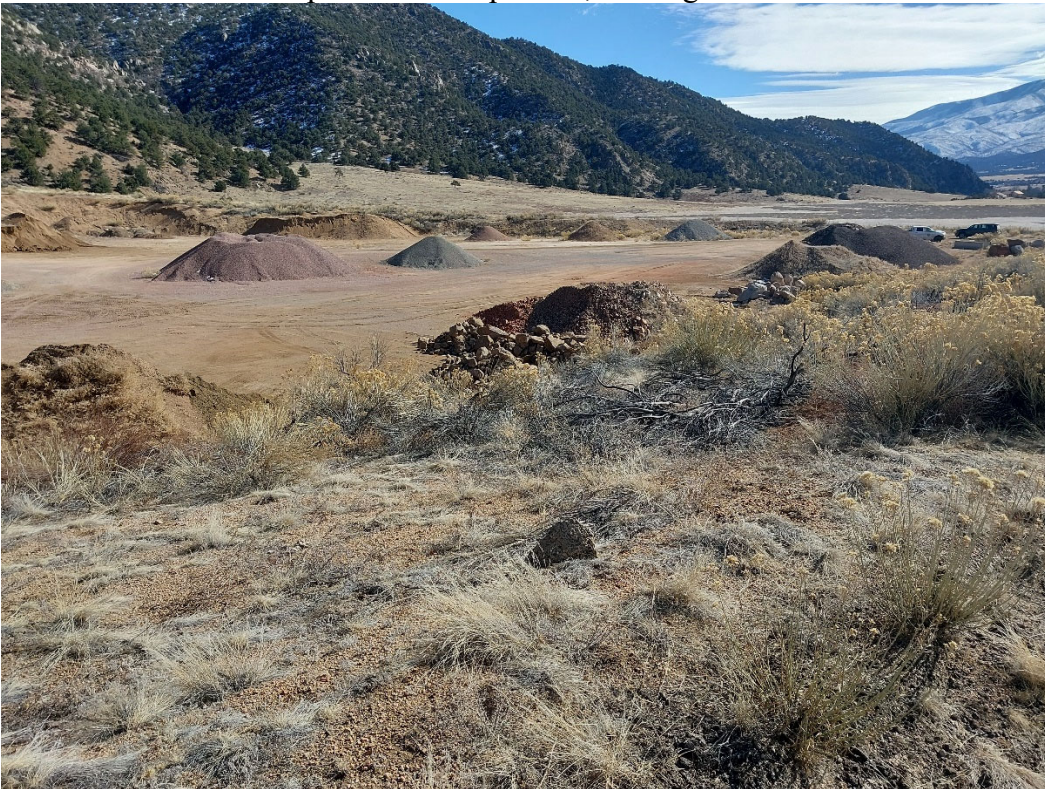
Photo #12: View of the stockpiled material observed on the pit floor; looking to the south-southeast. Much of the material viewed are imported materials.
