MINERALS PROGRAM INSPECTION REPORT
PHONE: (303) 866-3567

MINE NAME: Climax Mine	MINE/PROSPECTING ID#: M-1977-493	MINERAL: Molybdenum	COUNTY: Lake
INSPECTION TYPE: Monitoring	WEATHER: Snowing	INSP. DATE: March 19, 2025	INSP. TIME: 11:15
OPERATOR: Climax Molybdenum Company, Climax Mine	OPERATOR REPRESENTATIVE: Alex Ungers	TYPE OF OPERATION: 112d-3 - Designated Mining Operation	
REASON FOR INSPECTION: Normal I&E Program	BOND CALCULATION TYPE: None	BOND AMOUNT: \$284,783,656.00	
DATE OF COMPLAINT: NA	POST INSP. CONTACTS: DRMS	JOINT INSP. AGENCY: None	
INSPECTOR(S): Amy Yeldell	INSPECTOR'S SIGNATURE:

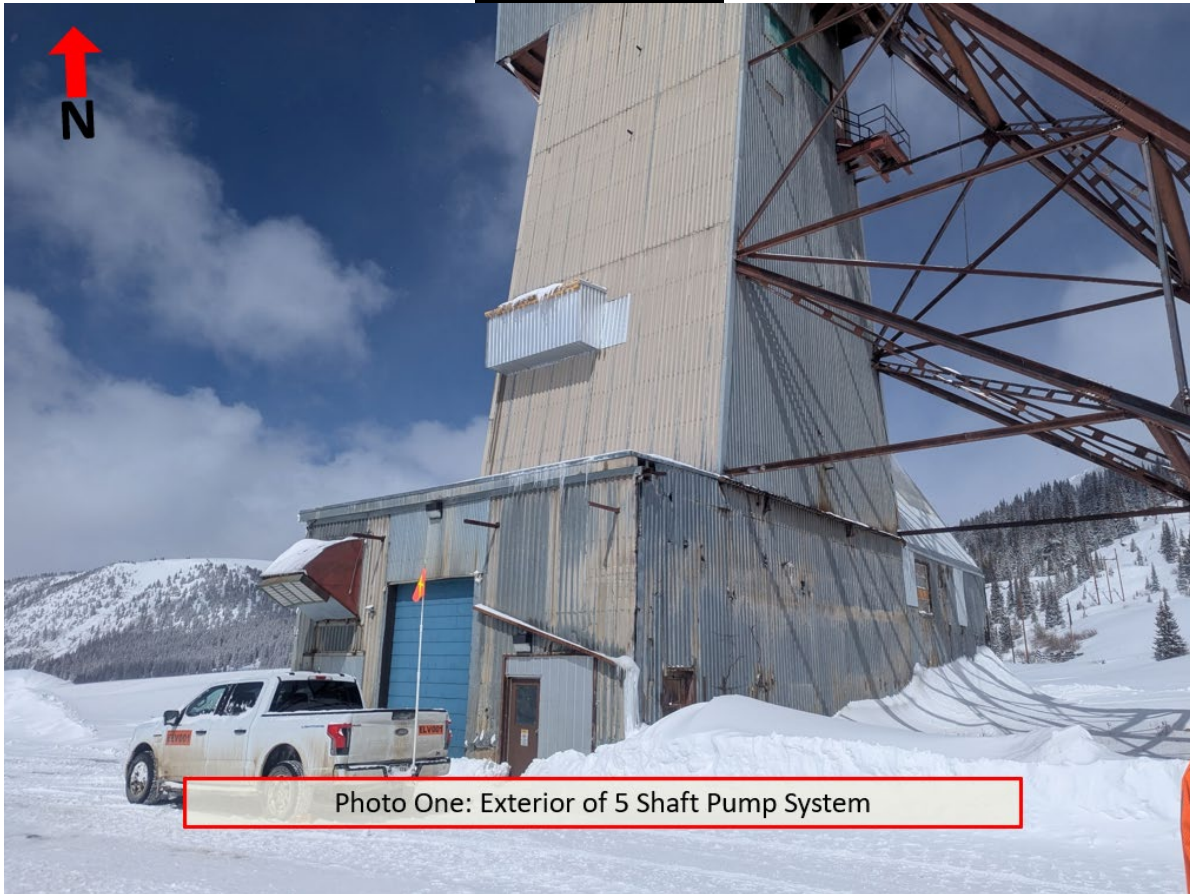
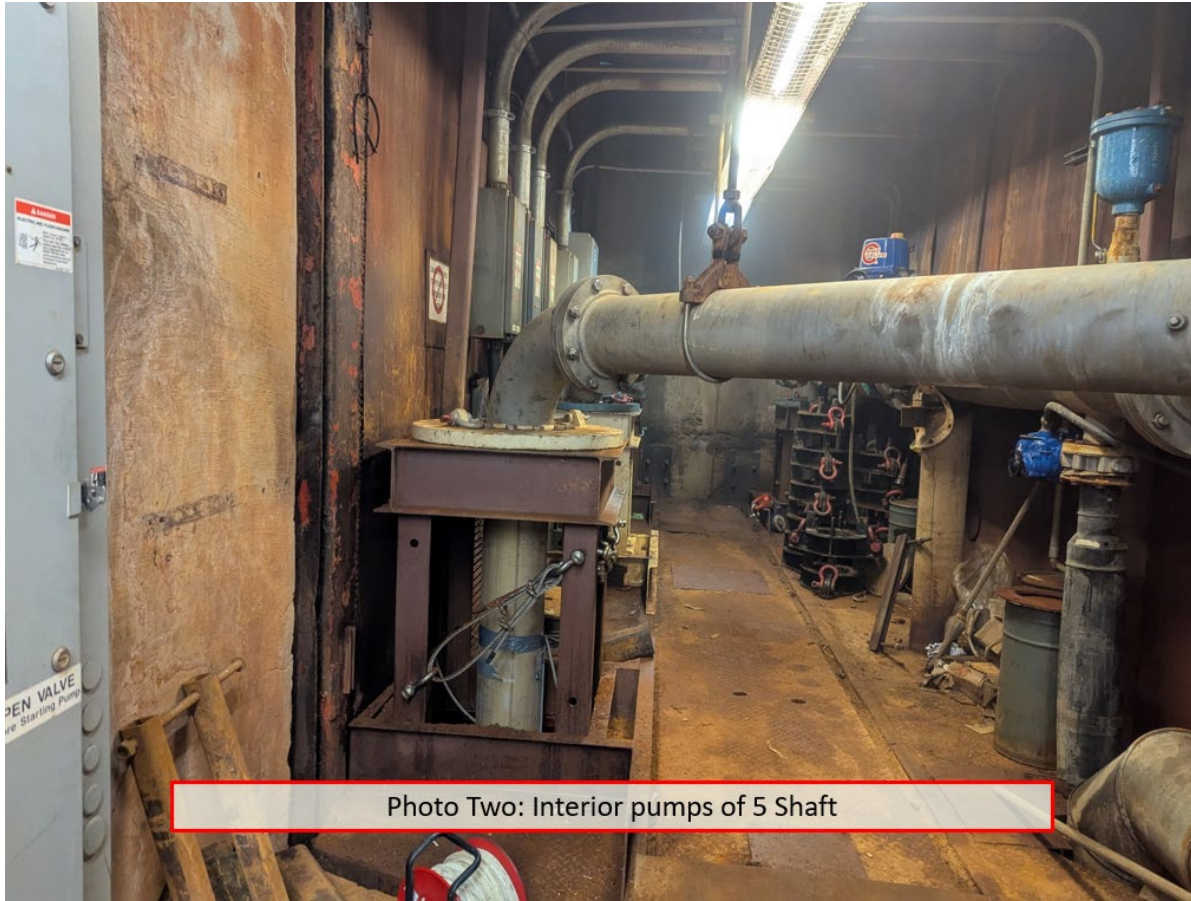
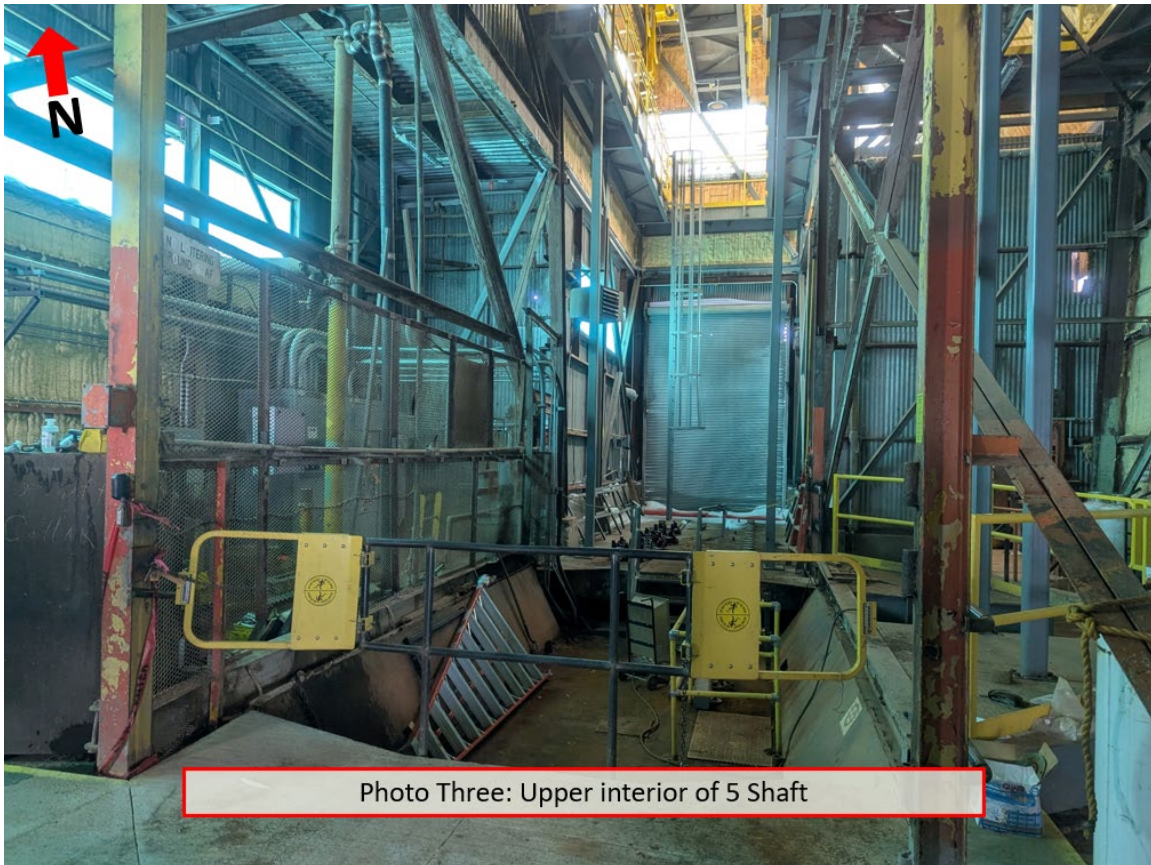
5 Shaft Pump System (Photos One thru Three)

Storm water becomes impacted as it passes through the open pit area and collects in the underground mine workings. The 5-Shaft Pump System serves to maintain the water level in the pit and underground workings at a level below which could impact the Arkansas Basin. The level of water in 5-Shaft is kept below the apex of the Mosquito Fault in order to prevent mine impacted water from potentially impacting the Arkansas River. Impacted water is pumped from 5-Shaft through the Storke Pipeline to the ETDL and water treatment/process circuit in the Tenmile Creek watershed. No leaks or other apparent problems were noted in this area.

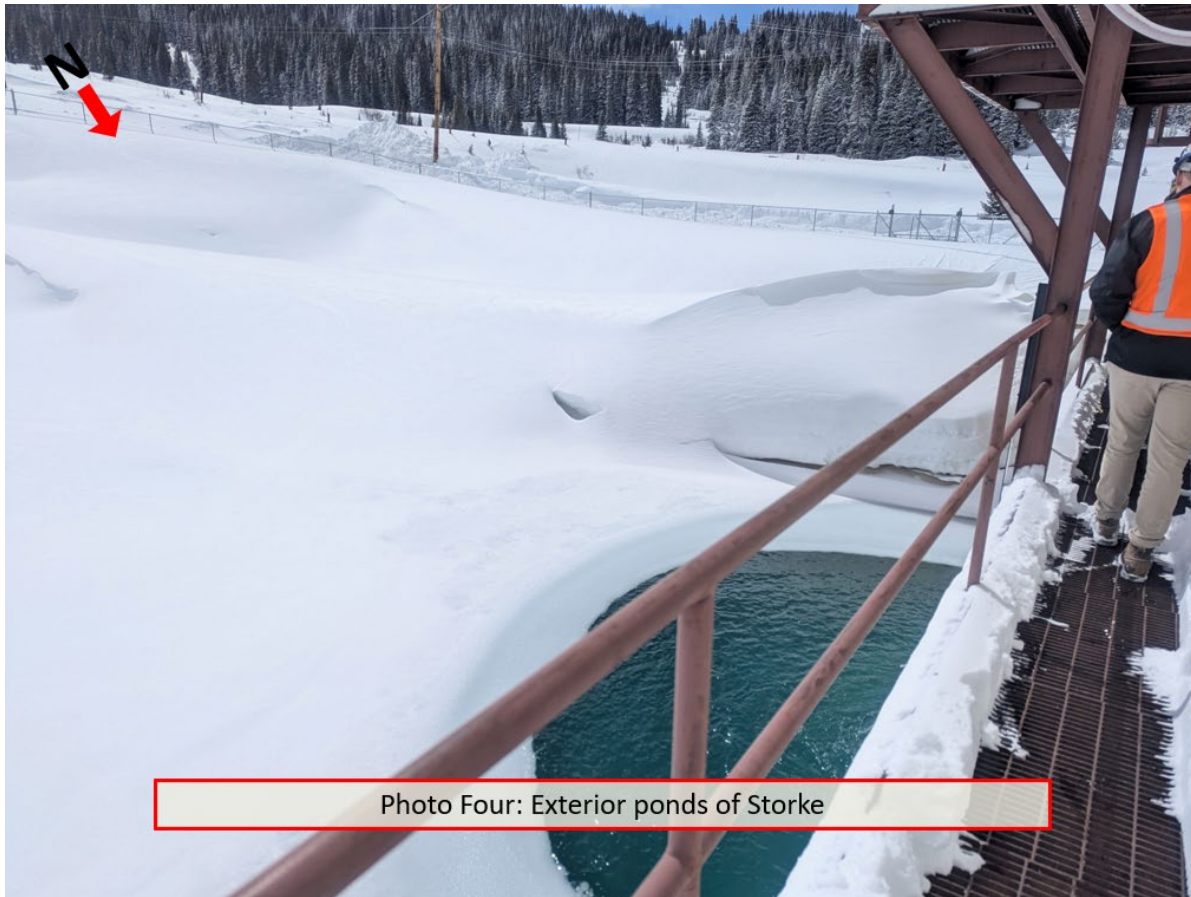
The Storke Wastewater Pump Station is located just below the Storke Yard on the other side of Freemont Pass which reports to the Arkansas River. It consists of two concrete lined ponds which collect seepage and stormwater. The potentially impacted water collected then pumped into the ETDL where it mixes with other mine water prior to treatment and discharge into Tenmile Creek. Ponds were located within a fenced in area and buildings were secure.

Photo Four: Exterior ponds of Storke

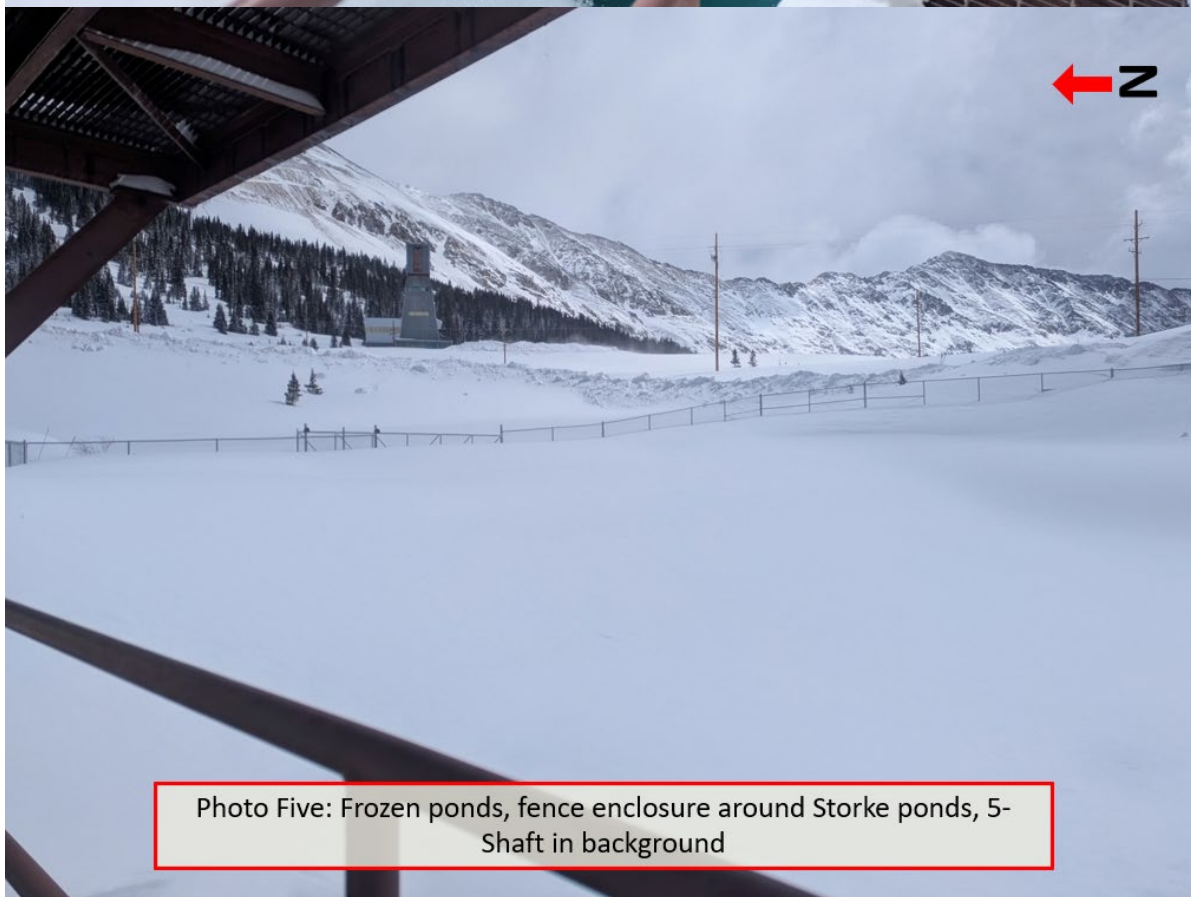
Photo Five: Frozen ponds, fence enclosure around Storke ponds, 5-Shaft in background

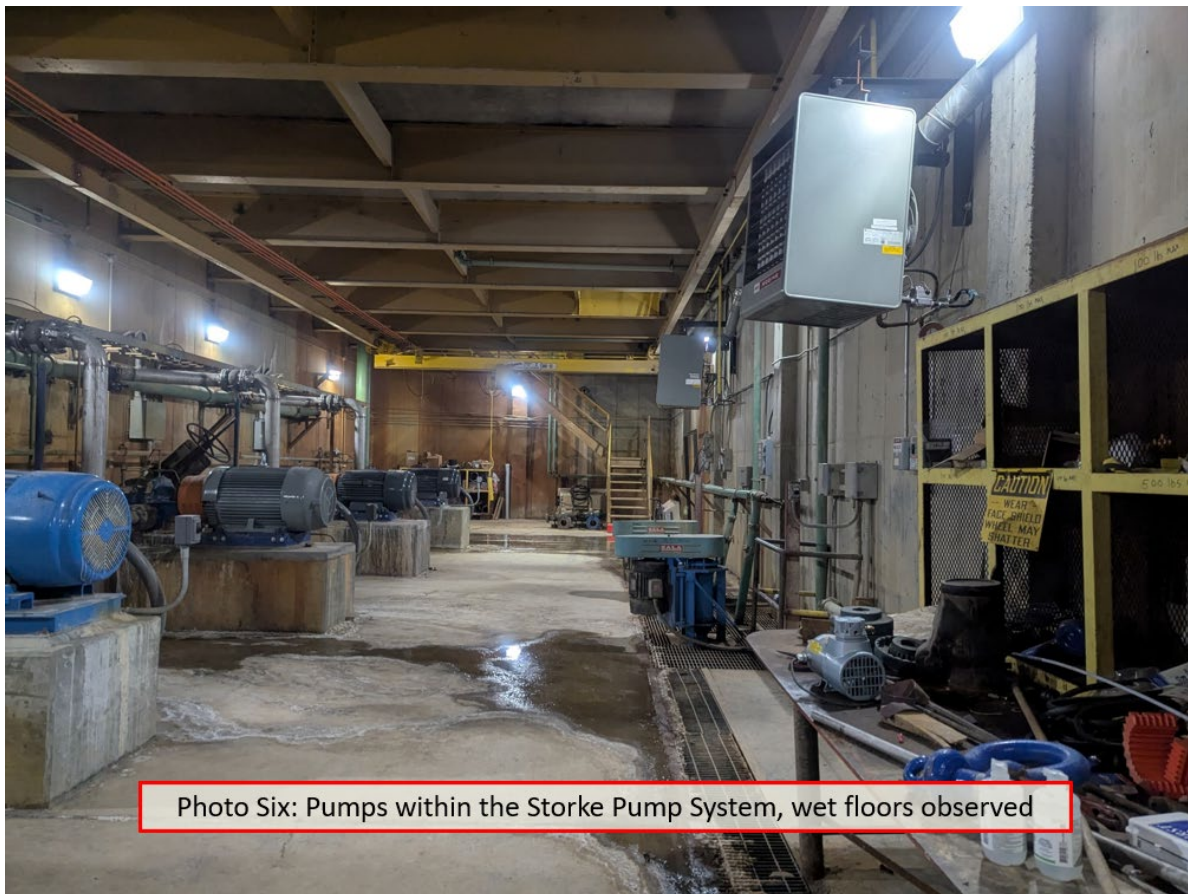
Sludge and other sedimentation were cleaned out of the ponds earlier the previous summer (2024). Removed sediment and sludges were placed in SDP Sludge cell. The water in the ponds appeared clean and ponds had sufficient freeboard. Mr. Ungers explained that the system has redundant pumps so at any time 2 pumps are functioning and 2 are backups. Minor leaking was observed from the pumps which was indicated to be normal and has been indicated in previous inspections. Leaks reported to the in-floor sumps which go back to the ponds. Sumps were clean with no build up and appeared to be functioning properly.

Photo Six: Pumps within the Storke Pump System, wet floors observed

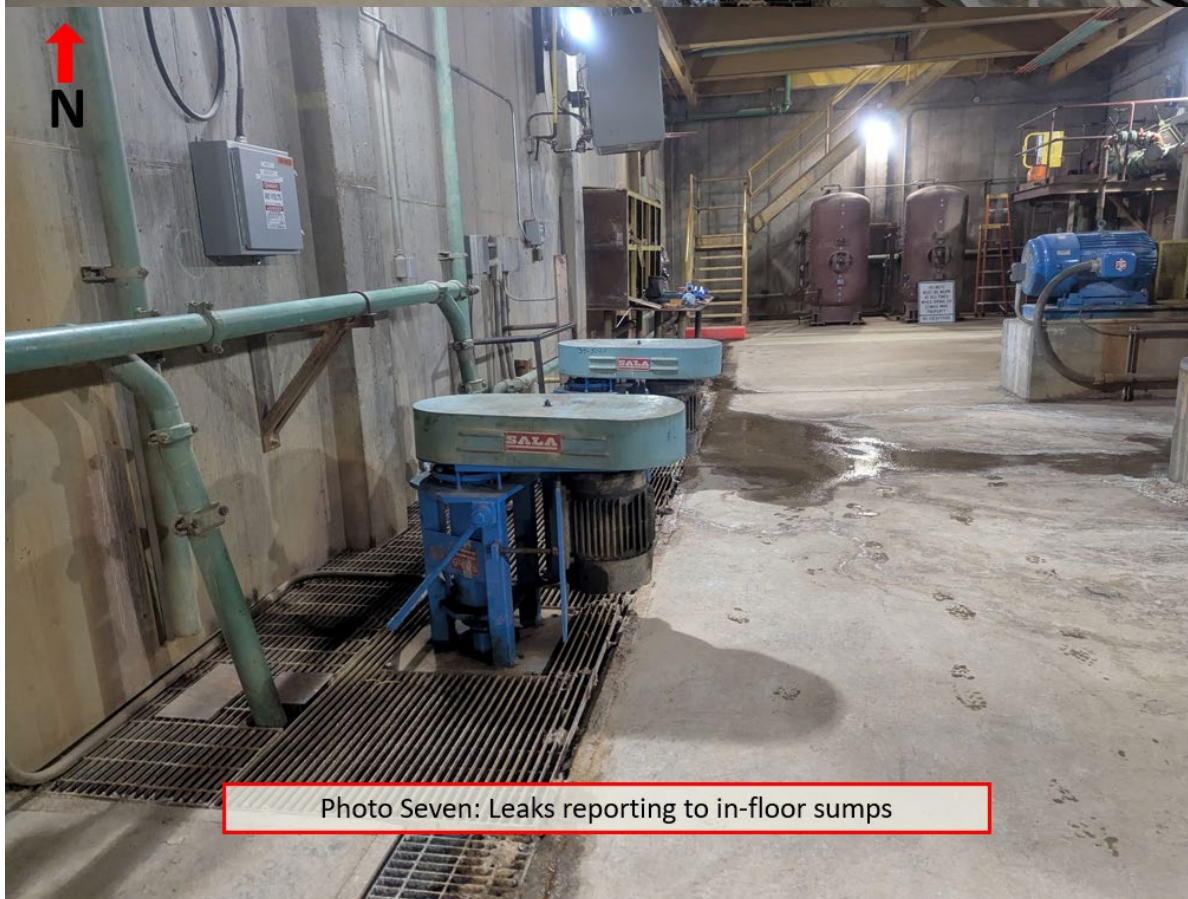
Photo Seven: Leaks reporting to in-floor sumps

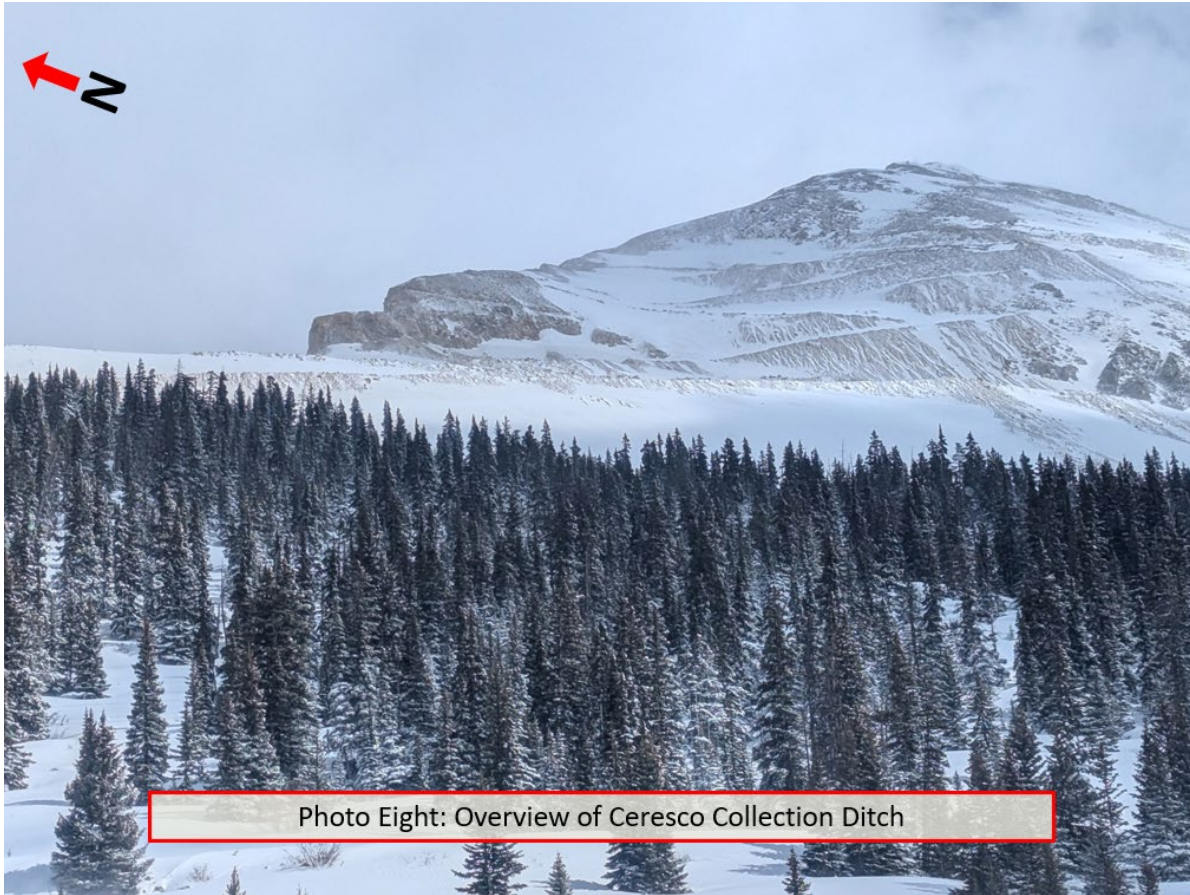
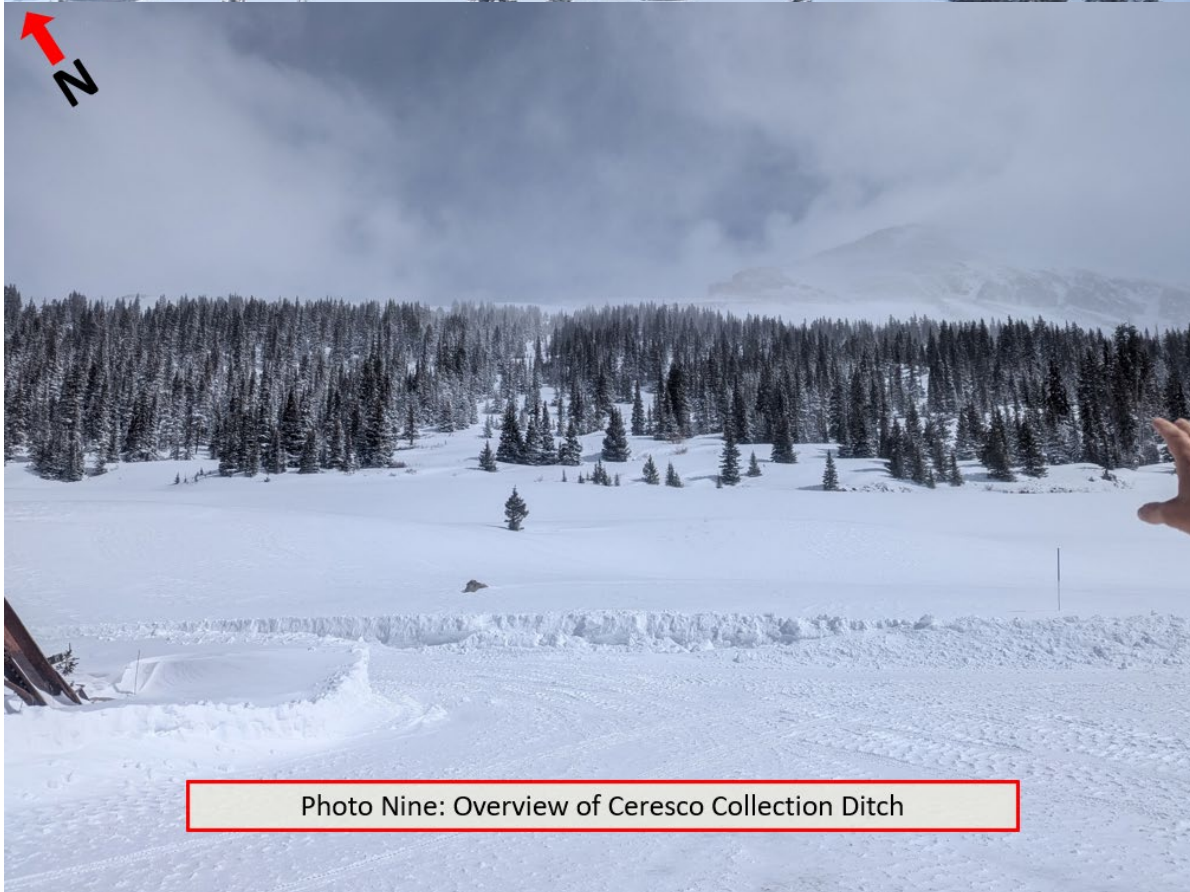
Ceresco Seepage Collection System (Photos Eight and Nine)

The Ceresco Seepage Collection System consists of a ditch constructed below the Ceresco Ridge haul road. The collection ditch intercepts potentially impacted water and routes it to the Camp drainage, and then to water treatment. The Ceresco Seepage Collection Ditch could not be directly observed. Access from the top haul road was precluded based on weather, only observations were made from the 5 Shaft area. Overall, the Ditch appeared to be in good shape and is anticipated to function properly once temperatures increase and seepage water is intercepted. No flowing water was observed in the ditch.
